RAILROAD ACCIDENT REPORT

**REAR-END COLLISION OF
CONRAIL COMMUTER TRAINS
PHILADELPHIA, PENNSYLVANIA**

OCTOBER 16, 1979

NTSB-RAR-80-5

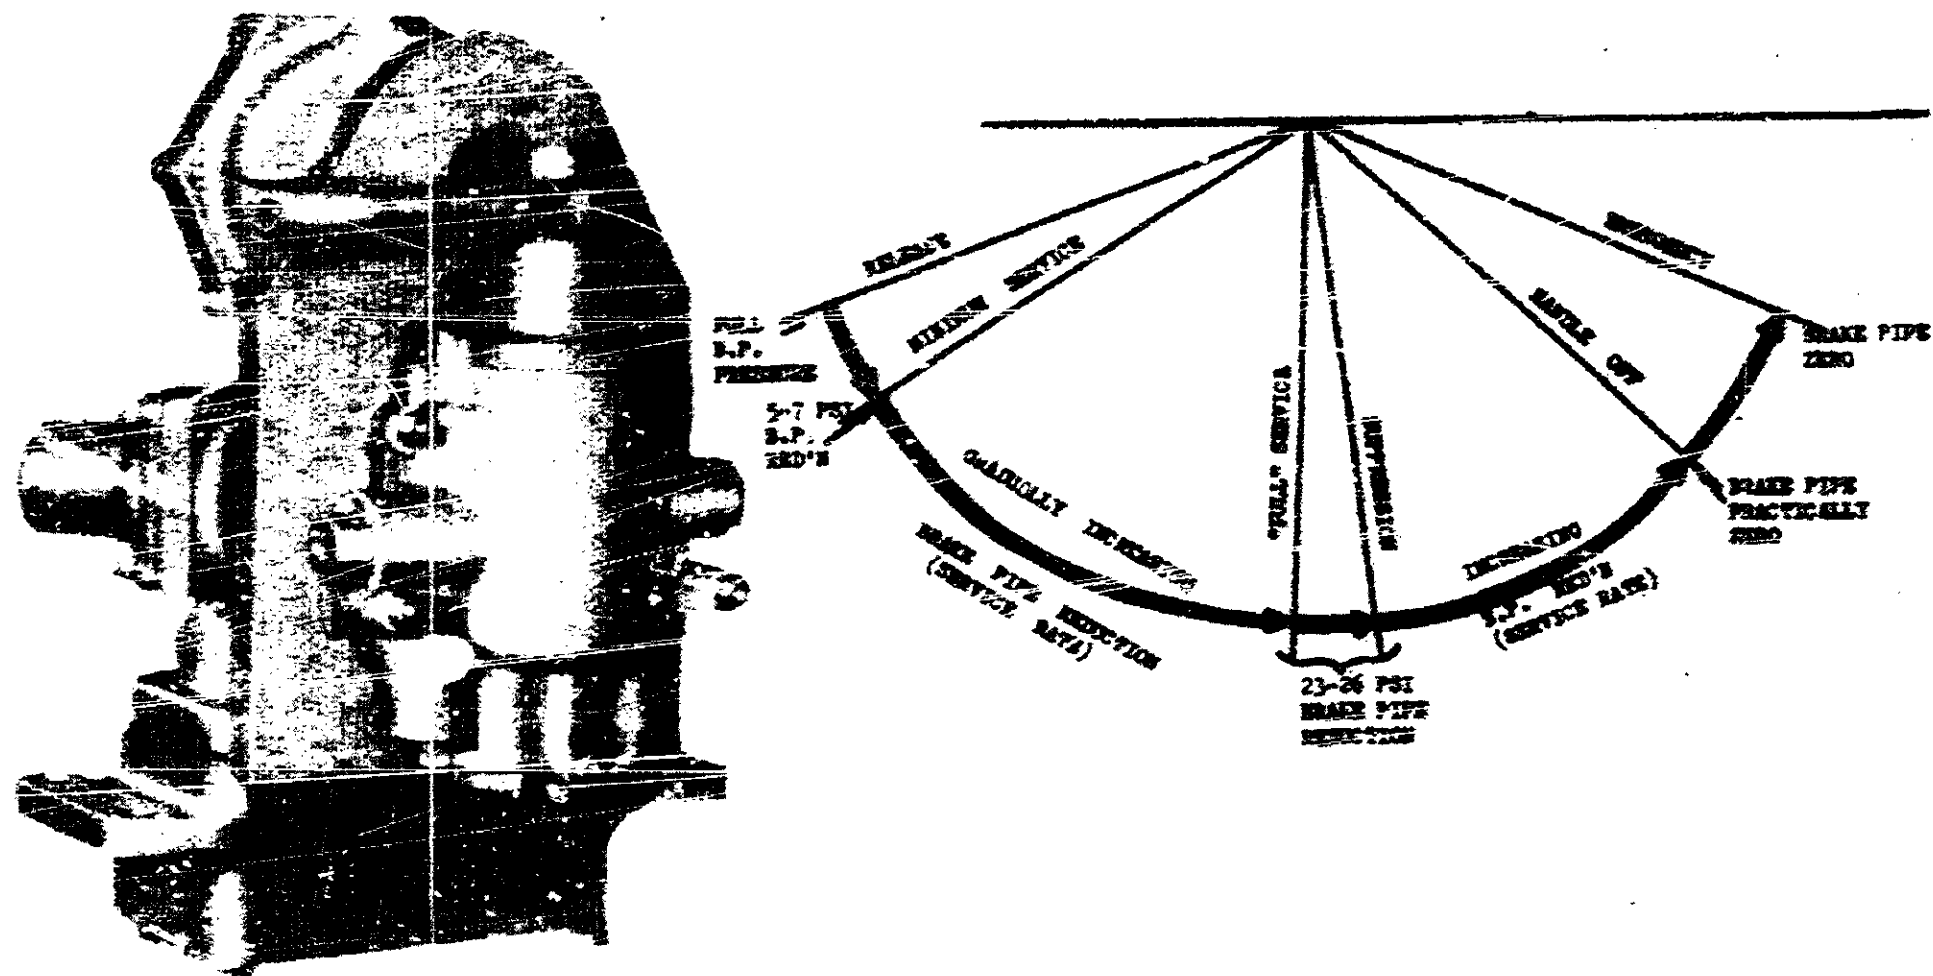
Figure 1.—26-B-1 automatic brake valve.

Following the accident, an inspection of the operating controls of train No. 1718 indicated that the brake valve was cut in, with the handle in the handle-off position. The master controller handle was missing but the handle receptacle indicated that the controller was in the center or emergency position. The control plug, which activates the car's controls, was inserted.

Car No. 265, the first car of train No. 1718, was damaged so severely that it could not be tested. However, the 26B1 brake valve equipment was removed from car No. 265 and installed on car No. 255 for testing. A brake pipe leakage test conducted at 110 psi brake pipe pressure indicated a 4 psi per minute leakage. A 6-pound reduction with a brake pipe pressure of 110 psi gave a brake cylinder pressure of 25 psi, and a full-service reduction gave a brake cylinder pressure of 65 psi and a brake pipe pressure of 85 psi. Further testing of the system indicated that all brake demands were met with no discrepancies noted.

In addition to the service testing on car No. 255, the 26B1 brake valve and other brake equipment were disassembled for inspection. No defects were found. A "DB" electronic printed circuit board associated with the control of the "decelostat" valve was checked for faults and none were found.

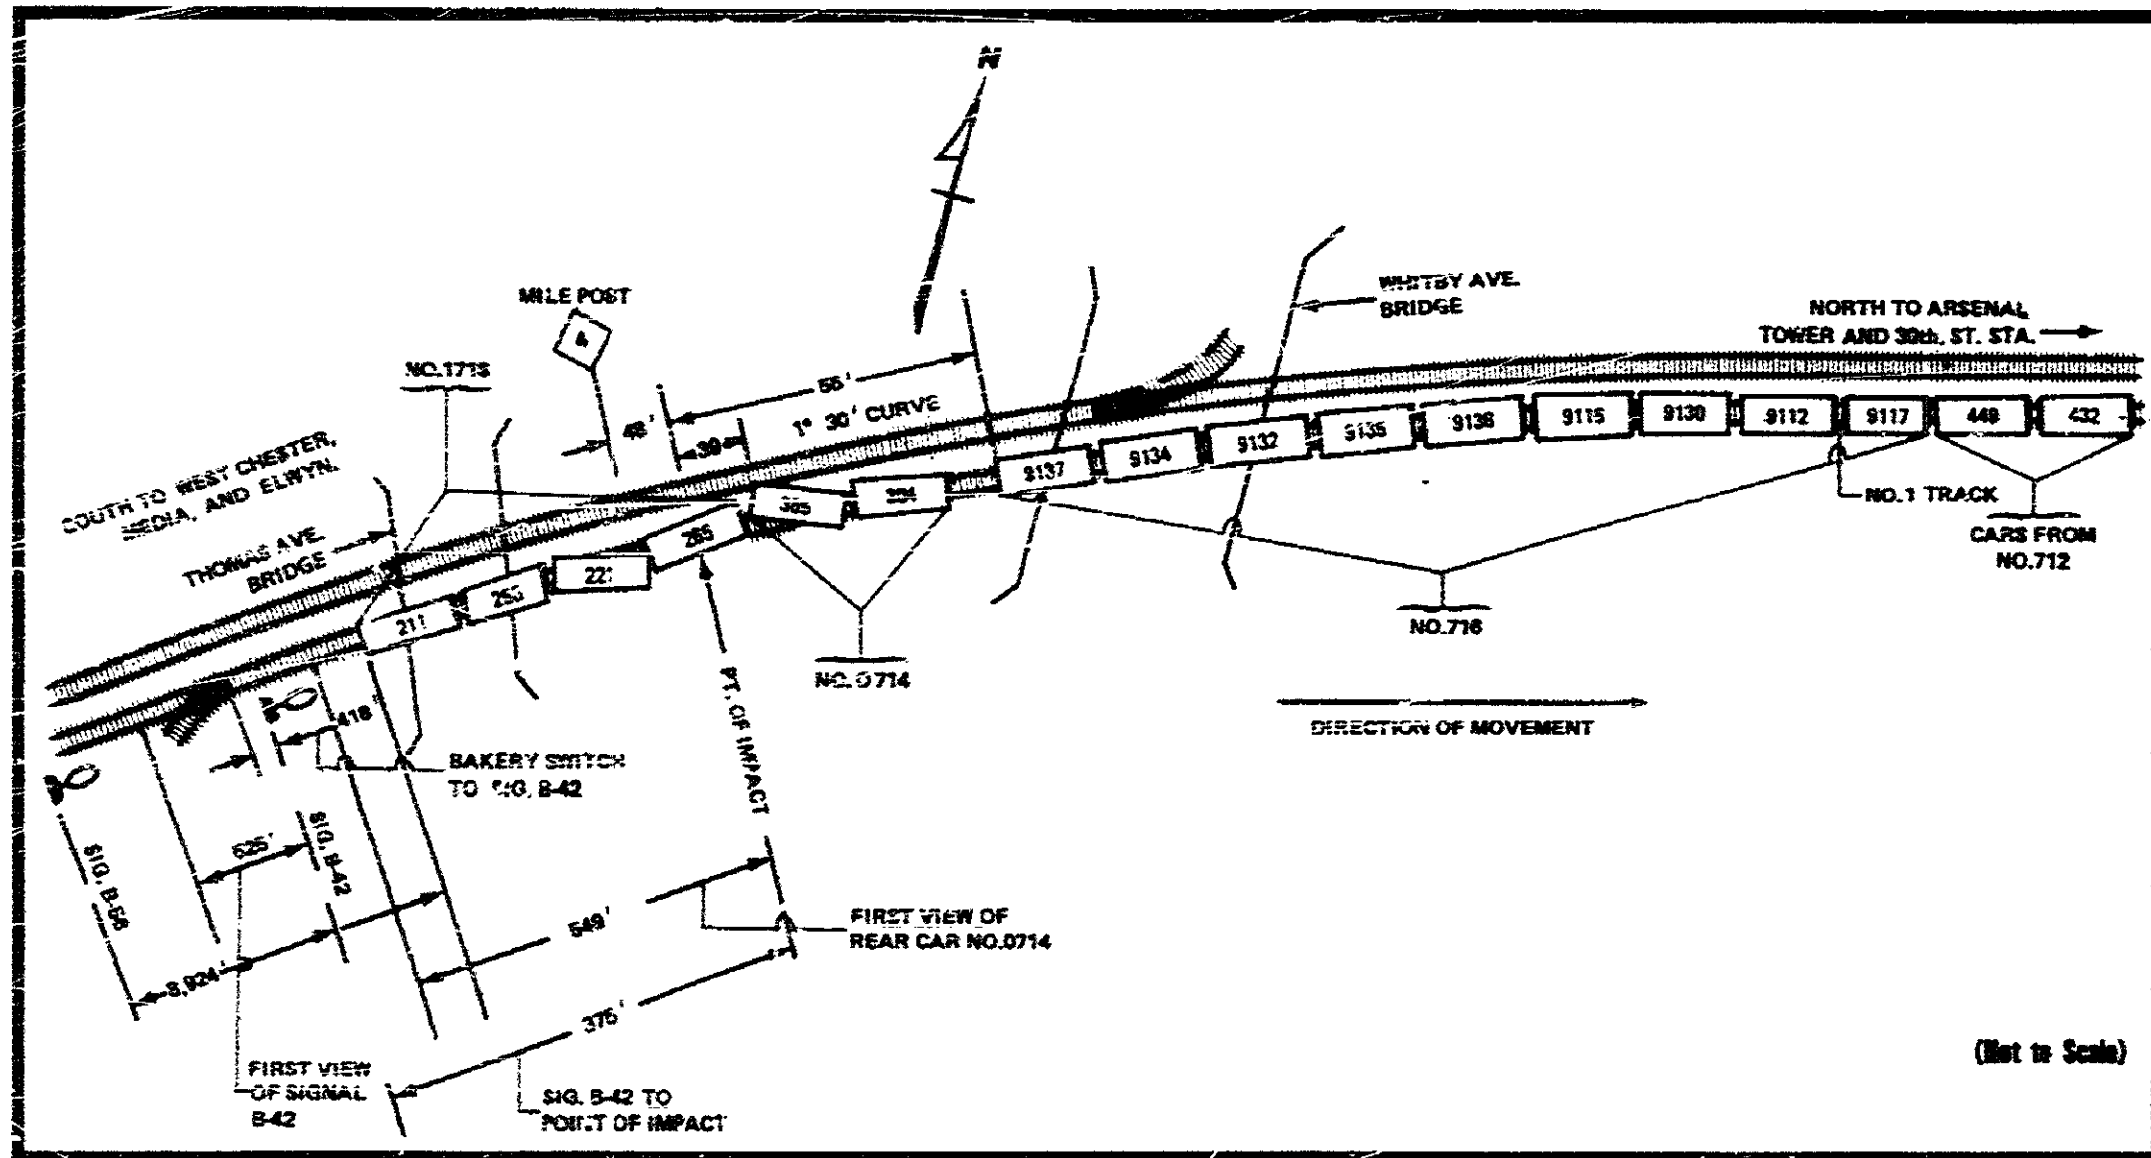
Trains Nos. 1718 and 0714 collided 375 ft north of signal B-42. Train No. 716 was moved forward 55 ft, and train No. 0714 was moved forward 39 ft. After the collision, the two trains, Nos. 0718 and 0714, were separated by 5 ft. At the time of impact, brakes were not applied on the 11 cars of train No. 716.

Figure 2.—Plan view of accident site.

The approach signal, B-56, for signal B-42 is 8,924 ft south of signal B-42. Signal B-42 is 385 ft south of the point of impact. (See figure 2.) The position light signals can display the following aspects:

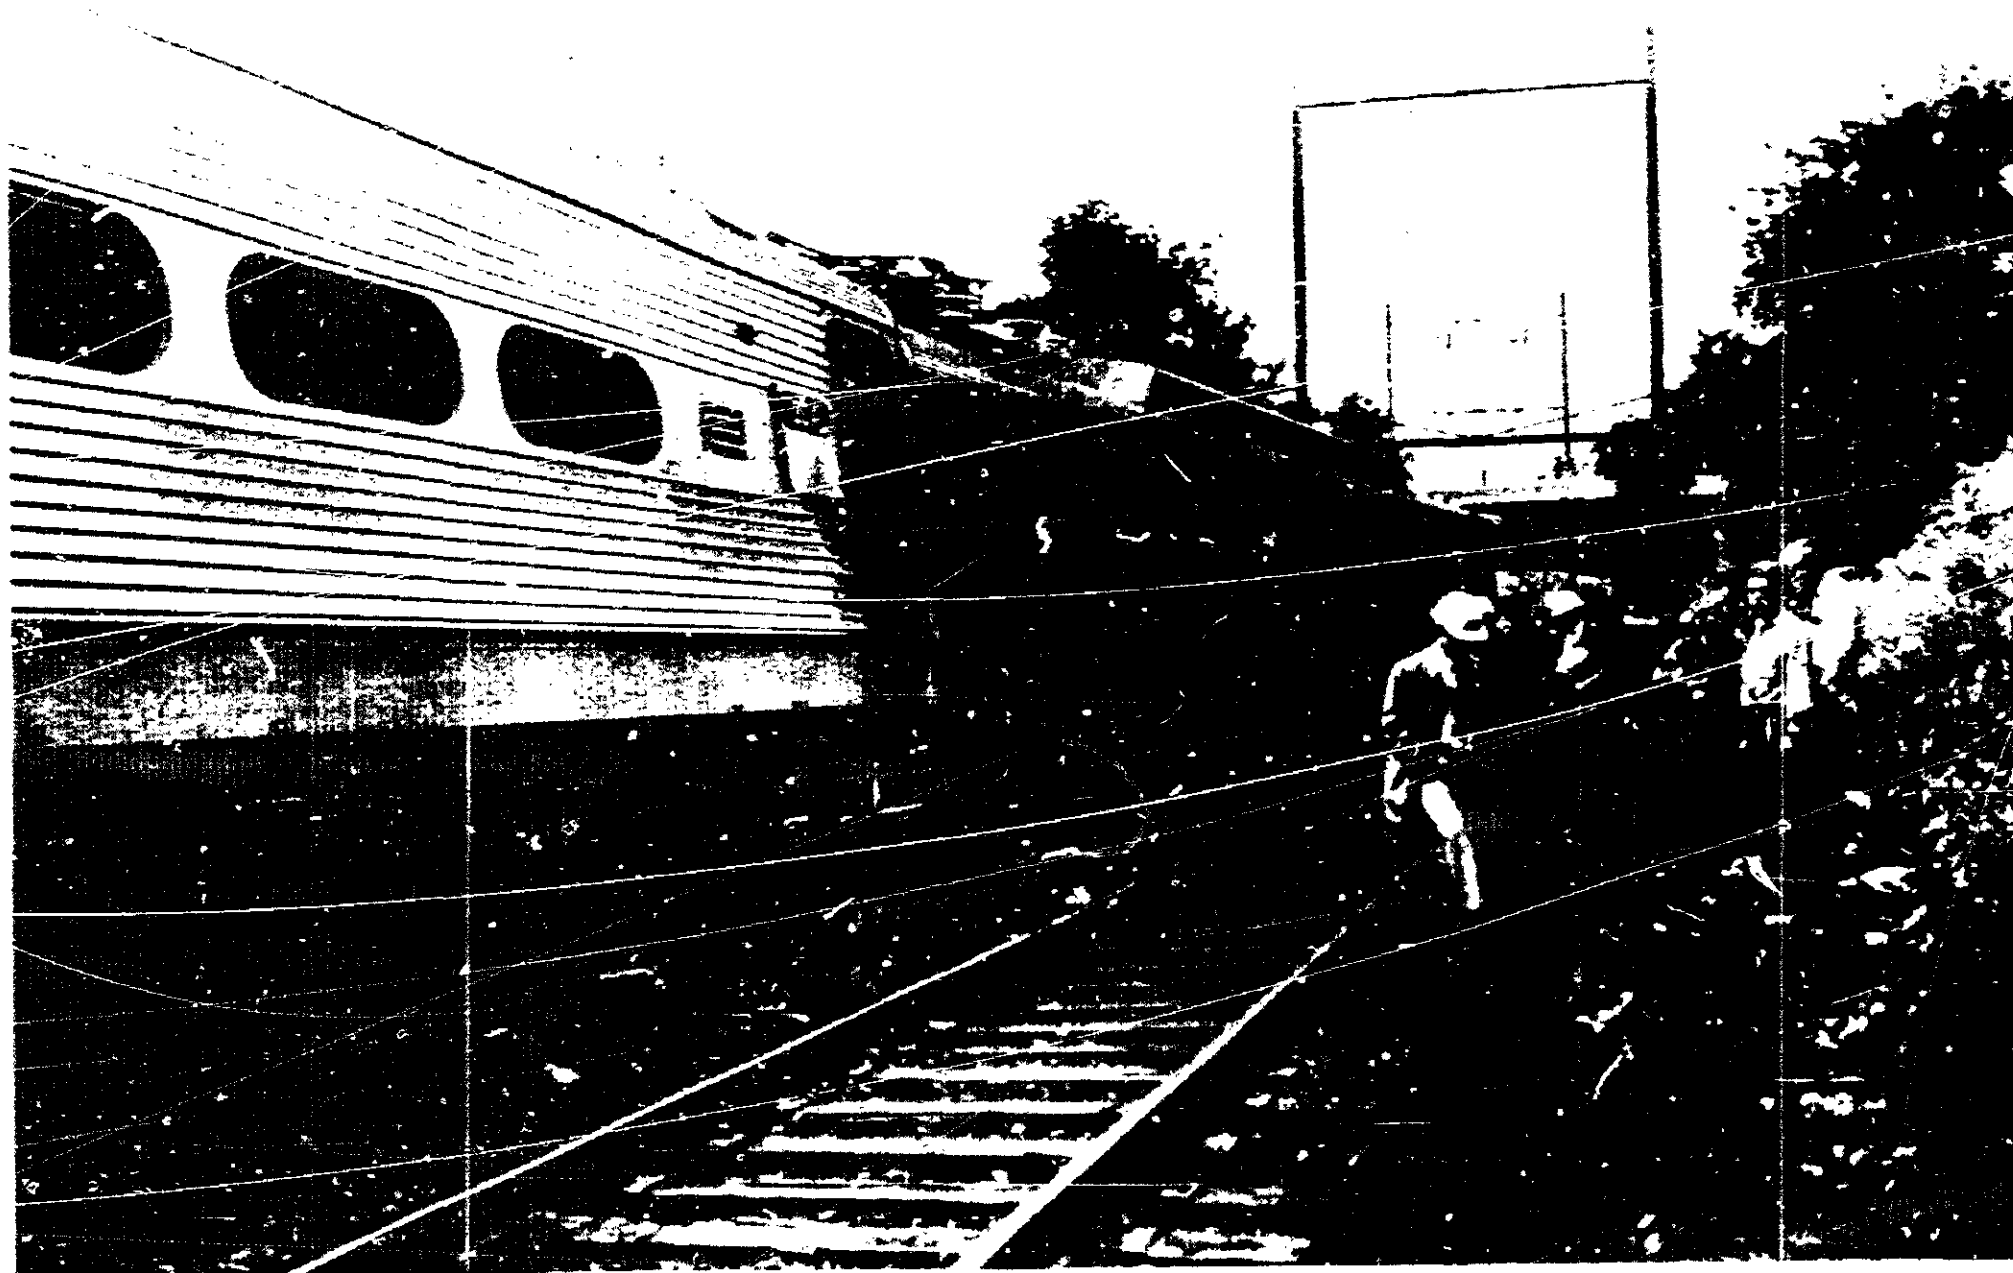
Cars Nos. 305 and 304 in train No. 0714 derailed and moved toward the west a sufficient distance to block track No. 2, but they remained upright and in line. Cars Nos. 265, 221, and 255 in train No. 1718 derailed but remained upright and in line with the track. Although the catenary structure was not damaged and power was not disrupted, power was cut off at 8:22 a.m., as a safety precaution. (See figures 3 and 4.)

Figure 4.--Train No. 0714; view is south.

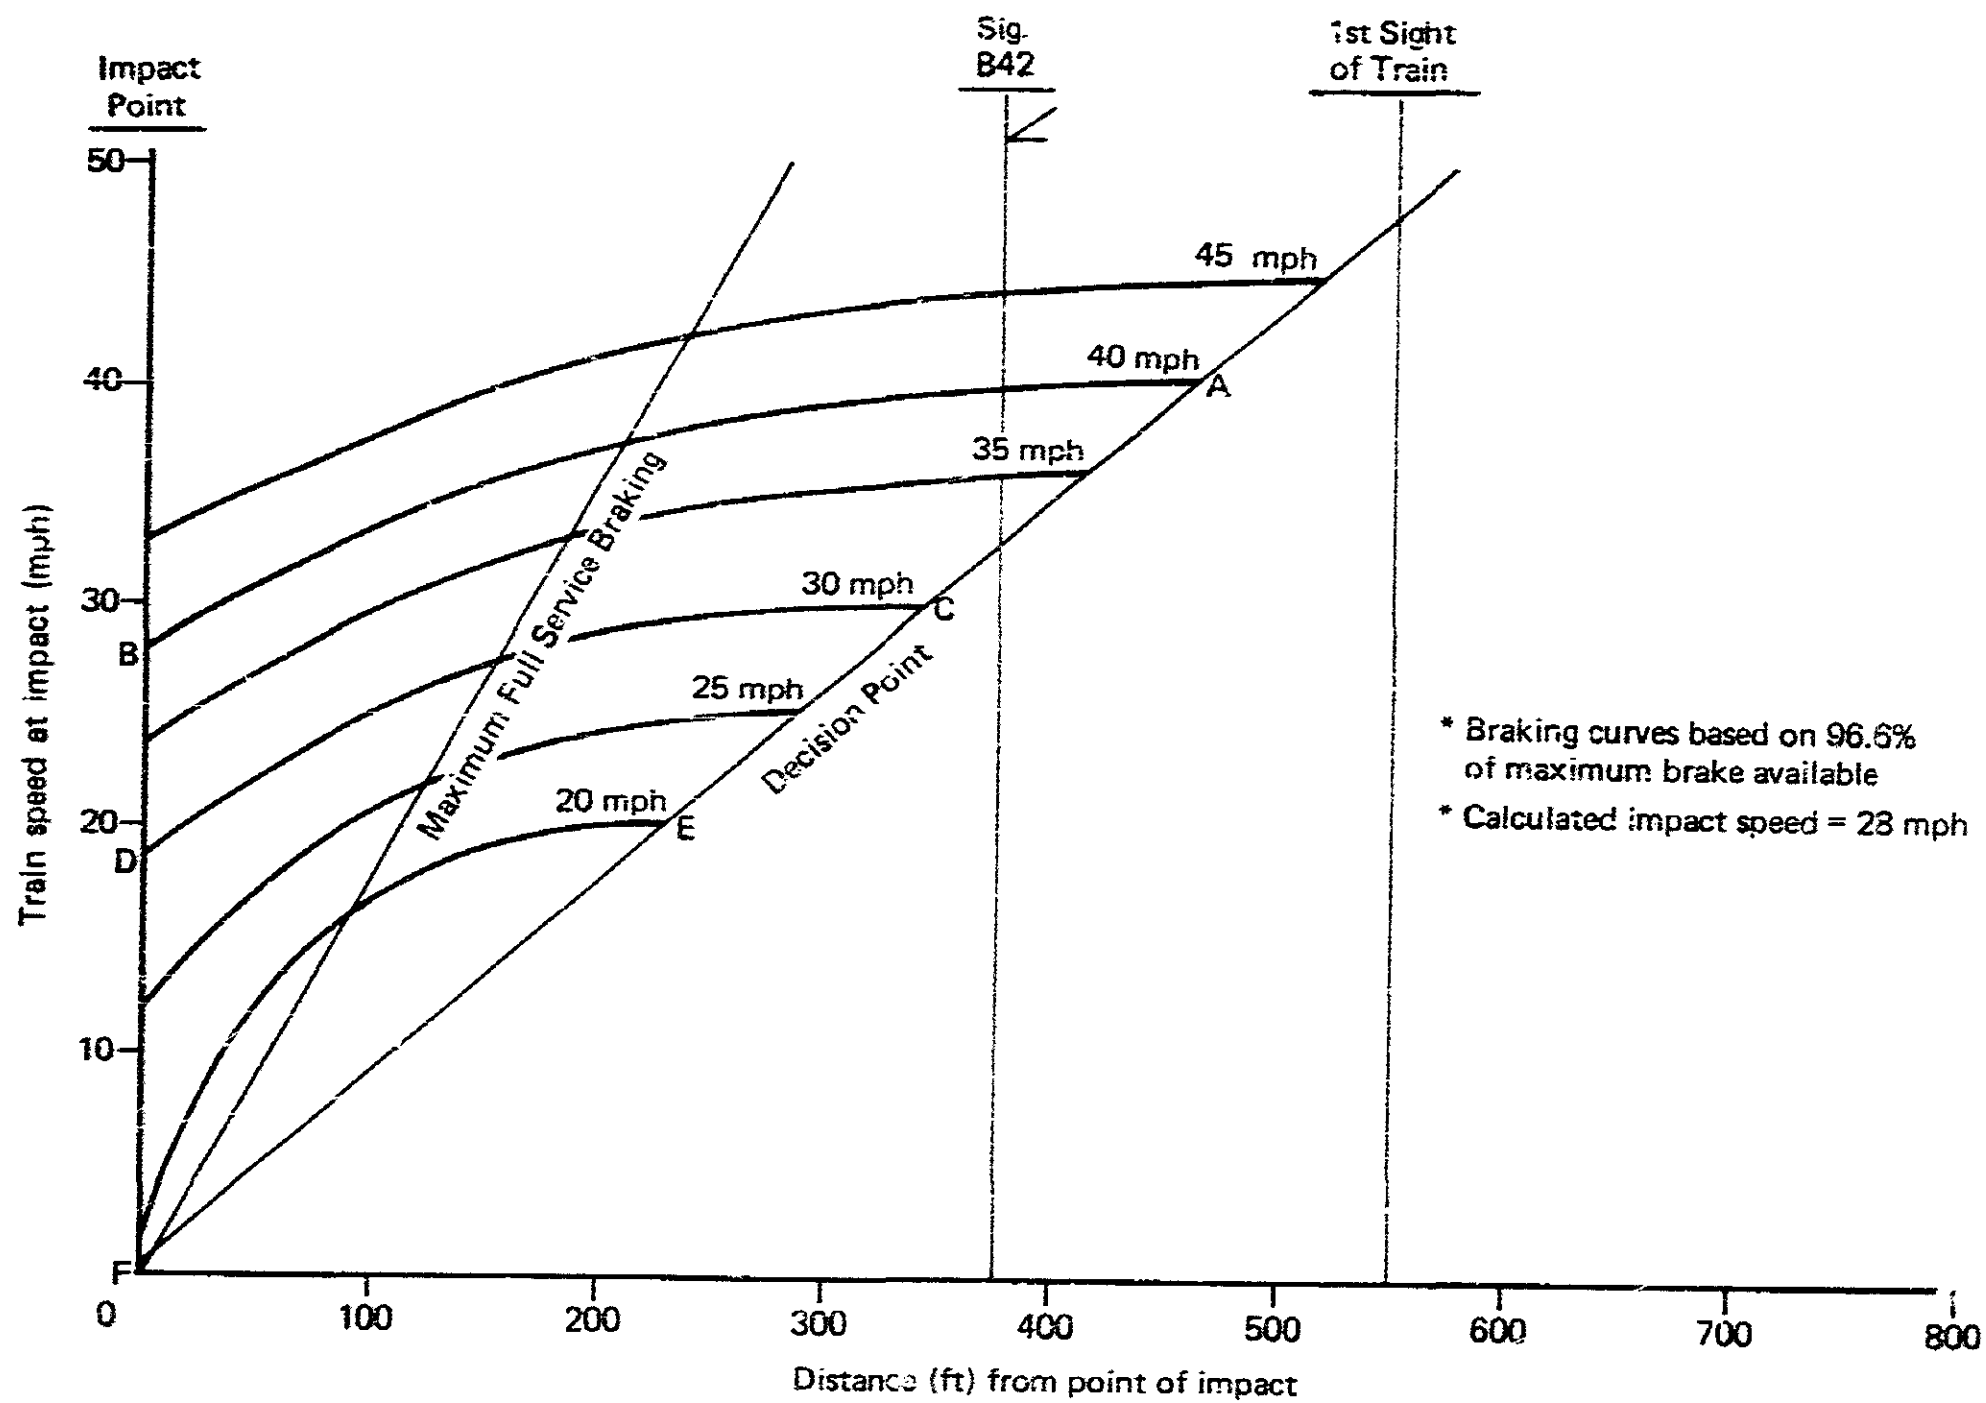
Test results indicate that the brakes were operable and effective. Therefore, the Safety Board must conclude that the train was being operated at a speed greater than the 20 mph estimated by the engineer for the resulting damage to have occurred.

- o The 40-mph curve indicates that, if a decision was made to stop and a full-service brake application was made, the train's speed would be reduced to the computed collision speed, 28 mph, in approximately 460 ft (points A to B).
- o Allowing time for a decision to stop and make a full-service brake application; the 30-mph curve indicates that impact would have occurred at a lower speed, 18 mph, after traveling approximately 350 ft (points C to D).
- o Under the same conditions for the 20-mph curve, the 20-mph curve indicates that train No. 1718 would have stopped before hitting train No. 0714 (points E to F).

Figure 5.—Impact speed vs. train speed (mph).
