# NATIONAL TRANSPORTATION SAFETY BOARD

## RAILROAD ACCIDENT REPORT

DERAILMENT OF  
AMTRAK TRAIN NO. 7,  
THE EMPIRE BUILDER,  
ON BURLINGTON NORTHERN TRACK,  
GLACIER PARK, MONTANA  
MARCH 14, 1980

NTSB-RAR-80-6

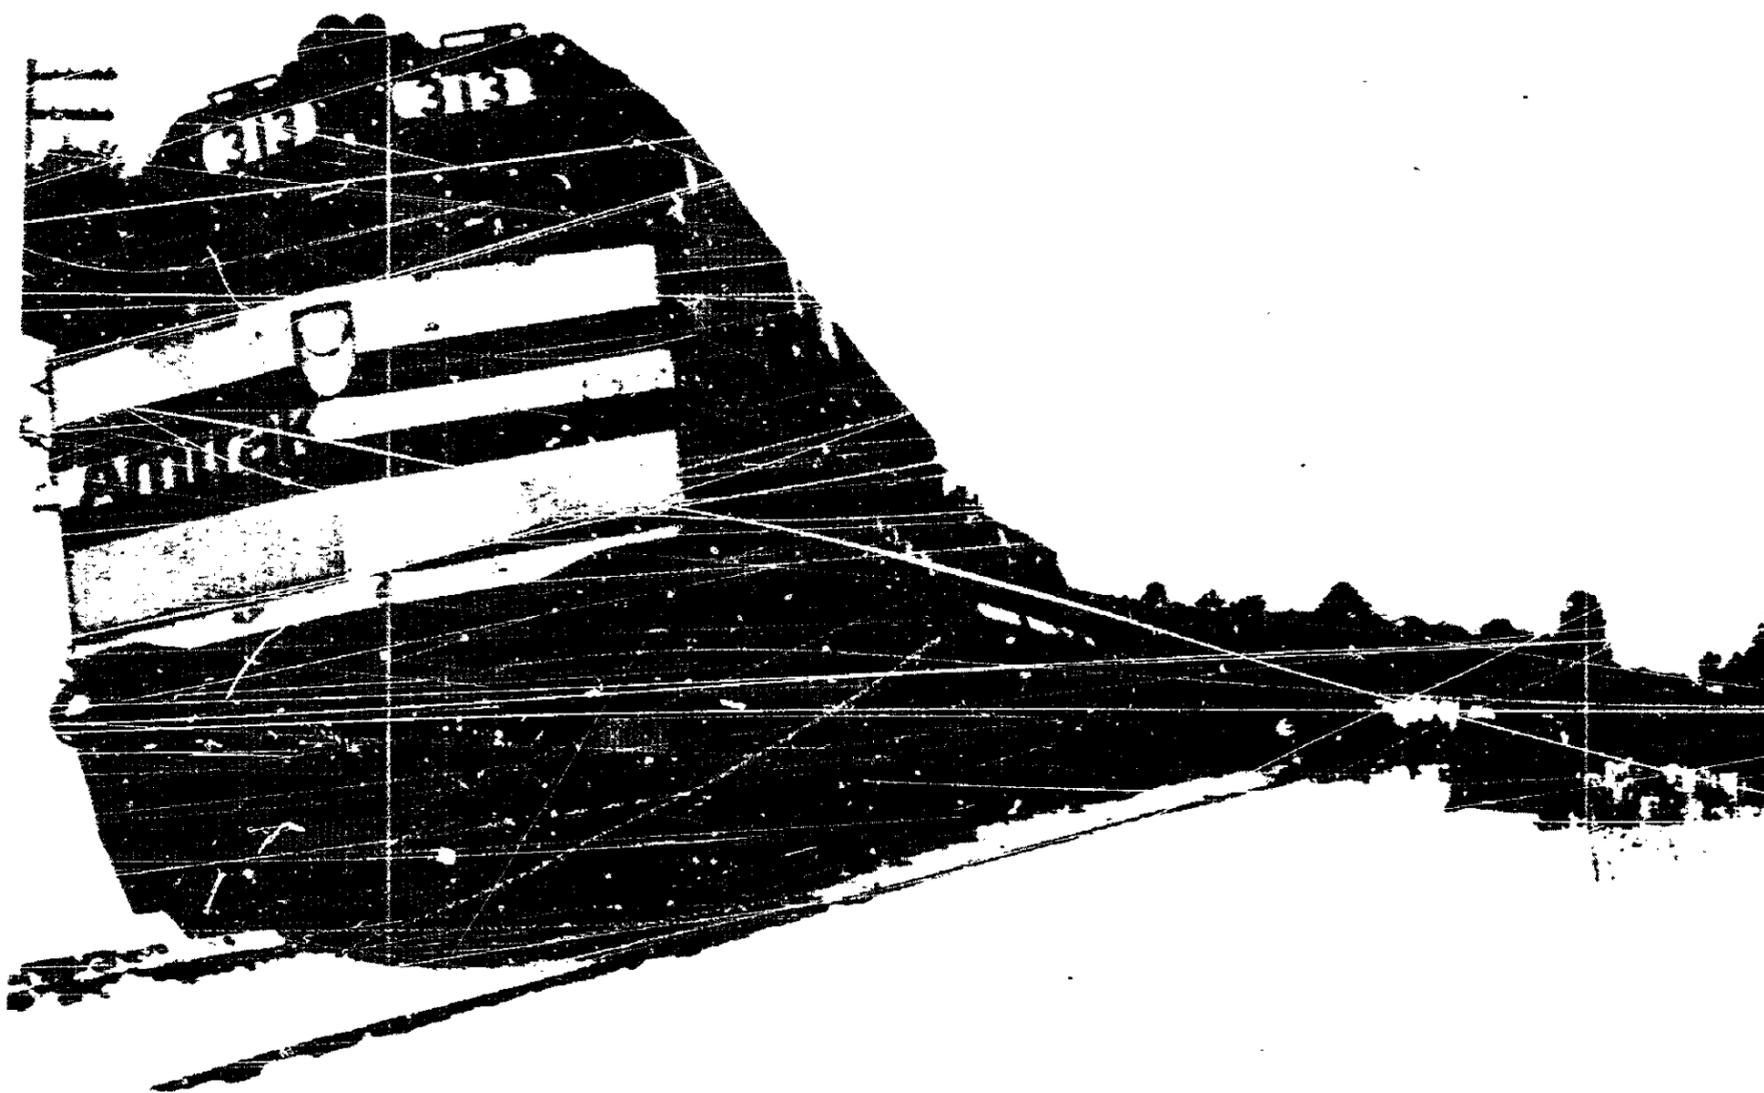
After derailing, the locomotive continued over 800 ft around the remainder of the curve, stopping about 60 ft beyond the curve on tangent track. (See figure 1.) Both locomotive units, the baggage car, and the first two coaches remained coupled. The two coaches had tipped toward their right sides and were leaning at a 45° angle against the bank of a side hill cut. (See figure 2.) The fourth and fifth cars continued down a 15-ft-high embankment and tipped onto their sides near the bottom. The sixth car was leaning about 30° near the top of the bank. The seventh and eighth cars remained upright and derailed within the track structure. (See figure 3.)

Figure 1.--Derailed locomotive.

The traction motors on the two locomotive units were damaged and the right front of the snowplow-type pilots were dented as they rode on the overturned north rail.

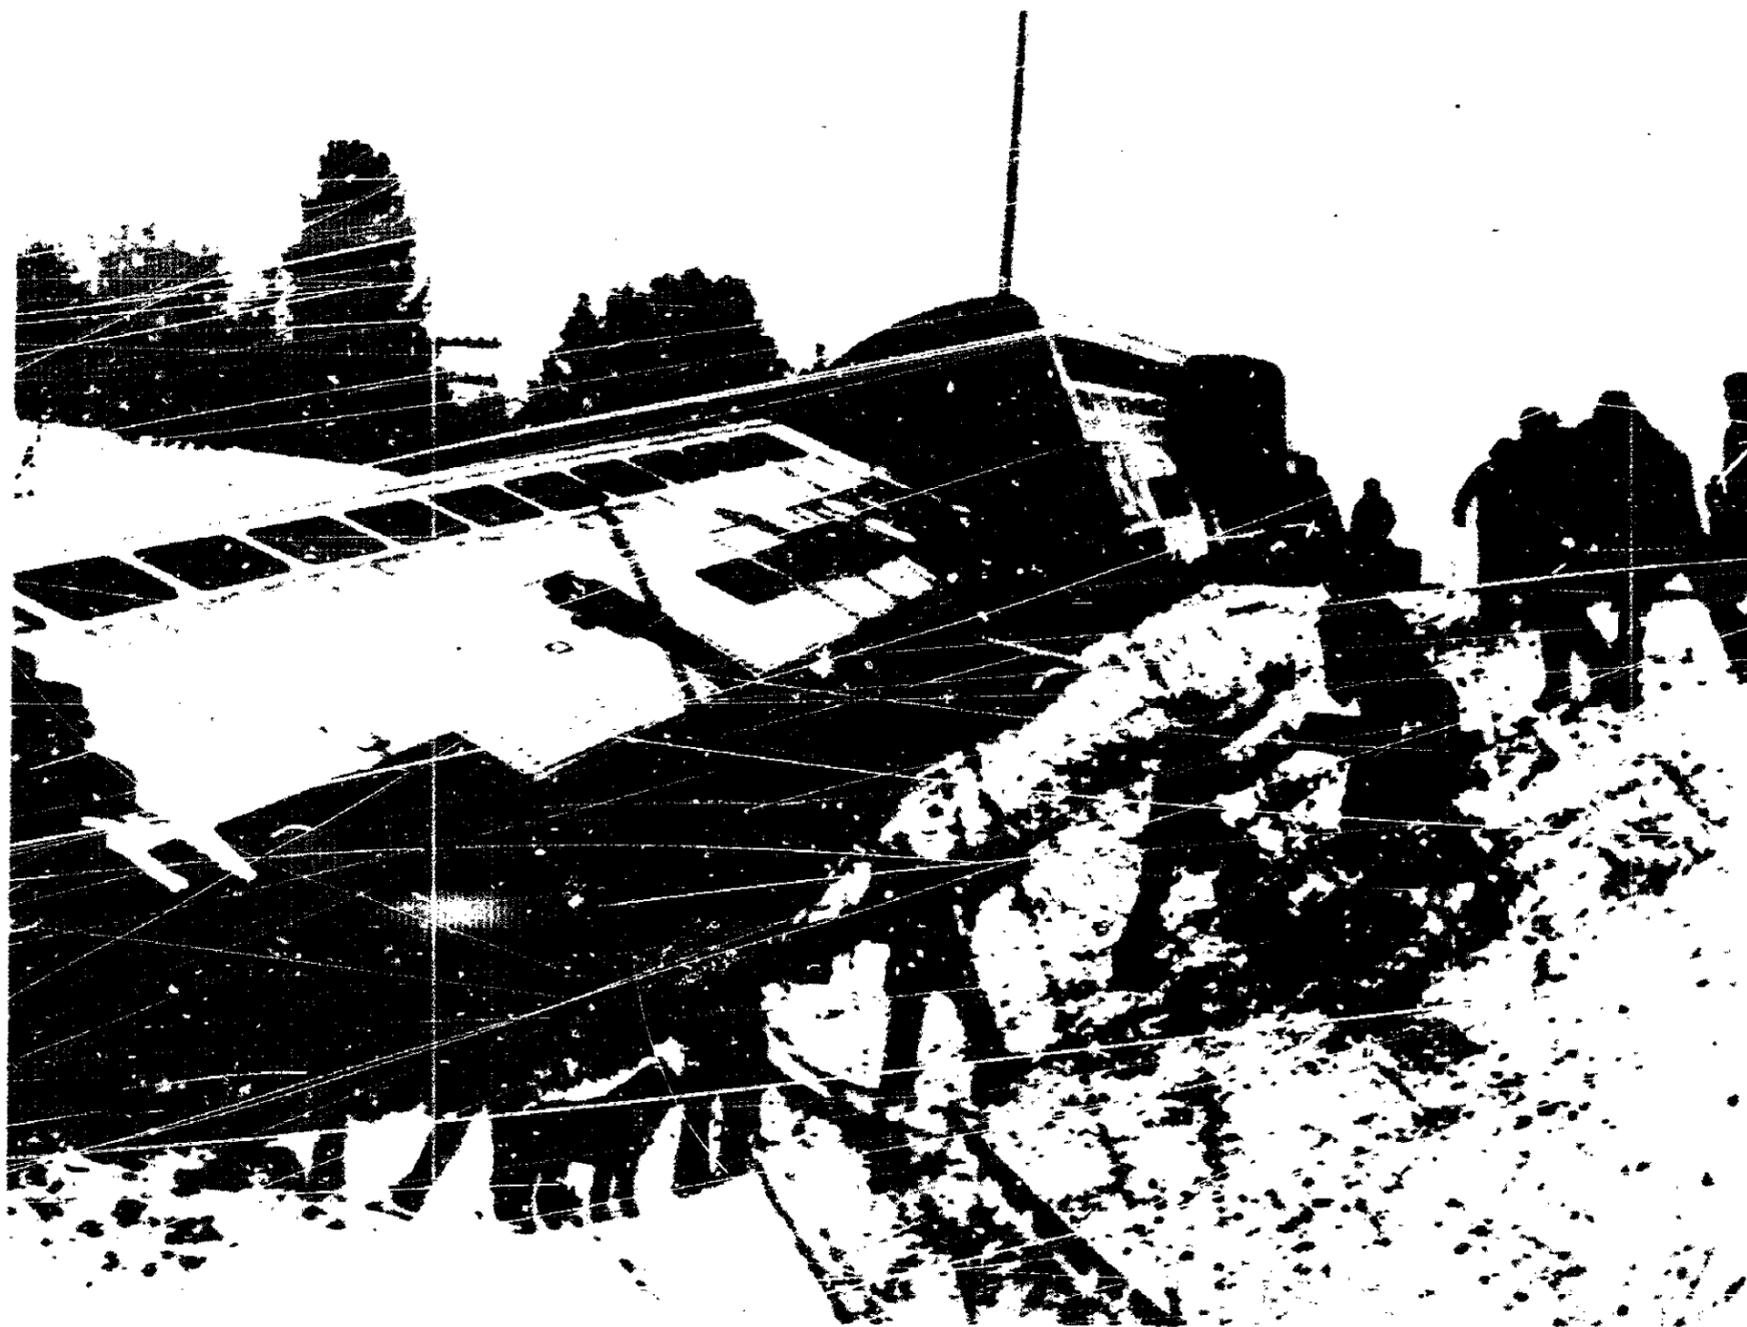
Figure 3.--Last three derailed cars.

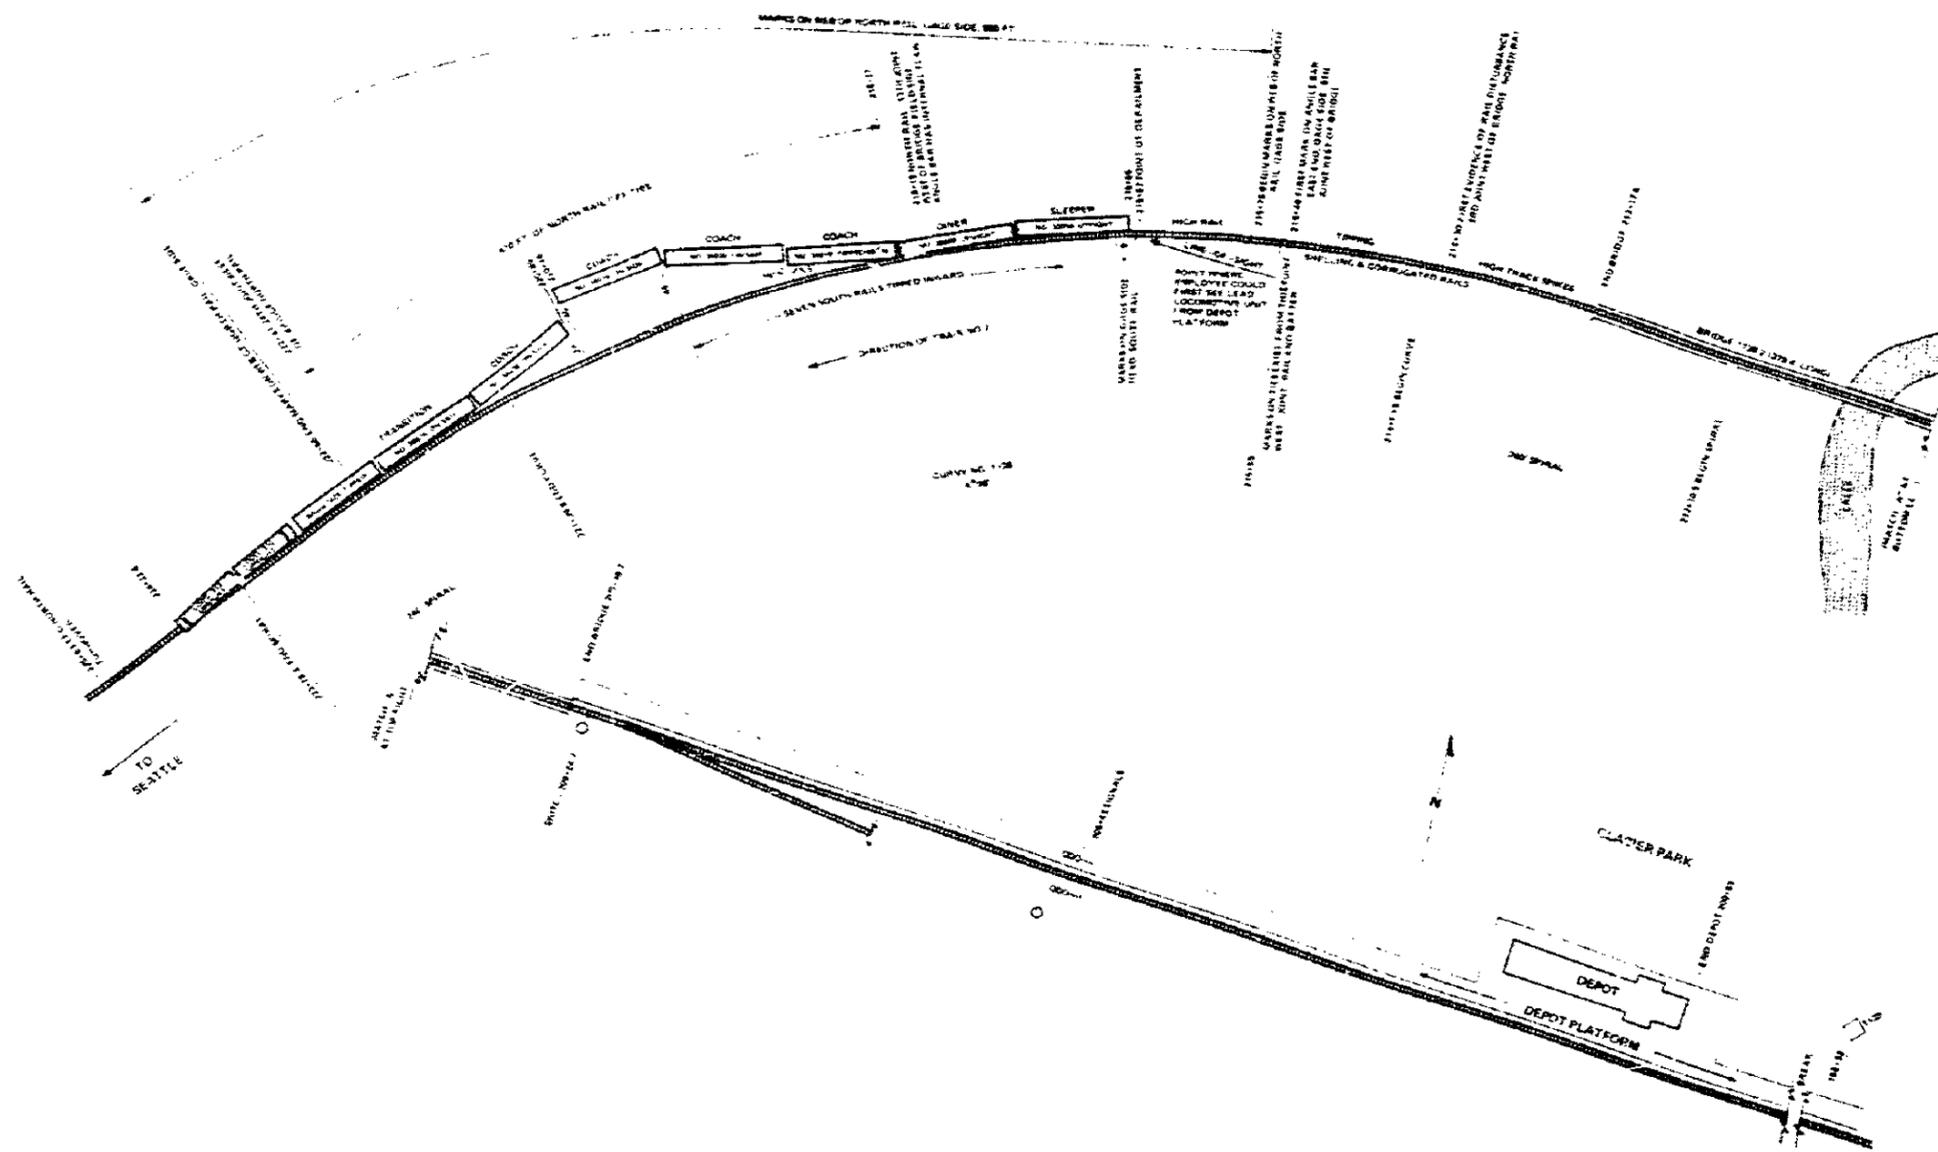
As a result of the derailment, about 1,000 ft of the north high rail in the curve was tipped over and damaged. The north rail was broken in several places during the derailment. Near the middle of the curve, the south rail was tipped slightly inward for seven rail lengths. (See figure 4.) The cross-ties were damaged slightly, mainly by wheel flange markings on the surface. The roadbed was not damaged. Costs of damage were estimated as follows:

Figure 4.--Plan view of track and derailed train No. 7.

The first marks of the derailment were found on the high rail in the curve, on the gage side joint bar, located at the sixth joint, 228 ft from the bridge. The east end of the bar and its bolts and nuts were nicked. The high rail was tipped outward beginning at this joint. There were wheel marks on the web of the high rail and gage side joint bars, from the sixth to the twenty-fourth joint. Several of the rails east of the sixth joint had to be reset after the derailment because the heads of a number of gage side-track spikes were under the base of the slightly tipped rail. (See figure 4.)
