# NATIONAL TRANSPORTATION SAFETY BOARD

## RAILROAD ACCIDENT REPORT

HEAD-END COLLISION OF  
NINE BURLINGTON NORTHERN LOCOMOTIVE UNITS  
WITH A STANDING FREIGHT TRAIN  
ANGORA, NEBRASKA

FEBRUARY 16, 1980

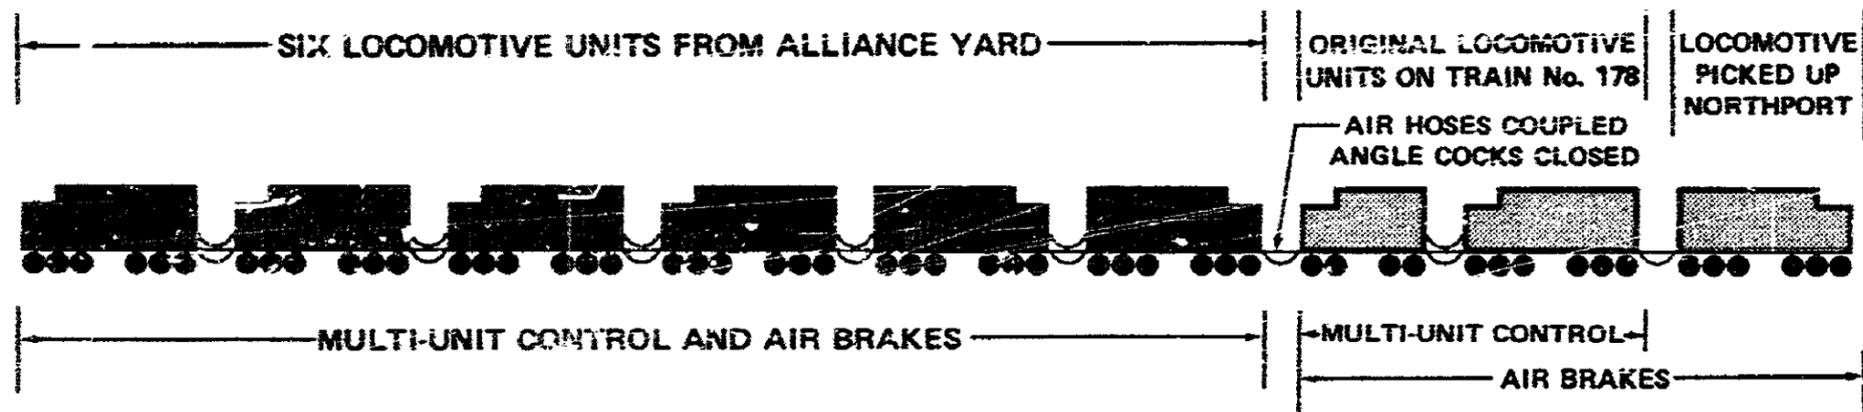
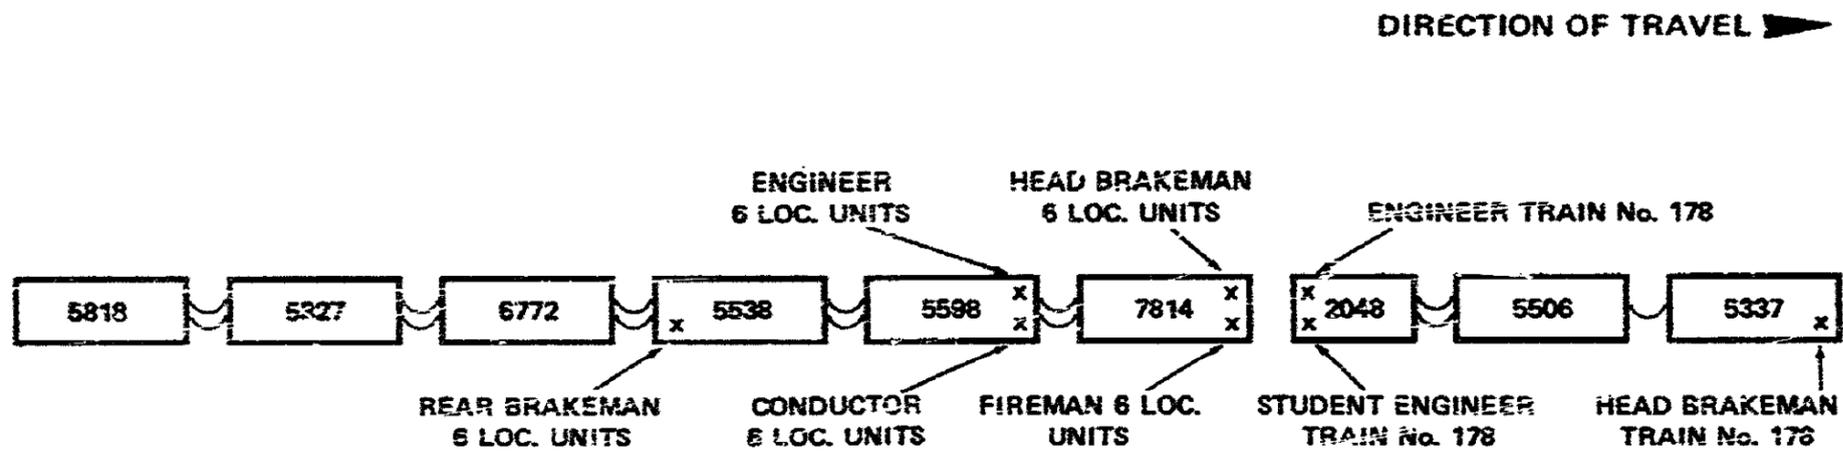
FIGURE 1

Extra 7814 West arrived 20 minutes after the locomotive units of train No. 178 had stopped on the main track at Angora. When the headlight of Extra 7814 West came into view, the engineer of train No. 178 told Extra 7814 West, over the radio, to come down and couple to his three units. As the locomotive of Extra 7814 West came close, the head brakeman of train No. 178 signaled him by lantern and the six locomotive units were coupled to the three standing units. The passing or meeting as directed by the train order was not completed, but the six locomotive units of Extra 7814 West were coupled to the east end of the three locomotive units of train No. 178. Neither the air brakes nor the multiple unit control were connected between the two sets of locomotive units. The engineer of train No. 178 instructed the fireman of Extra 7814 West to continue to operate the six units and to apply dynamic braking according to his radio instructions. The engineer and the fireman of train No. 178 were in the cab on the east end of the third unit, and the fireman of Extra 7814 West was in the cab on the west end of the fourth unit of the nine units. The conductor and the engineer of Extra 7814 West remained in the fifth unit throughout the operation. The head brakeman of train No. 178 was instructed to ride the cab on the west end of the lead unit, to maintain a lookout as the locomotives moved westward and to advise the engineer when they approached the standing train, or of any problems by radio. The engineer of train No. 178 proceeded to move the nine units toward the standing portion of train No. 178 from his position in the control compartment of the third unit. (See figure 1.)

**METHOD LOCOMOTIVE UNITS WERE COUPLED**

**LOCATION OF CREWMEMBERS PRIOR TO ACCIDENT**

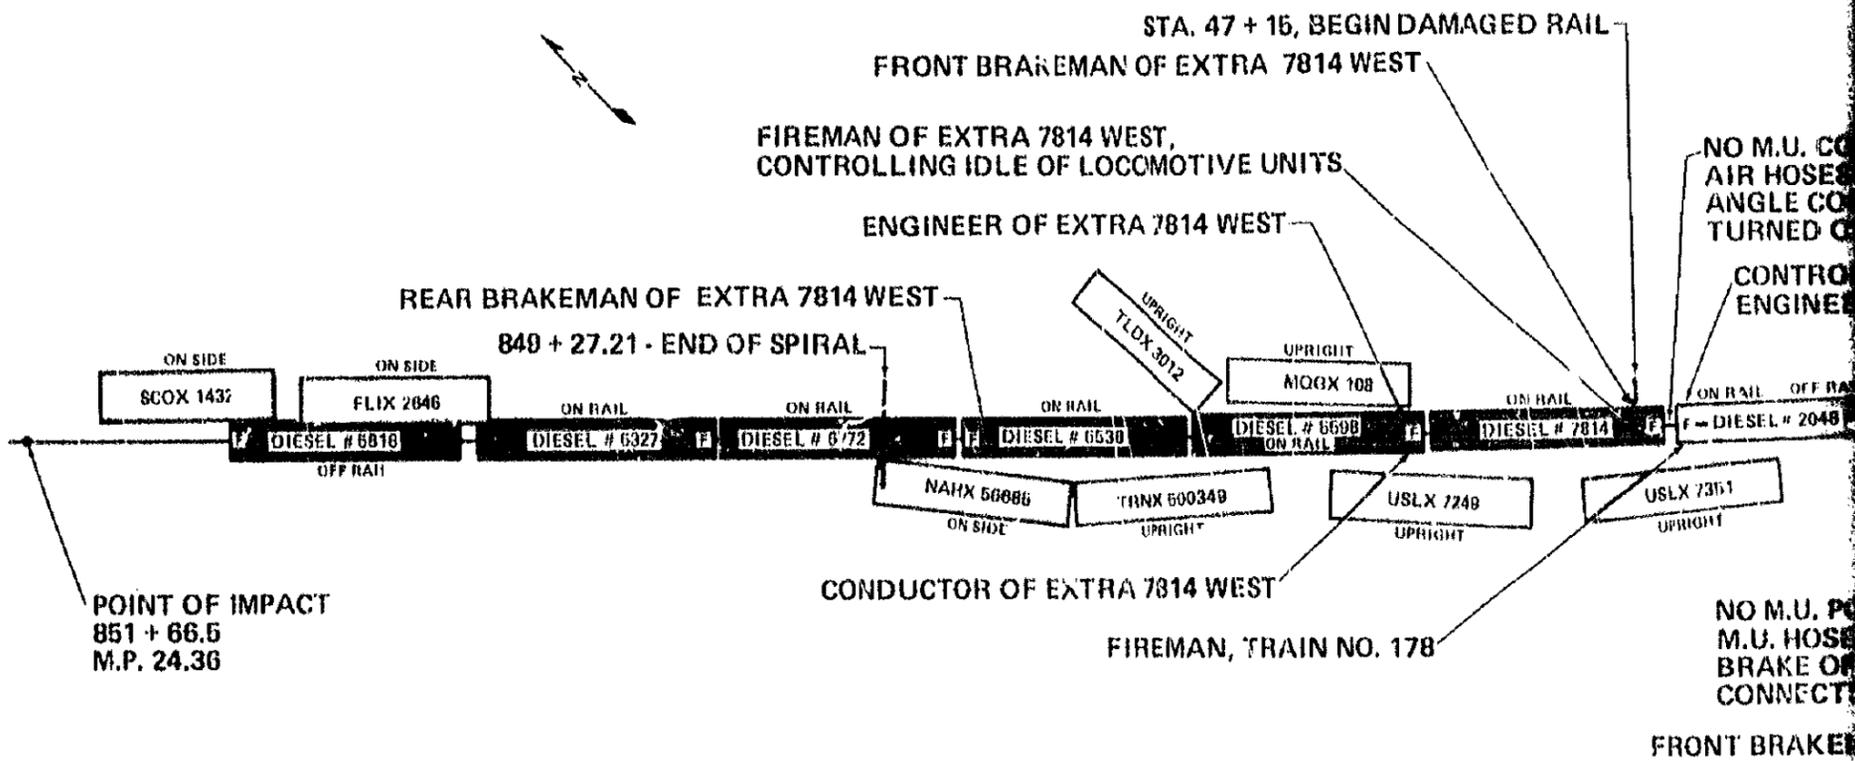
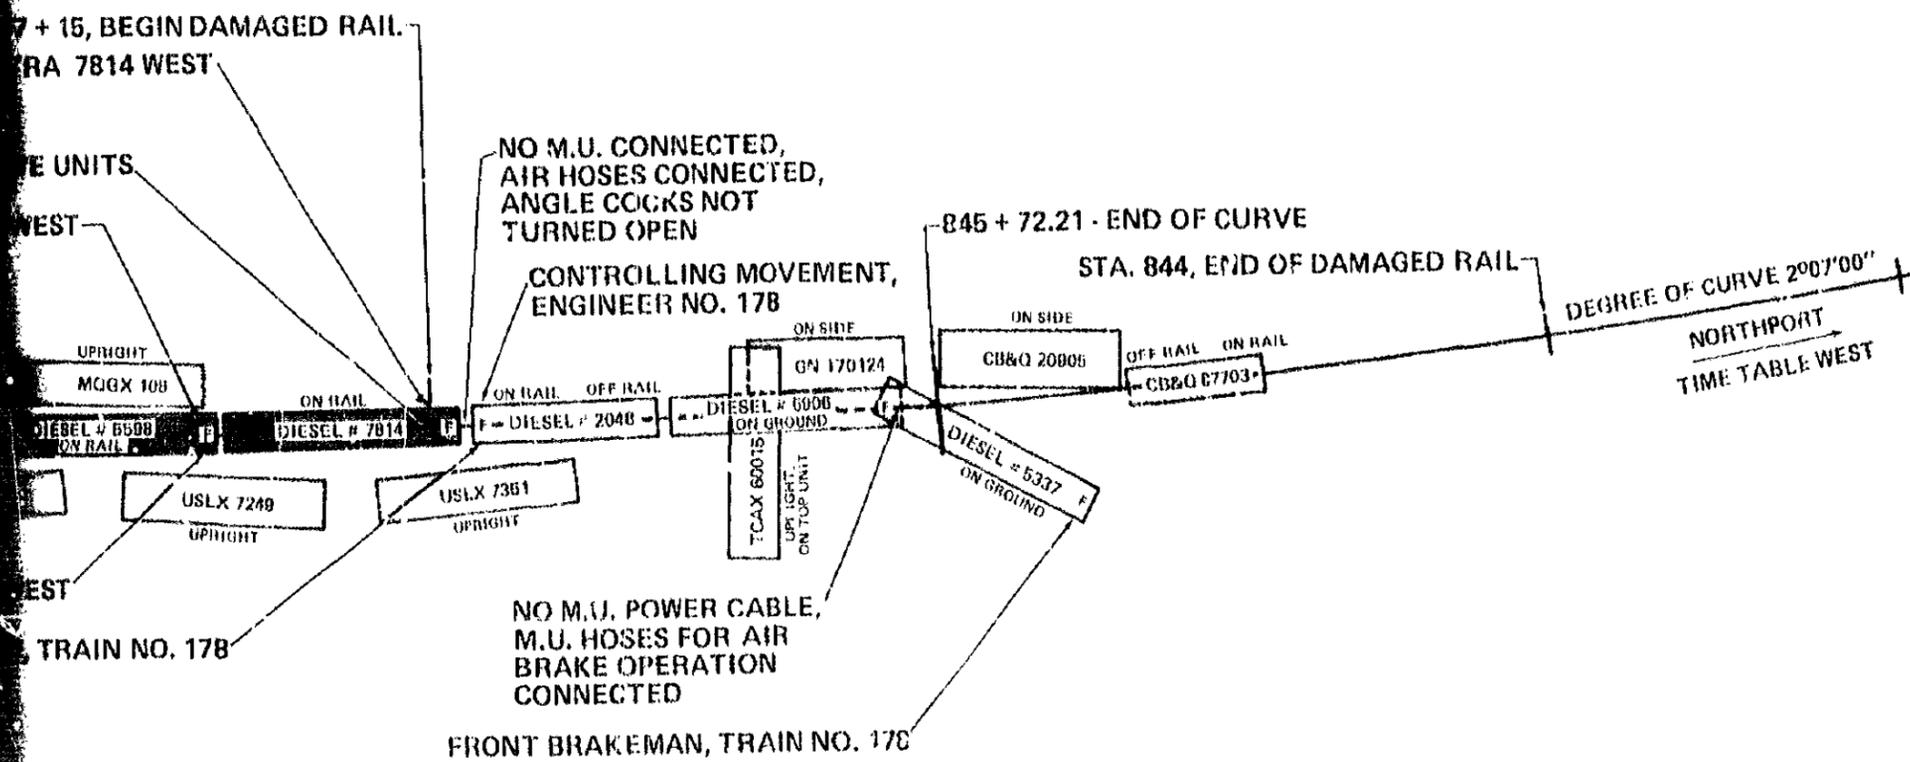
**Figure 2**  
**COLLISION OF 9 LOCOMOTIVE UNITS WITH STANDING T**  
**ANCORA, NEBRASKA**  
**FEBRUARY 16, 1980**

on the three units and radioed the fireman operating the six locomotive units of Extra 7814 to apply all available dynamic braking. However, before the fireman could apply dynamic braking, the locomotive unit collided with the standing portion of train No. 178. The head brakeman of train No. 178, in the lead unit, and the engineer of Extra 7814 West, in the fifth locomotive unit, were killed, and three other crewmembers were injured. (See figure 2.)

After the impact with the standing train, the locomotive units traveled westward 562 feet. The three leading locomotive units derailed. The lead unit was destroyed, the next four units were heavily damaged, and the following four units were slightly damaged. Eleven cars were heavily damaged and one was slightly damaged. Damage was estimated as follows:
