NATIONAL TRANSPORTATION SAFETY BOARD

RAILROAD ACCIDENT REPORT

HEAD-ON COLLISION OF
BALTIMORE & OHIO FREIGHT TRAINS
EXTRA 6474 EAST AND EXTRA 4367 WEST
ORLEANS ROAD, WEST VIRGINIA
FEBRUARY 12, 1980

NTSB-RAR-80-9

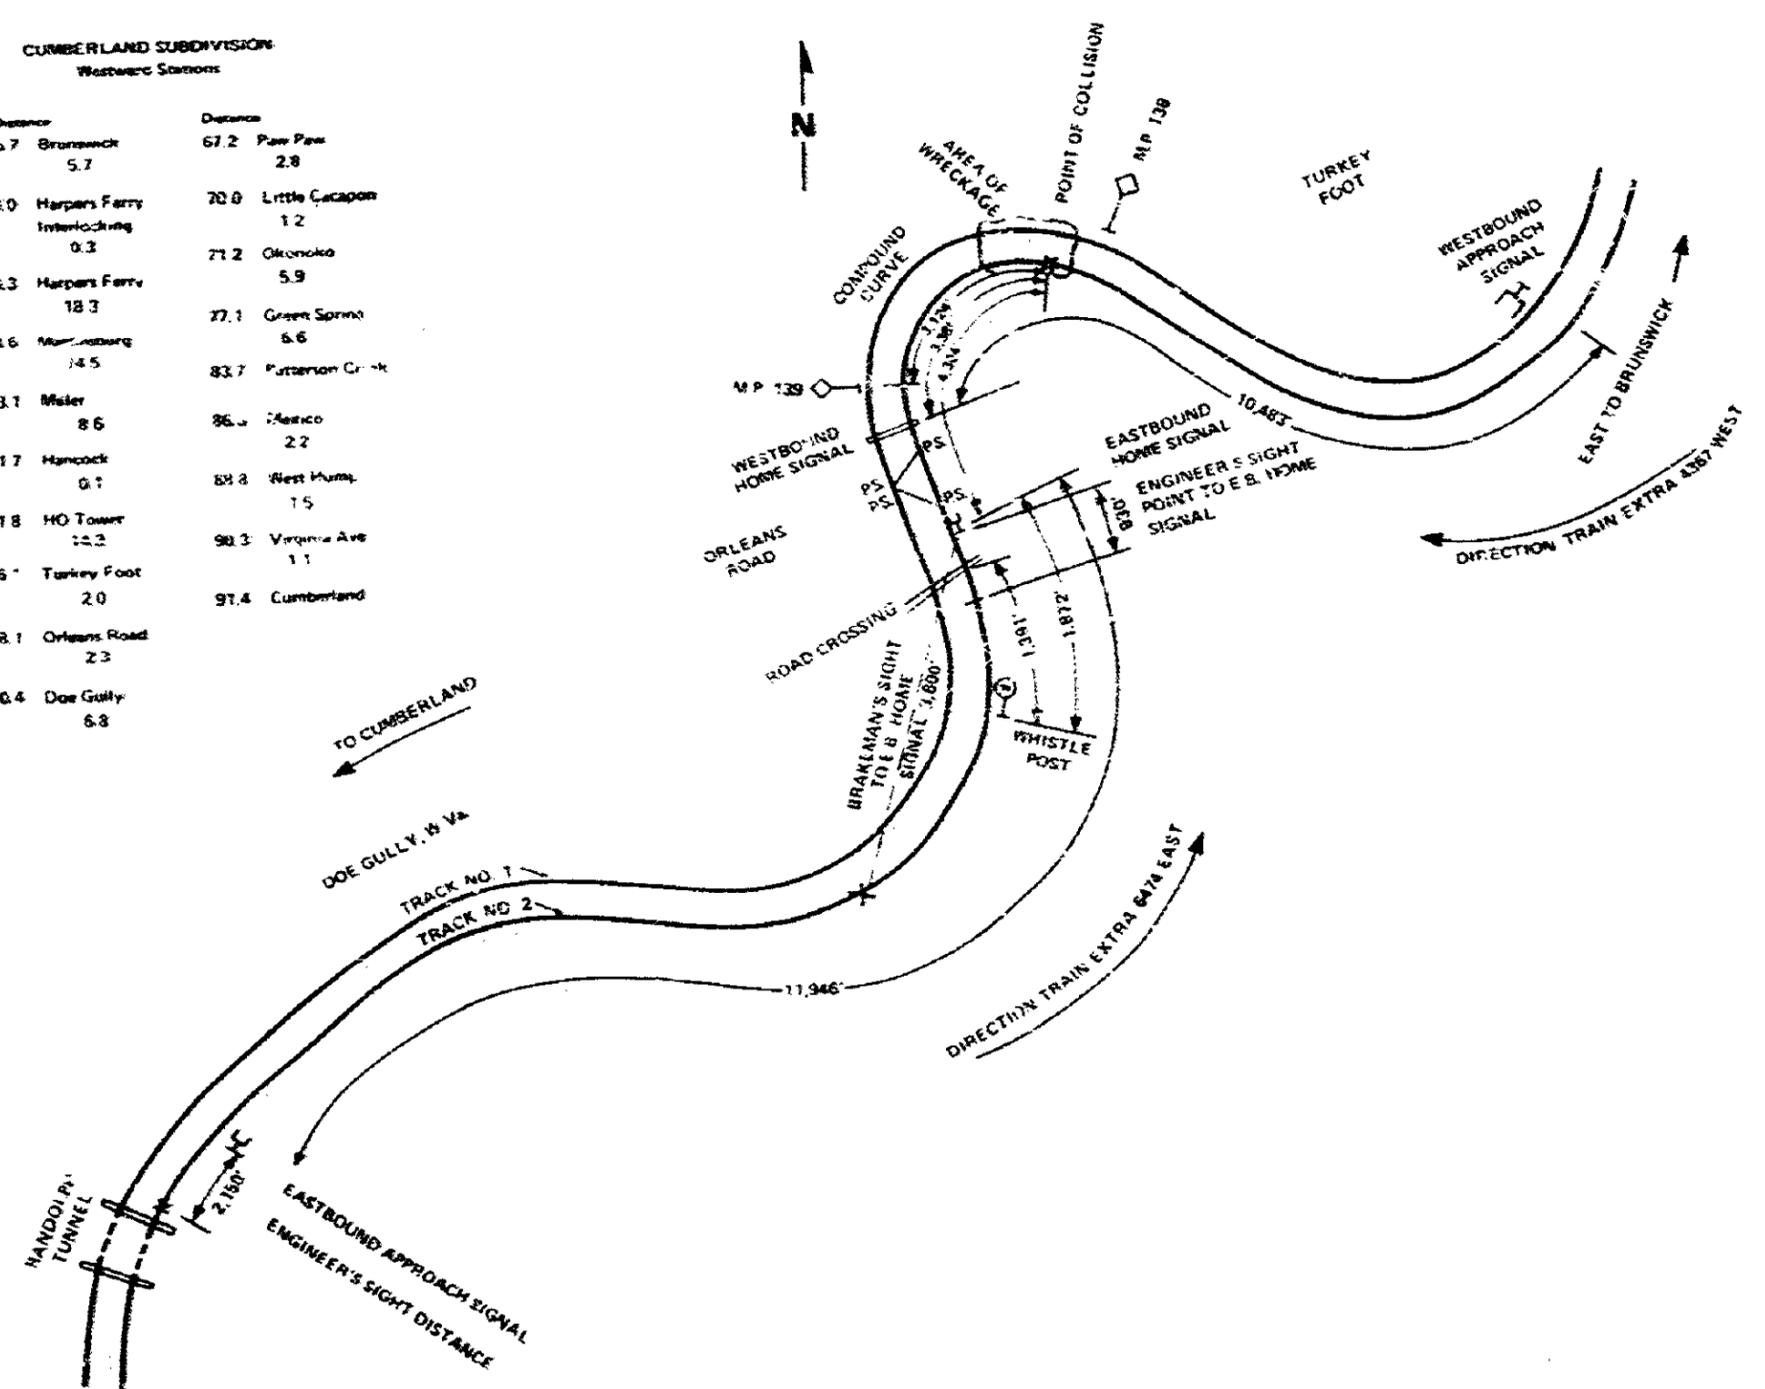
Figure 3.--Sketch of accident area.

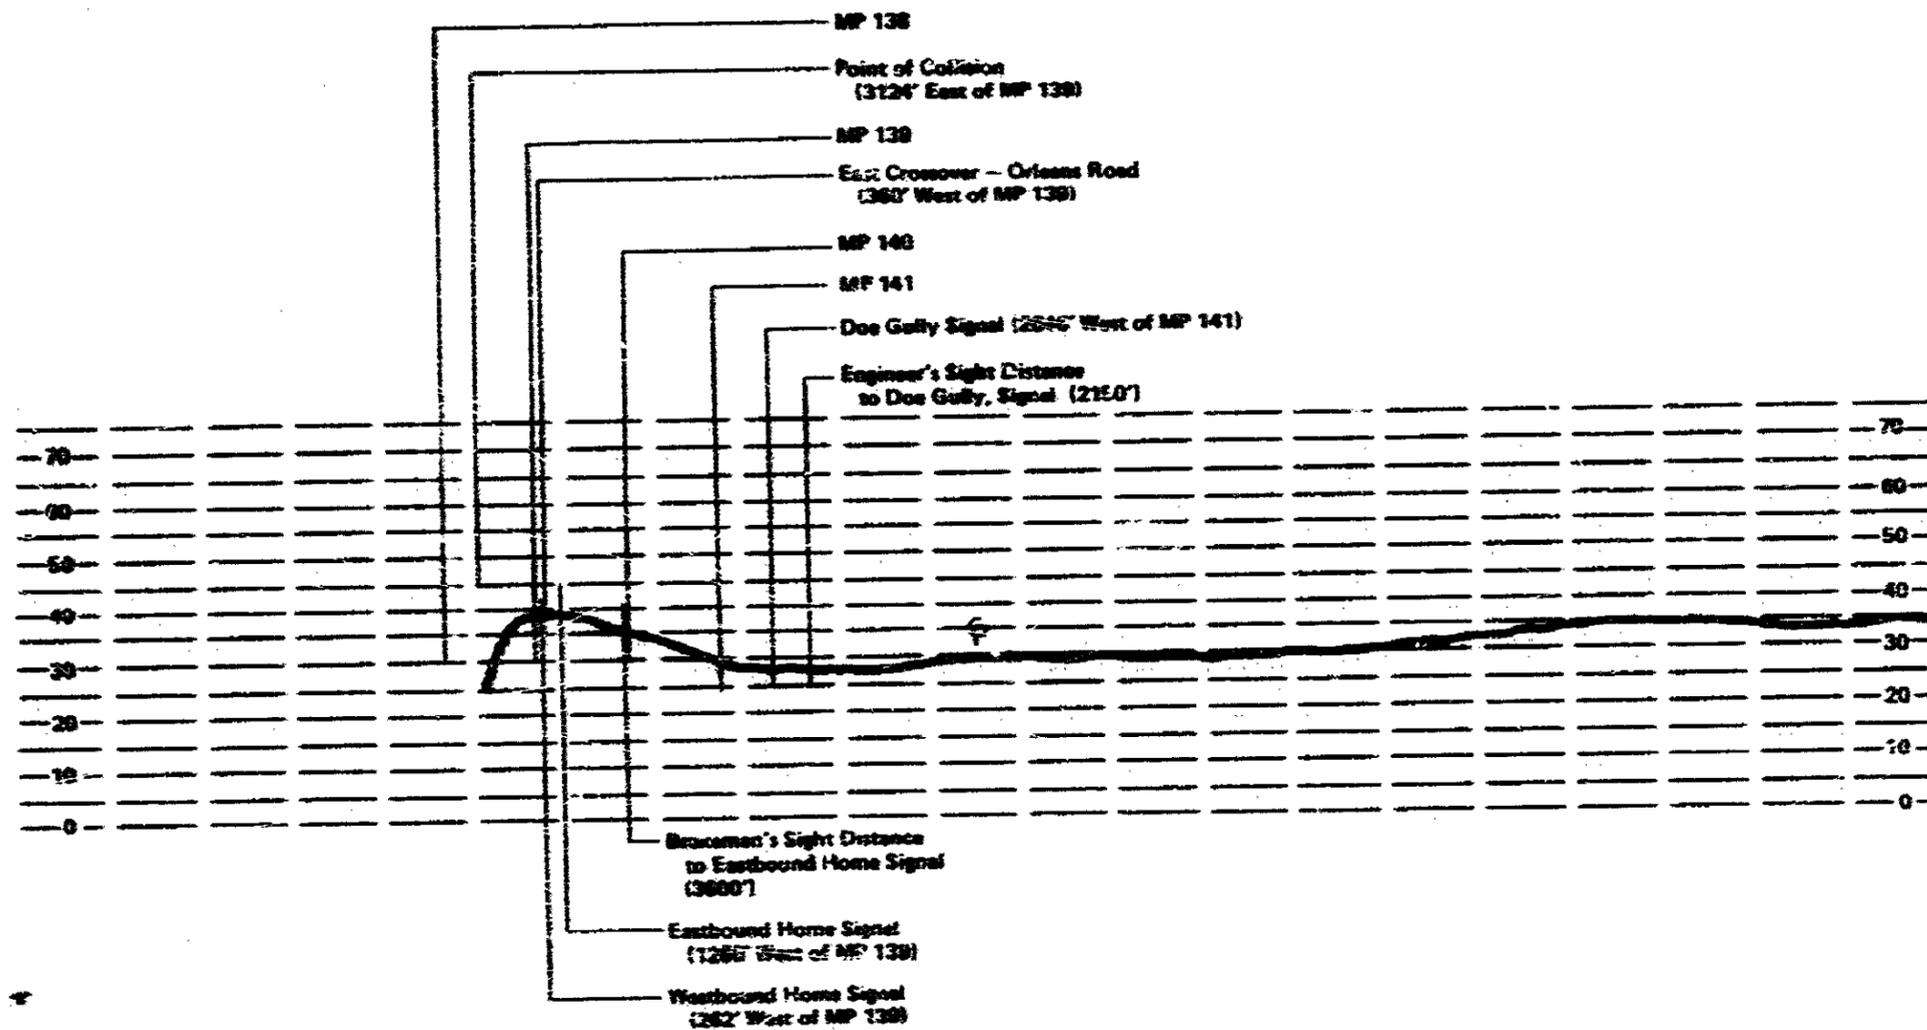
Examination of the speed recorder tape from train Extra 6474 East indicated that the engineer had properly controlled the speed of the train before approaching the approach signal for Orleans. The speed of the train in the 1-mile before the approach signal was 29 mph. The tape further indicated that, after passing the signal, the speed of the train gradually increased to 38 mph as the train passed the home signal at Orleans Road. After Orleans Road, the speed of the train immediately began to decrease to 25 mph at the point of collision.

SPEED TAPE REMOVED FROM THE LEAD UNIT OF EXT. A 6474 EAST AT ORLEANS ROAD

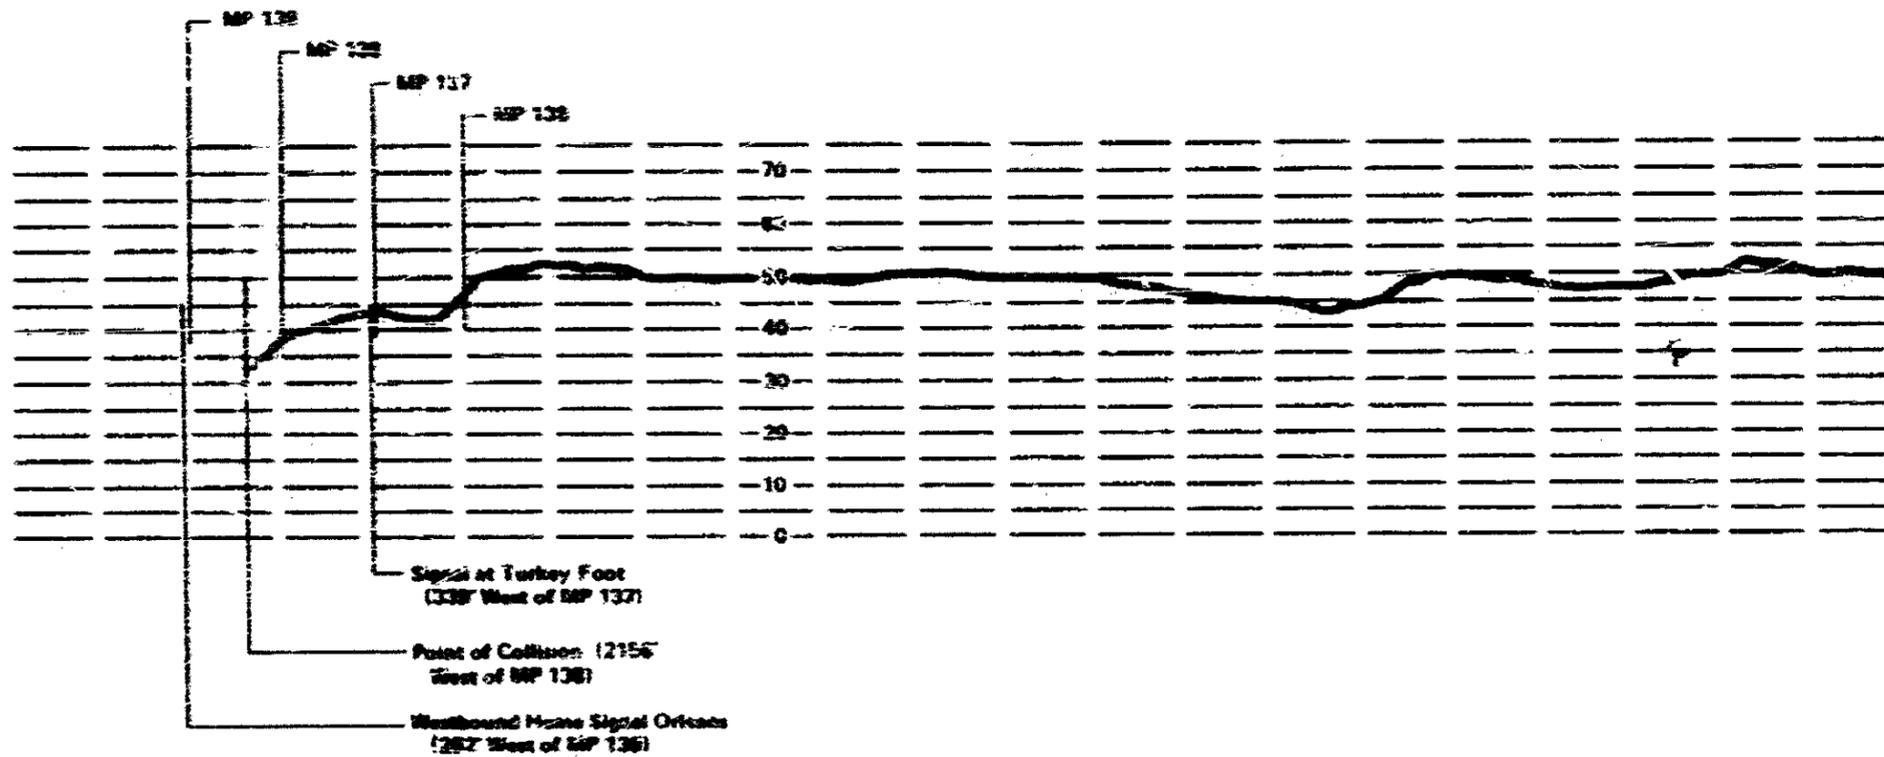
Examination of the speed recorder tape from train Extra 4367 West indicated that the speed of the train had been properly controlled from Brunswick to the point of collision. About 1 mile before the approach signal, the fireman started to reduce the train's speed from 50 mph, and it was 44 mph at the approach signal. The speed of the train then continued to be reduced and was 32 mph at the point of collision. (See appendix D.)

SPEED TAPE REMOVED FROM THE LEAD UNIT OF EXTRA 4367 WEST AT ORLEANS ROAD
