RAILROAD ACCIDENT REPORT

DERAILMENT OF
WESTERN PACIFIC RAILROAD COMPANY
FREIGHT TRAIN EXTRA UP 3734 WEST
(SEALAND 6)
HAYWARD, CALIFORNIA
APRIL 9, 1980

NTSB-RAR-80-10

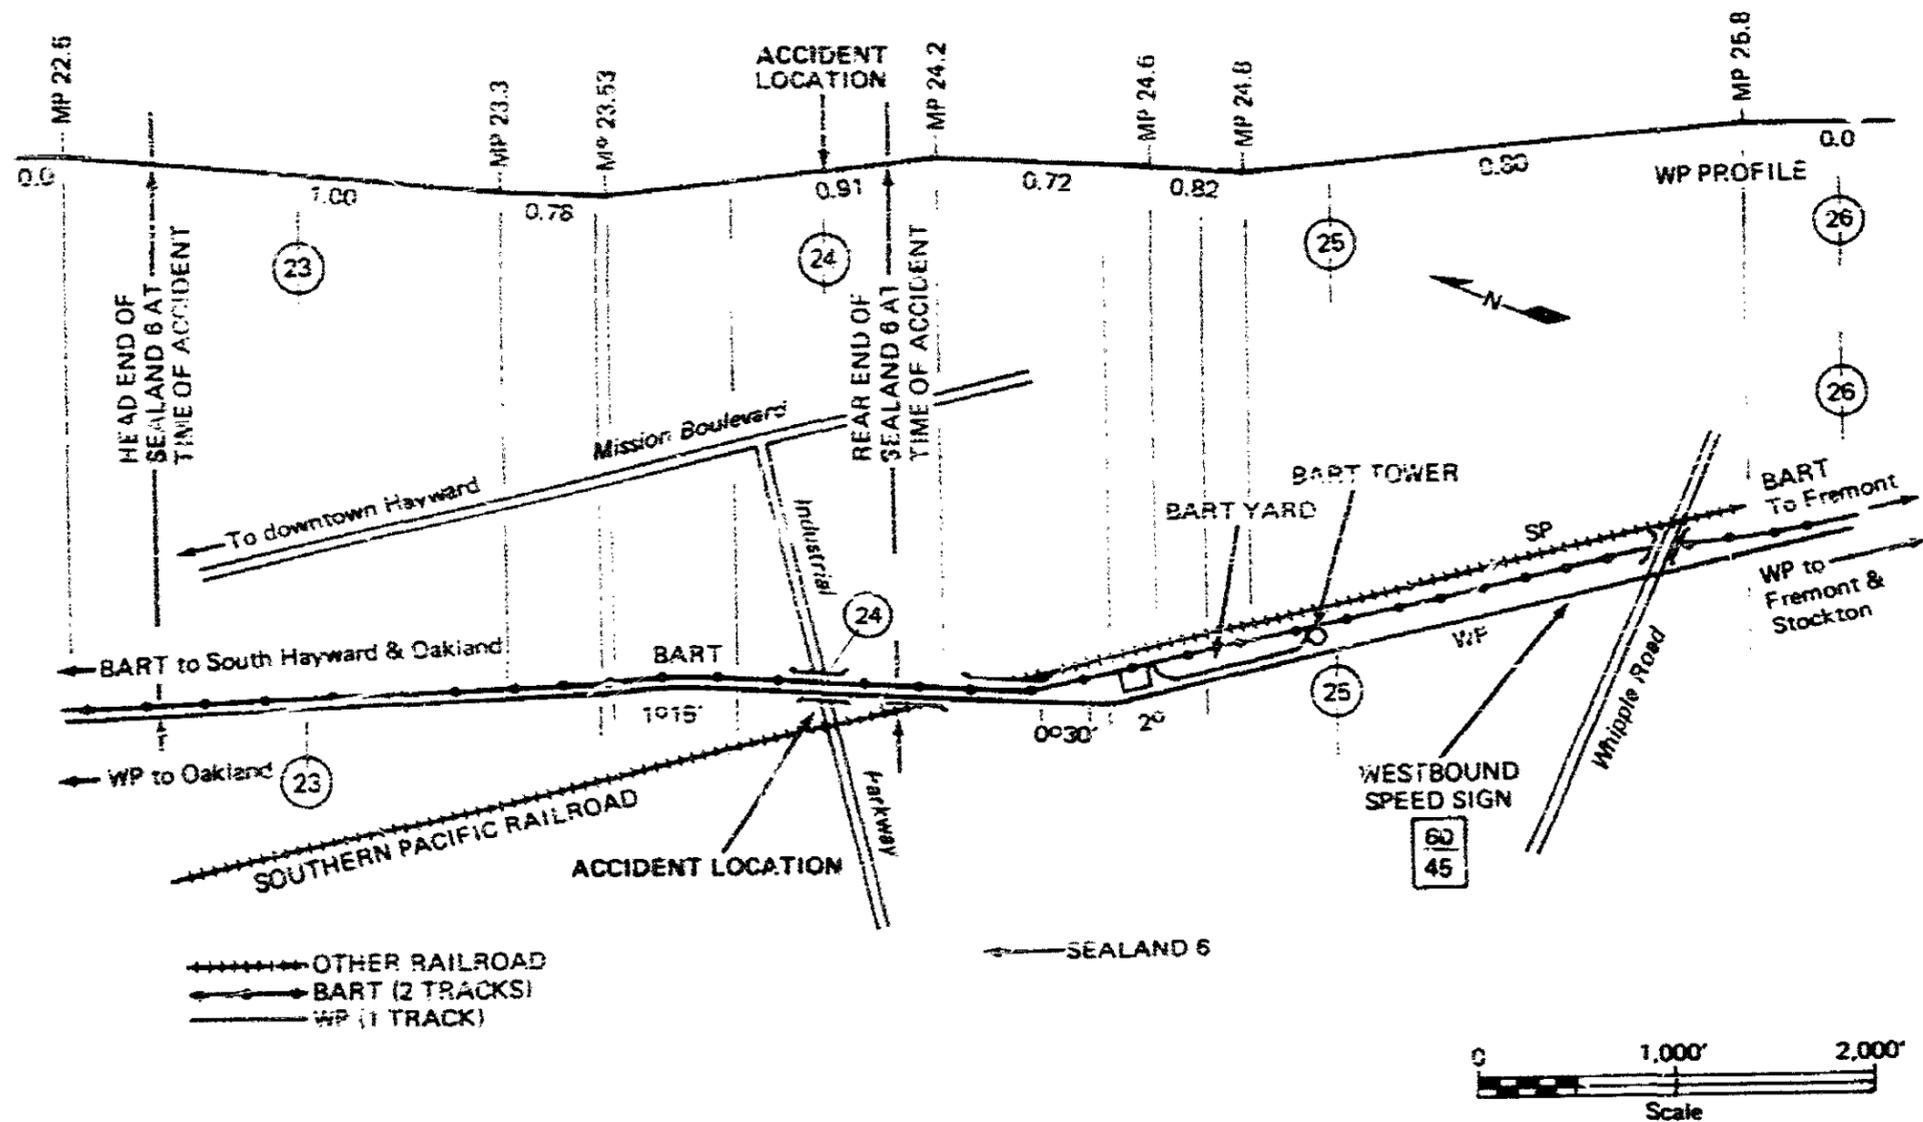
At Milepost 24.2 the head-end started down a 0.91 percent grade 0.7 mile long. The head-end engineer said he continued to run in full throttle but at this point made an automatic brake application to keep from accelerating beyond 60 mph. At the bottom of the grade, the engineer released the brake application and the head end started to ascend a 1-mile grade varying from 0.78 to 1.00 percent. Shortly afterward, the helper locomotive started down the 0.91 percent grade. When the helper reached Milepost 24 and the Industrial Parkway overpass, the forward two-thirds of the Sealand 6 was on the ascending grade and the rear one-third was on the descending grade. (See figure 1.) Indicated speed at the rear helper unit had reached 63 mph whereas, according to the engineer, the indicated speed of the lead unit at the head-end had dropped to 52 mph. The train experienced a severe run-in of slack at both ends, followed by the lead-end of the caboose ahead of the helper locomotive raising up from the track and derailling to the left. Separated from the car ahead and the locomotive behind, the caboose left the track structure at or near the south end 1/ of the overpass and came to rest on Industrial Parkway west of the overpass. The train brakes went into emergency simultaneously with or immediately after the caboose derailed.

Figure 1.--Diagram and profile of accident location and approach from Milepost 25.8.

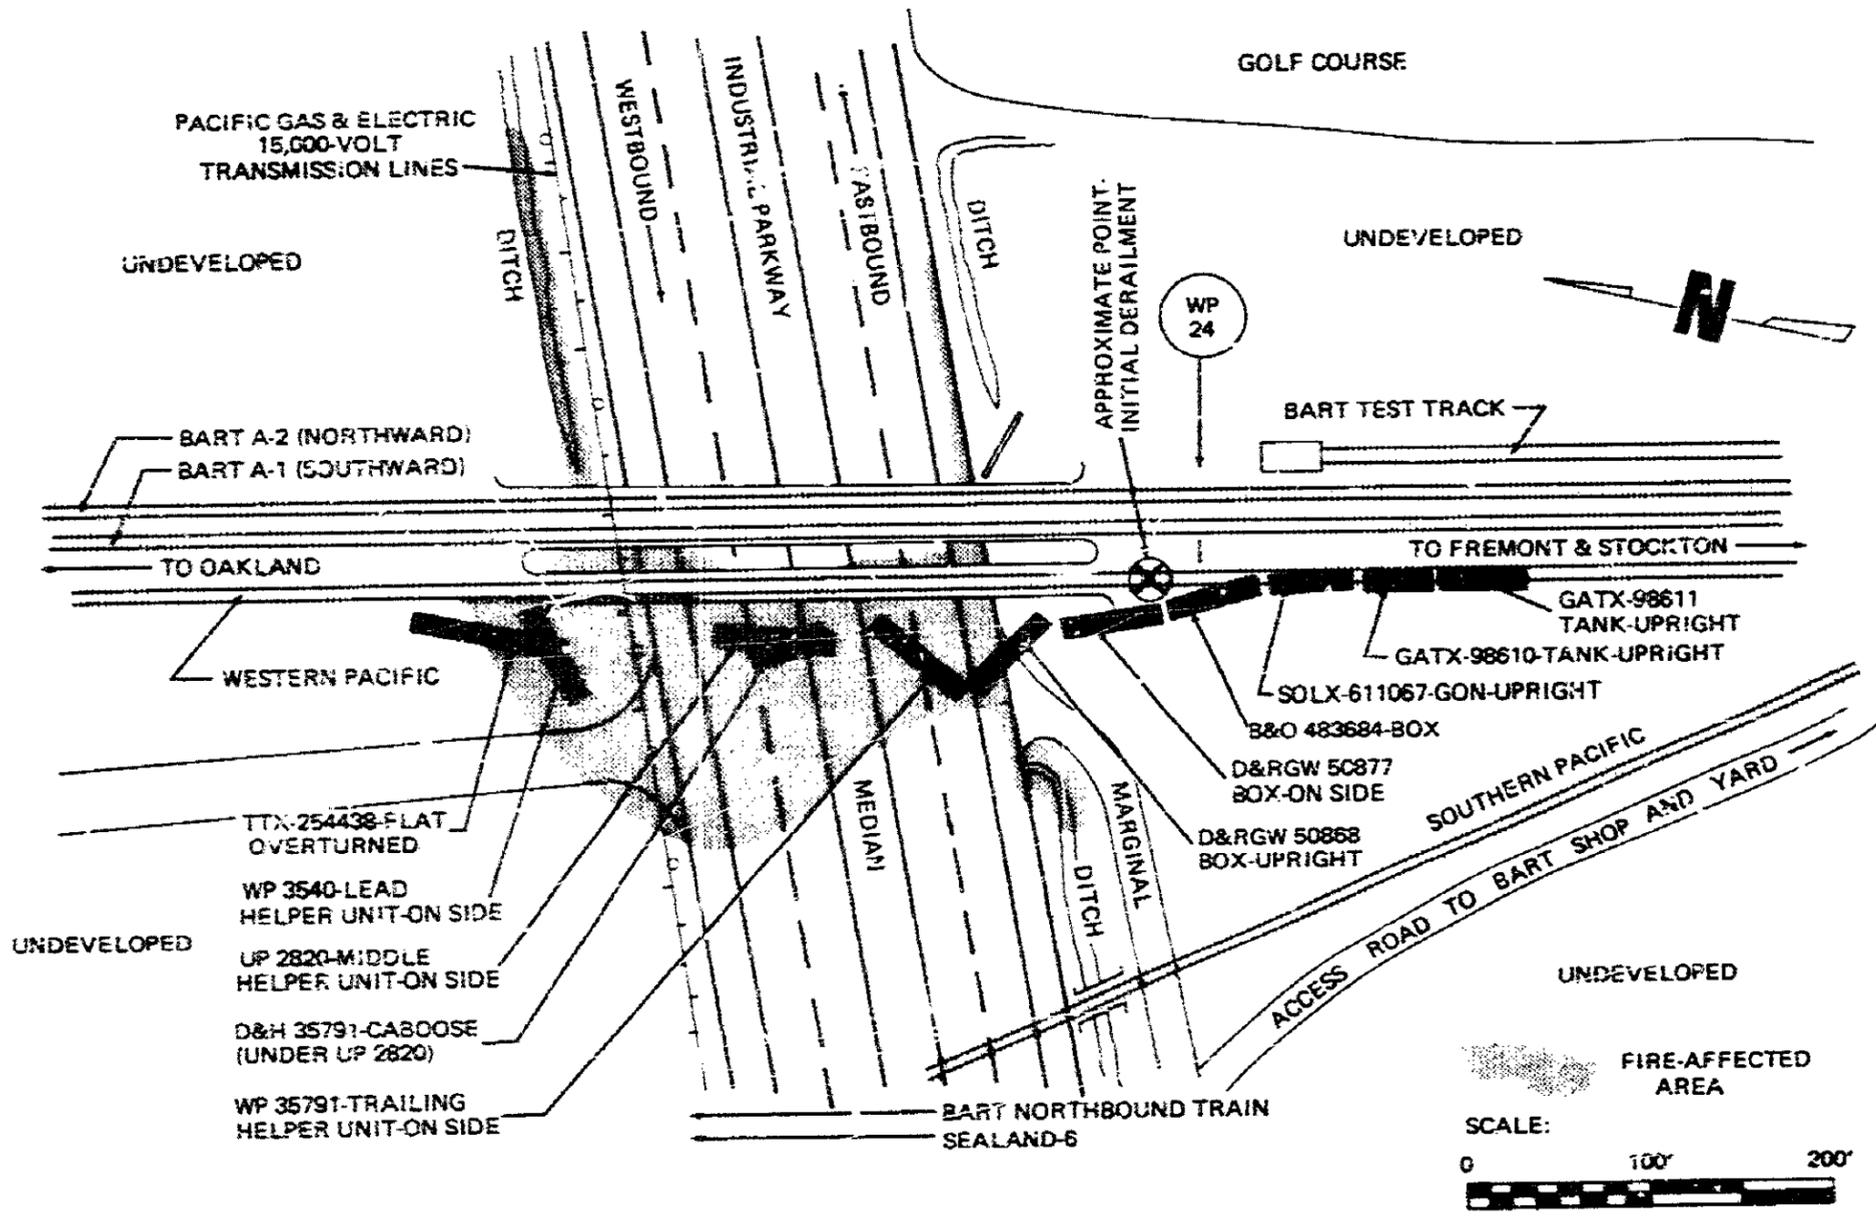
The rear truck of the car ahead of the caboose derailed to the left and the car was struck by the lead unit of the locomotive. Both vehicles left the track structure at or near the north end of the 230-foot overpass and came to rest on the west embankment north of Industrial Parkway. The second and third helper locomotive units derailed to the west and fell 30 feet from the overpass onto the highway. The second unit fell on the caboose. The third unit came to rest on the

eastbound traffic lane. (See figure 2.) The fuel tanks of all three units were ruptured in the derailment and escaping fuel was ignited immediately by the arcing of 15,000-volt Pacific Gas and Electric (PG & E) powerlines that had been severed in the derailment. (See figure 2.)

Figure 2.--Plan view of accident site and wreckage distribution.

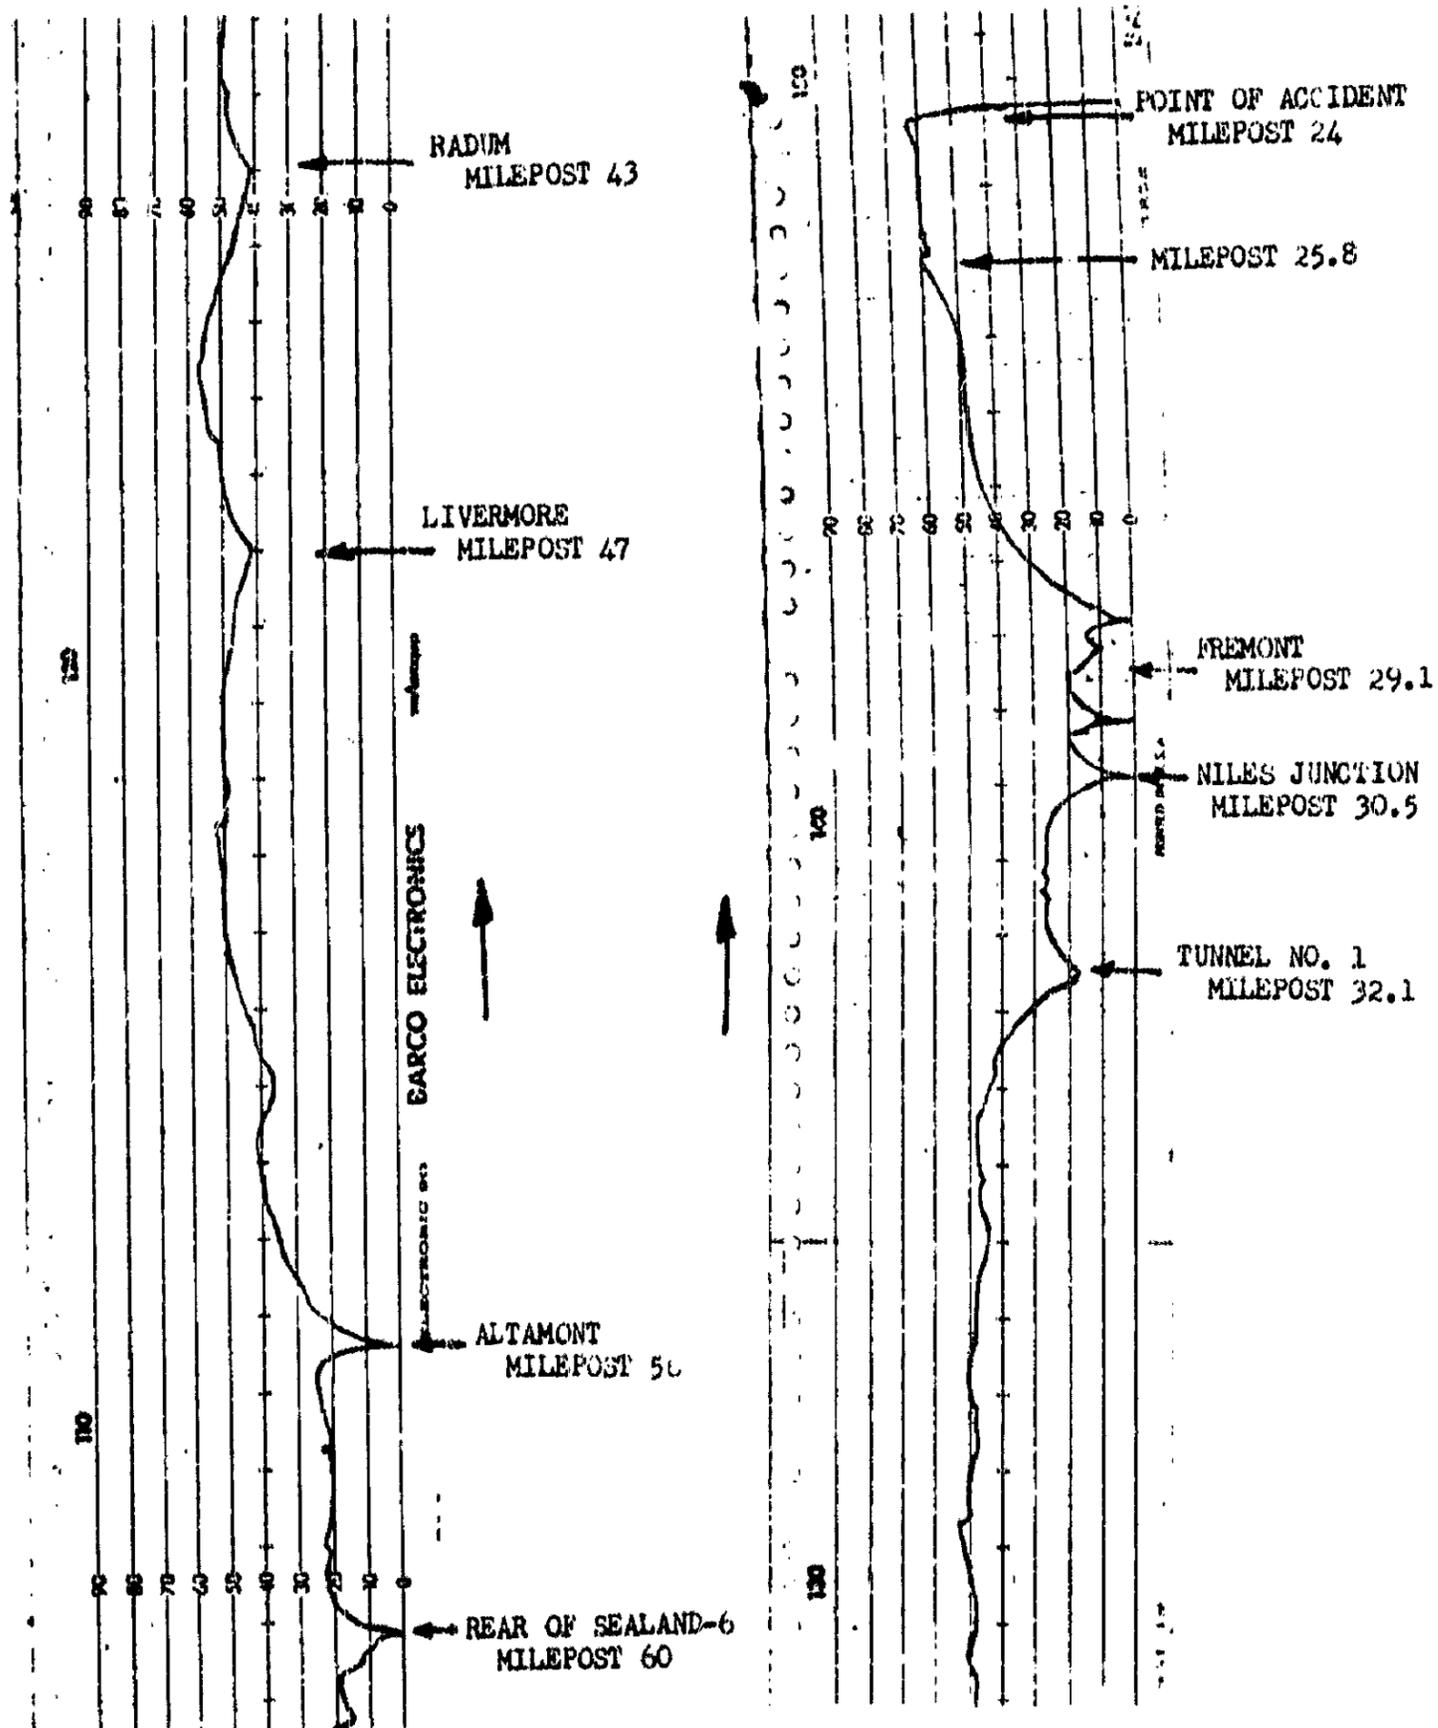
SPEED RECORDER TAPE REMOVED FROM THE LOCOMOTIVE OF RBW-9

Although the trailing helper unit was destroyed by fire, the speed recorder on this unit yielded a legible and undamaged tape. The recorder was calibrated and found to be accurate within 0.1 mph.
