# NATIONAL TRANSPORTATION SAFETY BOARD

## RAILROAD ACCIDENT REPORT

ILLINOIS CENTRAL GULF  
RAILROAD COMPANY  
FREIGHT TRAIN DERAILMENT  
HAZARDOUS MATERIAL RELEASE  
AND EVACUATION  
MULDRAUGH, KENTUCKY  
JULY 26, 1980

NTSB-RAR-81-1

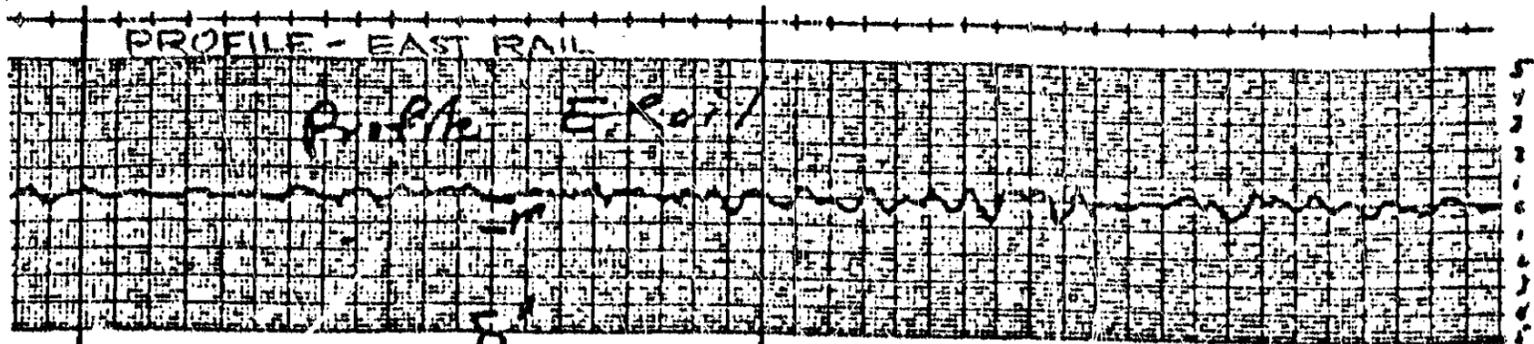
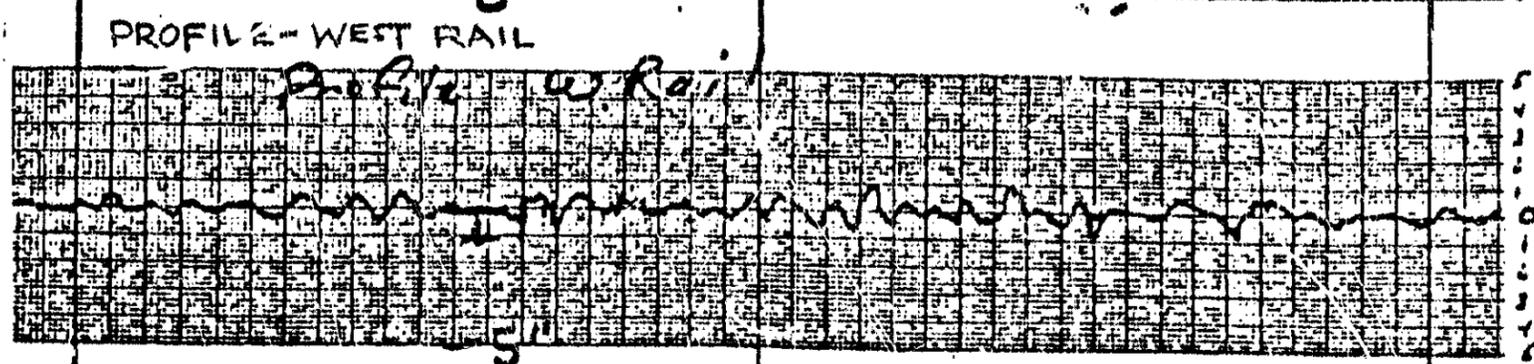
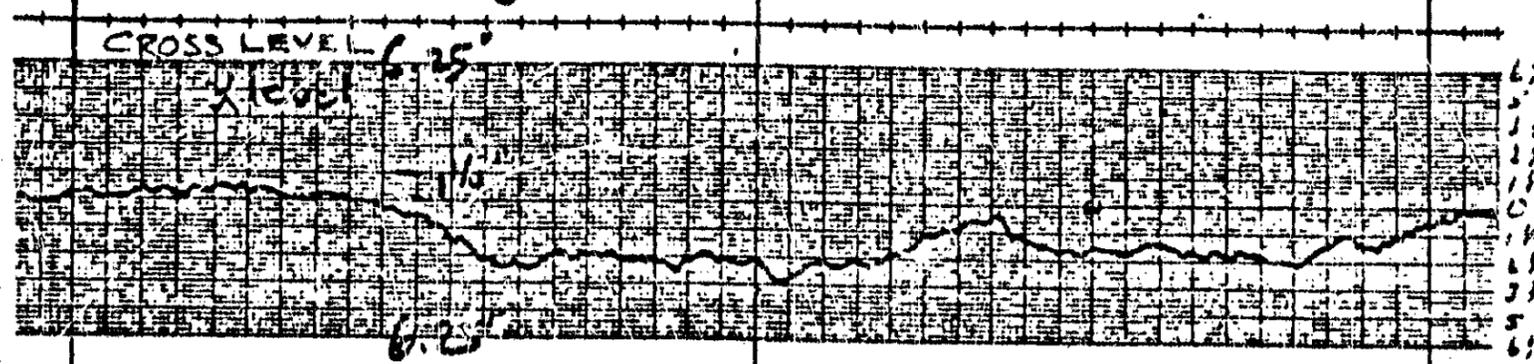
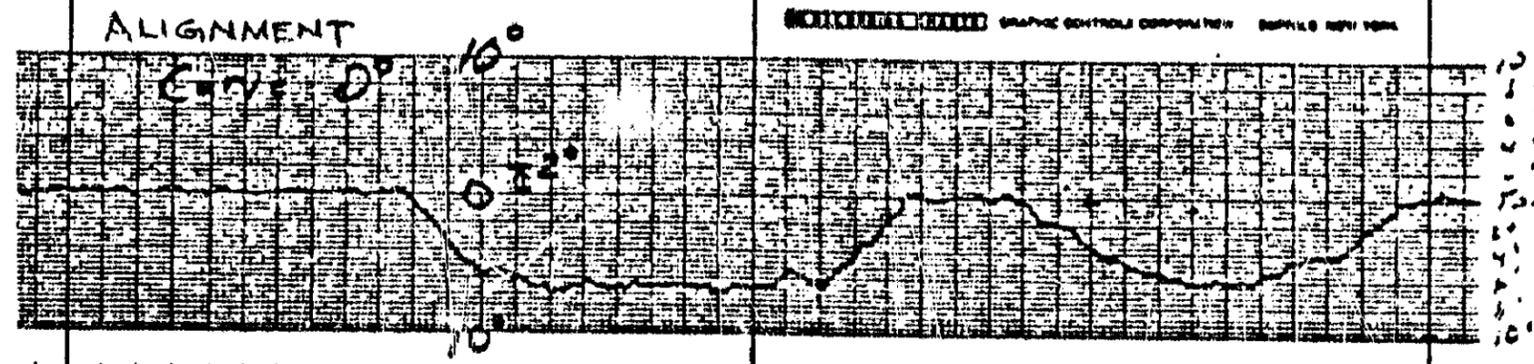
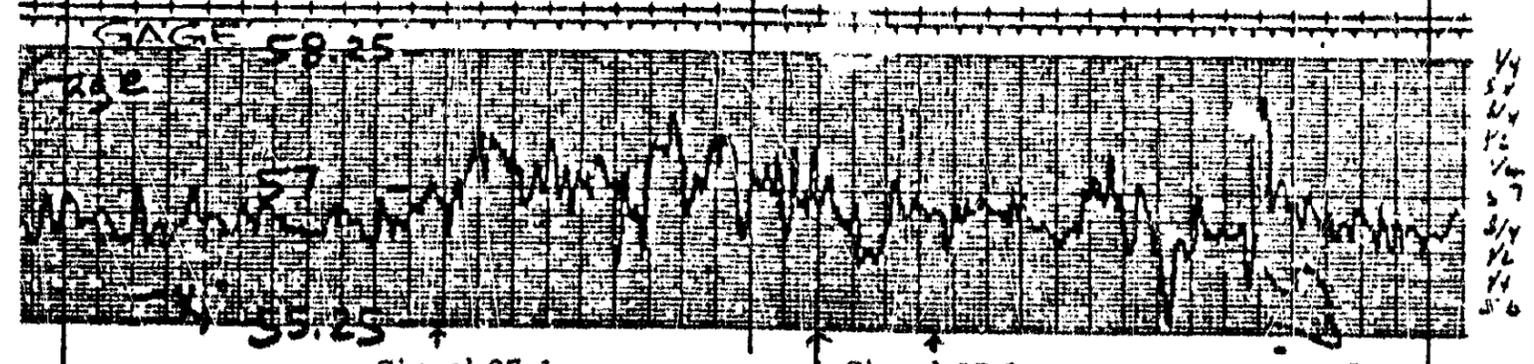
APPENDIX D  
FRA GEOMETRY TAPE,  
DECEMBER 14, 1979  
ICG TRACK, MP 27 TO 28

measurements of the track made by the FRA geometry car revealed abrupt changes in curvature and superelevation for a distance of about 84 feet at the beginning of the 6° curve. The variations of the 6° curve alignment from 5°30' to as much as 7° would have produced additional lateral forces on the outside rail of the curve as a train moved around the curve. Abrupt changes in the superelevation also would have produced unequal lateral forces. Even though these measurements were made about 6 months before the accident, there is no record that the repairs were made to correct these conditions before the accident occurred. Separately, these defects were not in violation of the standards for Class 3 track. However, constant traffic would, in all likelihood, have made the deviations greater than when originally measured. The increased possibility of derailment because of the combination of these deteriorating track conditions should have been recognized by inspectors.

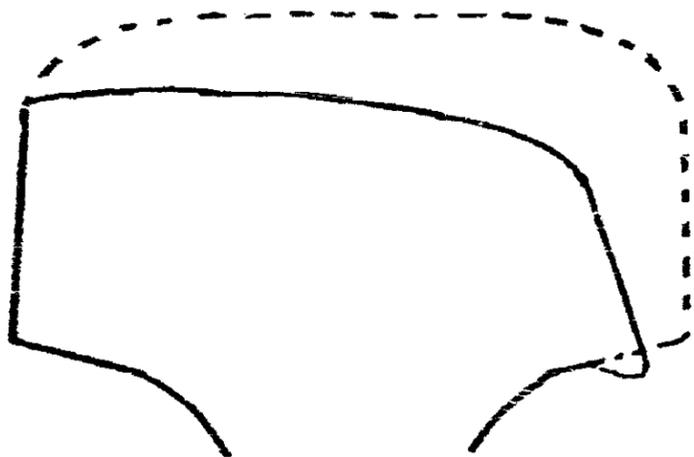
WEST RAIL, STA 30+71  
23% WEAR

A postaccident inspection revealed that the gage side of the head of the outside rail of the 6° curve was reduced between 28 to 44 percent of its surface. (See appendix E.) The ICG inspector who made the July 24, 1980, inspection said he noticed flange marks on the top of joint bars at milepost 27.5. He said he attributed the flange marks to railhead wear and curve-worn rail on the high side of the curve which would permit the flanges of the wheels to contact the joint bars. He did not note these conditions on the inspection report.

Many excessively curve-worn rails were found throughout the derailment area. The approximate 28- to 44-percent reduction in the cross section of the rail would have substantially lowered the rail's ability to withstand bending stresses. <sup>3/</sup> This worn condition would have made the rail more prone to breakage under the strain of the increasingly heavy loads carried by today's trains. <sup>4/</sup> A 44-percent reduction of cross section also would have made the rail more prone to tipping because the resultant force of the vertical and lateral component forces of the wheel on the rail could have been beyond the outside edge of the rail base. The use of such curve-worn rails is left to the discretion of the carrier. Neither the ICG nor the FRA have promulgated rules or regulations to limit wear for rails that are used in mainline trackage. The Safety Board believes that the use of such excessively worn rails should not be used on main or side tracks.
