## RAILROAD ACCIDENT REPORT

SIDE COLLISION OF  
NORFOLK AND WESTERN RAILWAY COMPANY'S  
TRAIN NO. 86 WITH EXTRA 1589 WEST  
NEAR WELCH, WEST VIRGINIA  
SEPTEMBER 6, 1980

NTSB-RAR-81-2

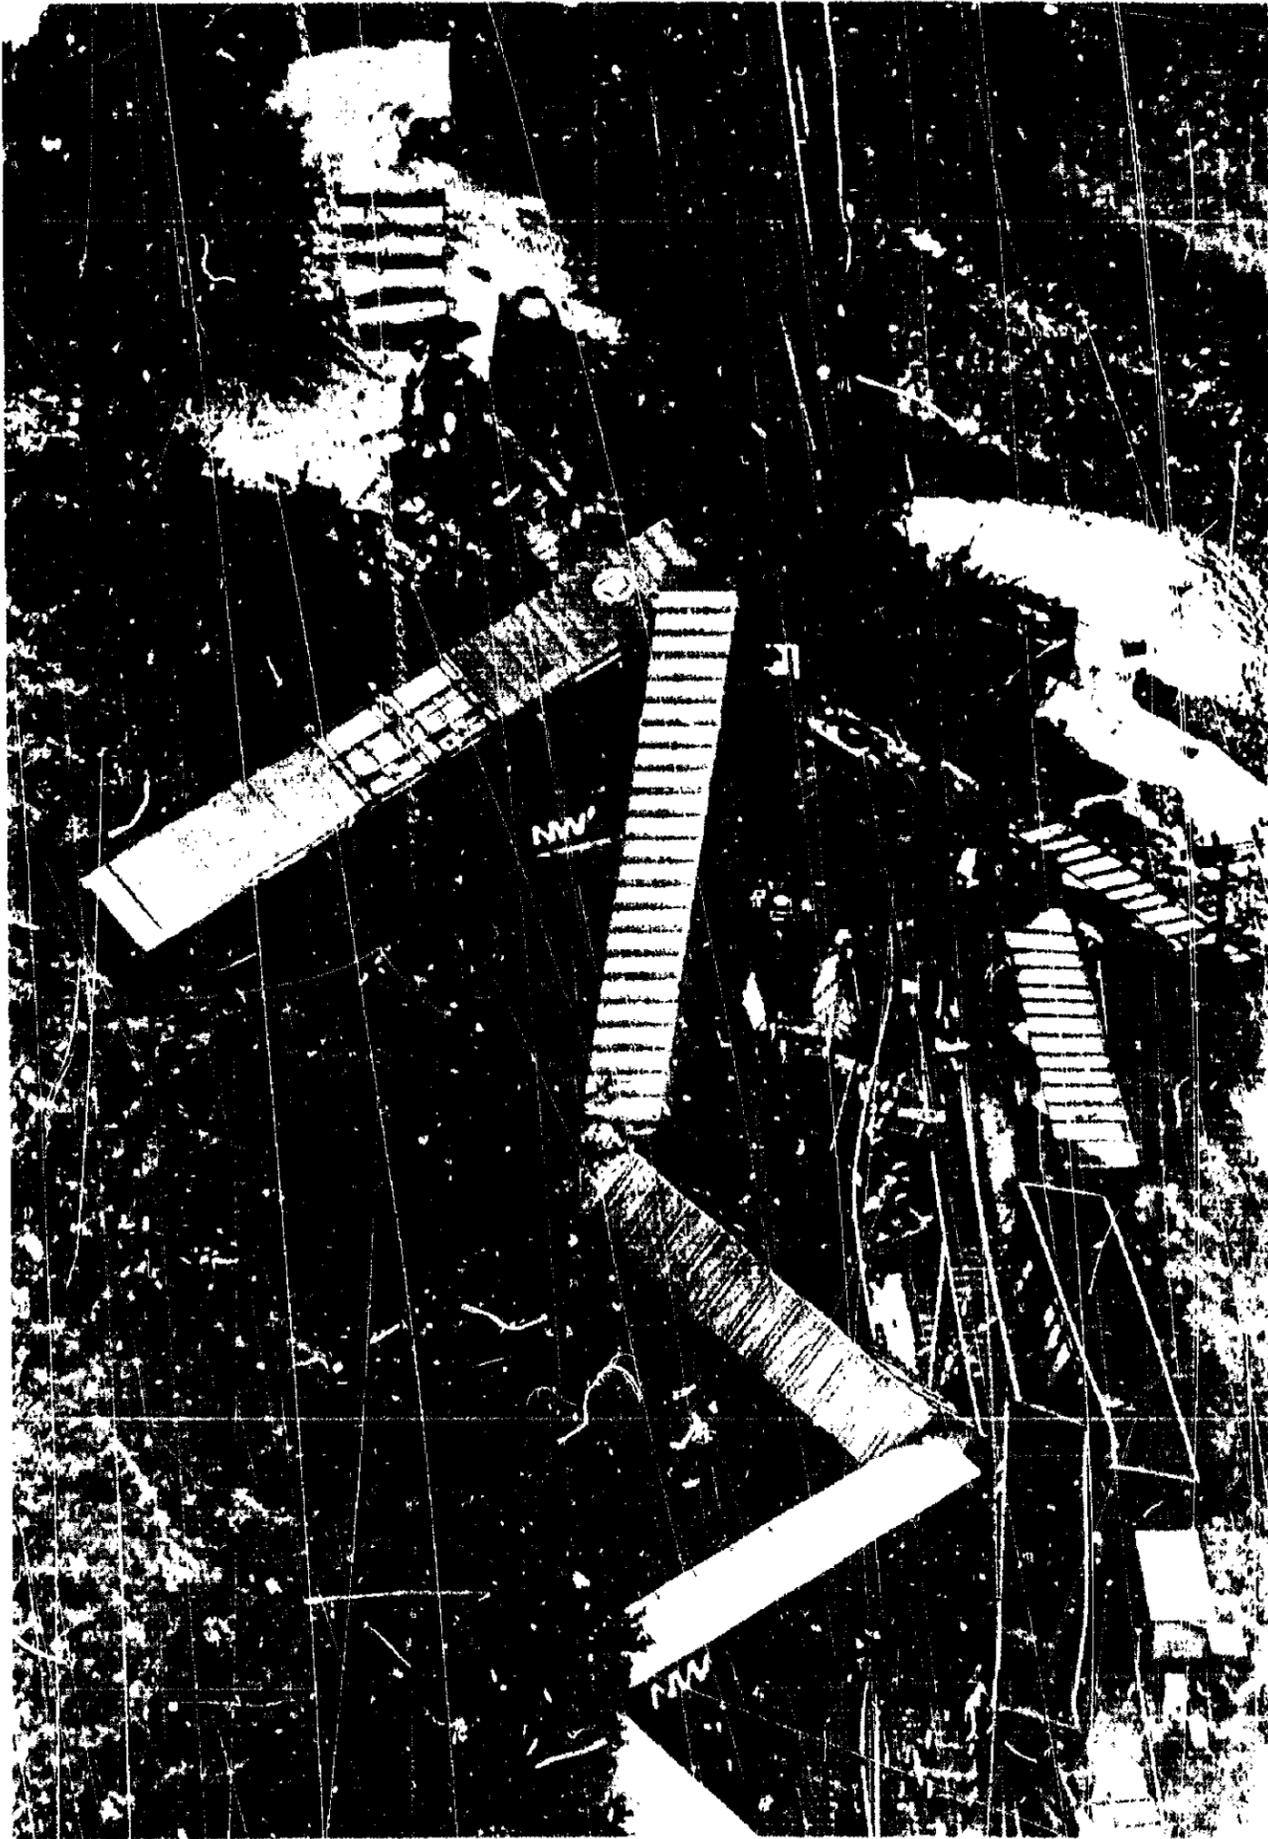
About 8:10 a.m., while moving at a speed of 38 mph, 180 feet east of the home signal and 1,359 feet into a compound curve to the left, the right front corner of the lead locomotive unit of train No. 86 collided with the sixth car behind the locomotive of Extra 1589 West as it was entering the passing track.

Figure 1. -Side collision of train No. 86  
(right) and Extra 1589 West (left).

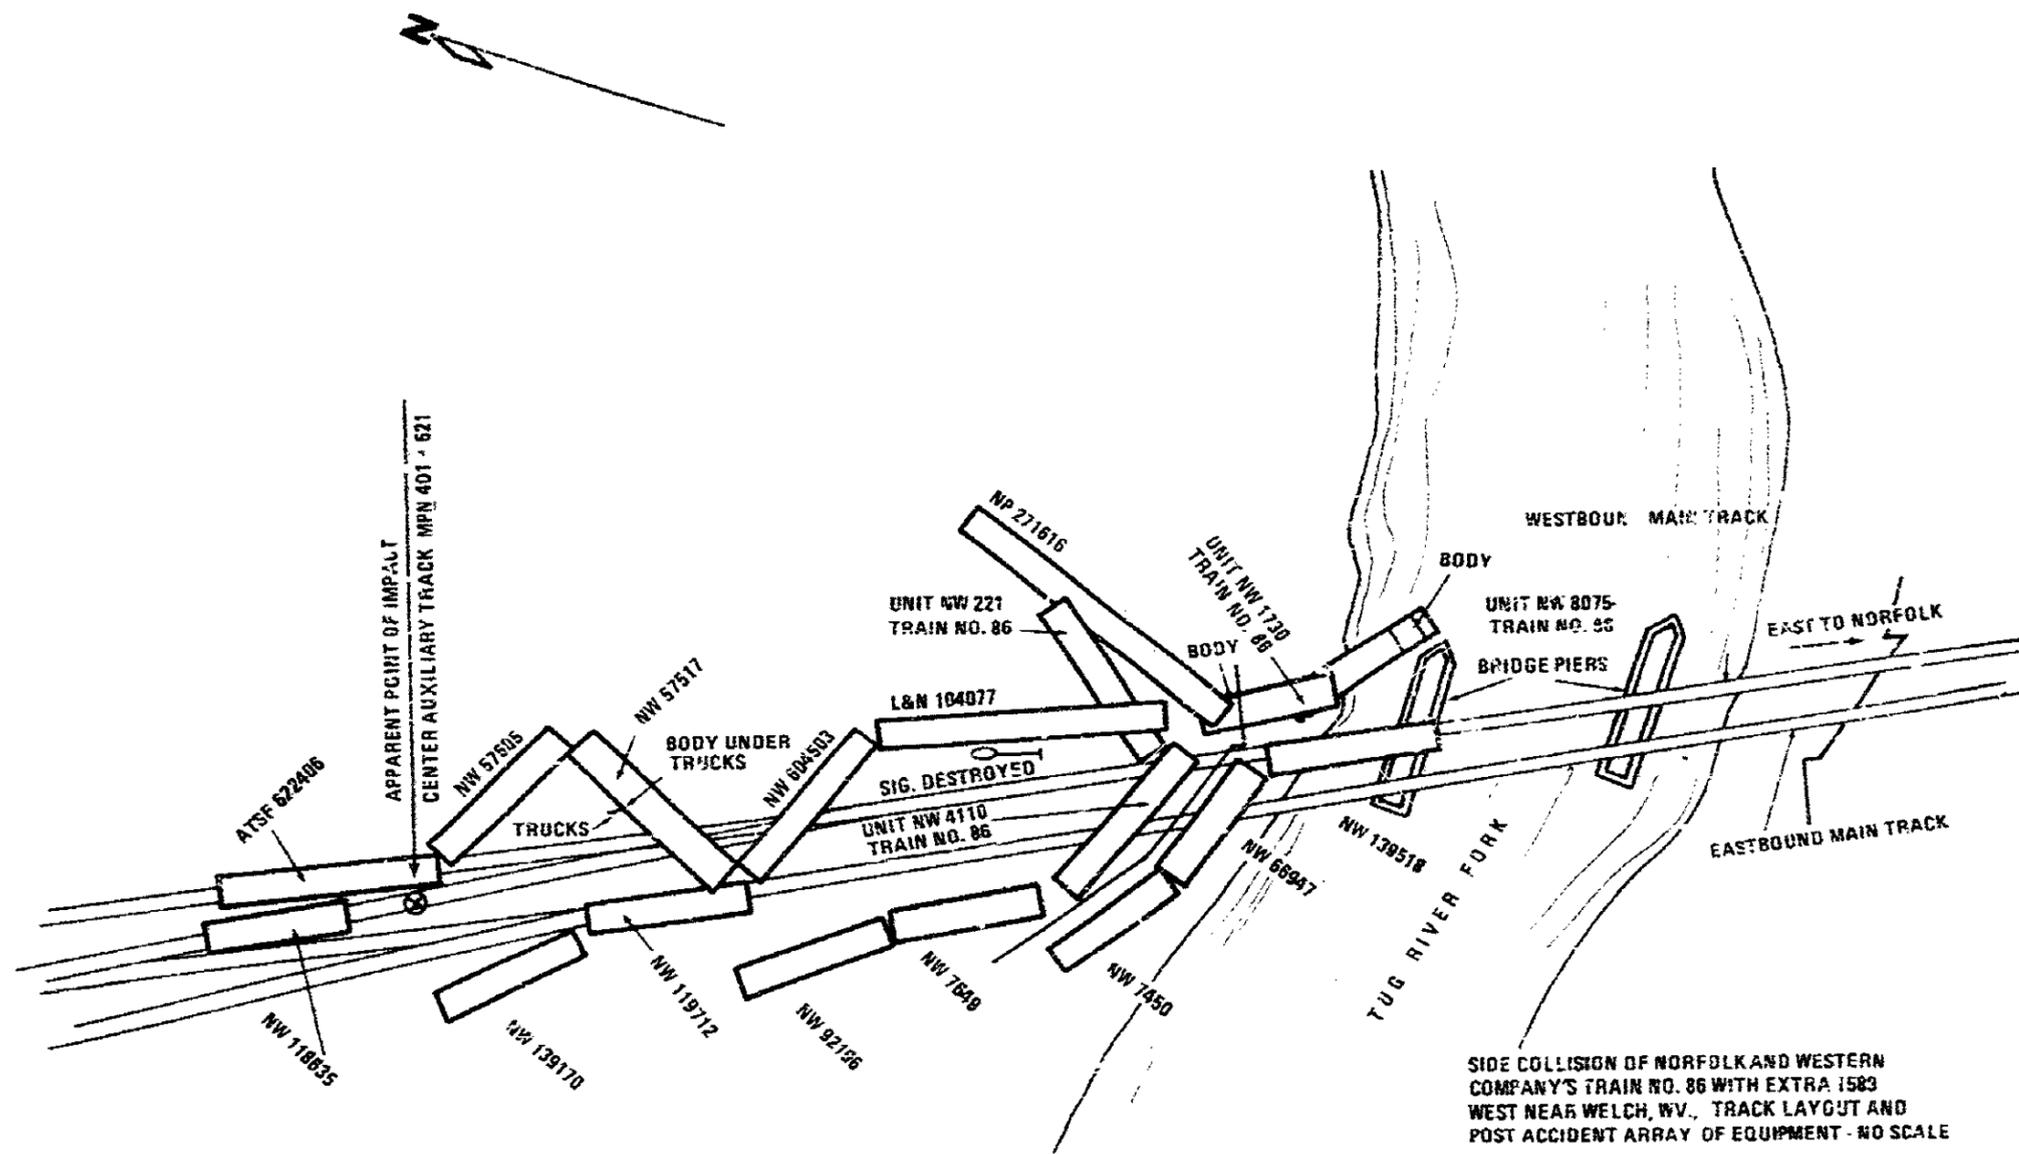
Of the eight empty coal-hopper cars of Extra 1589 West that were derailed, six were lying on or immediately to the south of the track structure. The two easternmost cars were still on the westbound main track and trestle.

Figure 4.—Track layout and postaccident array of equipment.

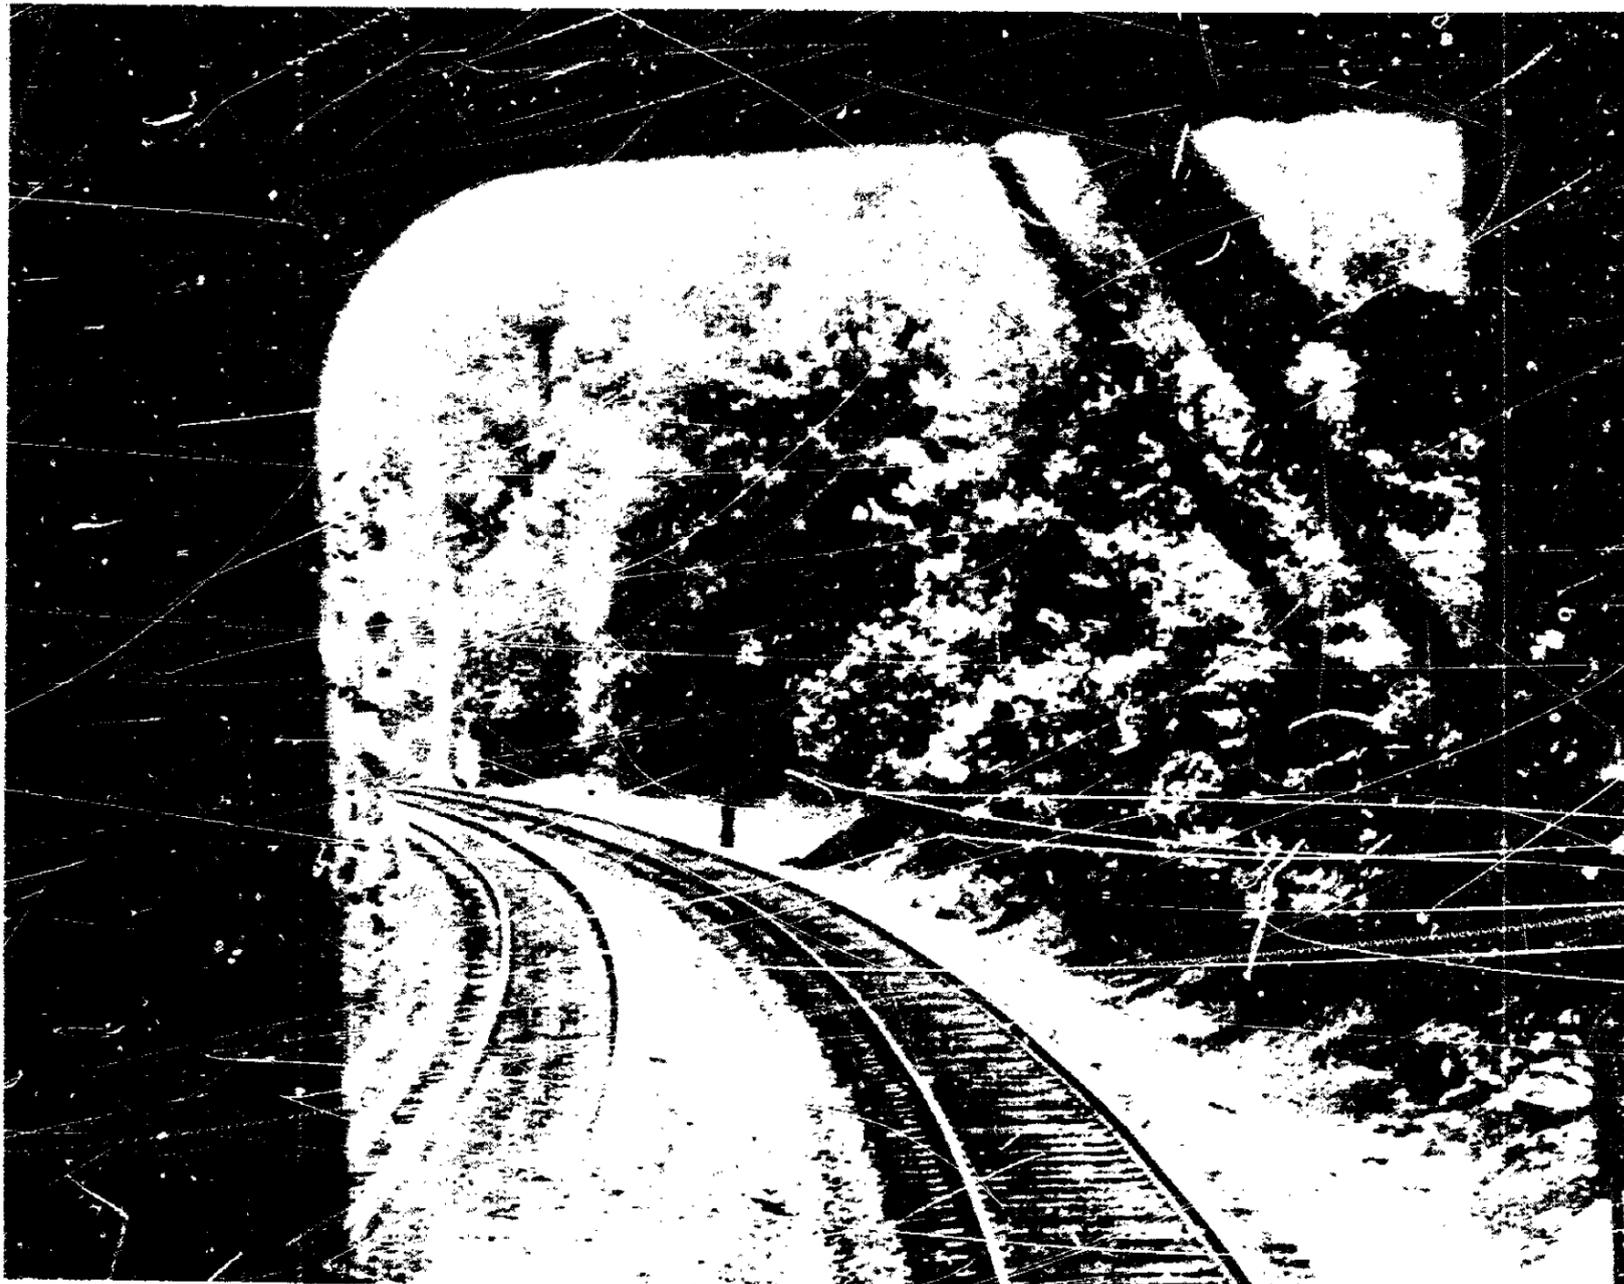
Figure 5.--Eastbound operator's first available sighting of the "approach" signal at the west end of Farm.

The 414-foot maximum clear sight distance between the position of the operator's seat of train No. 86 and the approach signal at the west end of Farm

allowed a maximum viewing time of 8.5 seconds at a train speed of 35 mph. (See appendix D.) At this speed, the cab of the lead unit would have passed both the clear signal at Mohegan and the approach signal at the west end of Farm, a distance of 1,149 feet, in about 22 seconds. The transit time for these distances is considerably less than the total 60-second timing cycle of the crew alertness device.

Modify existing signals so that an "advance approach" aspect will be displayed for eastbound trains on both tracks at Mohegan when an "approach" aspect is displayed on either track at the west end of Farm. Where similar conditions exist at other locations, also provide an advance approach aspect. (Class II, Priority Action) (R-81-37)
