NATIONAL TRANSPORTATION SAFETY BOARD

RAILROAD ACCIDENT REPORT

HEAD-ON COLLISION BETWEEN
BALTIMORE & OHIO RAILROAD COMPANY
TRAIN NO. 88 AND THE BRUNSWICK HELPER
NEAR GERMANTOWN, MARYLAND
FEBRUARY 9, 1981

NTSB-RAR-81-6

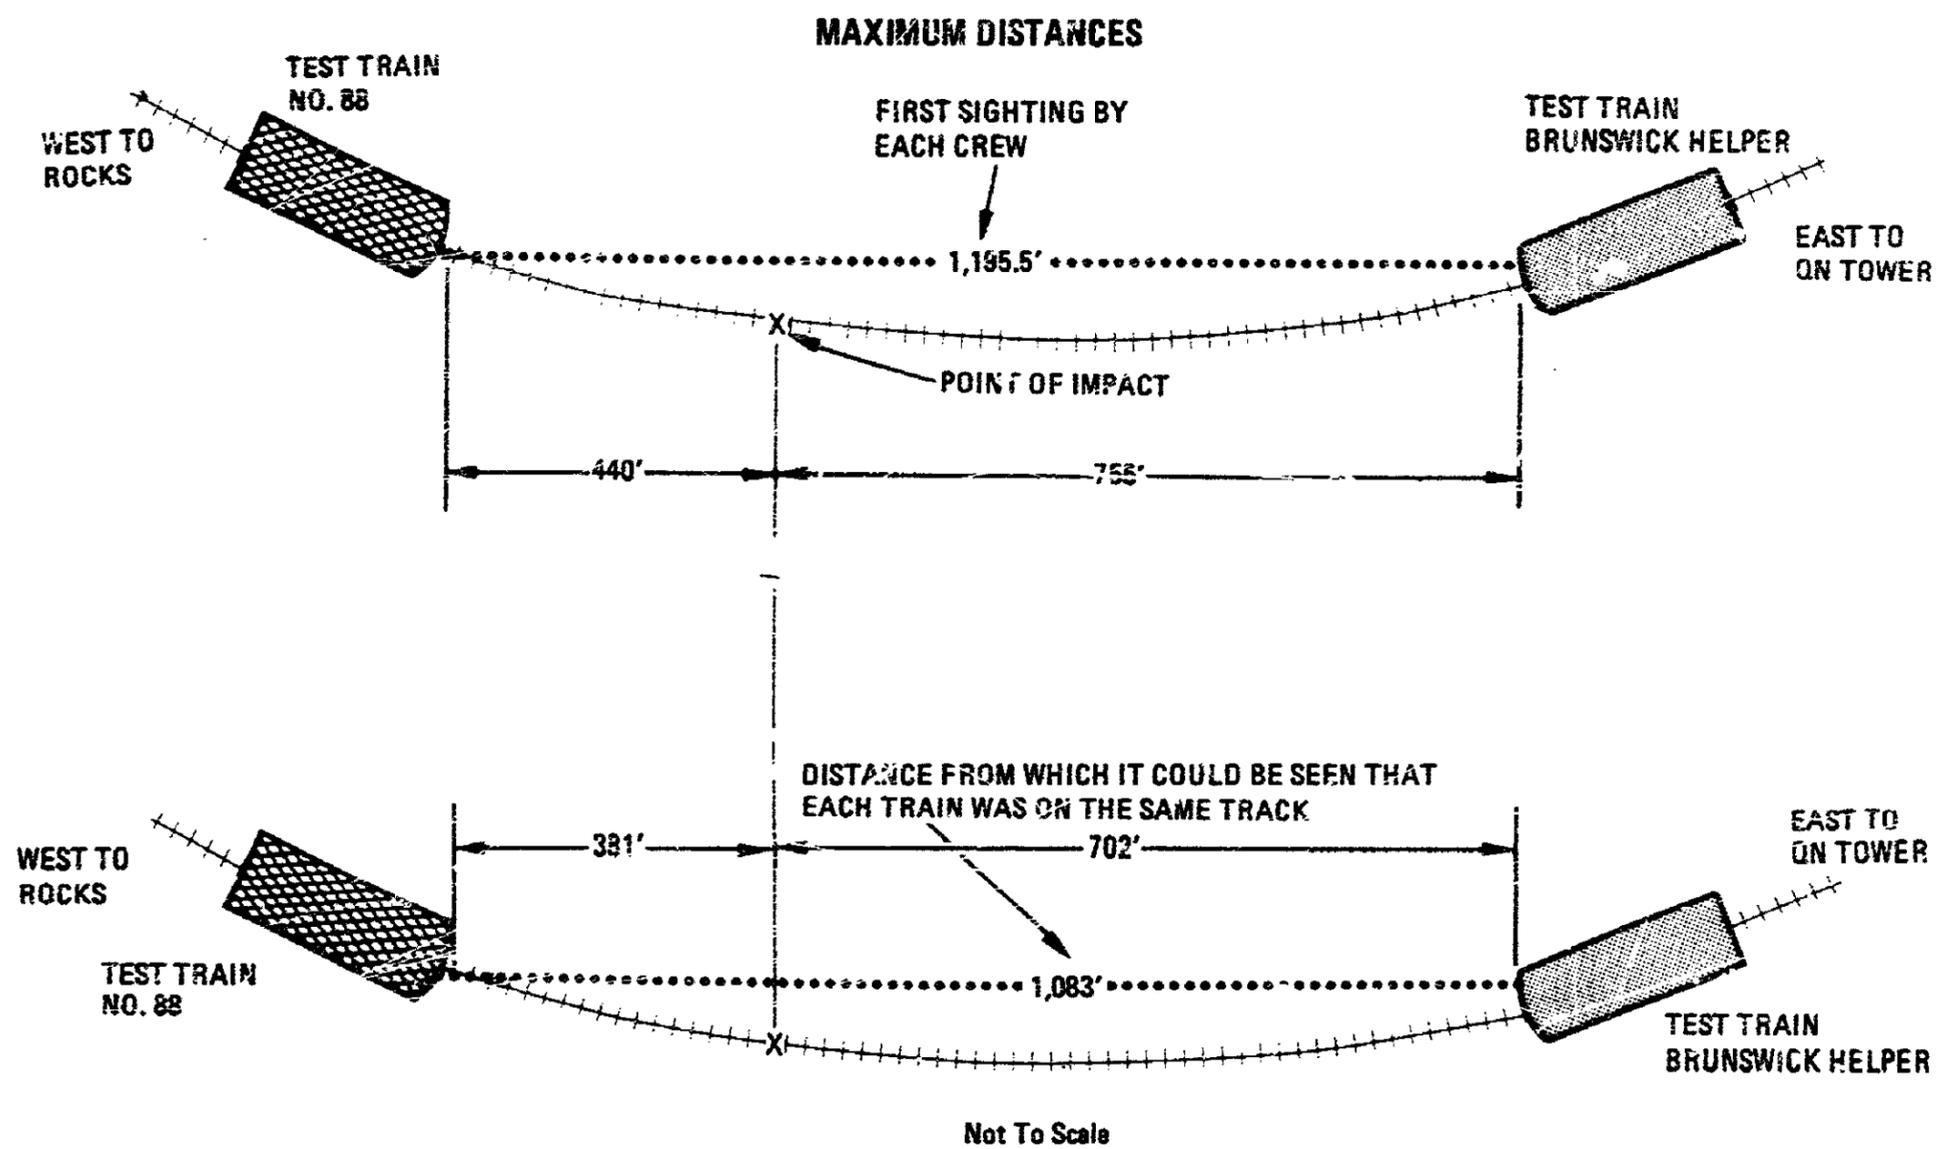
Figure 4.-- Sight distance as determined by test trains.

On February 19, tests were conducted to establish sight distances for the curve on which the trains collided. Locomotive units similar to the units involved in the collision were used and were oriented in the same position and direction as those of the accident trains. Tests simulated the view from each train to the other. (See figures 4 and 5.)
