NATIONAL TRANSPORTATION SAFETY BOARD

RAILROAD ACCIDENT REPORT

**REAR-END COLLISION OF
UNION PACIFIC RAILROAD COMPANY
FREIGHT TRAINS EXTRA 3119 WEST
AND EXTRA 8044 WEST
NEAR KELSO, CALIFORNIA
NOVEMBER 17, 1980**

NTSB-RAR-81-7

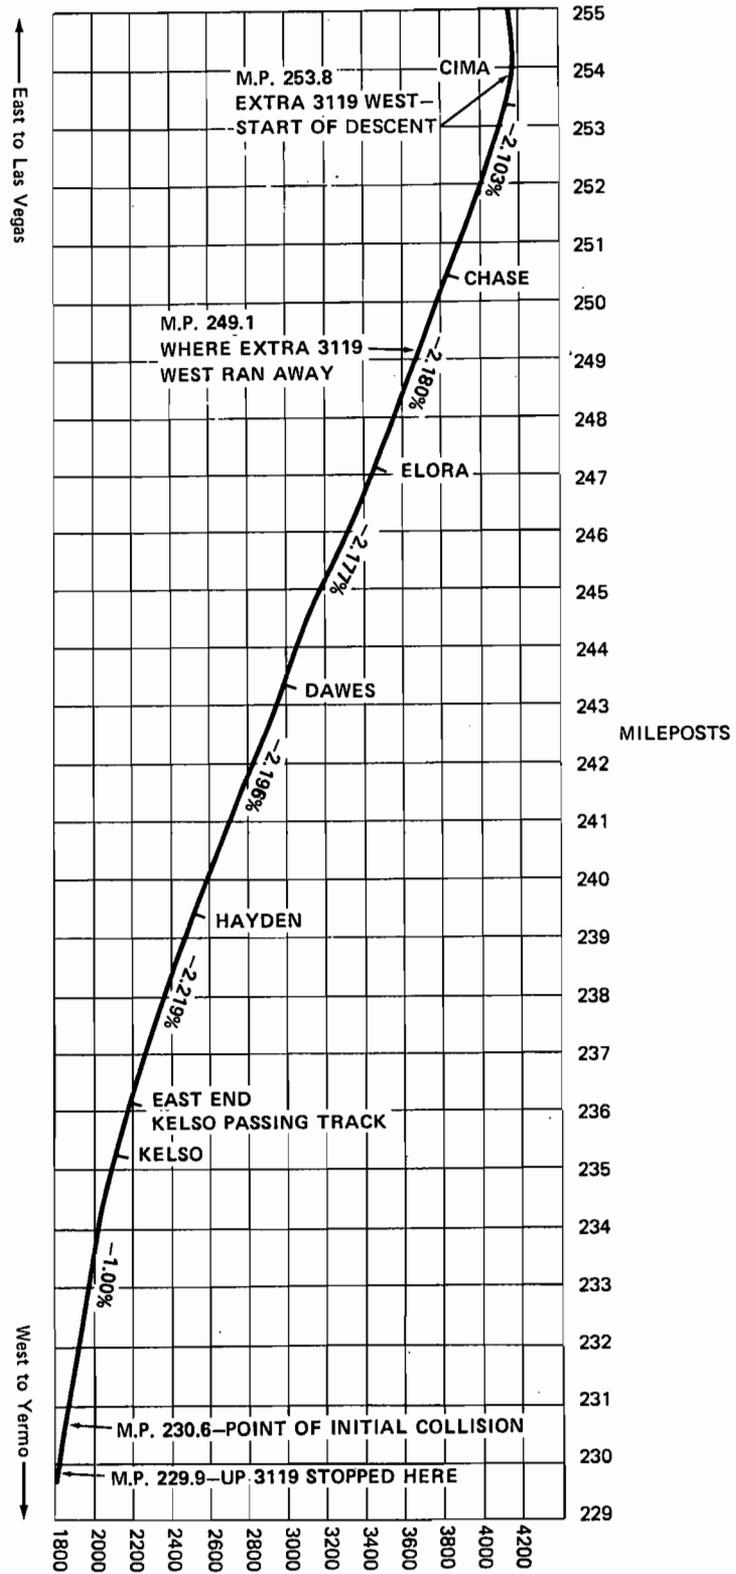
Figure 1.--Profile of Union Pacific Railroad from Cima to Kelso, California, and the point of collision.

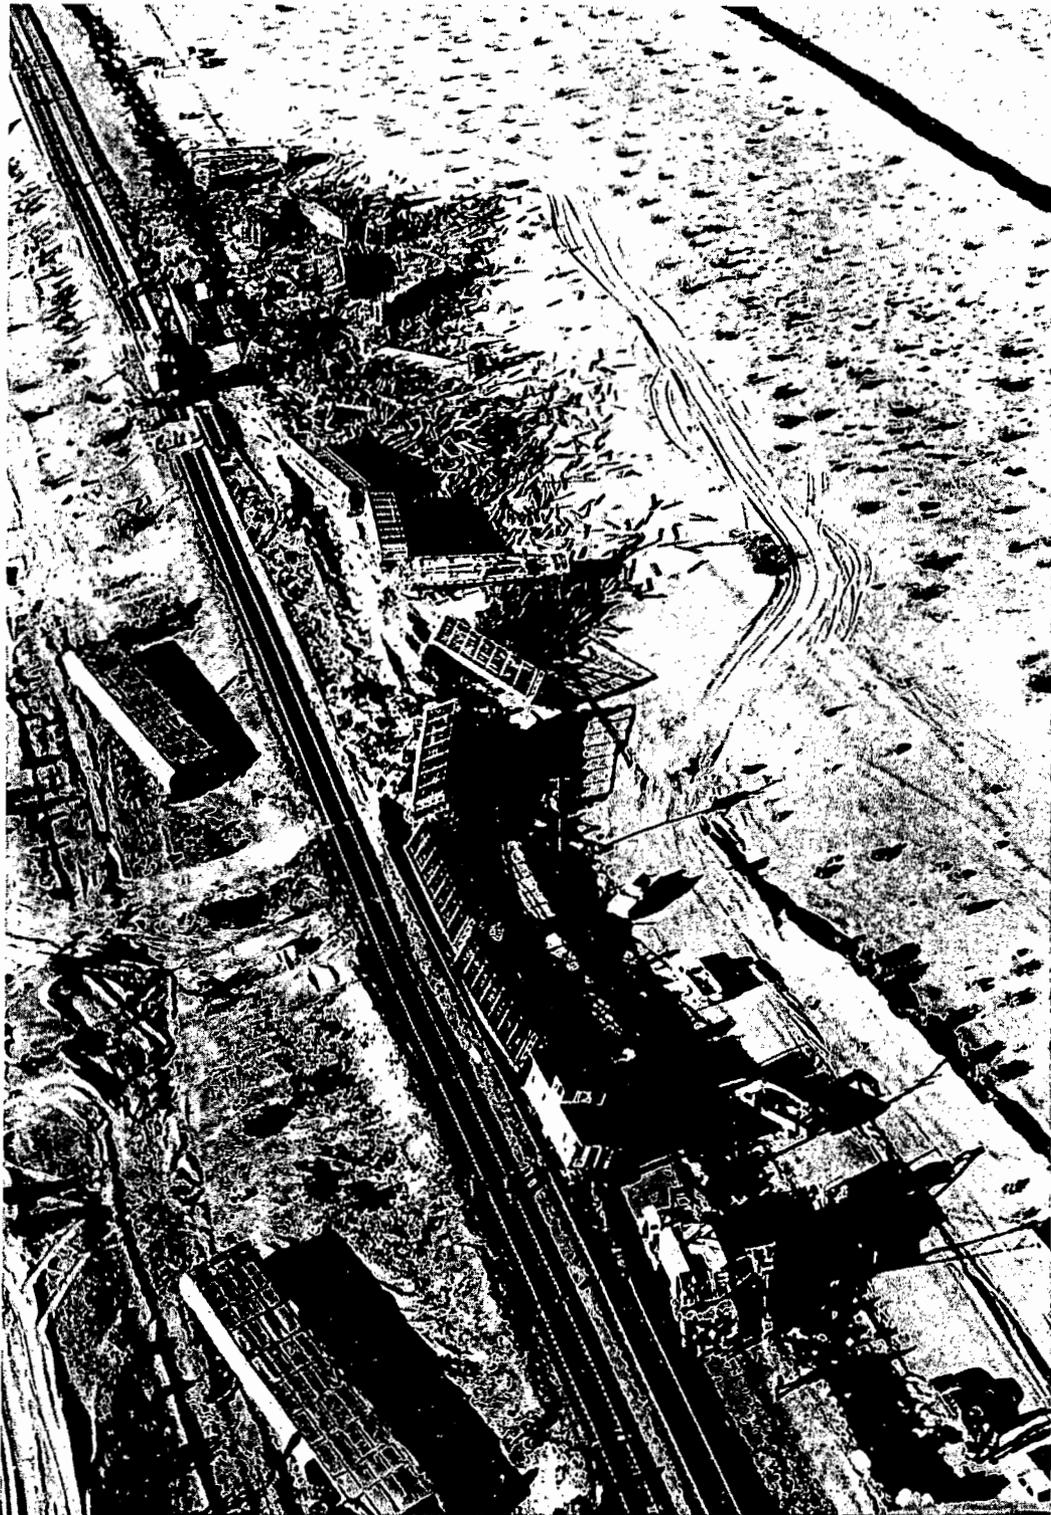
The general derailment area began about 500 feet west of the initial collision location and extended for 700 feet farther west. The locomotive unit of Extra 3119 West stayed on the track structure and came to a stop about 2,100 feet west of the original point of collision and 1,900 feet west of the caboose of Extra 3119 West.

Figure 2.--Aerial view of accident location viewed to the west. The caboose and cars of Extra 3119 West are to the right of the tracks. Derailed auto rack cars of the VAN train are to the left. The left-hand track was constructed after the accident for train operations during wreckage clearing operations.

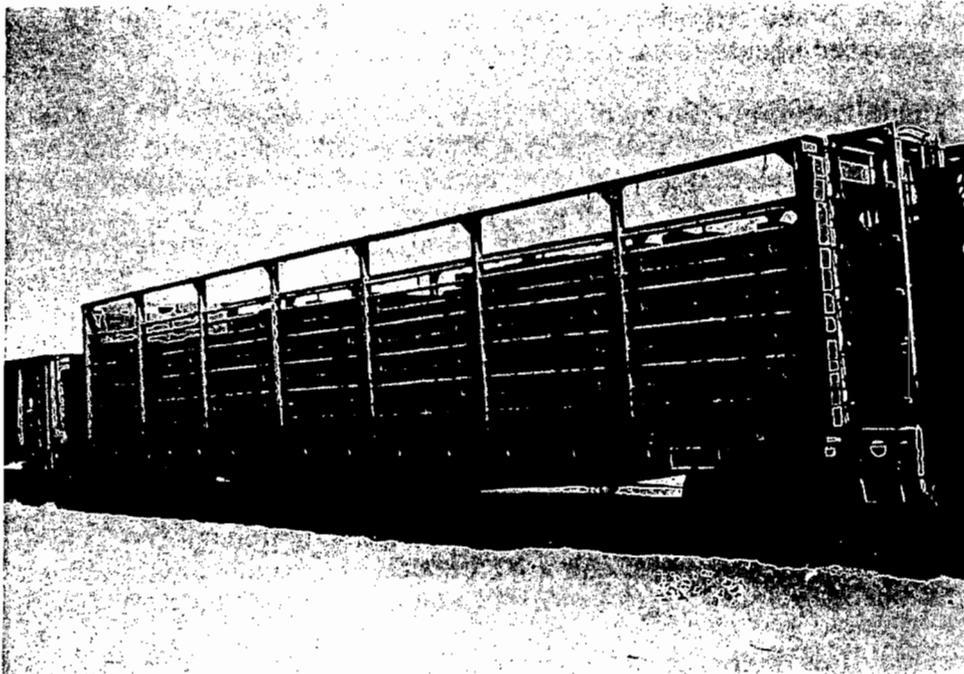
Figure 4.--Partly-loaded UP 913000-series bulkhead flatcar modified for hauling cross-ties. This car was of the same type and class as the tie cars in Extra 3119 West.
