RAILROAD ACCIDENT REPORT

**DERAILMENT OF SOUTHERN PACIFIC
TRANSPORTATION COMPANY
FREIGHT TRAIN EXTRA 9164 WEST
SURF, CALIFORNIA
MAY 22, 1981**

NTSB-RAR-81-8

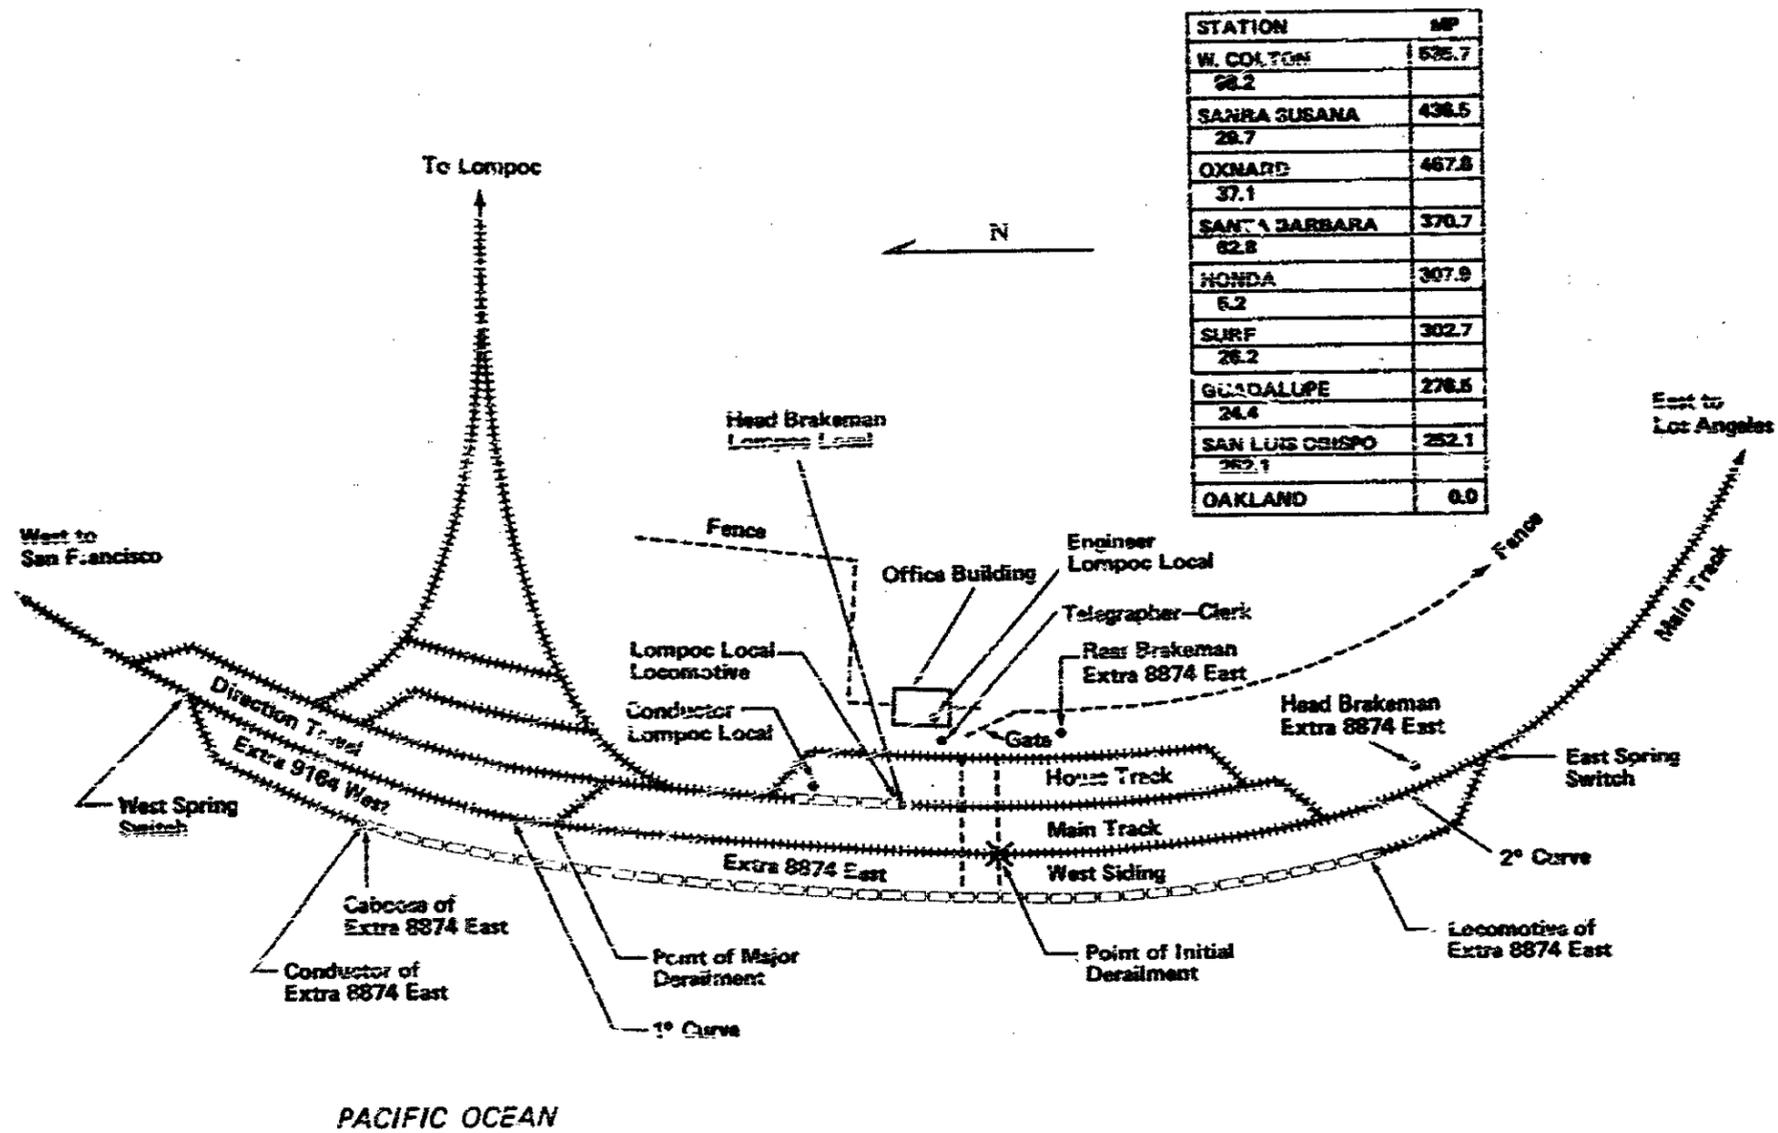
Figure 1.--Plan view of accident site.

The fireman, who was also qualified through training and examination as an engineer, began operating the train at Santa Barbara. The train reached the summit of a 0.8-percent grade about 2 miles west of Honda, California, and 3.2 miles east of Surf, California. As the train passed over the crest of the grade, the fireman progressively reduced the throttle setting. The fireman estimated that the train was traveling about 55 mph with the throttle in position run 2 as it passed through Surf. Because of the undesired emergency brake application at Oxnard, the engineer and fireman decided that the airbrakes would be used only if necessary, and the airbrakes had not been used after leaving Oxnard. Therefore, as the train descended a 1-percent grade through Surf, neither the dynamic brakes nor the airbrakes were used. About 4 a.m., when approximately one-half of the train had moved past the SP train order office building at Surf, cars began to derail and the train's brakes applied in emergency. The initial derailment occurred about 50 feet east of the train order office, but the major derailment occurred near a crossover about 1,100 feet west of the office. (See figure 1).

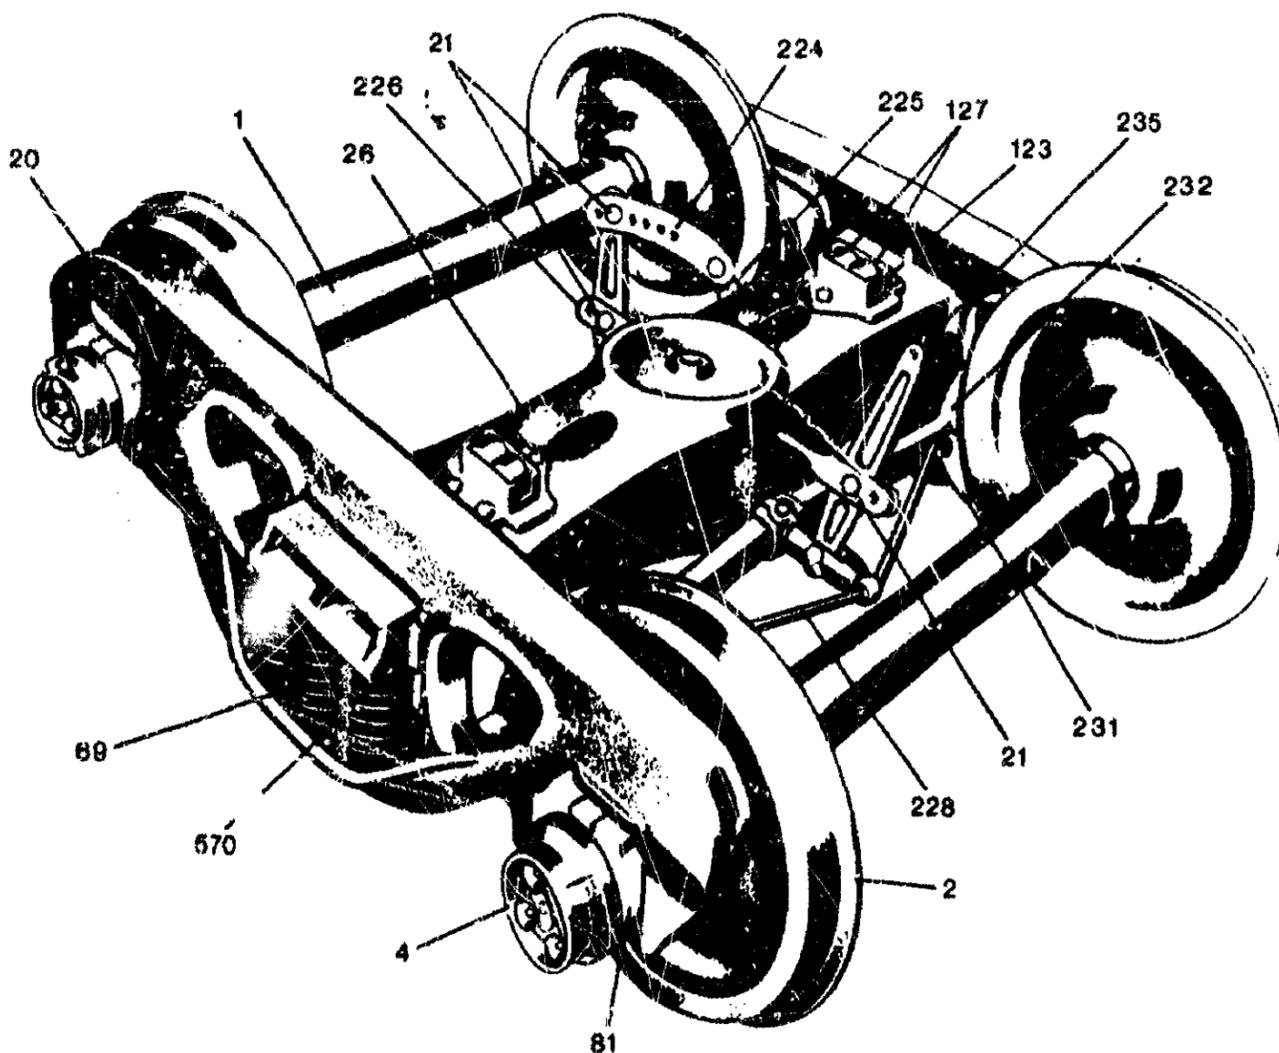
On June 3, 1981, the truck from the "A" end of the 53d car was inspected and tested at the SP mechanical facility at Roseville, California. The truck was a National C-1 Roller Bearing with hangerless-type brake beams. (See figure 3.) The matching truck sides were cast in June 1962 and the truck bolster in June 1959. The roller bearing adapters were gauged and were within acceptable tolerances. The roller bearing cups showed damage at R-3, L-3, and L-4 which occurred in the derailment.

Figure 3.—Freight truck similar to the truck from the "A" end of the 53d car.

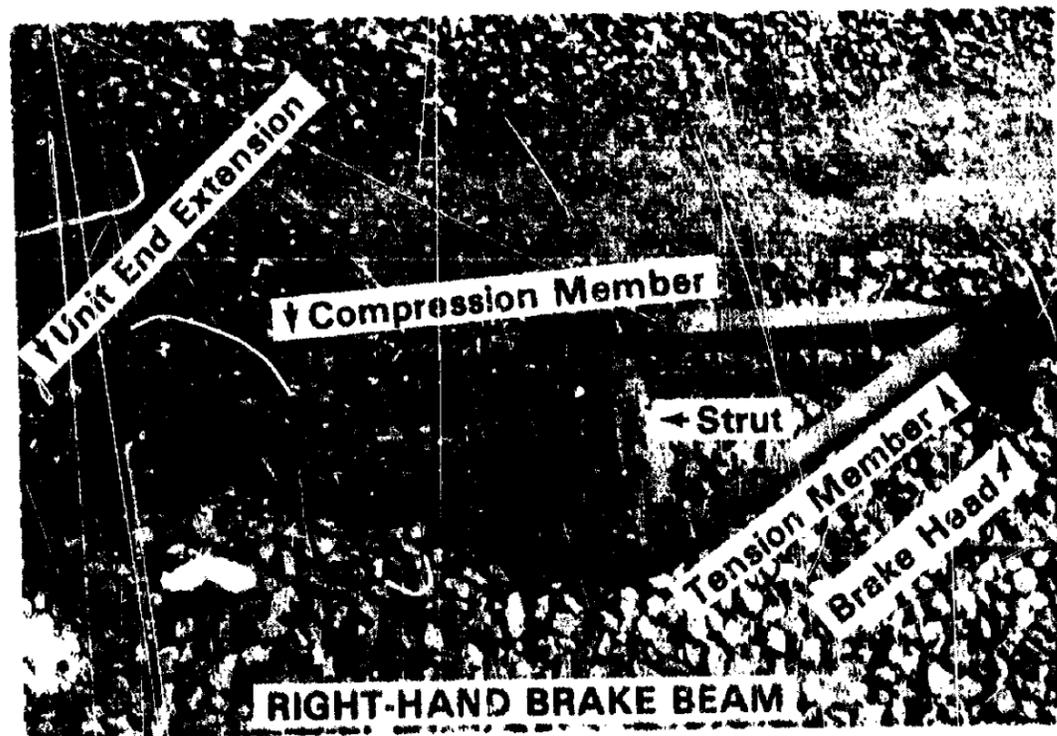
"L" end had the lower half of the brake head missing. The tension member had been pulled loose at the point at which it was welded to the compression member. (See figure 5.) The weld did not break as the tension member was pulled loose. The tension member had a slight bend toward the rear of the car near the strut member. The unit end extension was rotated nearly 180° and the metal was severely distorted from heat. It was apparent that it had been affected by a great amount of heat generated from an undetermined cause. There were no wheel flange marks on the brake beam and only light scuffmarks.

Figure 5.—Damaged brake beam identified as being the No. 4 brake beam from the 53d car (top) and an undamaged brake beam (bottom).

The brake beam had been overheated from an undetermined cause. There was evidence that the bottom rod connecting the Nos. 3 and 4 brake beams on the "A" truck had been rubbing against an opening in the car bolster. However, because the bottom rod extended through the bolster, the downward travel of the brake beam would have been limited. If the brake beam had been dragging for some length of time, an alarm should have been given by one of the dragging equipment detectors, but none, including the one 9.8 miles east of Surf, was actuated. Also, it is possible that the hot box detector at the same location or one passed earlier might have been activated if the brake beam had been abnormally hot at that point. The emergency stop made by Extra 9164 West at Oxnard could have caused damage to the brake beam, but there is no evidence to support this possibility. The compression member, which could have had an old fracture or could have been fractured at Oxnard, was not deformed from its normal alignment except for the twisted brake head and unit end extension. The deformation of the brake beam could not have occurred while the brake beam was cold because there was no evidence of brittle breakage or cracking. Therefore, it seems unlikely that the brake beam was bent between Los Angeles and Oxnard and seems likely that it was overheated and bent at a point west

of Oxnard. Additionally, there was no trouble observed or reported on Extra 9164 West before it arrived at Oxnard. Because of the lack of evidence that the brake beam was down, and as a result of the tests conducted at Roseville, the Safety Board concludes that the brake beam did not cause the derailment.
