RAILROAD ACCIDENT REPORT

**HEAD-ON COLLISION OF
BOSTON & MAINE CORPORATION
EXTRA 1731 EAST AND
MASSACHUSETTS BAY TRANSPORTATION AUTHORITY
TRAIN NO. 570
ON FORMER BOSTON & MAINE CORPORATION TRACKS
BEVERLY, MASSACHUSETTS
AUGUST 11, 1981**

NTSB-RAR-82-1

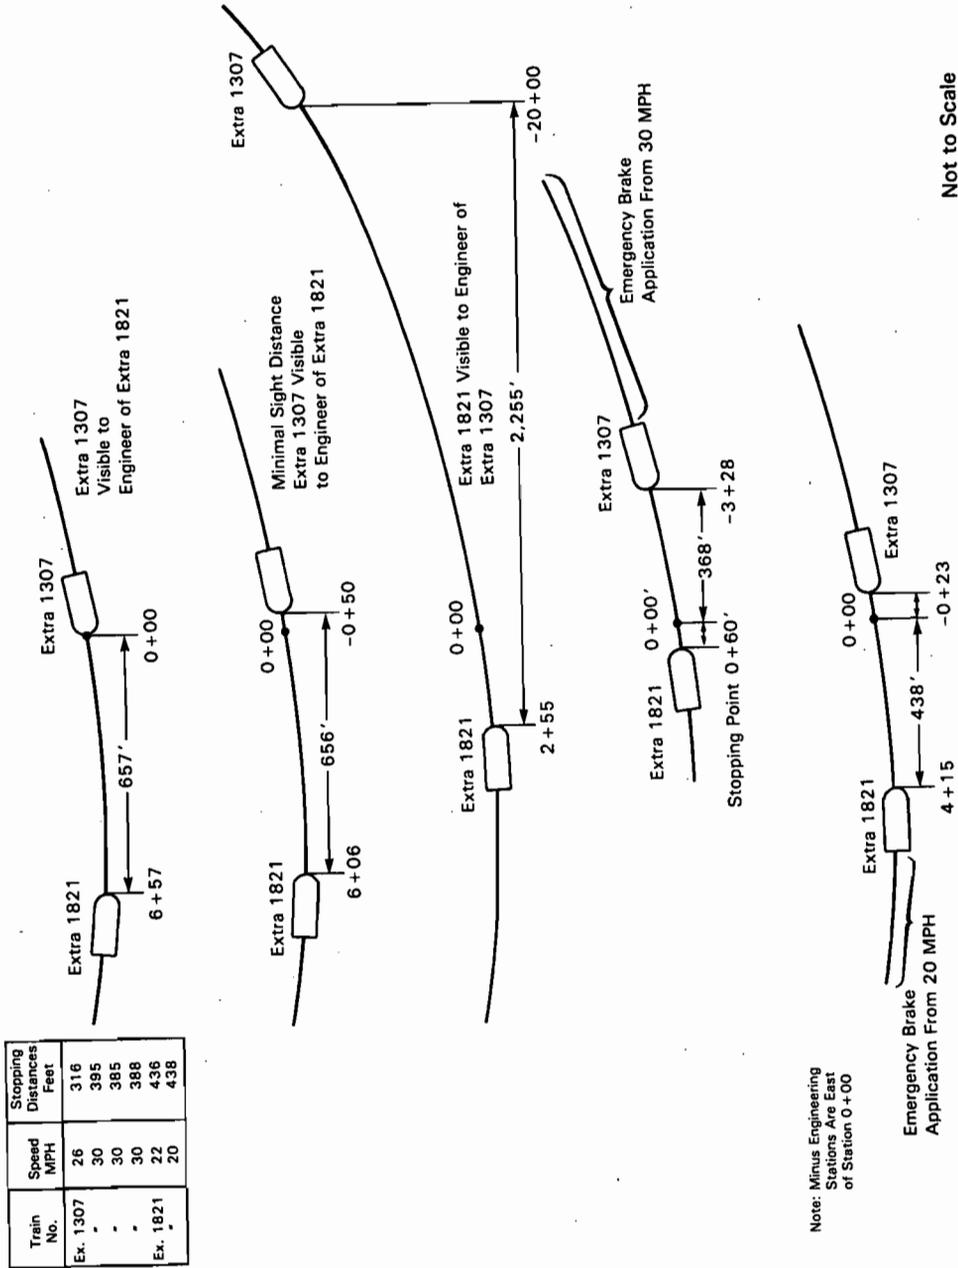
Figure 3.—Summary of data from sight distance tests.

The sight distance and stopping tests indicated that the engineers of the two trains saw each other at about the maximum available sight distance. The points at which sand was first observed on the rails placed the two trains about 750 feet apart when the brakes were applied, and the sand on the rails is an indication that the brakes of each train were applied in emergency. Also, the conductor of No. 570 said he felt the brakes applying, and the speed indications shown on the speed tapes indicated that the speed of the two trains had reduced. The sight distance was limited because Extra 1731 East was in the 2° curve and the trains were out of sight of each other. Whether or not the brakes functioned effectively, the trains could not have stopped in the distance available to them. Each engineer made an effort to stop as evidenced by the emergency brake application. It is questionable whether either engineer heard the whistle from the other train.
