## **RAILROAD ACCIDENT REPORT**

**REAR END COLLISION OF  
LOUISVILLE & NASHVILLE RAILROAD COMPANY  
TRAINS NO. 586 AND EXTRA 8072 NORTH  
NEW JOHNSONVILLE, TENNESSEE  
DECEMBER 28, 1981**

**NTSB-RAR-82-4**

**Adopted: August 23, 1982**

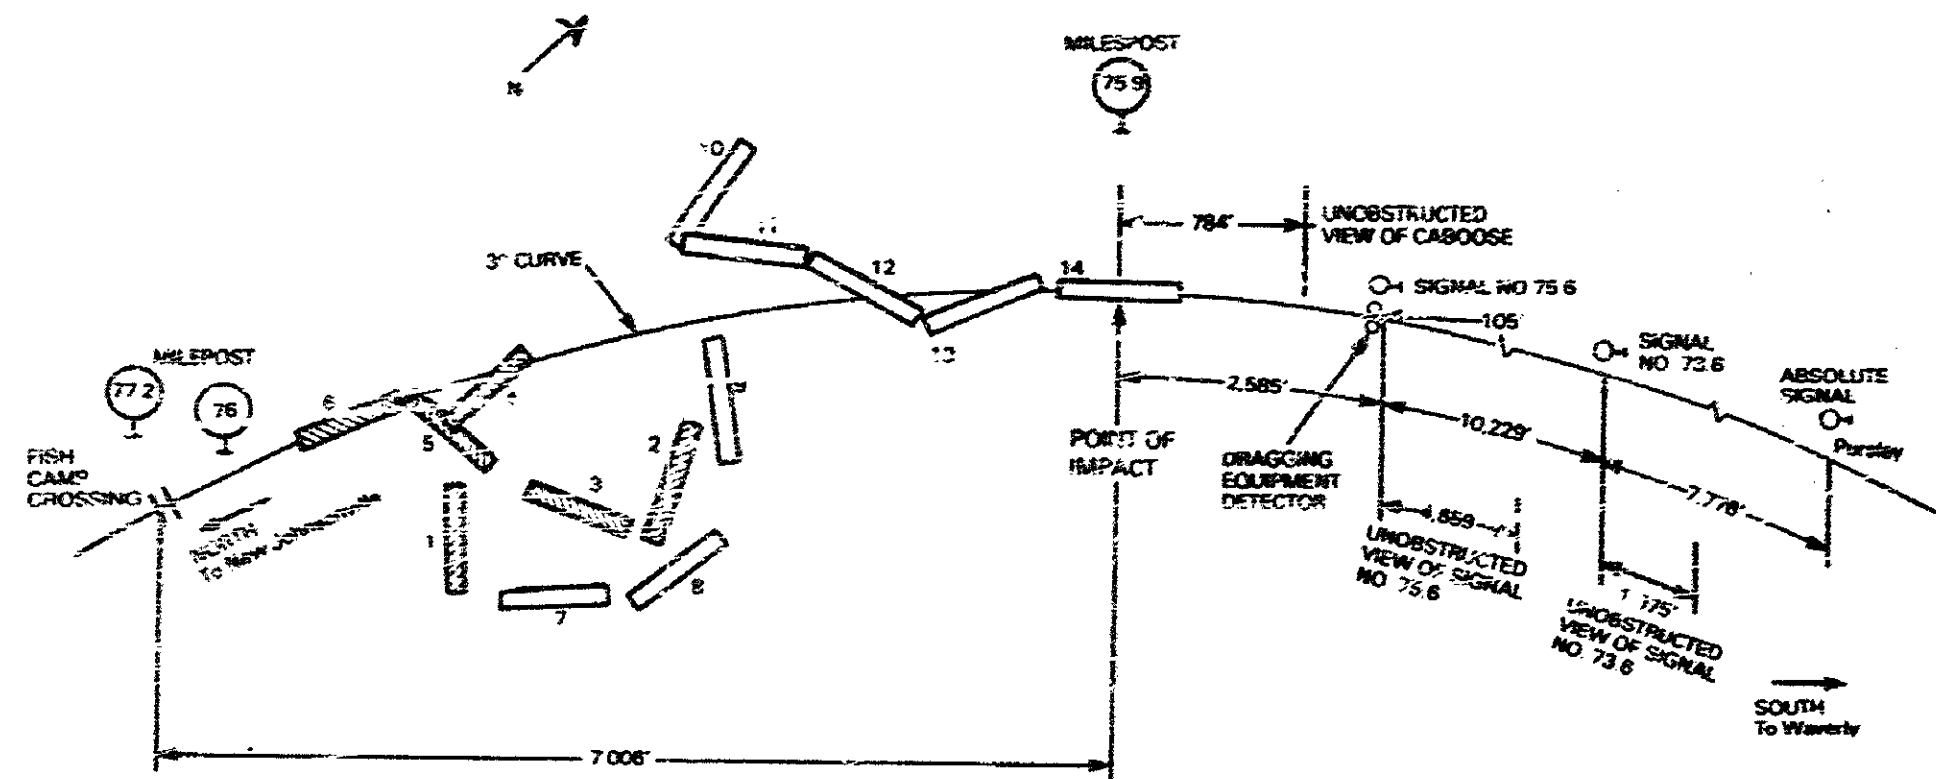
Figure 1.--Plan view of accident site.

About 9:35 a.m., while the cars of Extra 8072 North were standing in the block of automatic signal No. 75.6, they were struck from the rear by No. 586. (See figure 1.)

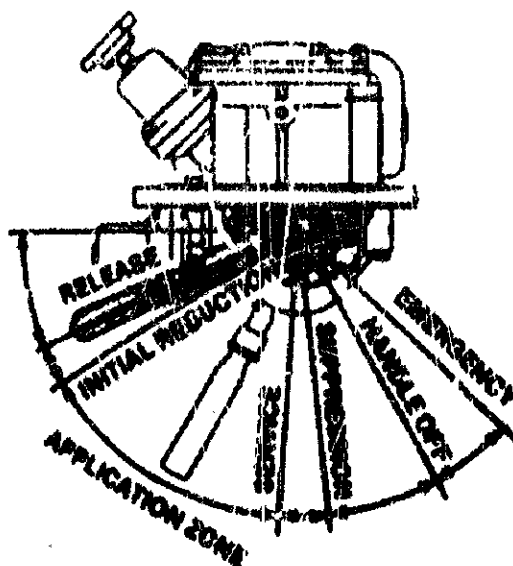
Figure 3.--Automatic brake valve handle positions on No. 26-L brake equipment.

The automatic brake handle being found in the handle off position and the dynamic brake control lever being found in the fully applied position do not comport with the head-end crew's testimony. The impact forces created by the locomotive's striking the rear of Extra 8072 North, which was standing with its airbrakes set in a heavy application, and the forces developed during the rolling and pitching of the unit could have caused the automatic brake handle and the dynamic brake control to have moved. Further, it is possible that a person in leaving the operating position hurriedly could have brushed against the automatic brake handle and moved it from the emergency position to the handle off position.
