NATIONAL TRANSPORTATION SAFETY BOARD

RAILROAD ACCIDENT REPORT

**DERAILMENT OF
WASHINGTON METROPOLITAN AREA
TRANSIT AUTHORITY
TRAIN NO. 410
AT SMITHSONIAN INTERLOCKING
JANUARY 13, 1982**

NTSB-RAR-82-6

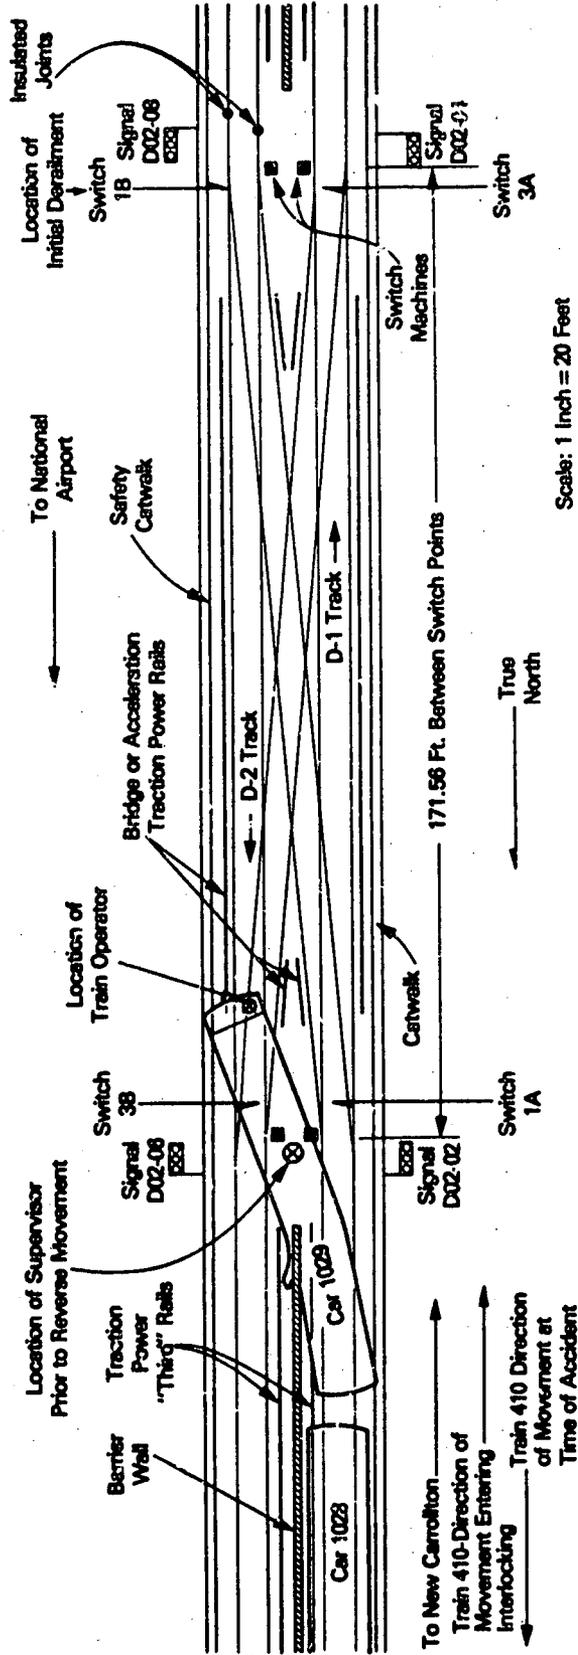
Figure 3.--Plan view of Smithsonian Interlocking showing location of car No. 1029 after the accident.

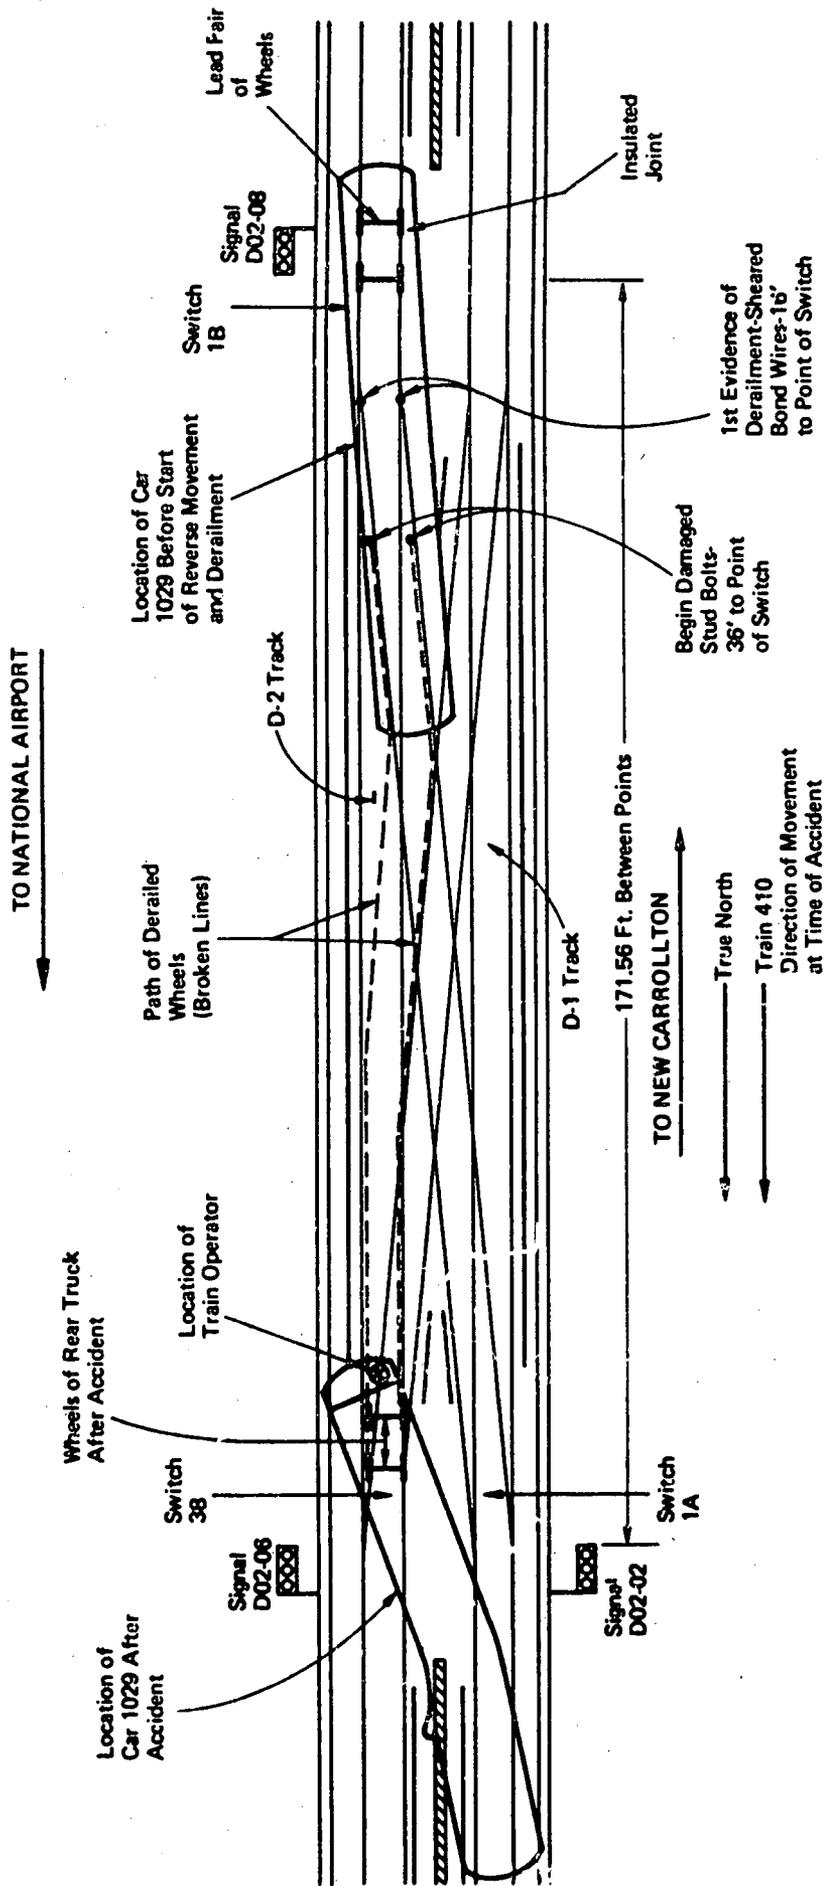
Figure 4.--Locations of car No. 1029 before the reverse movement of train No. 410 and following its derailment and collision with the barrier wall. Dotted lines indicate the paths taken by the wheels of the car's derailed truck.

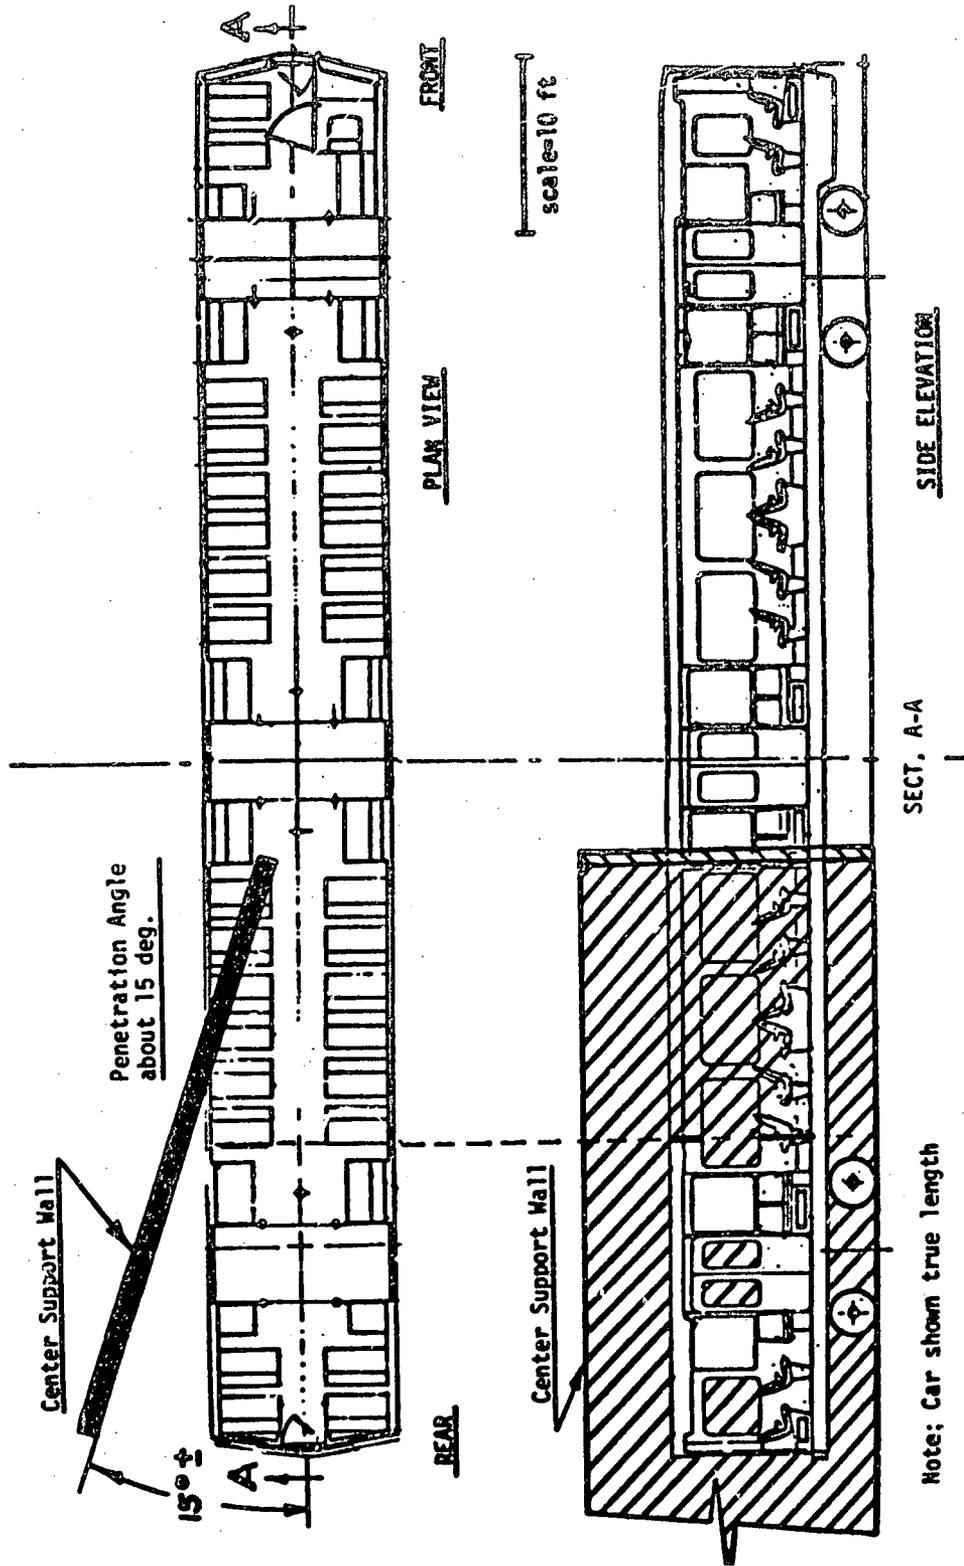
Figure 5.—Plan view and side elevation showing point of impact between car No. 1029 and barrier wall, and degree of penetration by the wall.

Car No. 1029 struck the barrier wall at a point about 20 feet from the forward end of the car on the right-hand side. ^{21/} The actual impact point was in the right front main compartment, just behind the first large window, about 8 feet behind the forward door and opposite the forward-facing half of the double-backed middle seat. The car impacted the barrier wall with sufficient force (possibly as high as 300,000 pounds) to fracture both the upper and lower side sills. Longitudinal penetration at an angle of about 15 degrees was about 14 feet through the rear half of the compartment to a point between the middle doors. Transverse penetration occurred through fully one-third of the car width. The lower sidewall was severed and peeled outward along the D-2 track side of the barrier wall. (See figures 3 and 13.)

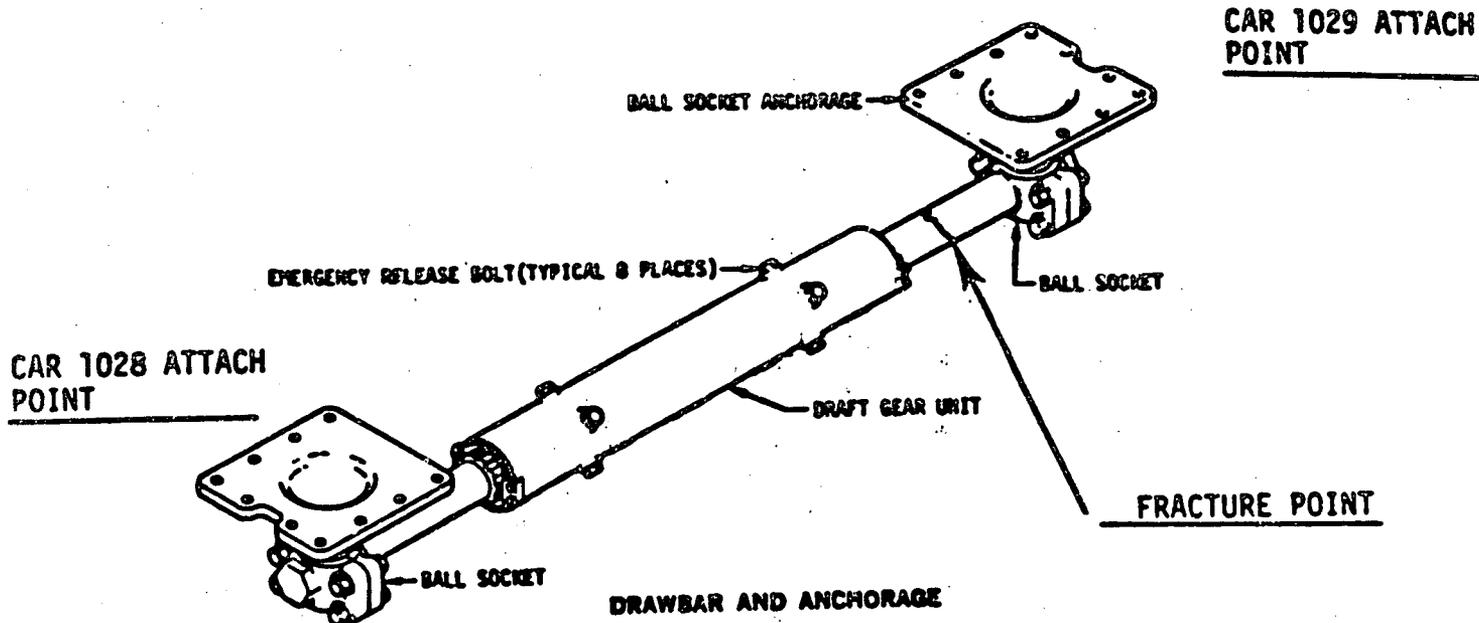
The rear ends of the married cars are coupled by a semi-permanent drawbar (see figure 8) that is fixed at the "A" car to prevent rotational movement. The drawbar between cars 1028 and 1029 fractured through the tail socket. The normal 3-inch opening between the two cars' anti-climbers was stretched to about 4 feet, which caused the battery train line between the cars to part, shorting out the entire emergency power system of the train and rendering all its emergency systems inoperative.

Note: Emergency release bolts did not fracture.

Figure 8.—Semi-permanent drawbar and anchorage between WMATA married cars, showing fracture that occurred between cars Nos. 1028 and 1029 on January 13, 1982.

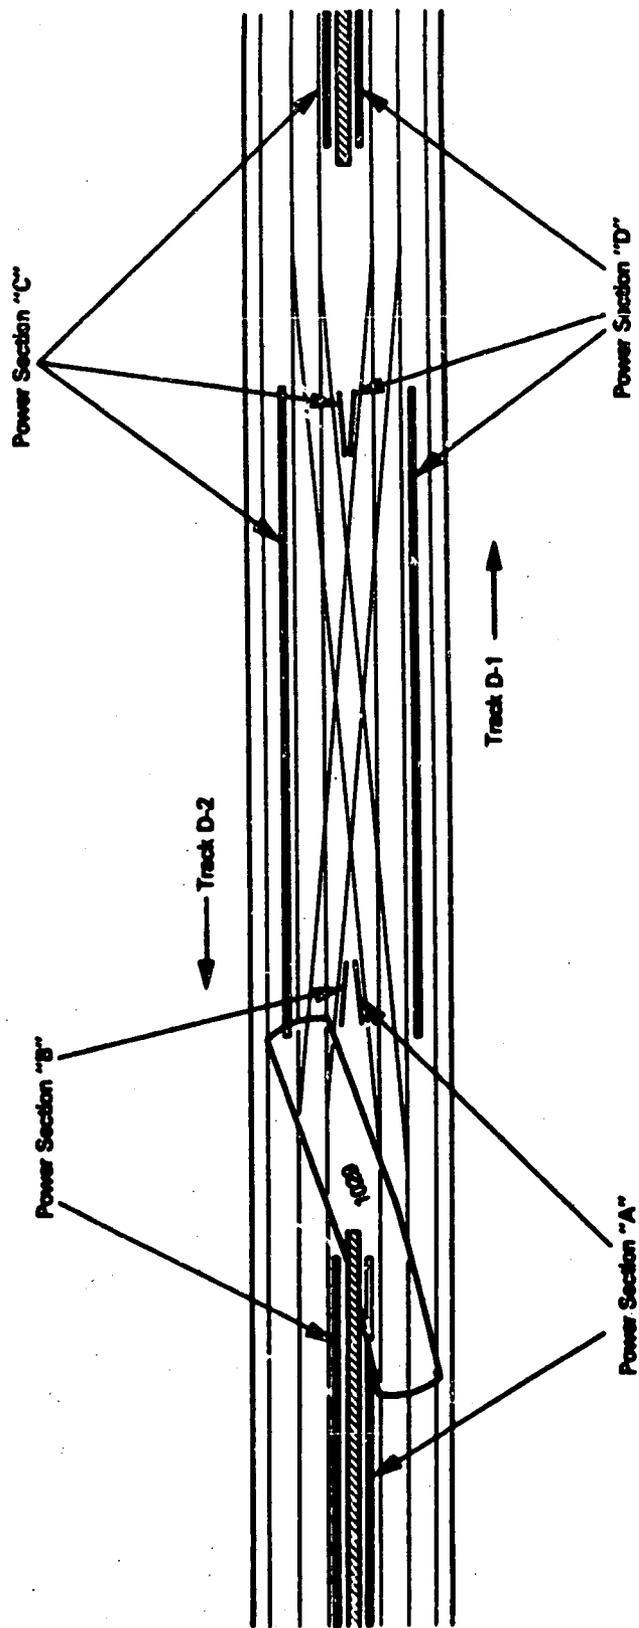
Figure 12 shows the four power circuits and the third rails involved. When car No. 1029 crossed the two short acceleration or bridge power rails at the north end of the interlocking, both power sections (A) and (B) were momentarily shorted out. When the car came to rest with the forward end on the third rail along the D-1 track, a fault occurred which caused the breakers of the (A) section to open. The middle of the car was between, but clear of, both third rails of power section (B). The rear end of the car stopped in contact with the long outside bridge power rail that was part of power section (C). Although the breakers for this section did not trip open, witness testimony indicates that there was arcing and smoking at this location after the accident.

Figure 12.—Position of derailed car No. 1029 in relation to third rail traction power sections at the Smithsonian Interlocking.

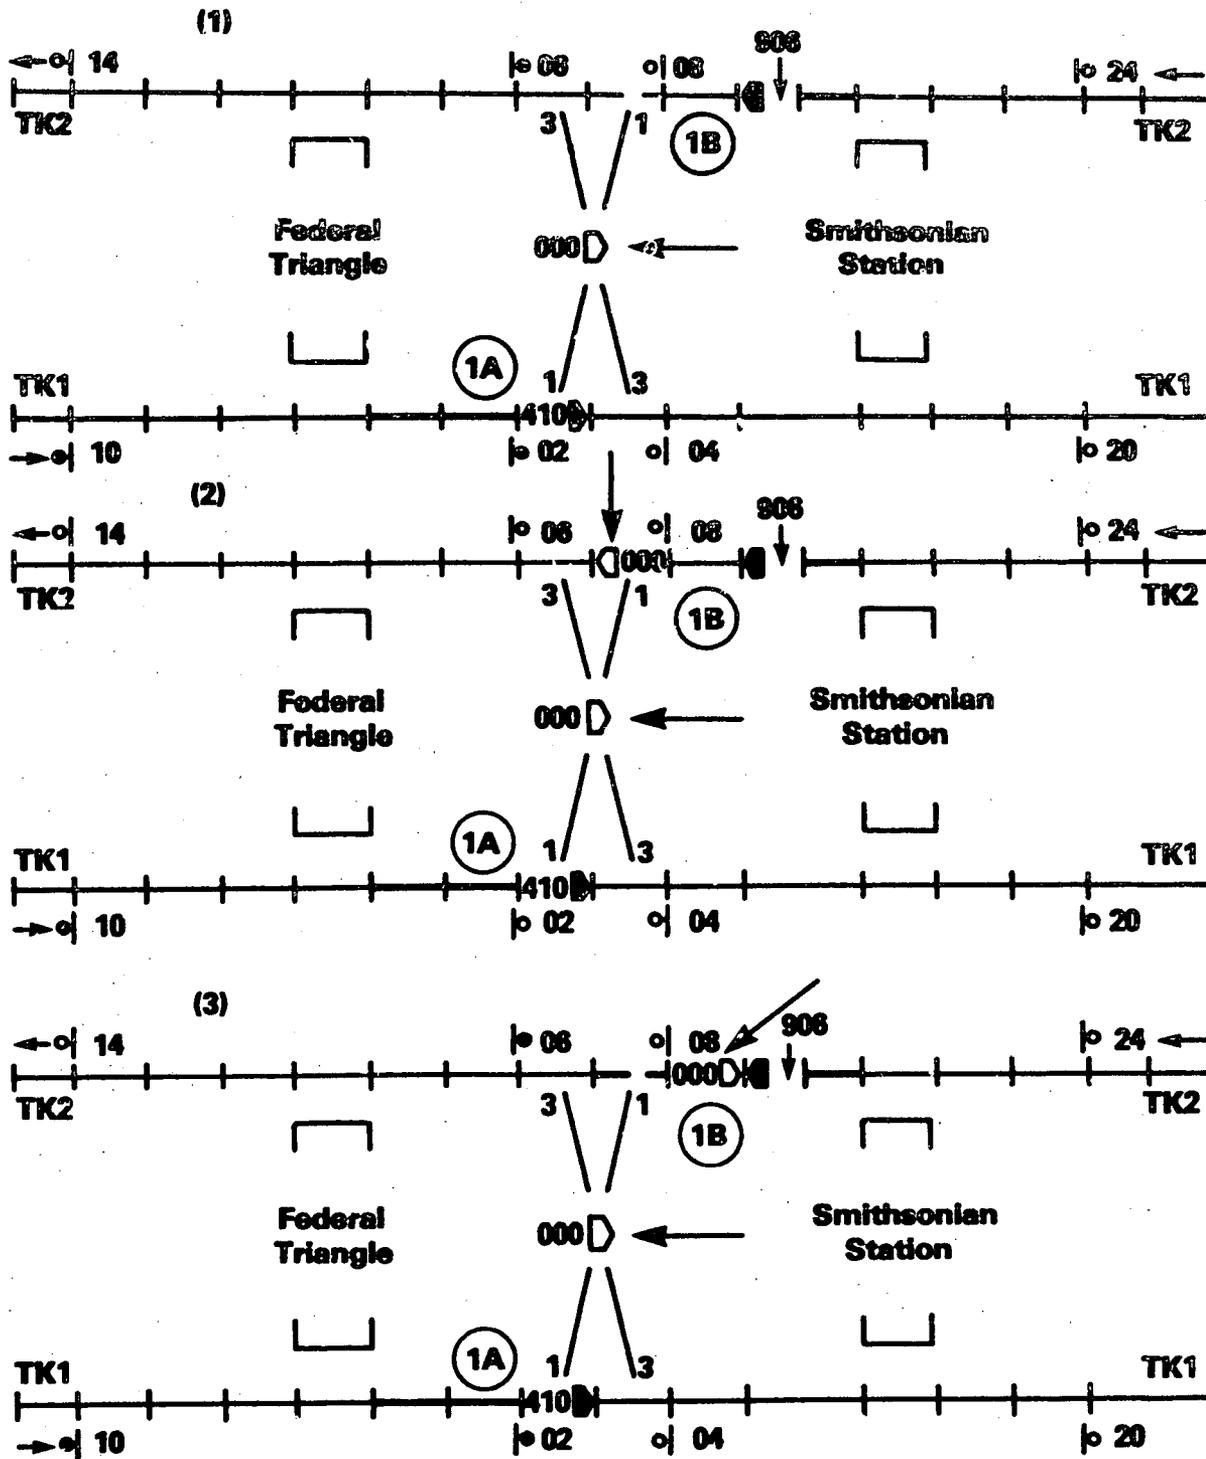
^{23/} Normal depiction of a train on the CRT display would be a solid arrowhead followed by the train's number. In a "phantom" depiction, the train appears as a arrowhead outline followed by three small zero outlines where the train number would normally appear. (See figure 15.)

Figure 15.--Cathode Ray Tube (CRT) screen displays that occurred as train No. 410 passed from the D-1 main track to the D-2 main track at Smithsonian Interlocking. From top to bottom, the displays show "phantom" indications (arrows) appearing as the train progressively occupied, (1) the crossing, (2) switch 1B at Signal D02-08, and (3) the first main track circuit beyond the interlocking.
