NATIONAL TRANSPORTATION SAFETY BOARD

RAILROAD ACCIDENT REPORT

DERAILMENT OF SOUTHERN PACIFIC
TRANSPORTATION COMPANY
TRAIN NO. 01-BSMFF-05
CARRYING RADIOACTIVE MATERIAL
AT THERMAL, CALIFORNIA
JANUARY 7, 1982

NTSB-RAR-83-1

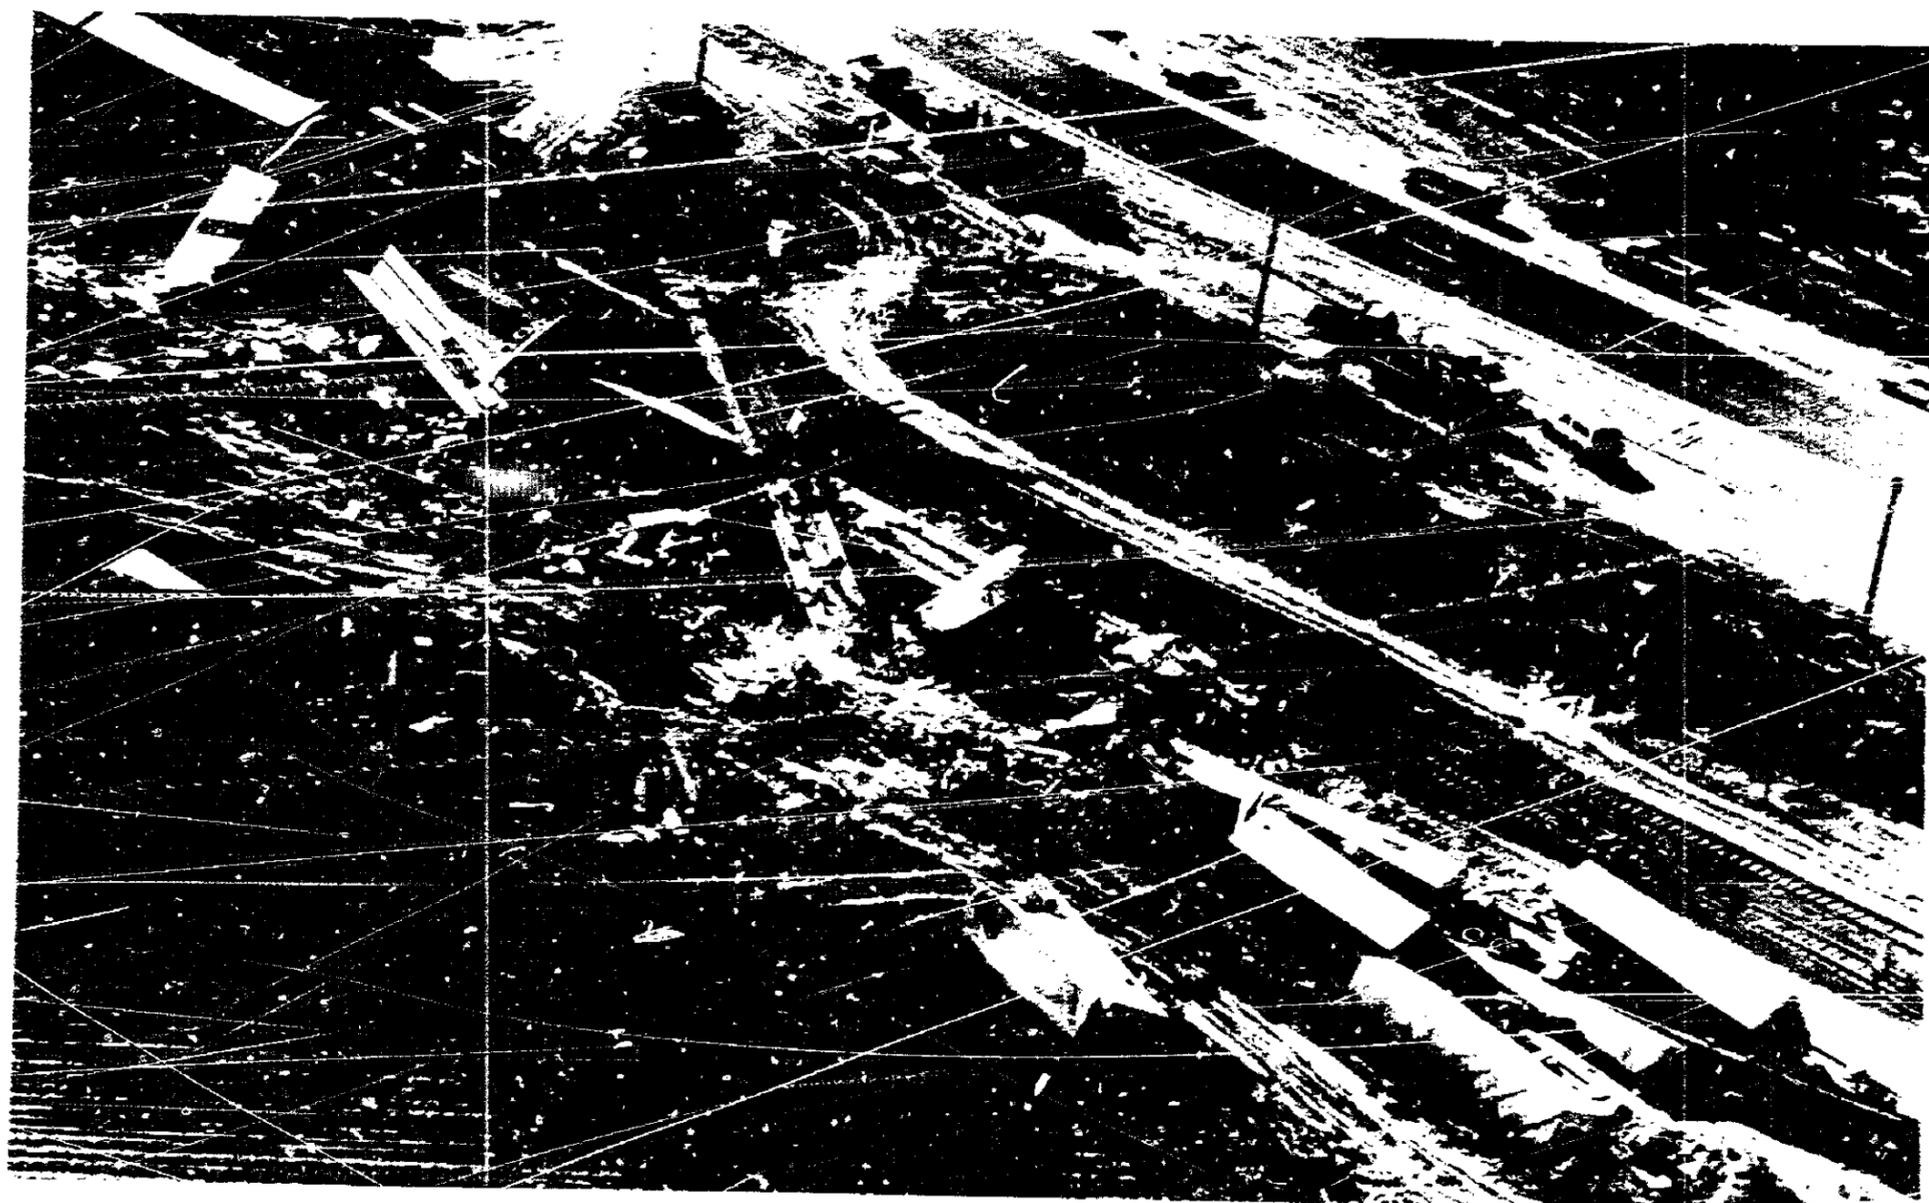
Figure 3.—Aerial view of accident site.

About 880 feet of the main track was damaged during the accident. The adjacent passing siding to the south of the main track was not damaged. A ballast deck bridge about 25 feet long and spanning a drainage ditch received damage to the bridge deck. The track circuit for the signal system was also damaged.

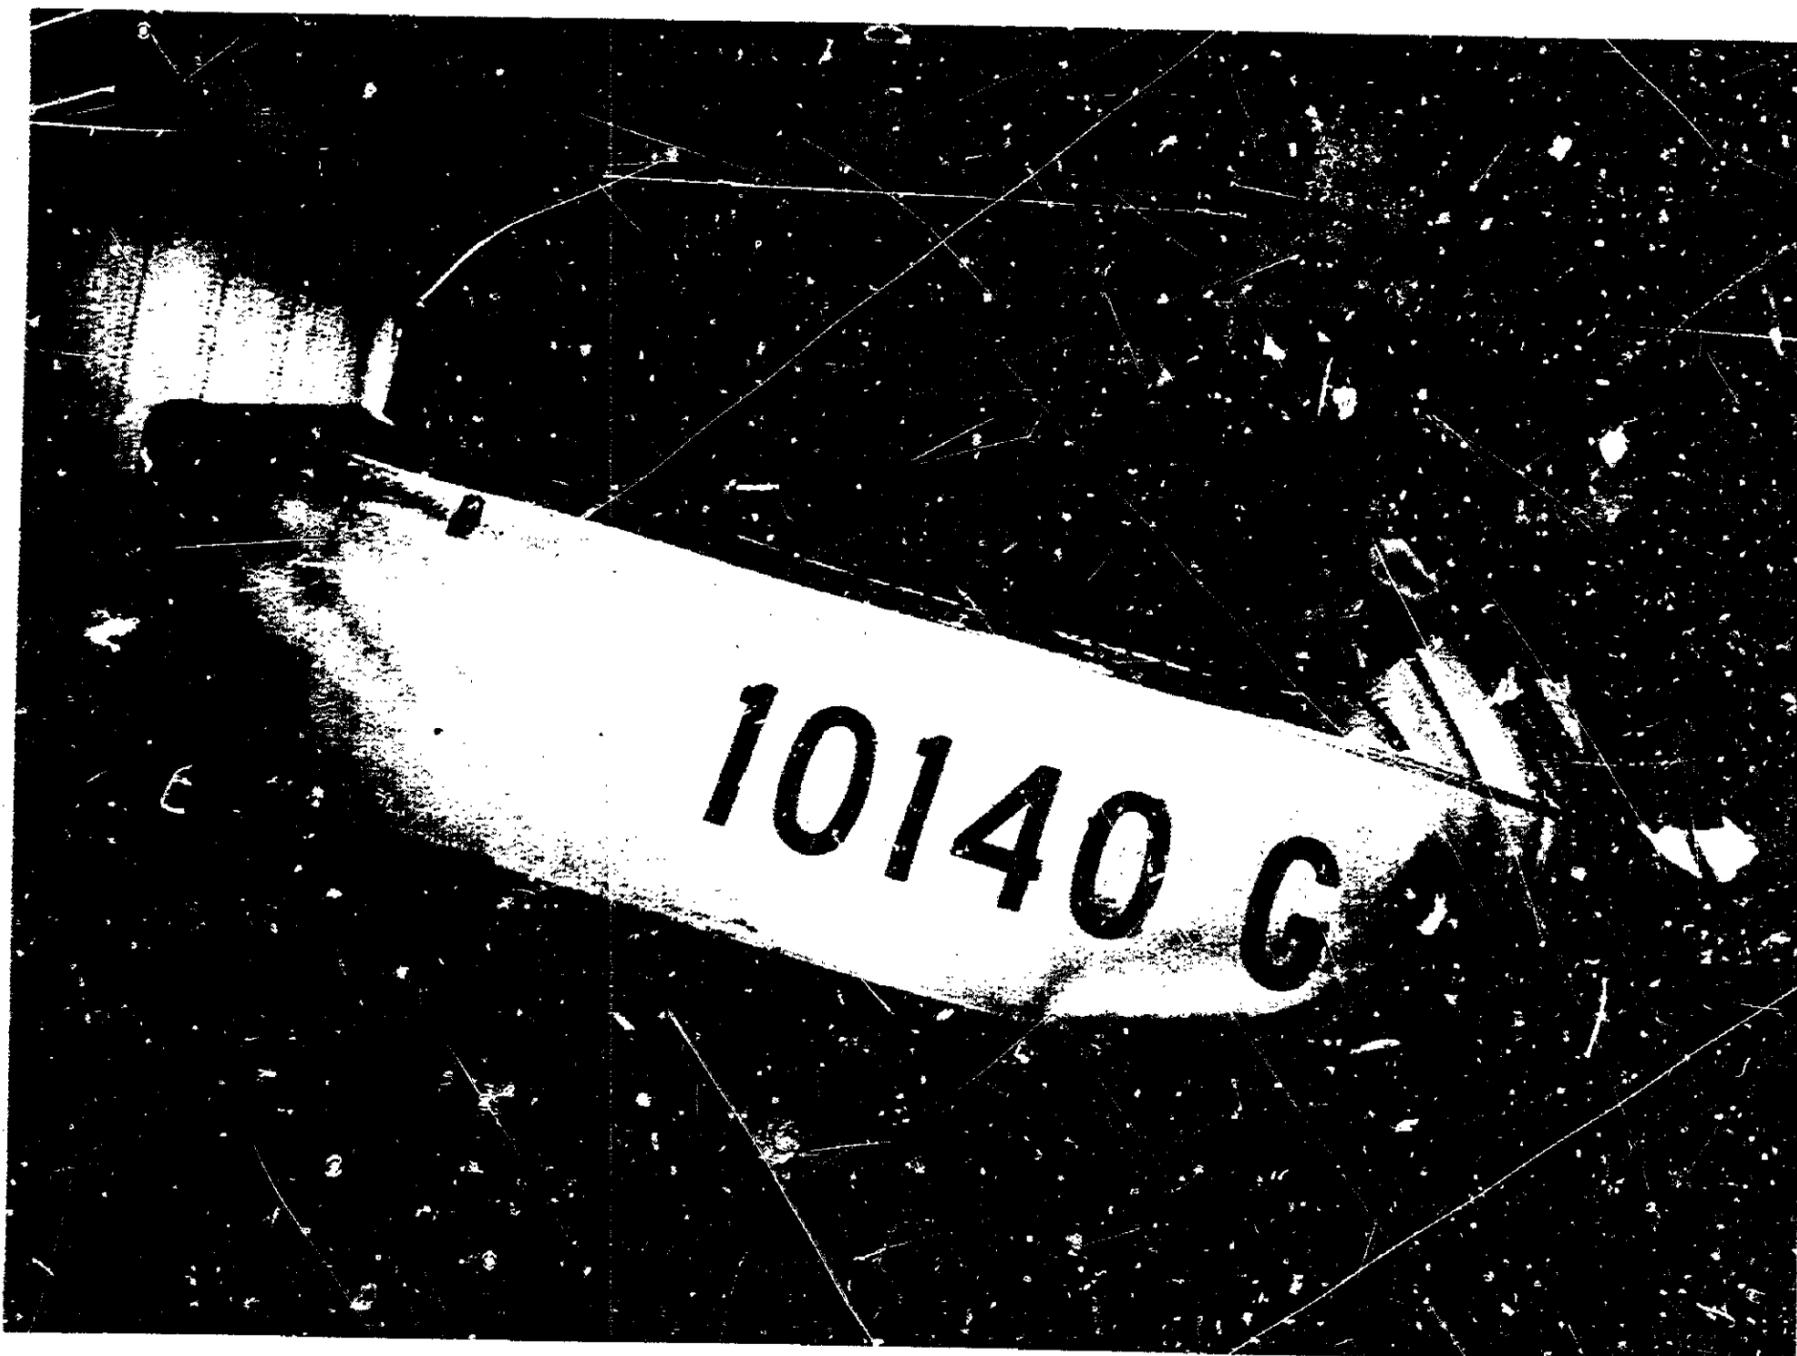
All the derailed cars were flat cars, each carrying two highway truck trailers. The 36th car of train No. 01-BSMFF-05 derailed, and although the truck trailers were separated, the car remained upright and in line with the track structure. The following 12 cars received substantial damage. These cars all derailed to the north of the main track, and all trailers were separated from their flat cars. The 48th car came to rest at about a 45° angle to the track, and its truck trailers, including GIL-10140, were separated

and destroyed (see figure 4). The 49th car of the train derailed, but also remained upright and in line with the track structure. The trailers on this car remained attached and were not damaged in the derailment, but were damaged during wreckage clearing. All other truck trailers involved in the derailment were destroyed, and their lading were badly damaged or destroyed.

Figure 4.—View of truck trailer No. GILFLEX 10140, containing radioactive material, as it came to rest after the derailment.

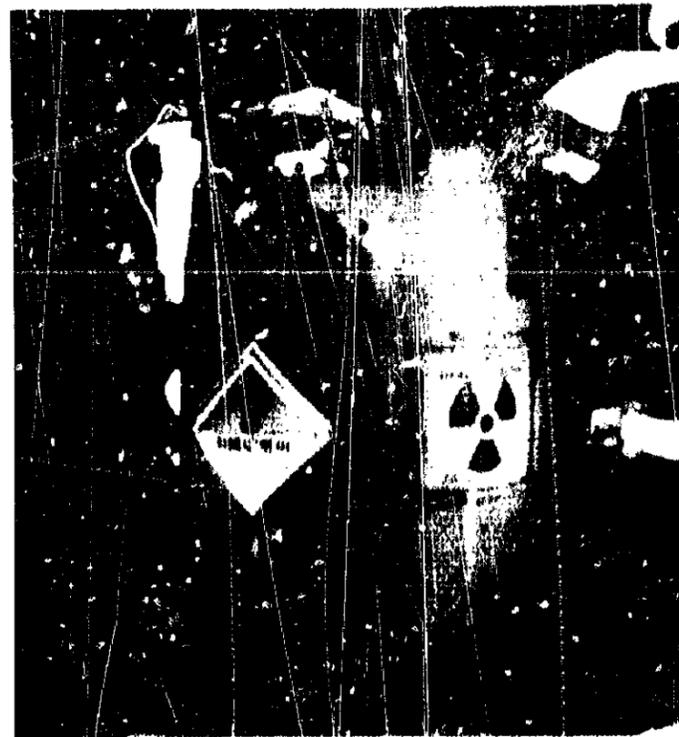
The outer container was visually examined after the accident and no apparent damage was noted (see figure 10). Radioactivity detection tests after the accident disclosed that the measured radioactivity from the container was at the same level as when the container had been prepared for shipment.

Figure 10.--View of RAM container after derailment.
