**NATIONAL
TRANSPORTATION
SAFETY
BOARD**

RAILROAD ACCIDENT REPORT

**DERAILMENT OF AMTRAK TRAIN NO. 5
(THE SAN FRANCISCO ZEPHYR)
ON THE BURLINGTON NORTHERN RAILROAD
EMERSON, IOWA
JUNE 15, 1982**

NTSB/RAR-83/02

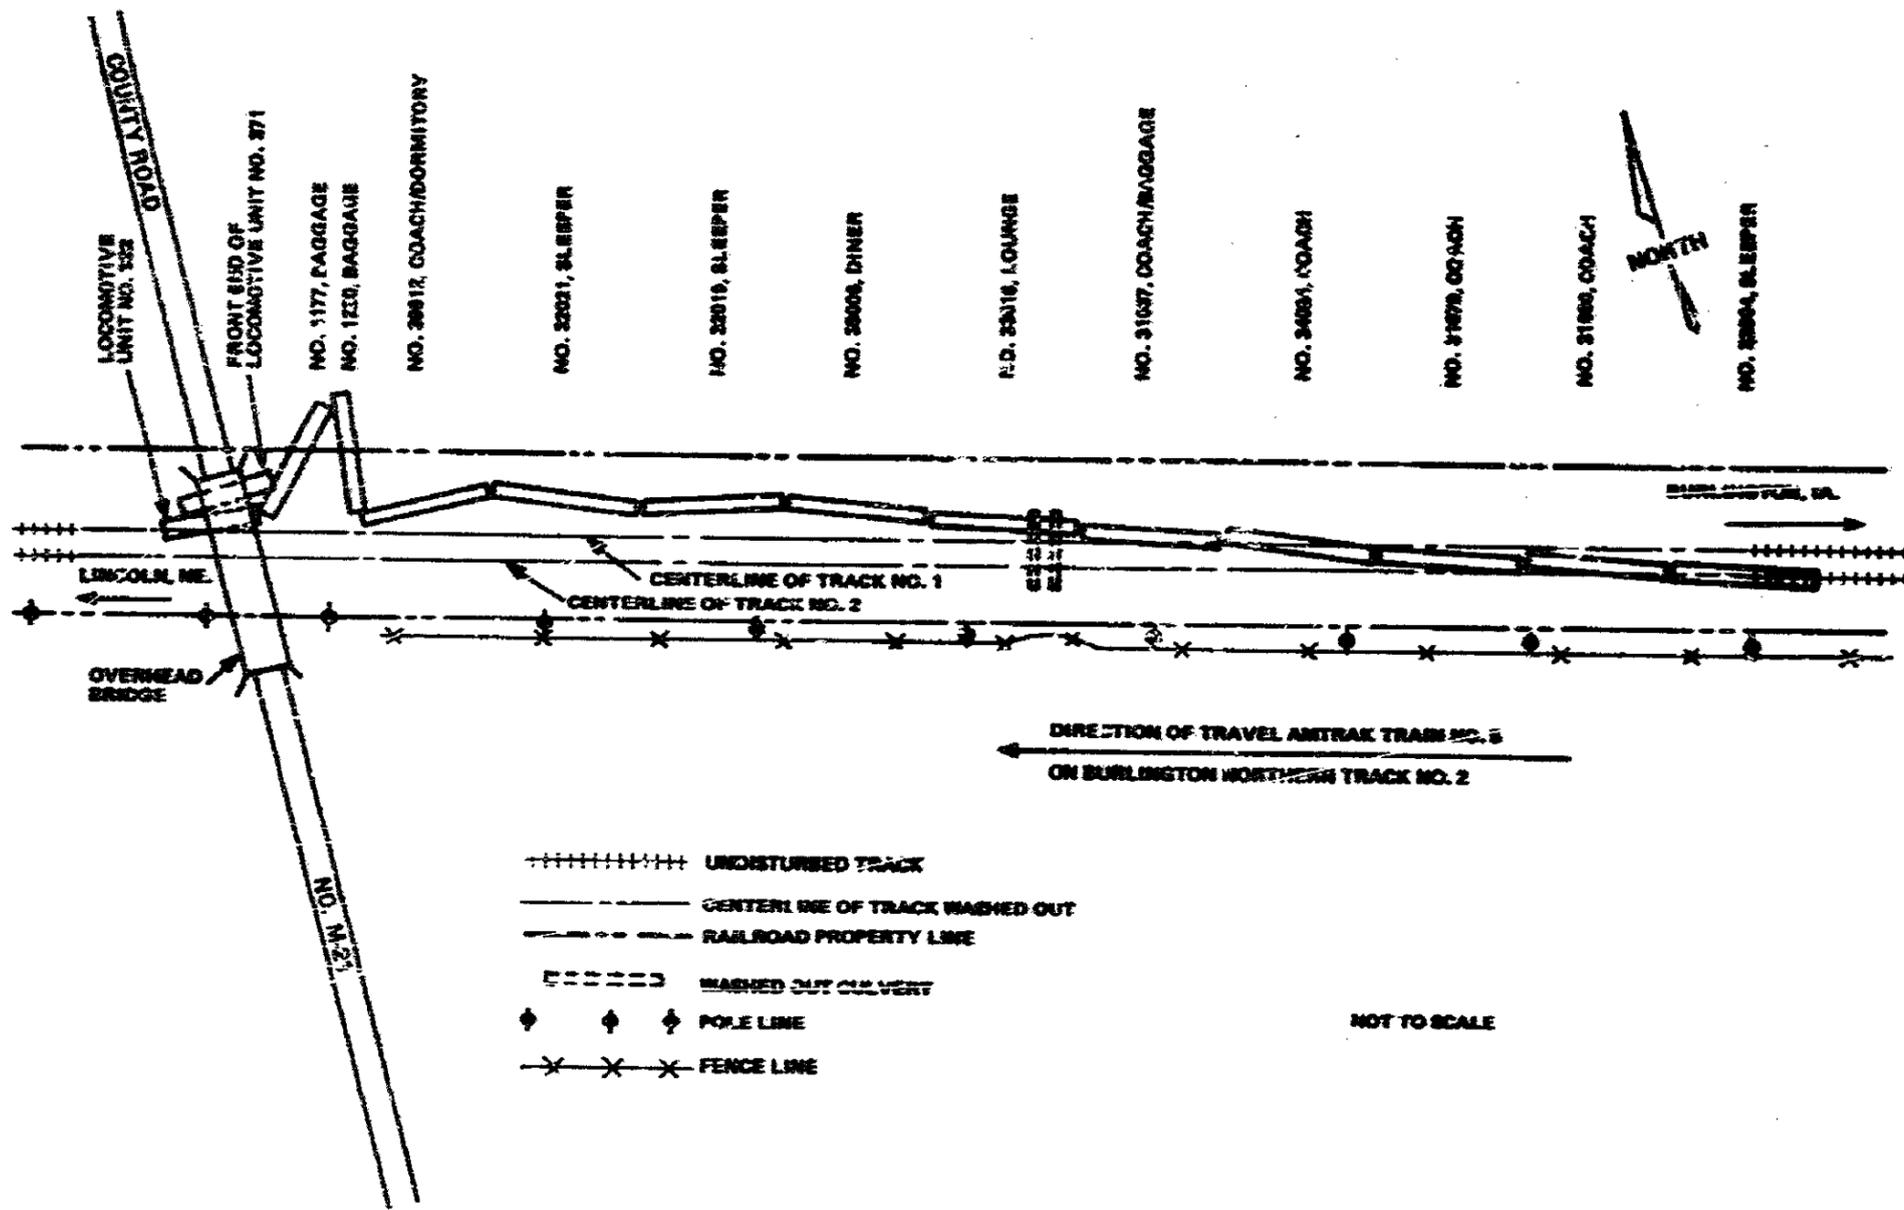
Figure 4.--Plan view of accident site.

train. (See figure 4.) Of the 315 persons onboard the train, 1 passenger was killed, and 27 persons were injured.

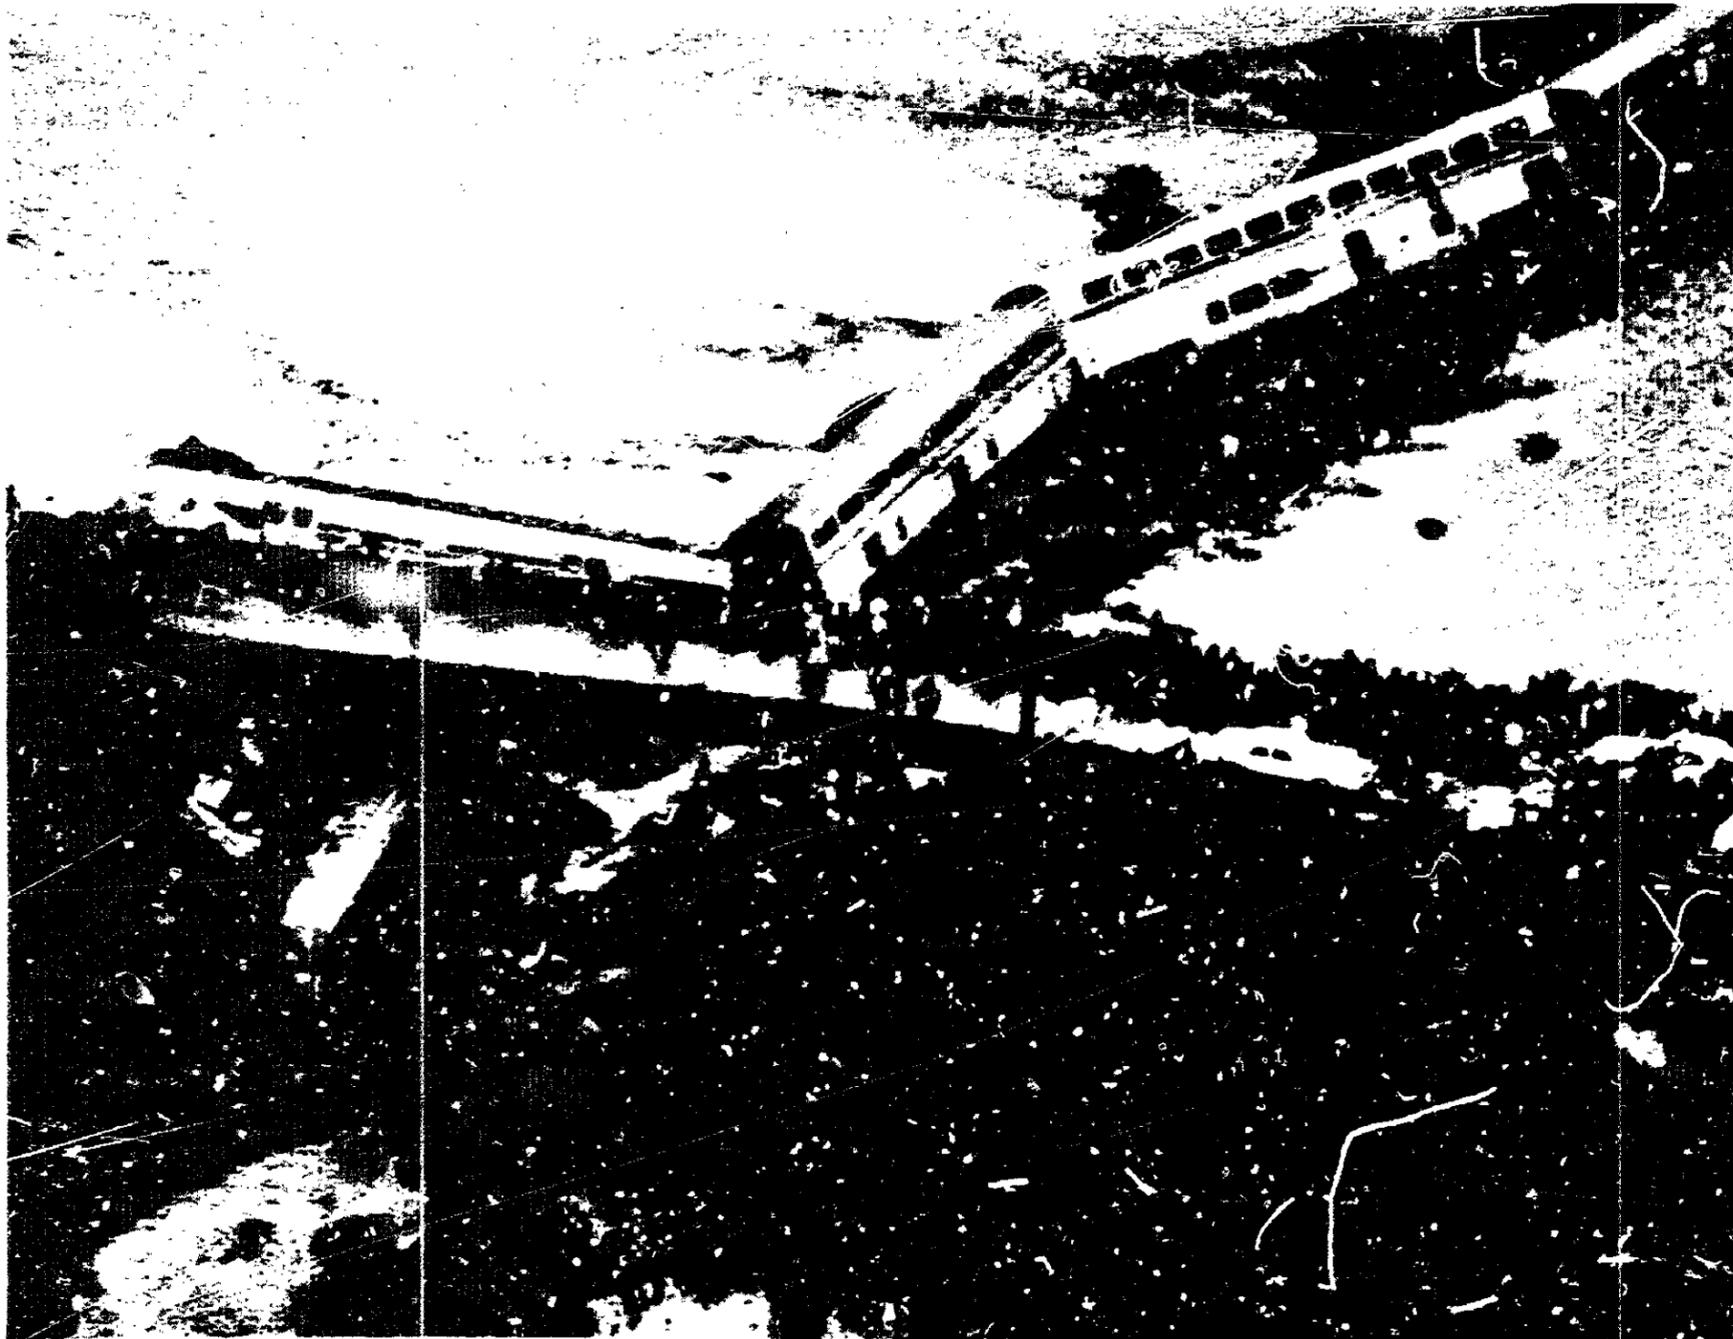
Figure 5.—Aerial view of Amtrak Train No. 5.

Both locomotive units were damaged extensively. (See figure 5.) The front section of the lead locomotive unit came to rest on the end of the lead baggage car, while the rear section of the lead locomotive unit was on the rear section of the trailing locomotive unit. The trailing locomotive unit came to rest on the fireman's side of the unit, partially underneath the lead locomotive unit and the lead baggage car. The lead locomotive unit struck and destroyed the north bridge pier. The lead baggage car was destroyed, and the second baggage car was damaged extensively. The following coach/dormitory

car sustained extensive undercar and end damage, and extensive interior mud and water damage. The following two sleeper cars also sustained structural damage and interior mud and water damage. The following diner car received undercar and structural damage and interior mud and water damage; the car's equipment room was damaged by an intruding rail. The following lounge car received undercar damage and interior mud and water damage. The following four coach cars were severely damaged, and the first three coach cars had interior mud and water damage. The last car, a sleeper car, was damaged at its leading end and at the derailed front truck.
