# NATIONAL TRANSPORTATION SAFETY BOARD

## RAILROAD ACCIDENT REPORT

SIDE COLLISION OF  
TWO MISSOURI PACIFIC RAILROAD COMPANY  
FREIGHT TRAINS  
AT GLAISE JUNCTION,  
NEAR POSSUM GRAPE, ARKANSAS  
OCTOBER 3, 1982

NTSB/PAR-83/06

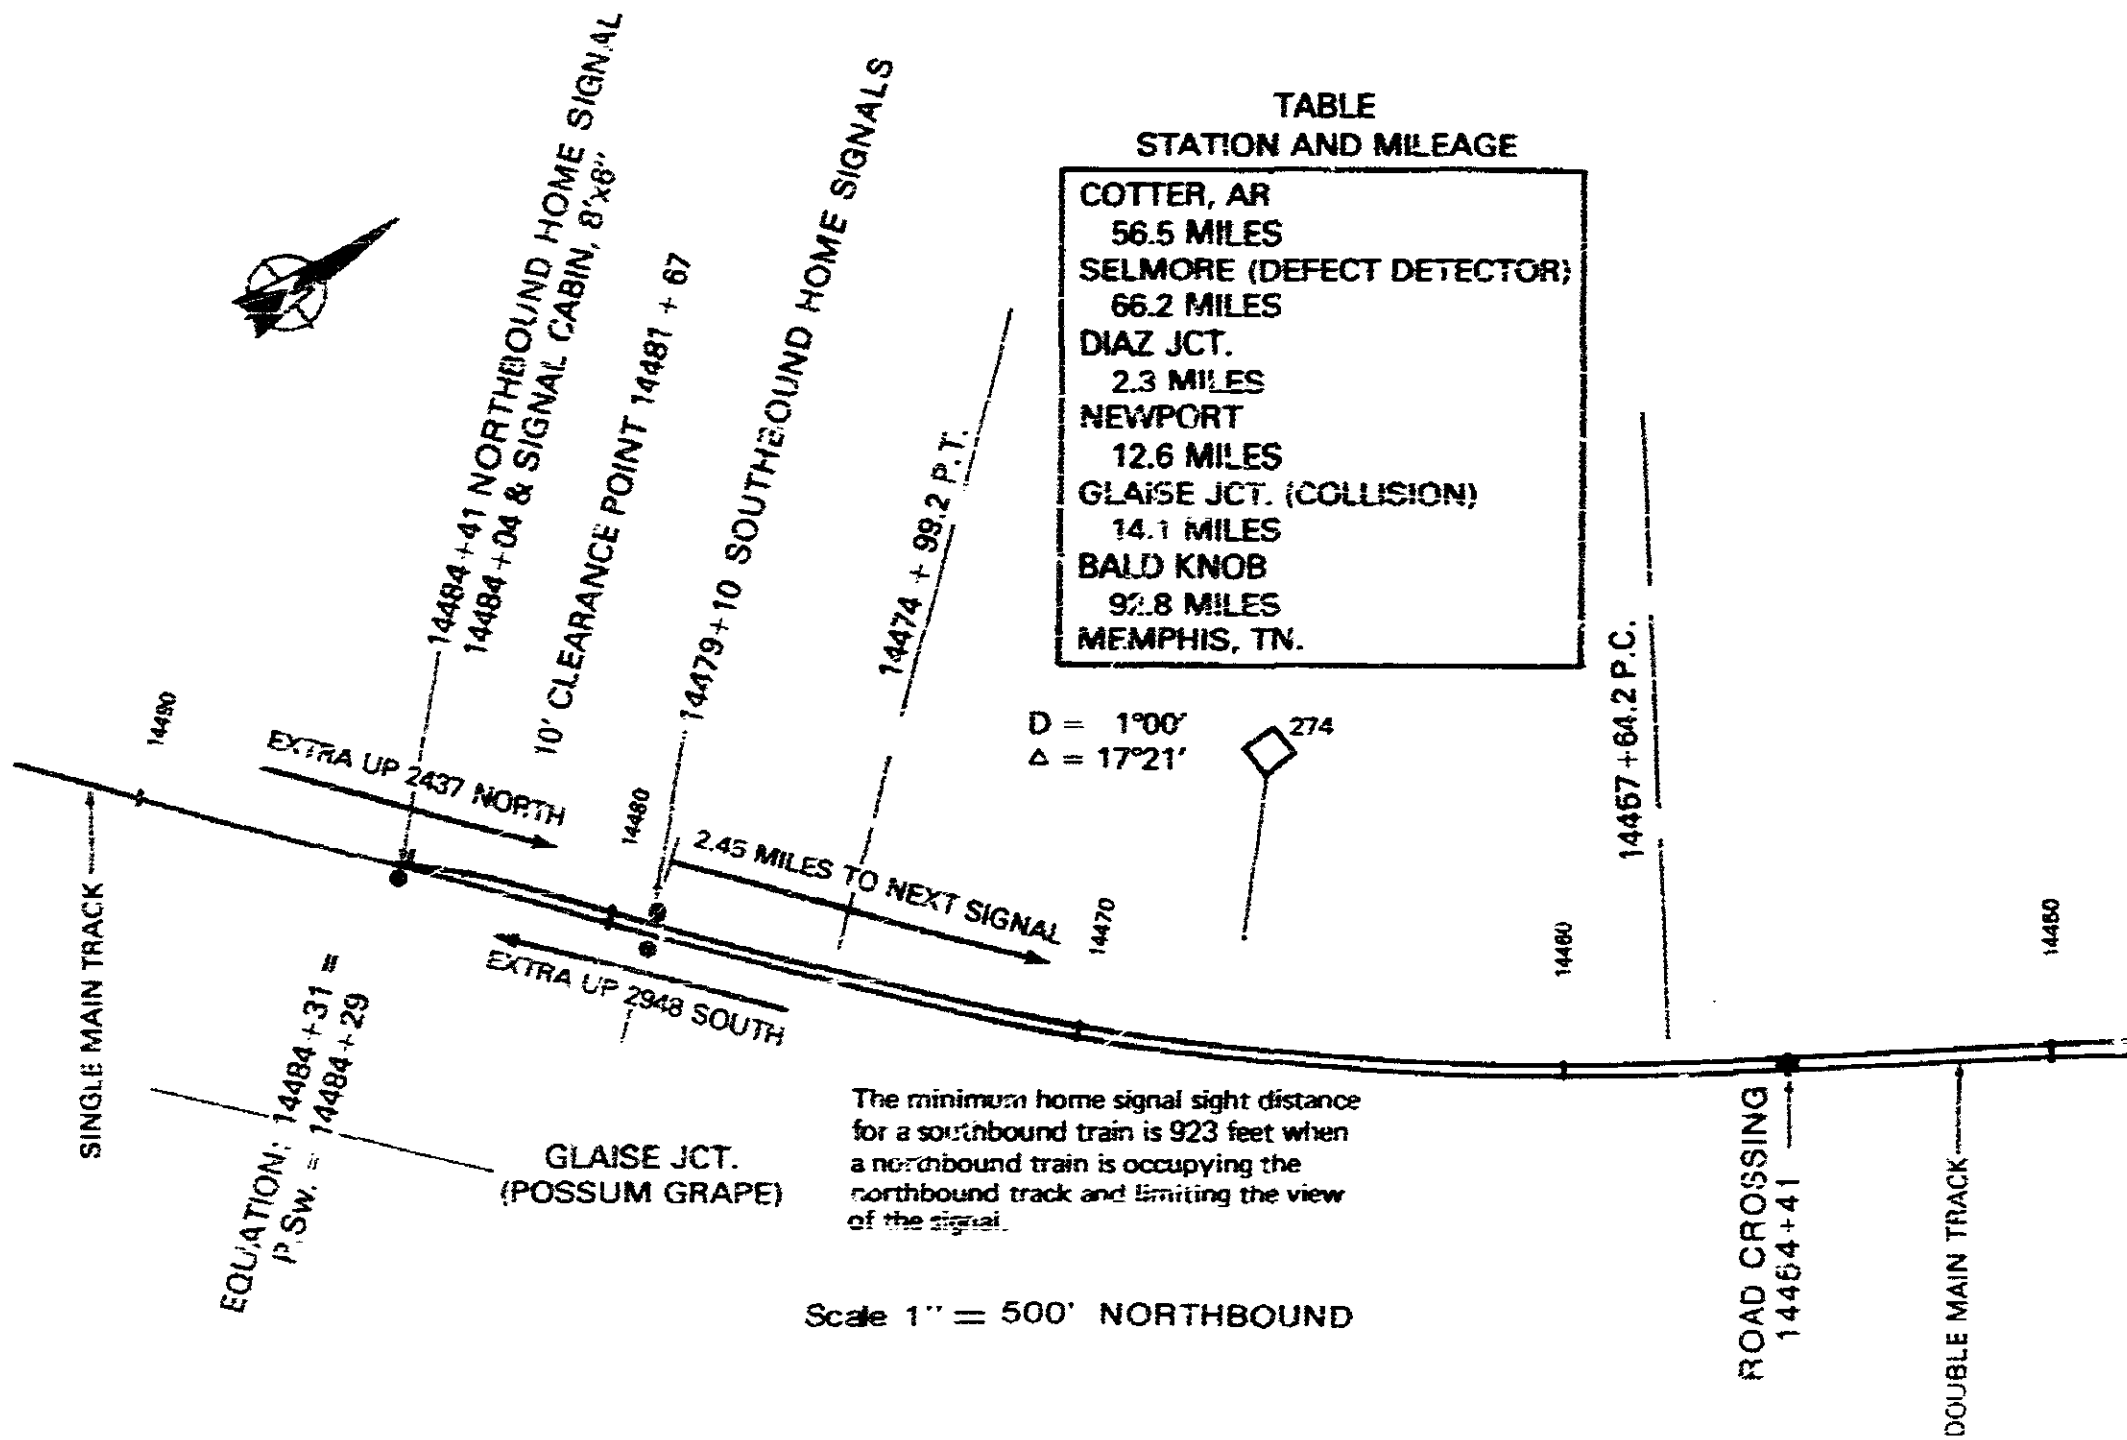
Figure 1.--Plan view of track at accident site.

initial terminal air brake test and was operated to Glaise Junction, Arkansas, a distance of 107 miles, without incident. The engineer was seated at the controls of the lead locomotive unit, and the fireman and head brakeman were seated in their respective positions on the left side of the same cab as the train approached Glaise Junction. The conductor and rear brakeman were in the caboose. About 4:13 a.m., as Extra UP 2437 North approached the Glaise Junction switch, the train dispatcher aligned the remotely controlled switch and signal to enable Extra UP 2437 North to exit the single main track and enter onto the west track of the two-track system north of that location. (See drawing, figure 1.)

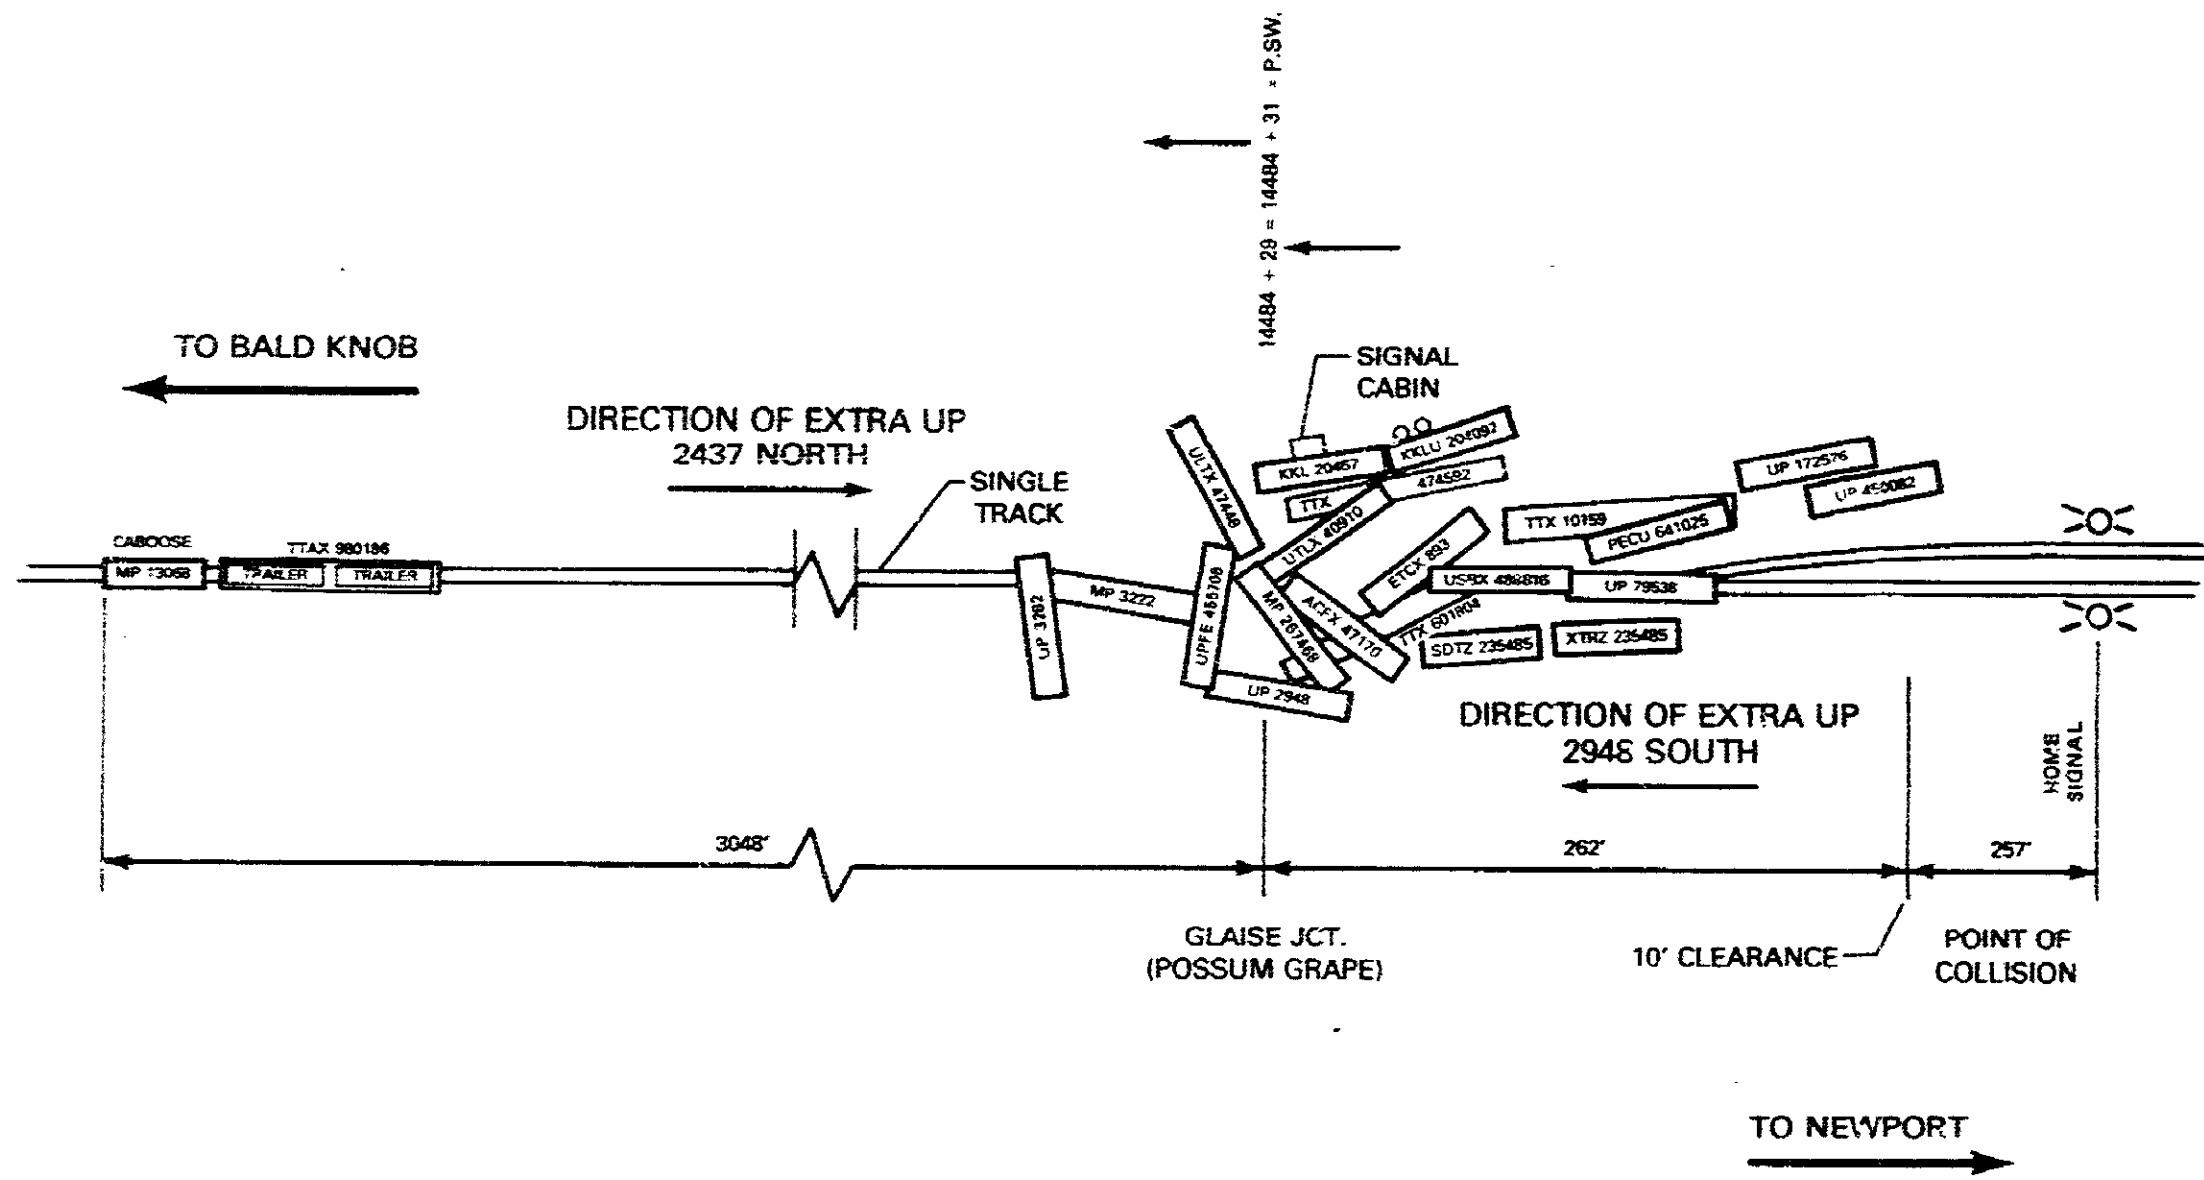
Figure 4.--Derailed equipment.  
(Not to Scale)

When Extra UP 2437 North was stopped as a result of the emergency application of the air brakes, the head brakeman and fireman proceeded toward the rear of their train. Upon their arrival, they observed that Extra UP 2948 South had collided with the eighth car ahead of their caboose. (See figure 2.) The Extra UP 2948 South's lead locomotive unit had derailed, rotated 180°, and turned over before it came to rest at the foot of an embankment and about 30 feet from the track where it was engulfed in a fire fed by diesel fuel and oil. (See figure 3.) The caboose of Extra UP 2437 North and car ahead rolled backward on the track about 0.4 mile before they stopped. (See figure 4.)
