RAILROAD ACCIDENT REPORT

ILLINOIS CENTRAL GULF RAILROAD COMPANY
FREIGHT TRAIN DERAILMENT
FORT KNOX, KENTUCKY
MARCH 22, 1983

NTSB/RAR-83/07

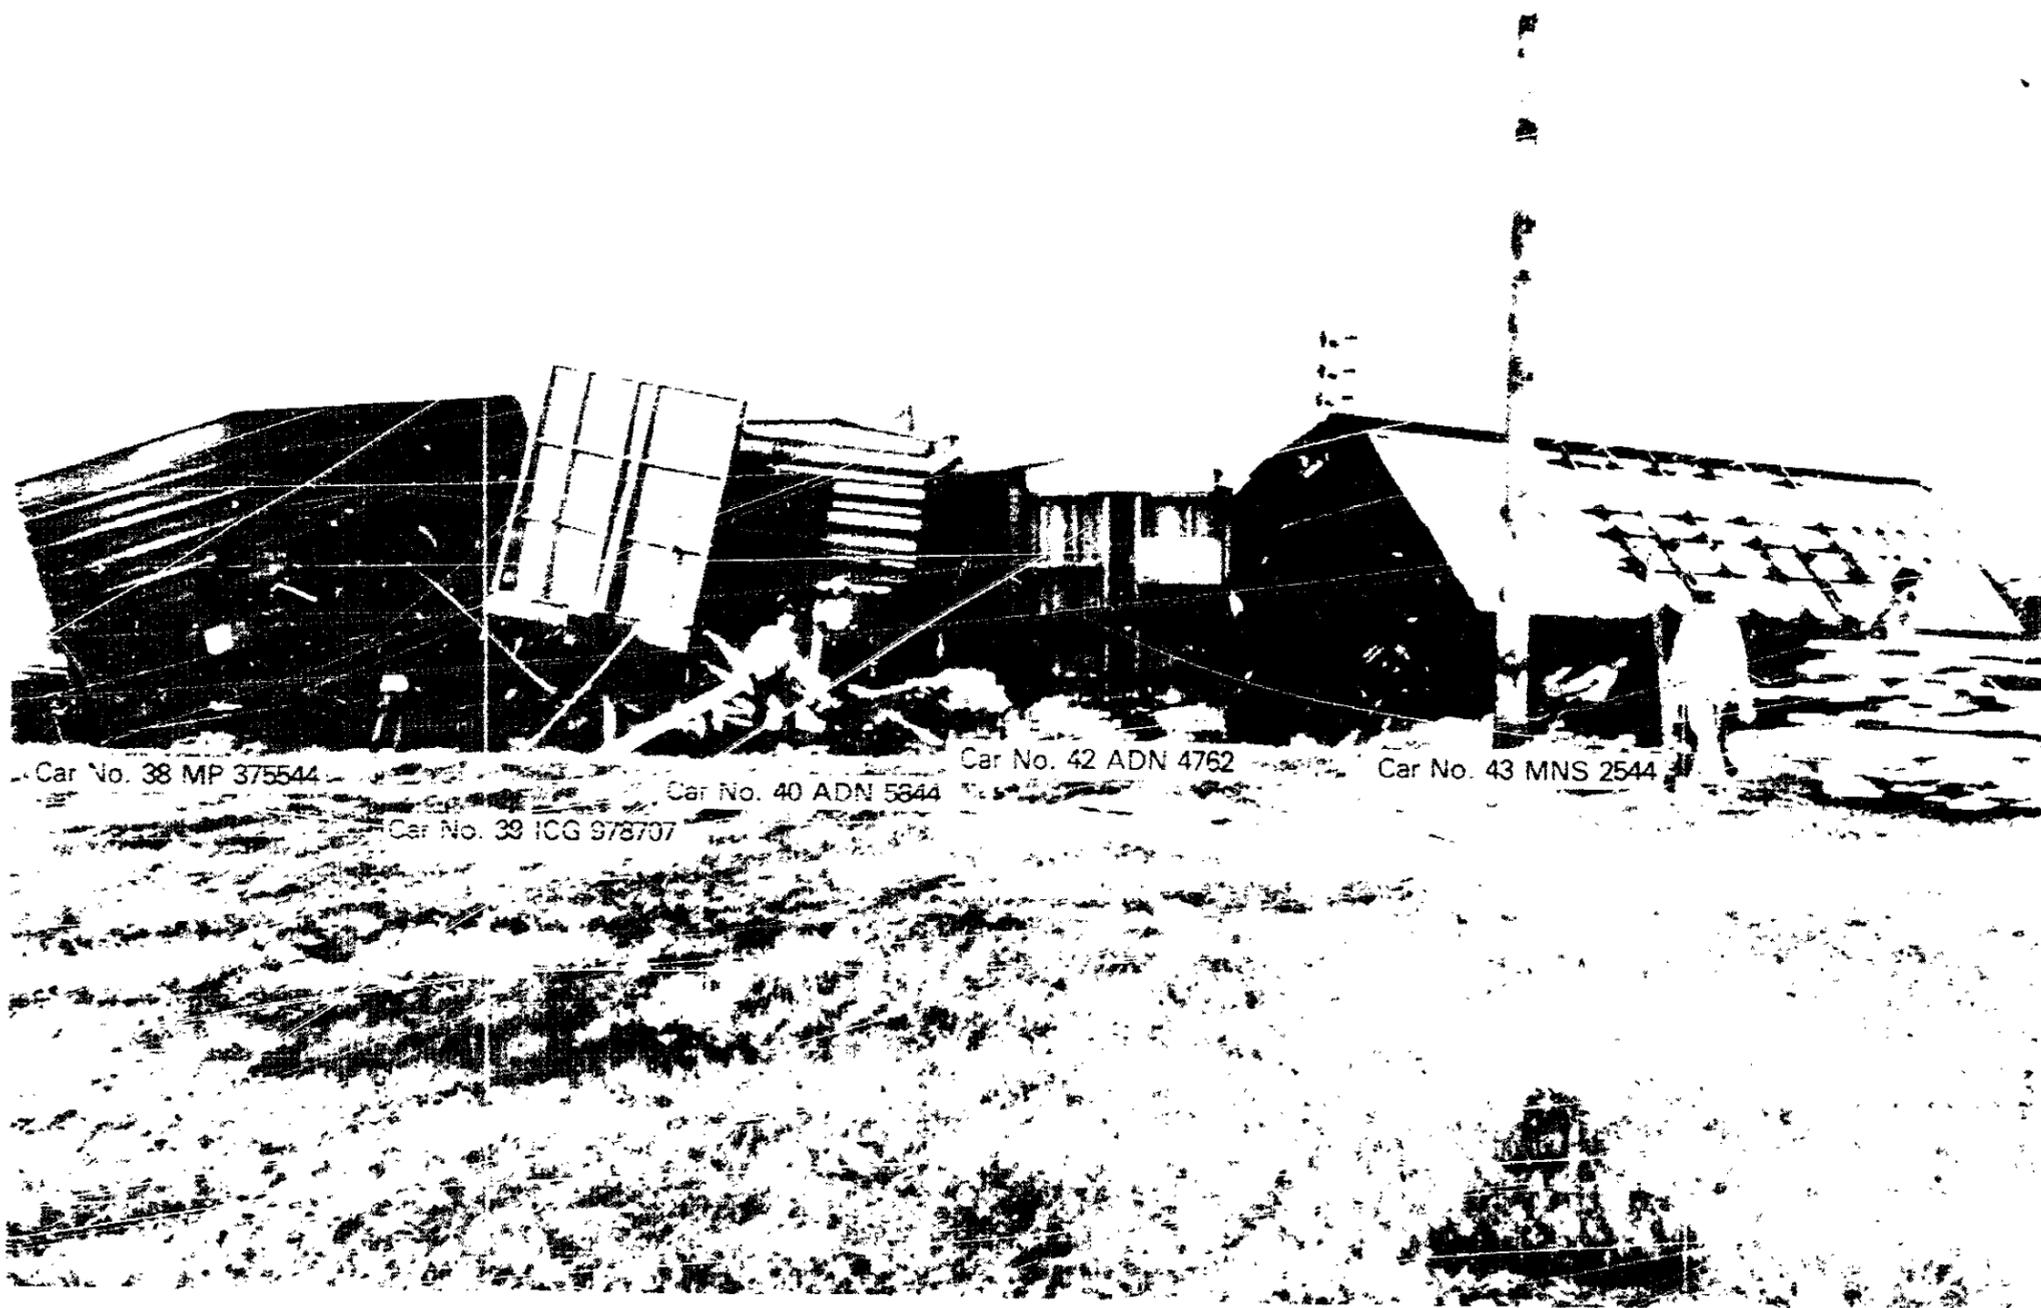
Figure 2.—Boxcar pile up at Fort Knox.
Direction of travel - right to left

Three tank cars, DUPX 20879, DUPX 20894, and GATX 50172, were damaged moderately. The degree of damage to the 10 boxcars ranged from moderate to severe. About 225 feet of track were destroyed and about 2 pole spans of signal wires were knocked down.

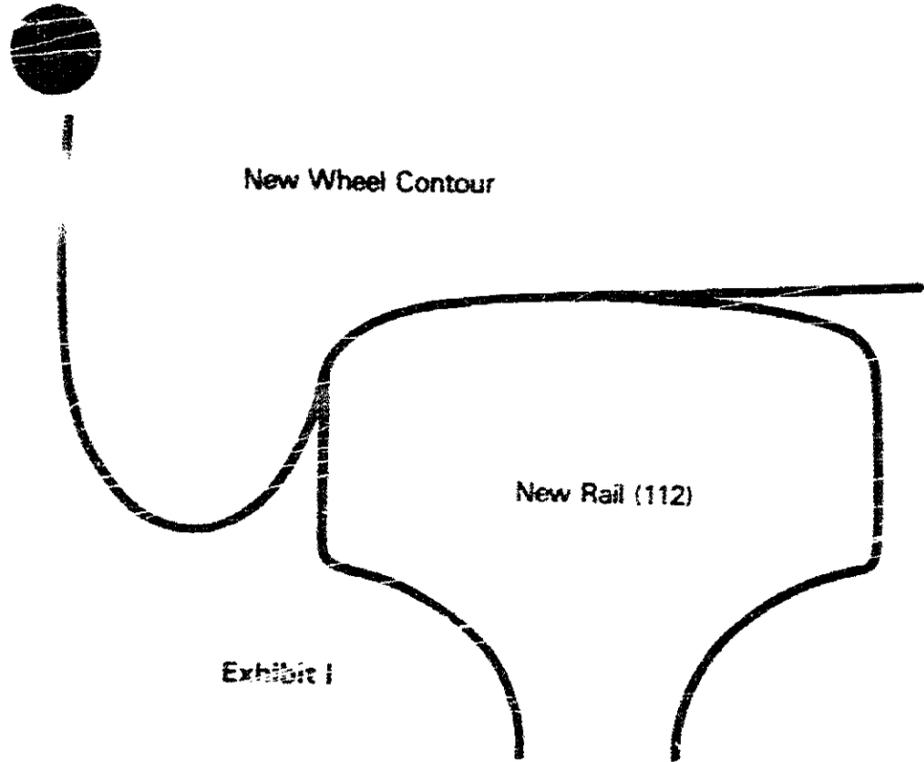
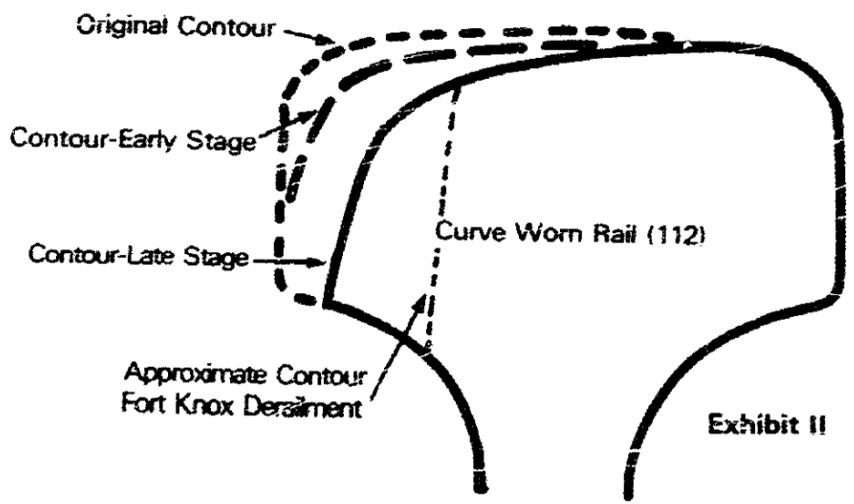
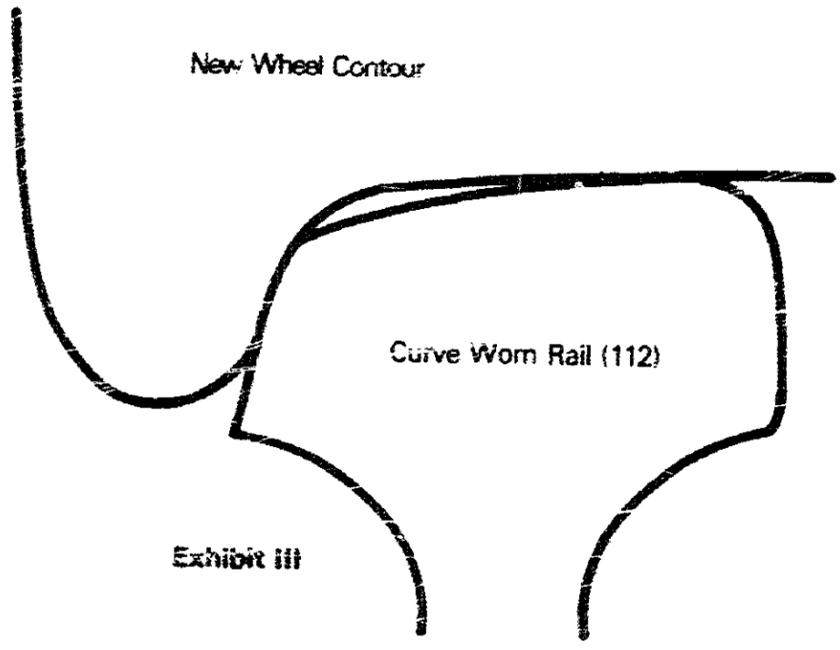
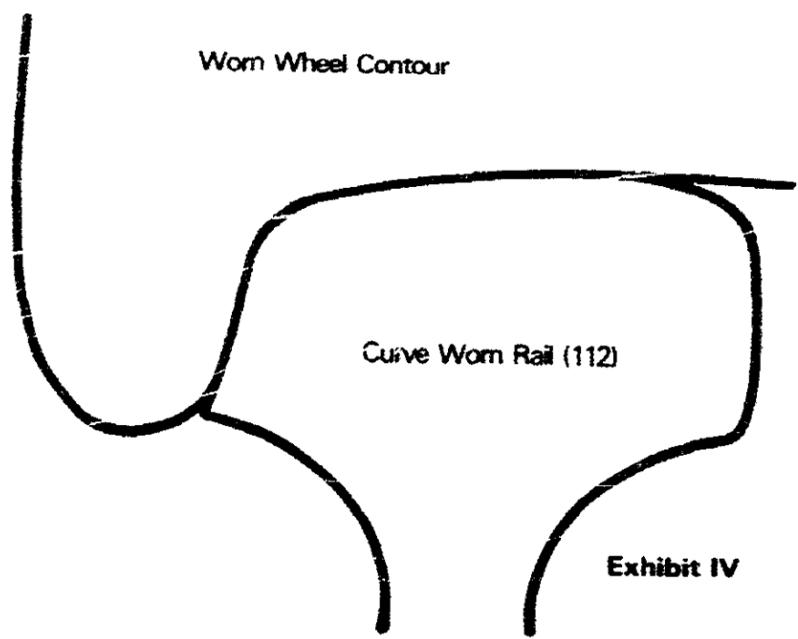
Figure 3.--Typical wheel-rail contact configurations.

The rail was placed in service during 1944. The outside (curve) railhead was worn about 7/8 inch on the gage side and it was badly shelled. The railhead of a new 112-pound RE-rail measures 2 23/32 inches. Some typical wheel-rail contact configurations are shown in figure 3.

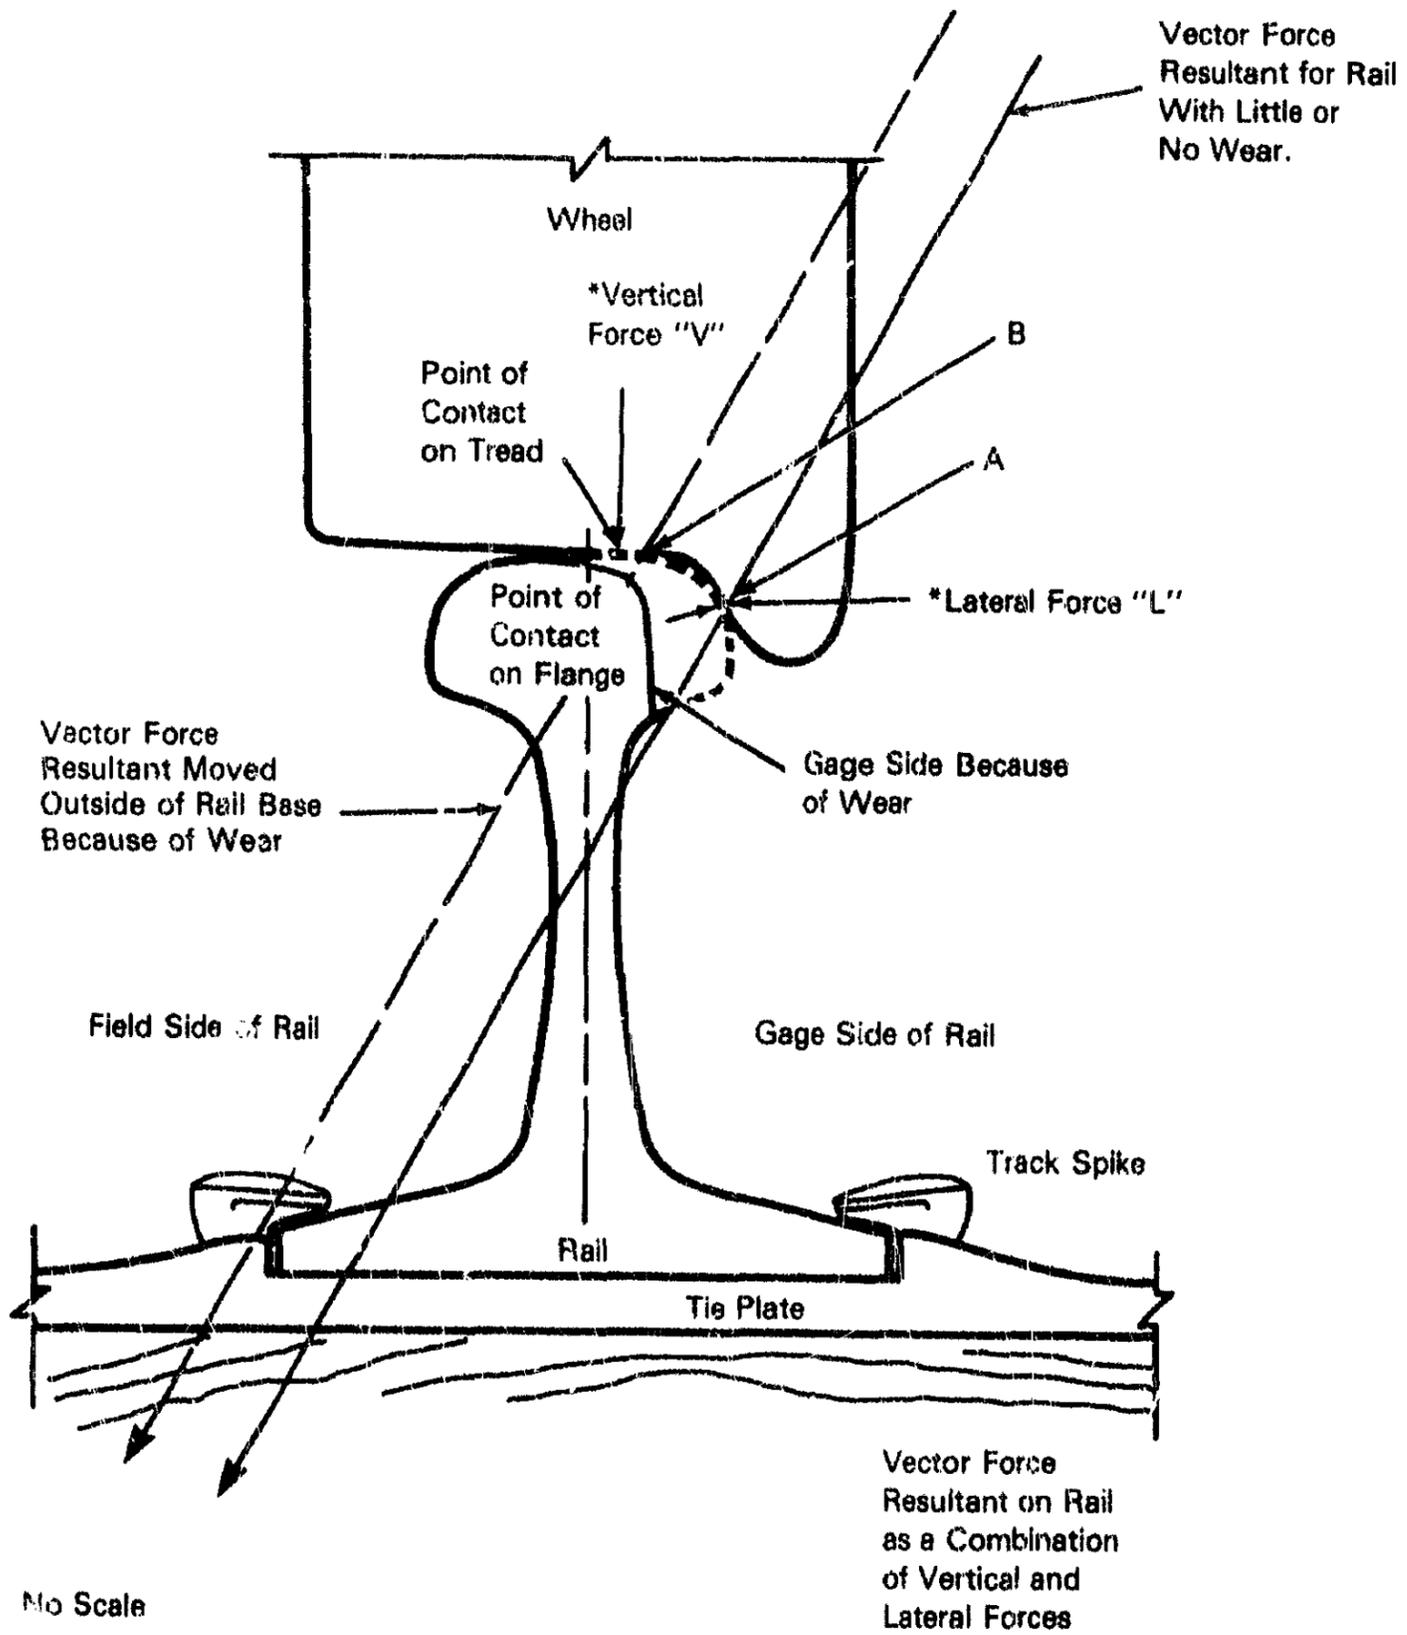
Figure 9.—Loading effect on rail.

In the absence of superelevation in the 2° curve and because of extreme wear of the railhead at the derailment site, the resultant force of the rail cars would have been manifested in a manner that would have increased the outward force on the outside curve rail. (See figure 9.) Because of the 7/8-inch railhead wear, a vector diagram constructed at the railhead would show the vector resultant has moved outward on the railhead. Unless the wheel climbed over the rail (and there are no marks on the railhead to indicate it had) the shift of the resultant vertical and centrifugal forces from A to B on the rail would cause the rail to move laterally and/or to tip.

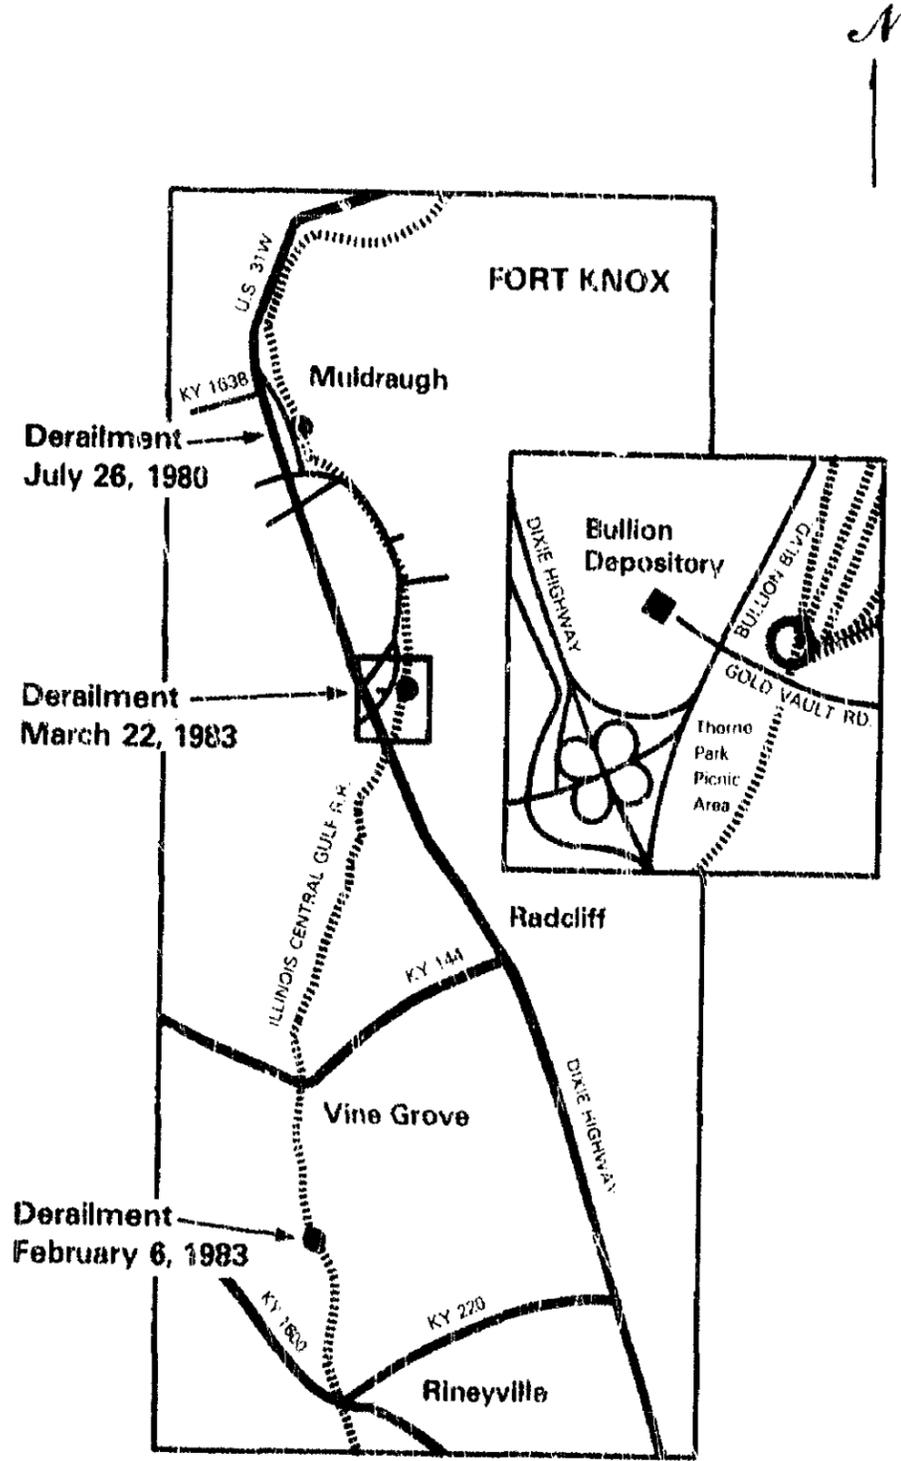
Figure 10.--Locations of derailments in the Fort Knox area.

6. The wear on the curve rail exceeded the maximum wear allowable by the ICG Engineering and Maintenance of Way Department.
7. Poorly maintained track contributed to two earlier derailments in the vicinity of Fort Knox within a 2 1/2-year period.
