**DERAILMENT OF  
BURLINGTON NORTHERN RAILROAD COMPANY  
FREIGHT TRAIN NO. MTC-0718  
NEAR CRYSTAL CITY, MISSOURI  
JULY 18, 1983**

NTSB/RAR-84/01

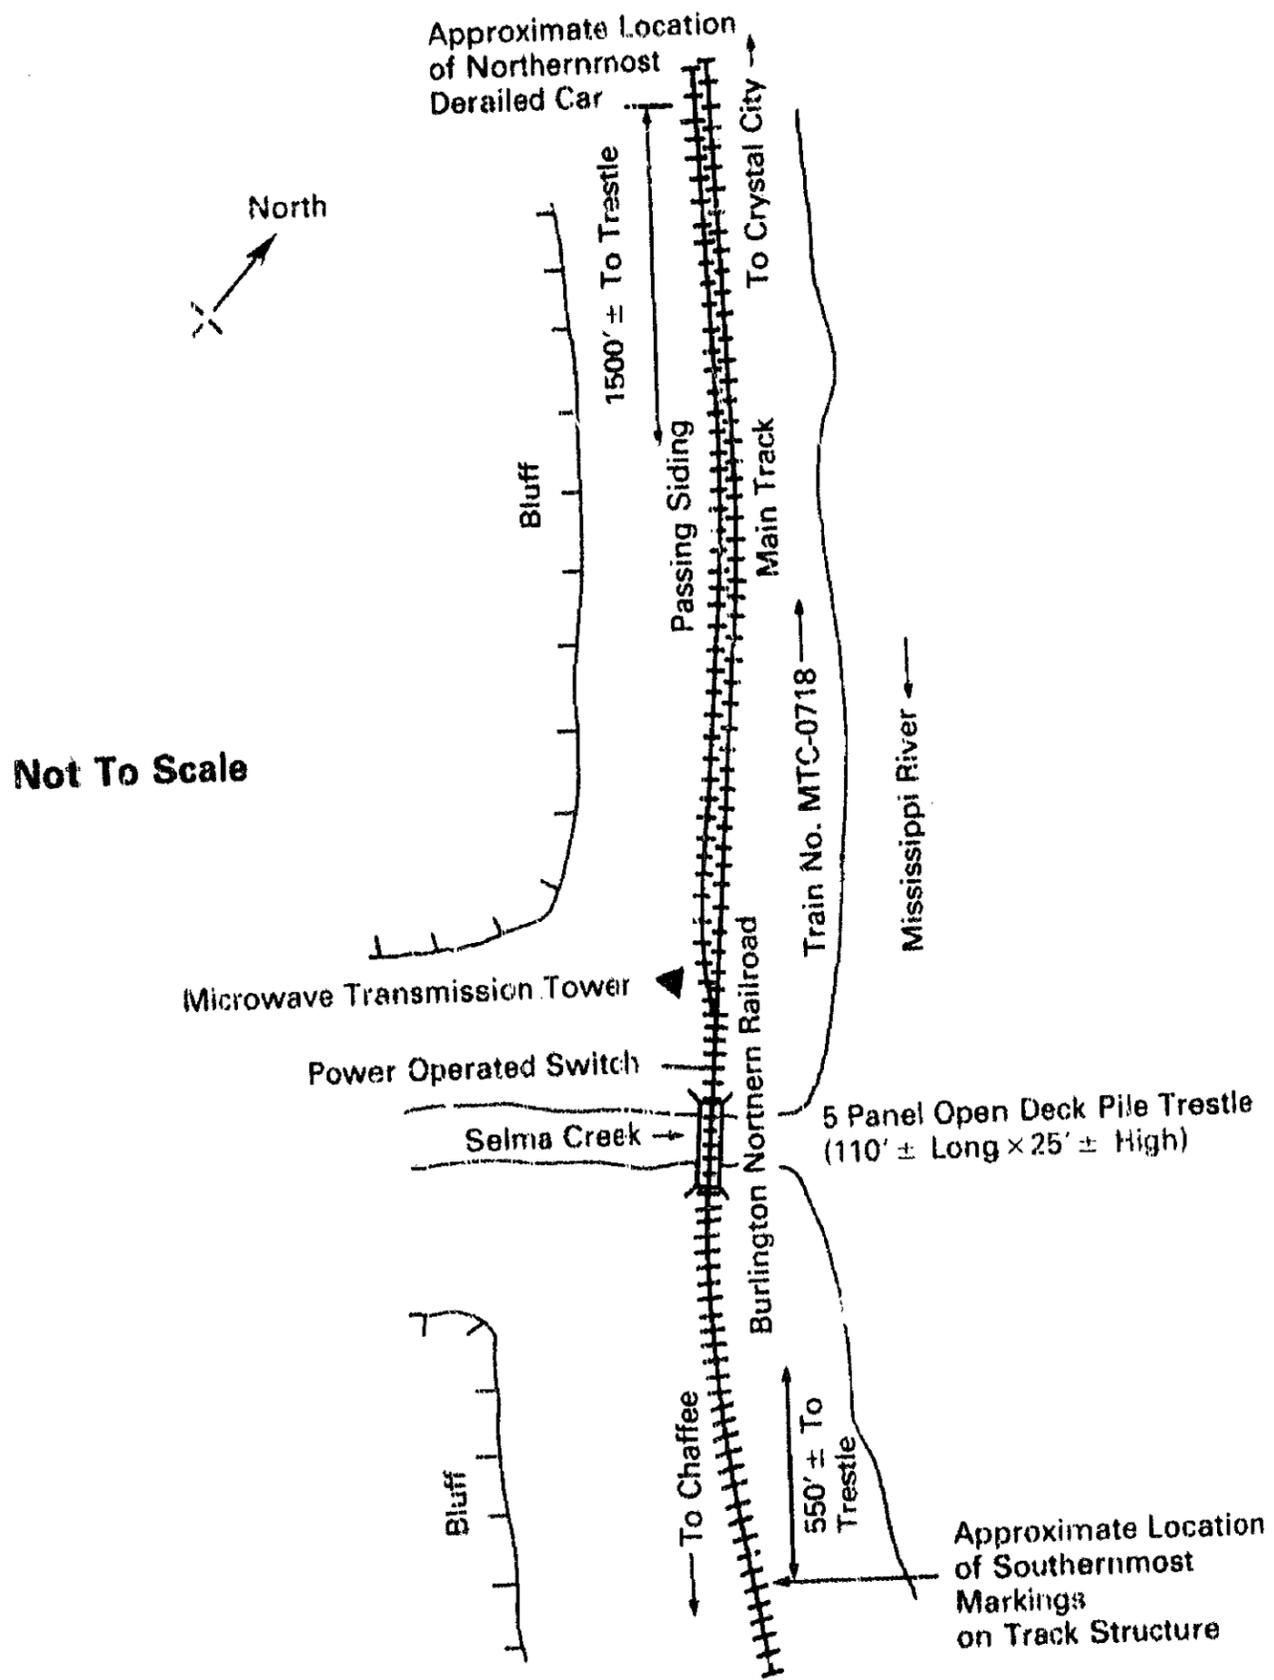
Figure 2.—Plan view of derailment site.

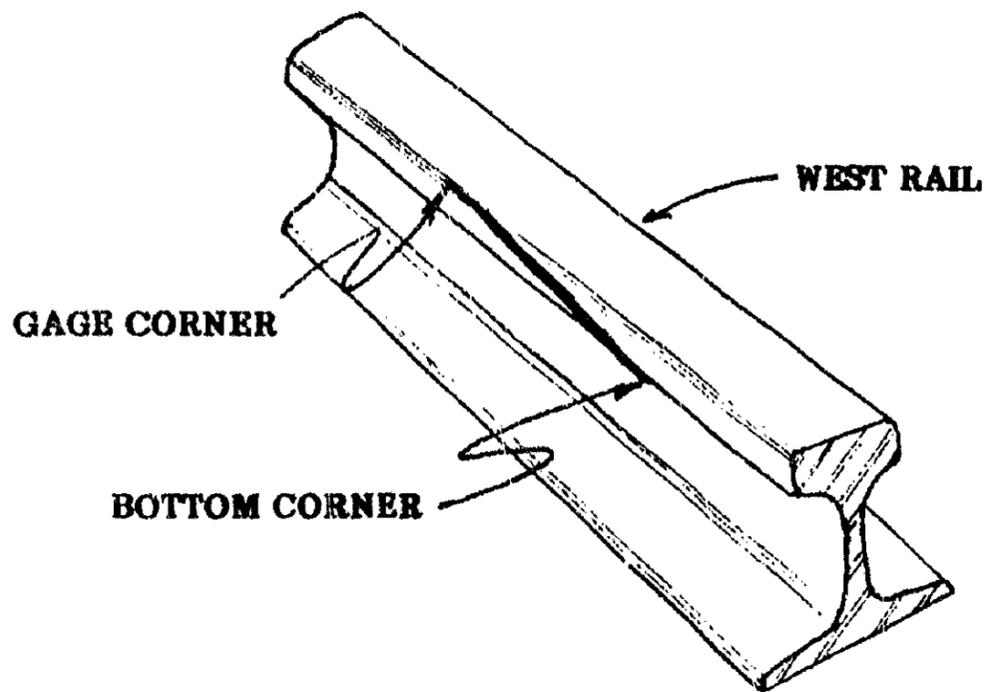
Figure 4.--Sketch of southernmost derailment marking at transition from tangent track into 3-degree curve.
