RAILROAD ACCIDENT REPORT

REAR END COLLISION
OF SEABOARD SYSTEM RAILROAD
FREIGHT TRAINS EXTRA 8051 NORTH
AND EXTRA 1751 NORTH
SULLIVAN, INDIANA
SEPTEMBER 14, 1983

NTSD/RAR-84/02

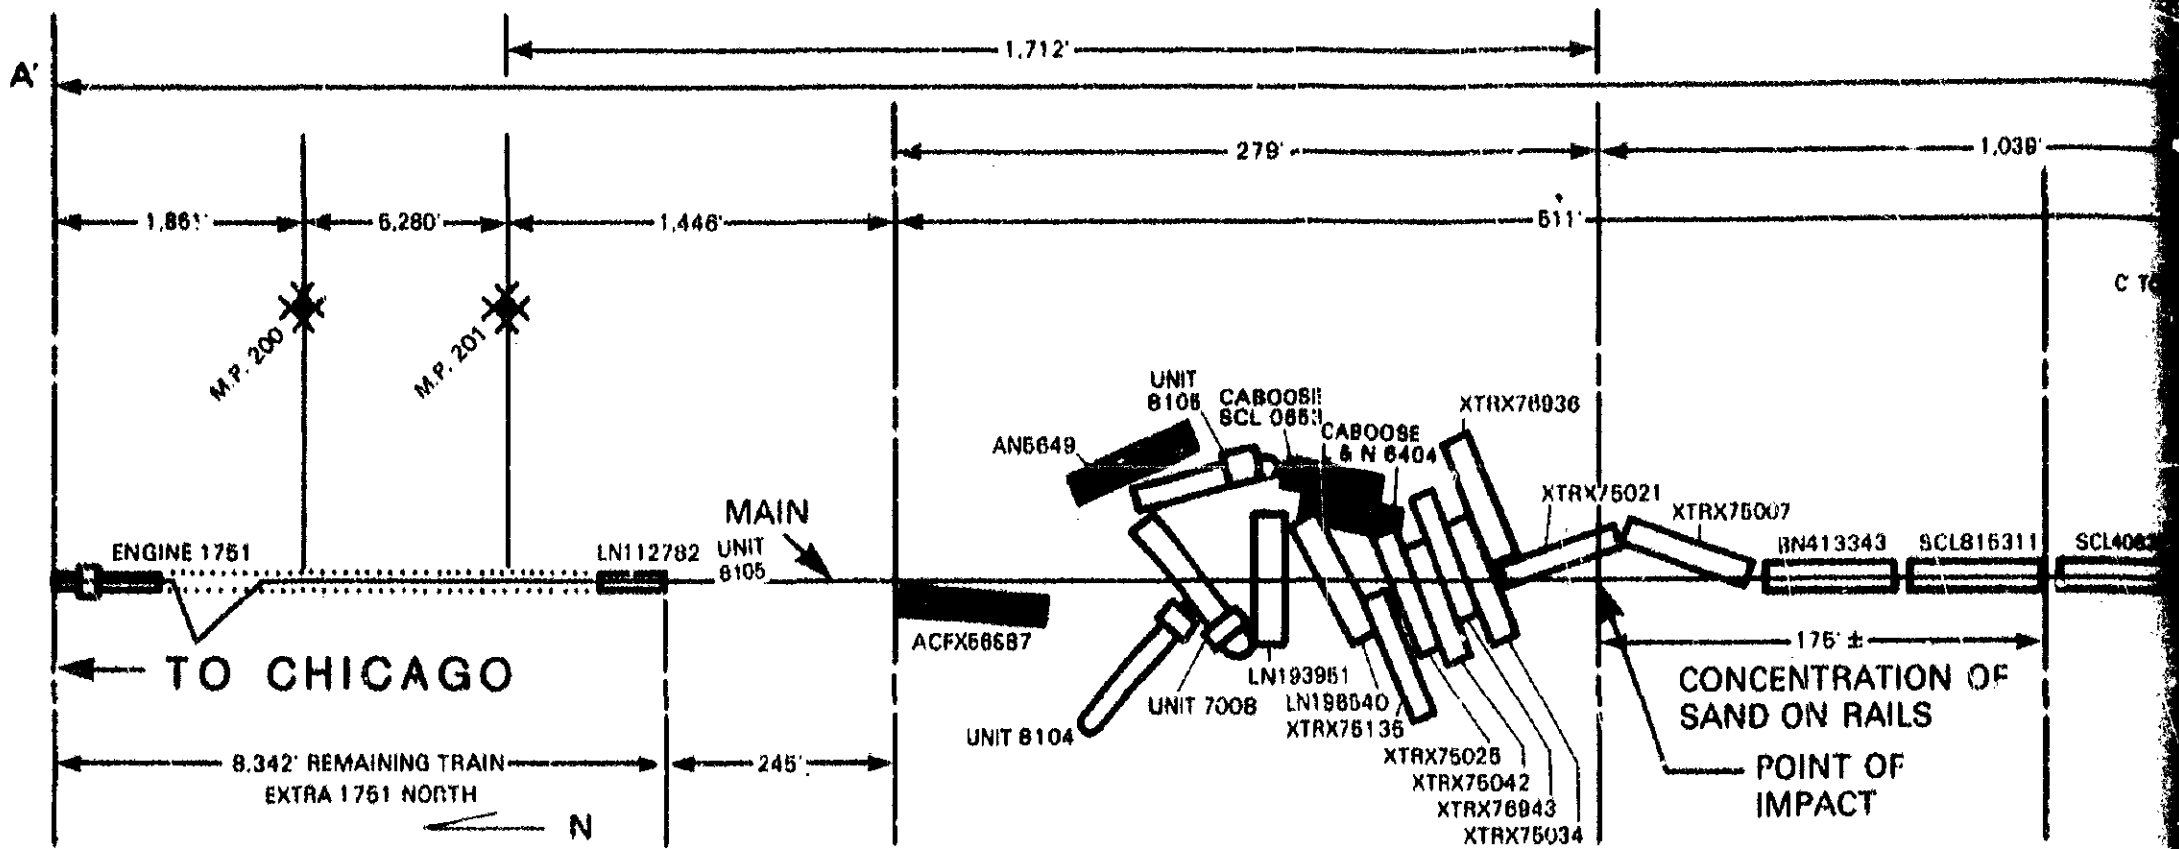
Figure 2.—Plan view of primary

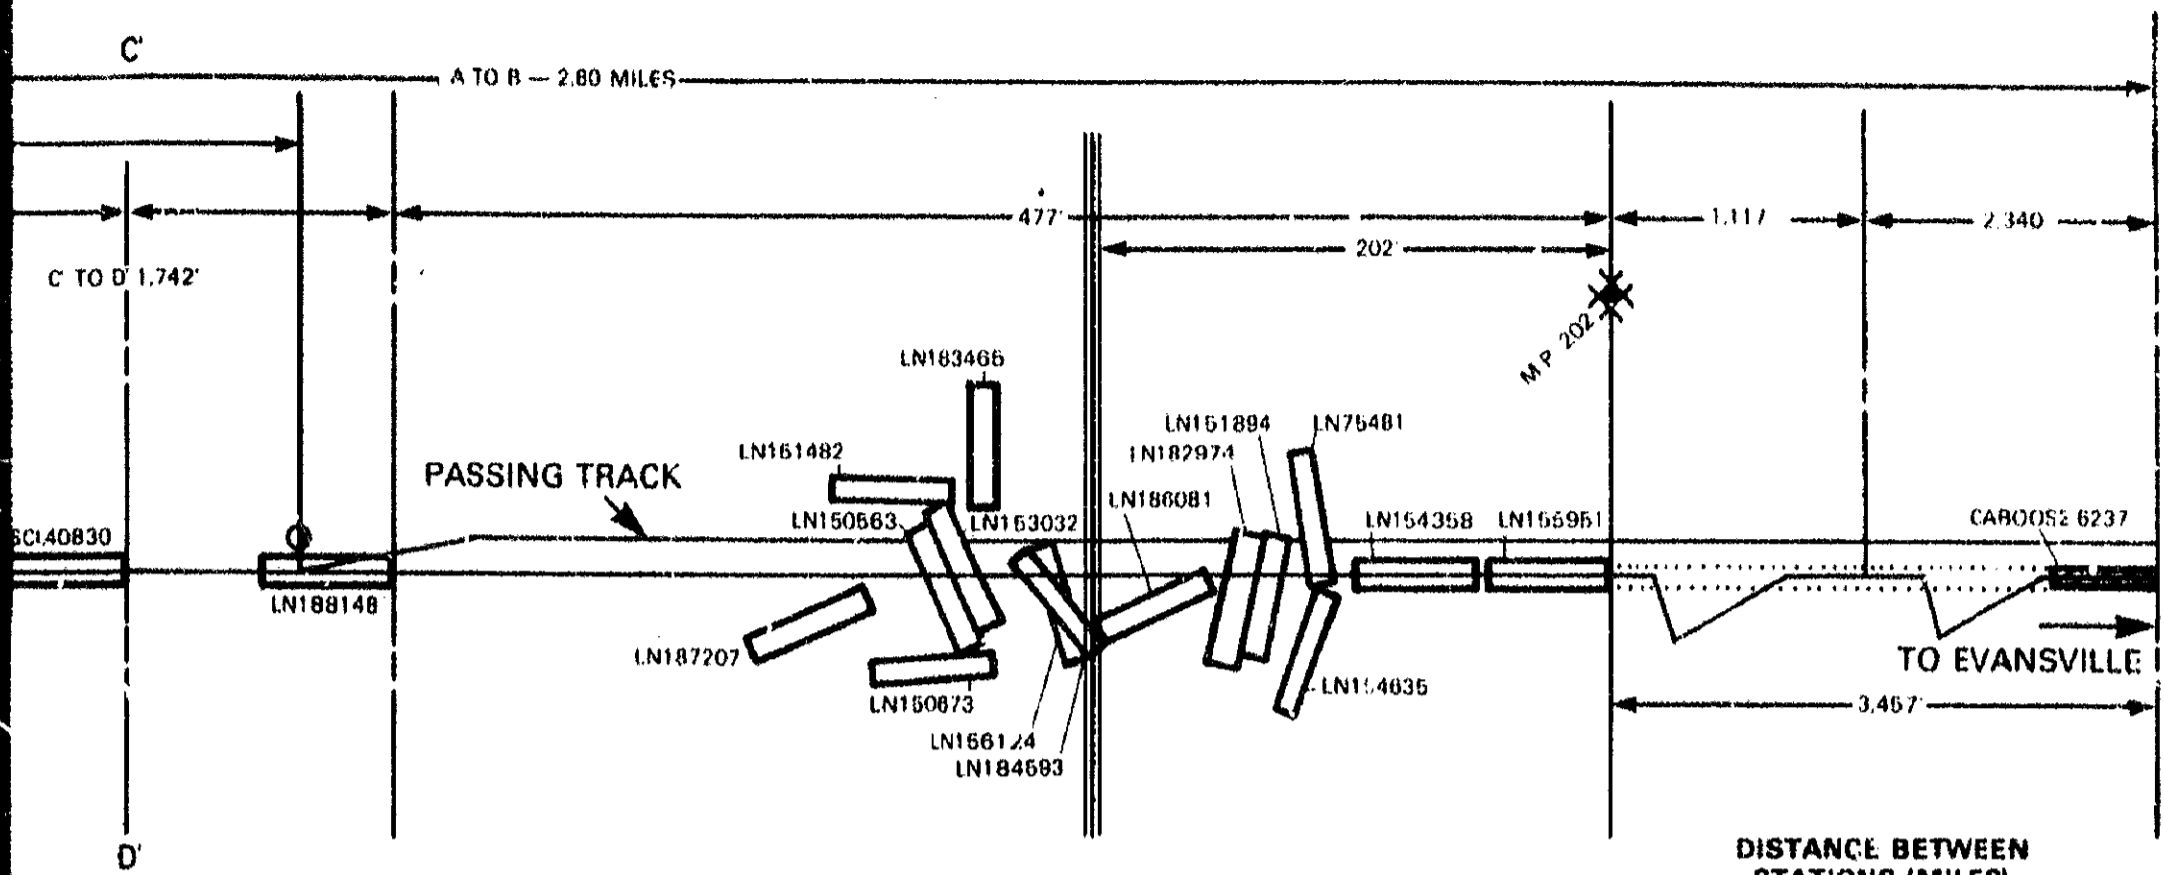
Primary and secondary derailment sites.
