NATIONAL TRANSPORTATION SAFETY BOARD

RAILROAD ACCIDENT REPORT

**DERAILMENT OF
AMTRAK TRAIN NO. 21 (THE EAGLE)
ON THE MISSOURI PACIFIC RAILROAD
WOODLAWN, TEXAS
NOVEMBER 12, 1983**

NTSB/RAR-85/01

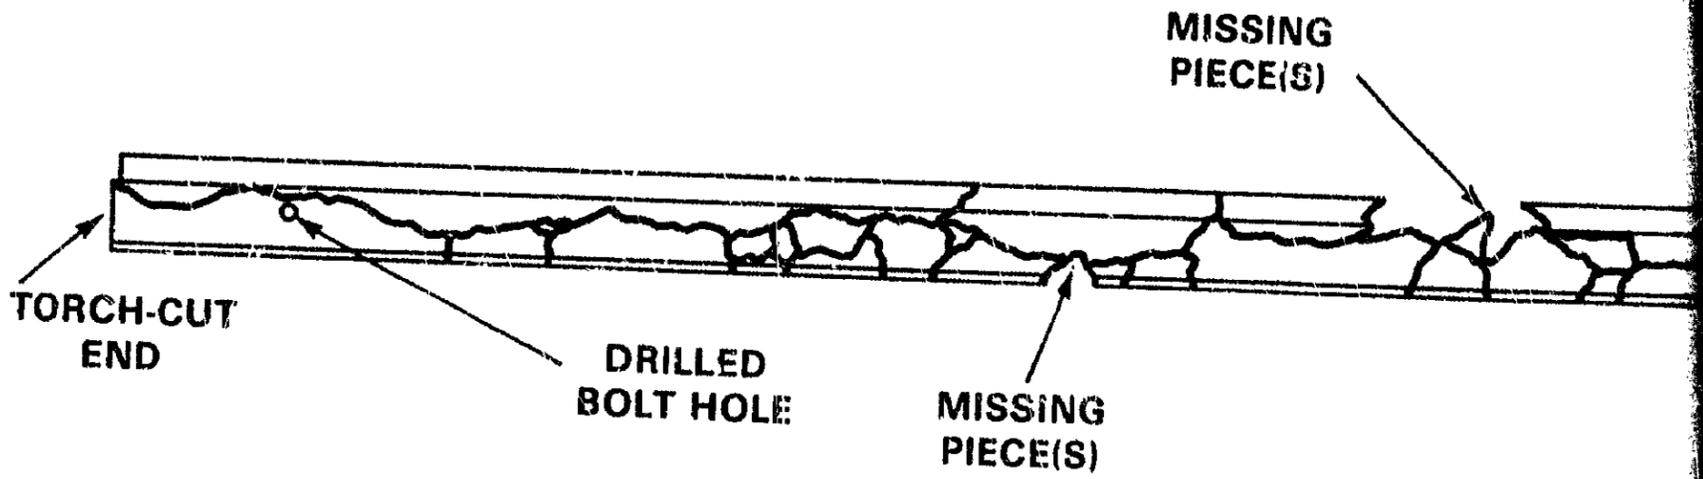
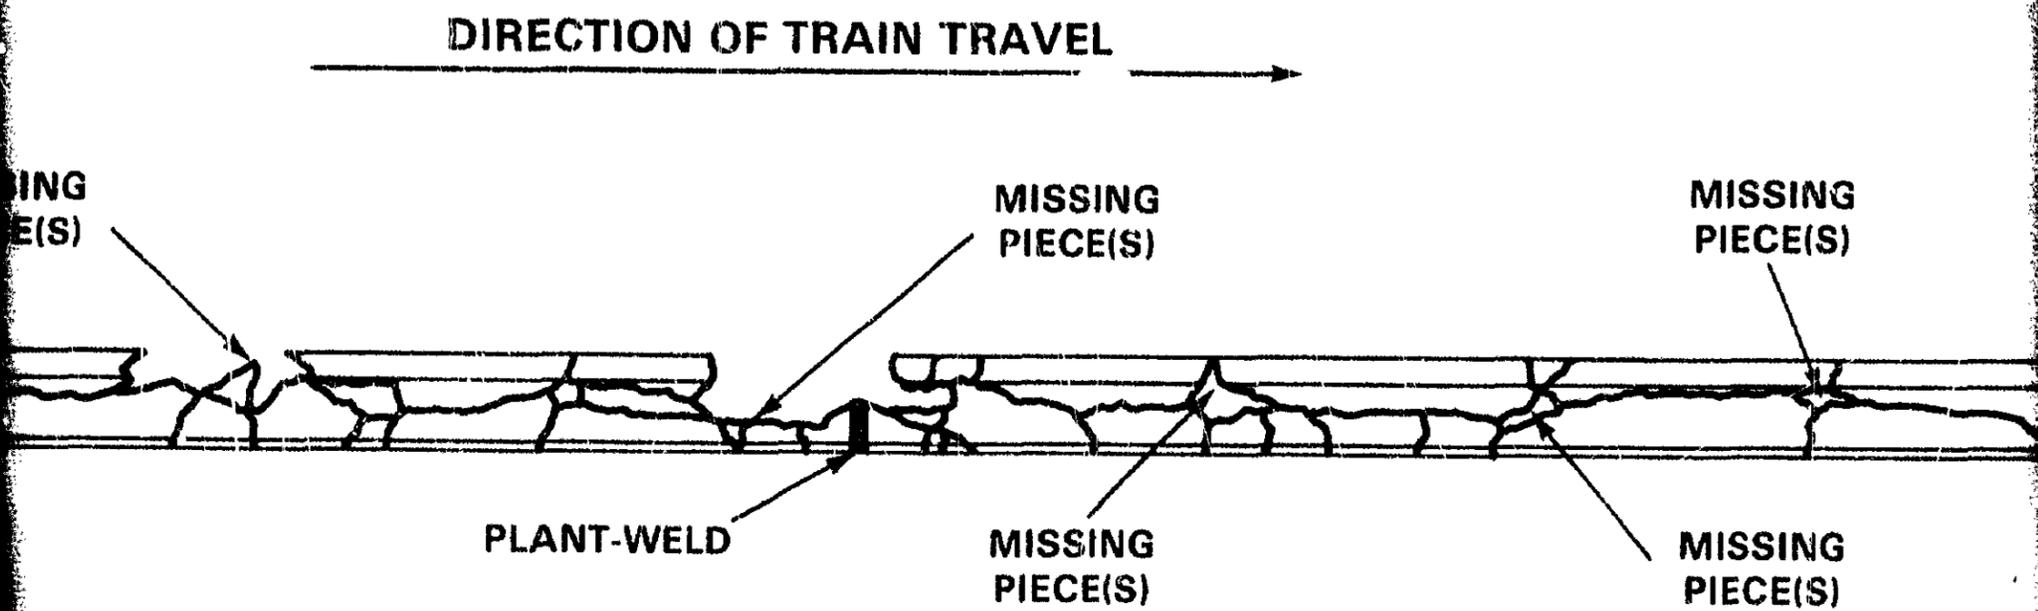
Figure 4.--Rail fracture diagram.

Initial onsite examination of the chrome-vanadium alloy rail indicated the presence of a small crack in the web of the rail at a discontinuity in the torch-cut face near where the alloy rail was bolted to the south end of the standard-carbon insert. The break appeared to extend from that discontinuity through the web a distance of about 6 feet. Within the next 34 feet approximately, the rail was broken into between 50 and 100 pieces of various size.

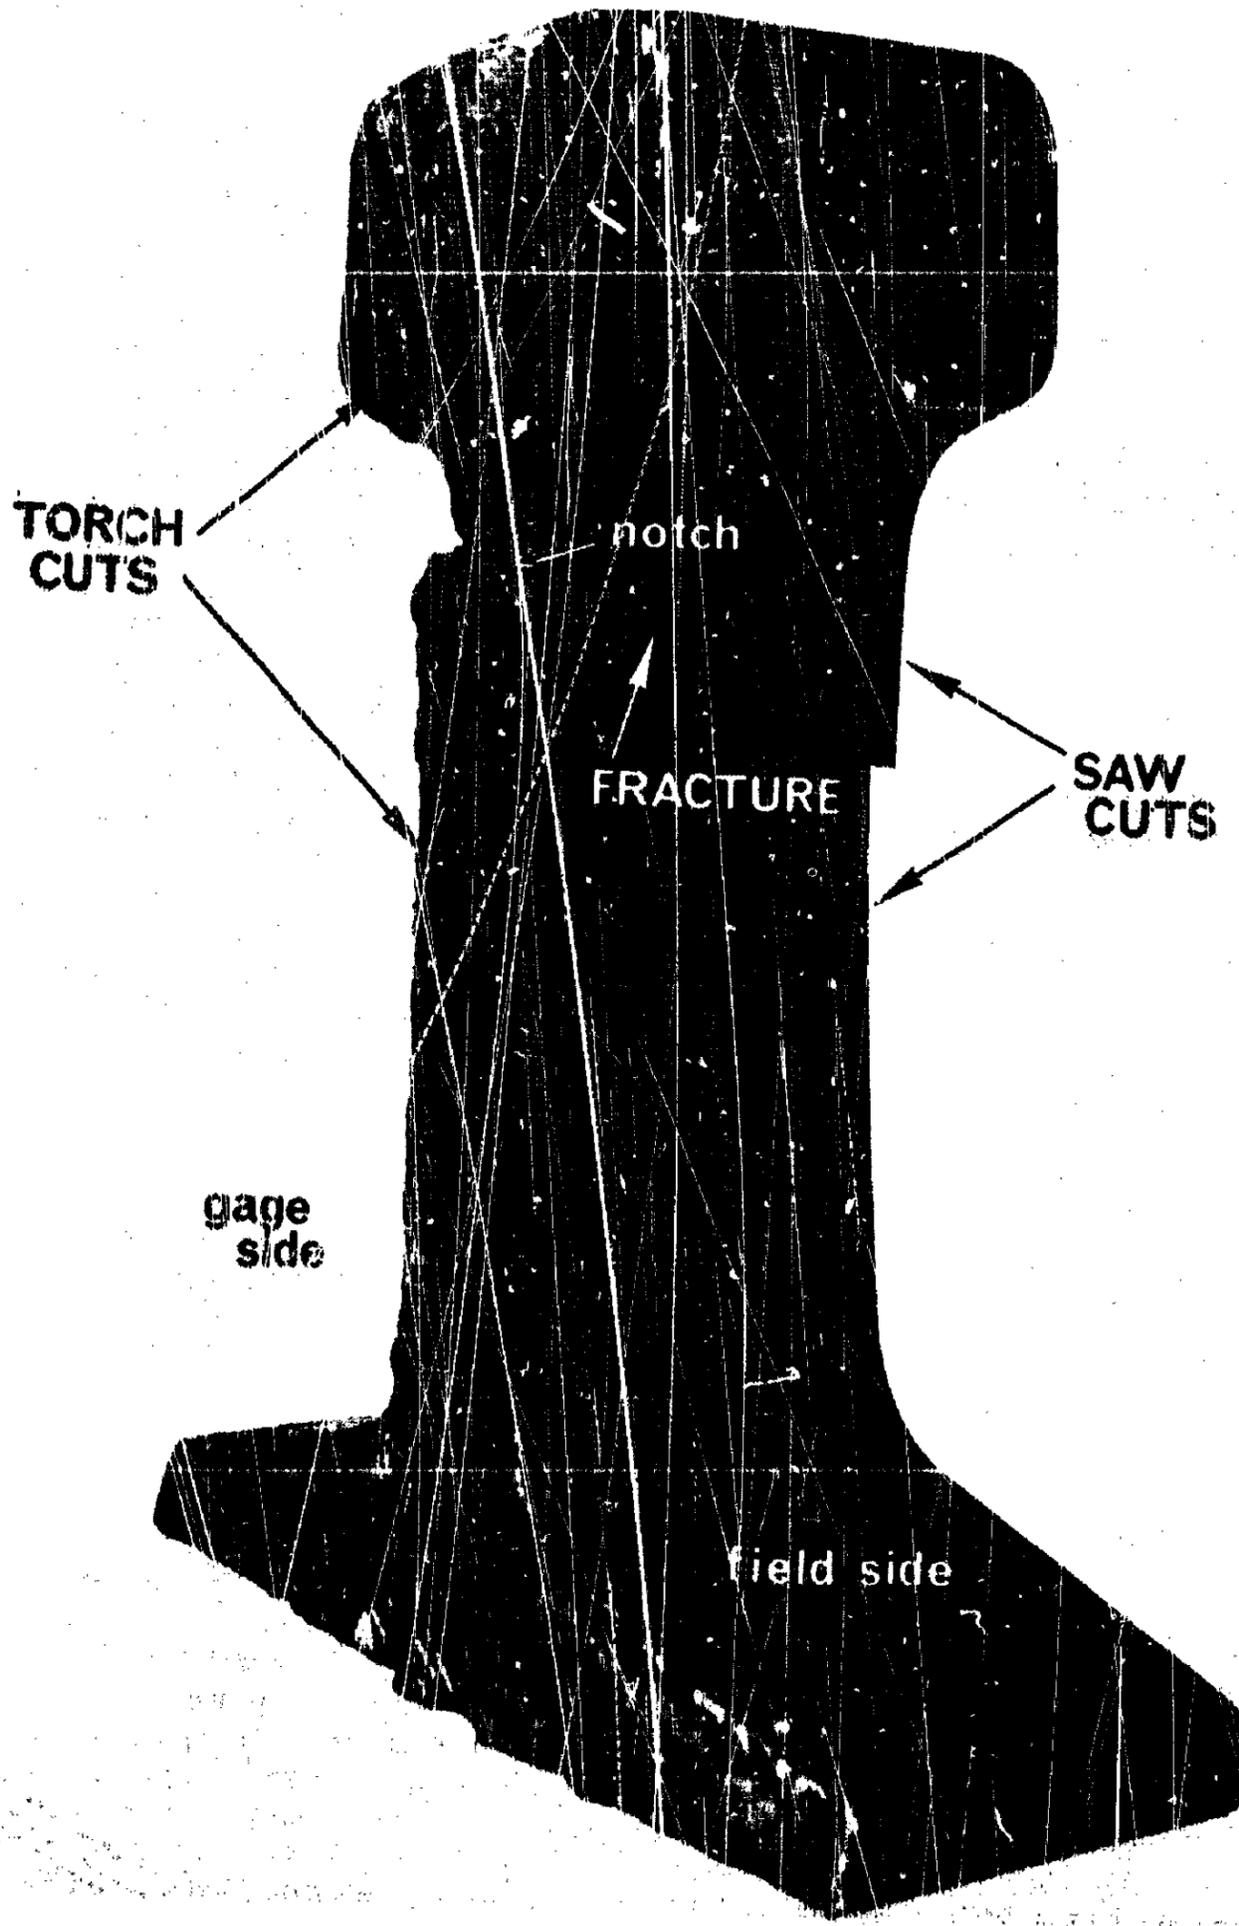
A section of the chrome-vanadium alloy rail containing numerous fractures, several locations of batterment, and the torch-cut rail end was taken from the accident site and sent by the MP to the Union Pacific (UP) Railroad Company testing facility for metallurgical analysis. ^{11/} Safety Board investigators present at the testing facility noted that all MP maintenance-of-way personnel who viewed the rail section, as well as the UP lab personnel who viewed the section, stated that the extent and manner of fracturing far exceeded that which any of them had witnessed previously. (See figure 4.) The torch-cut end of the rail displayed mismatched planes of torch-cut surfaces, with the mismatched planes offset by approximately one-eighth inch. (See figure 5.) Examination of the rail revealed that the line of fracture in the rail web intersected the mismatched planes of torch-cutting at the notch located at the juncture of those mismatched planes. Safety Board investigators noted thermal cracks at the intersection of the line of fracture in the rail web and the mismatched torch-cut planes. (See figures 6 and 7.)

Figure 5.--View of torch-cut rail end of chrome-vanadium alloy rail after the accident. The transverse saw cuts were made after the accident to separate the rail end pieces from the remainder of the rail.

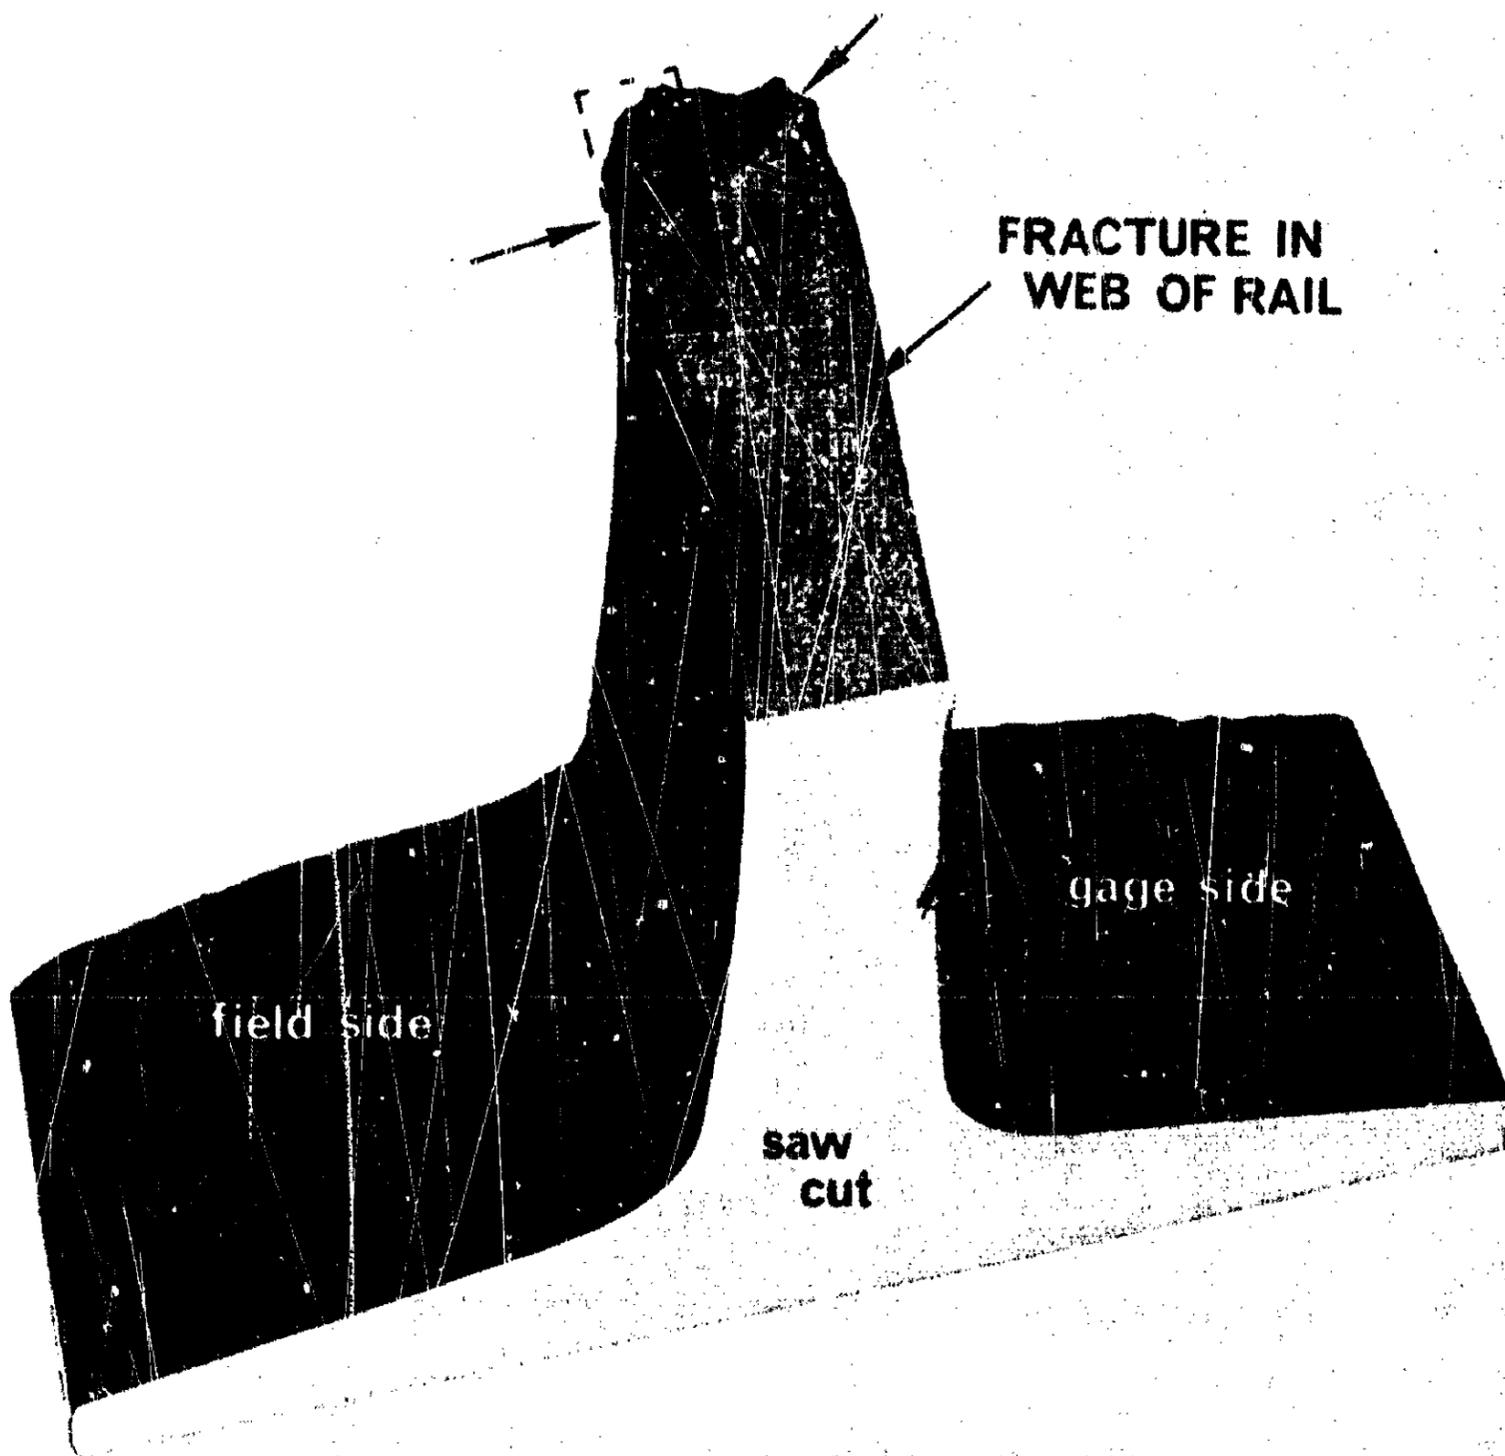
Figure 6.--View looking down on web fracture in lower portion of torch-cut rail end shown in figure 5. The arrows indicate the bottom of the notch created by the torch-cutting. The outlined area is shown in figure 7.

the rail web; the thermal crack at the torch-cut rail end probably served as the crack origin. The freight train which passed at 9:30 a.m. probably negotiated the temporary track repair successfully only because of its slower speed and resultant lower impact forces imposed on the rail joint. Further, recent tests performed by the AAR at its metallurgical testing facility indicate that the crack arrest characteristics of chrome-vanadium alloy rail are such that cracks travel four to eight times farther before arrest occurs, compared to standard carbon rail. It is therefore extremely unlikely that a crack which had initiated under the freight train could have existed without the rail fracturing severely until the passing of the passenger train.
