NATIONAL TRANSPORTATION SAFETY BOARD

RAILROAD ACCIDENT REPORT

**REAR END COLLISION
BETWEEN CONRAIL TRAINS
OIP1-6 AND ENPI-6X
NEAR SALTSBURG, PENNSYLVANIA
FEBRUARY 26, 1984**

NTSB/RAR-85/02

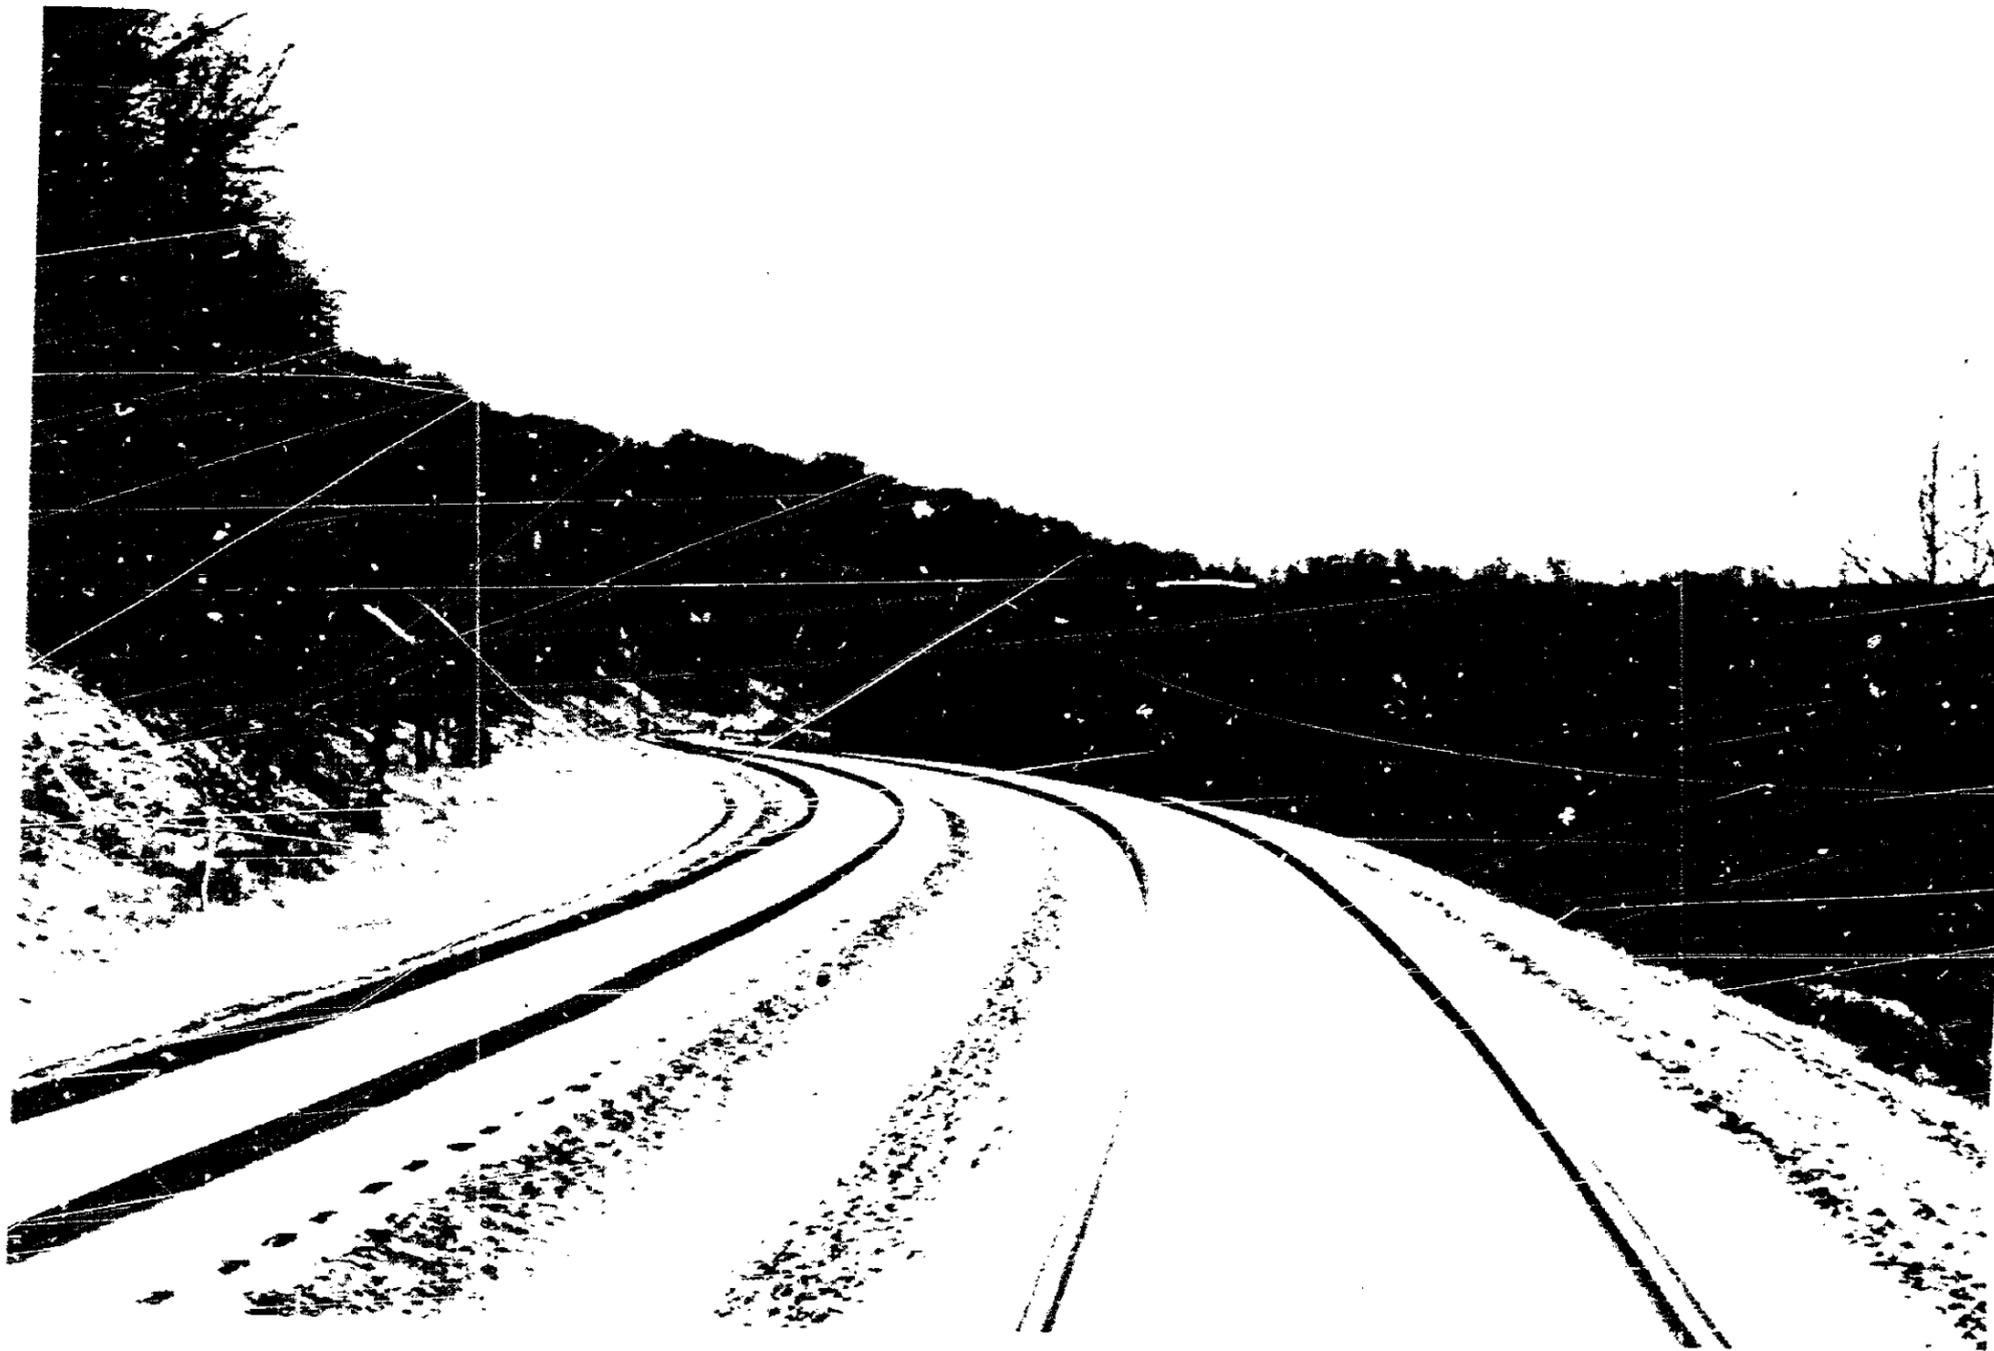
Figure 1.—No. 2 track on the right approaching the point of impact from the west.
Point of impact is on short length of tangent track between curves.

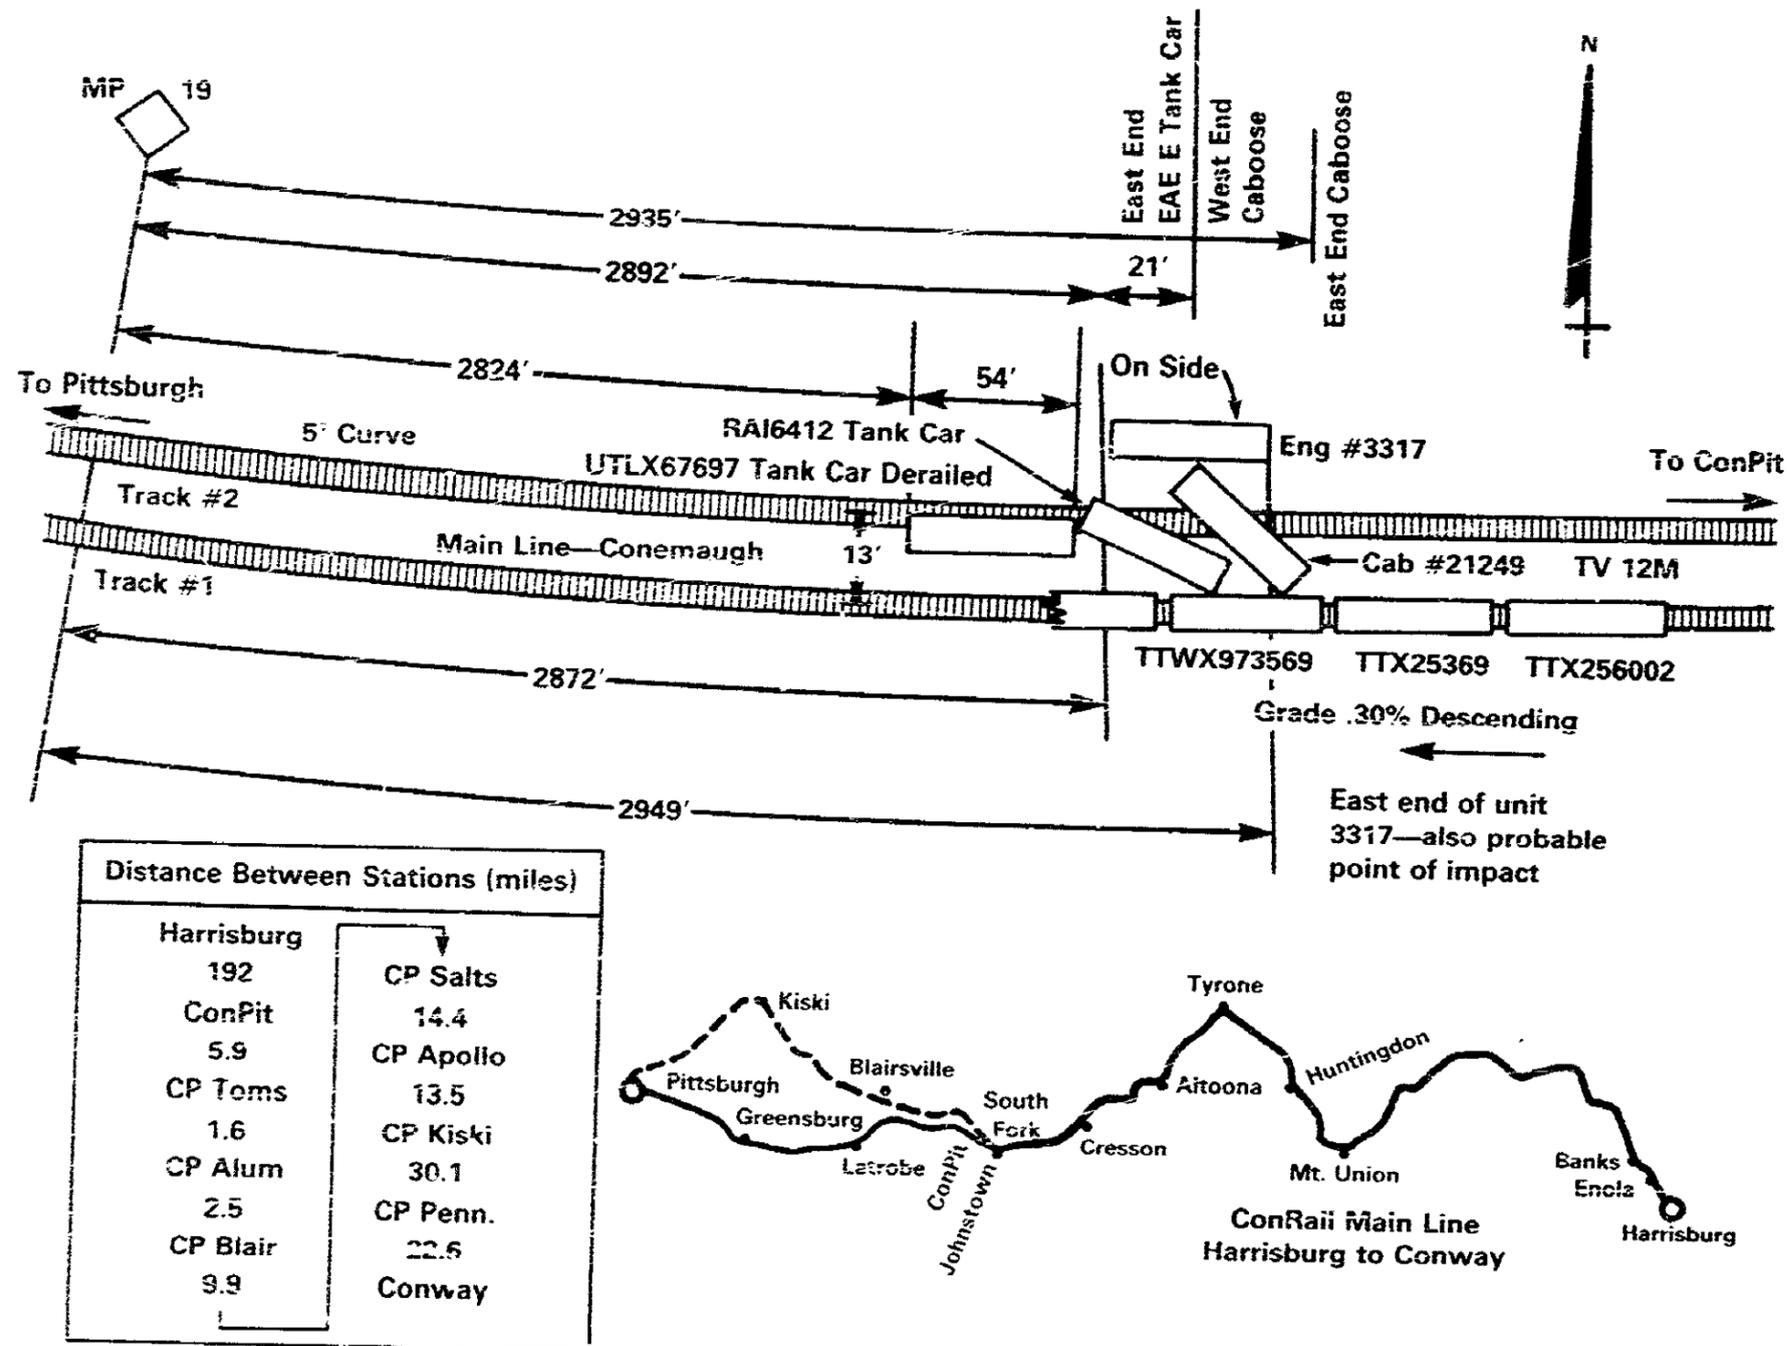
Figure 2.—Rear-end collision of Conrail trains OIPI-6 and ENPI-6X and involving train TV-12M at CP Salts.
