DERAILMENT OF
AMTRAK TRAIN NO. 81
THE SILVER STAR
ON THE SEABOARD SYSTEM RAILROAD
KITRELL, NORTH CAROLINA
MARCH 5, 1984

NTSB/RAR-85/03

**DERAILMENT OF AMTRAK TRAIN NO. 81
THE SILVER STAR
ON THE SEABOARD SYSTEM RAILROAD
KITTRELL, NORTH CAROLINA
MARCH 5, 1984**

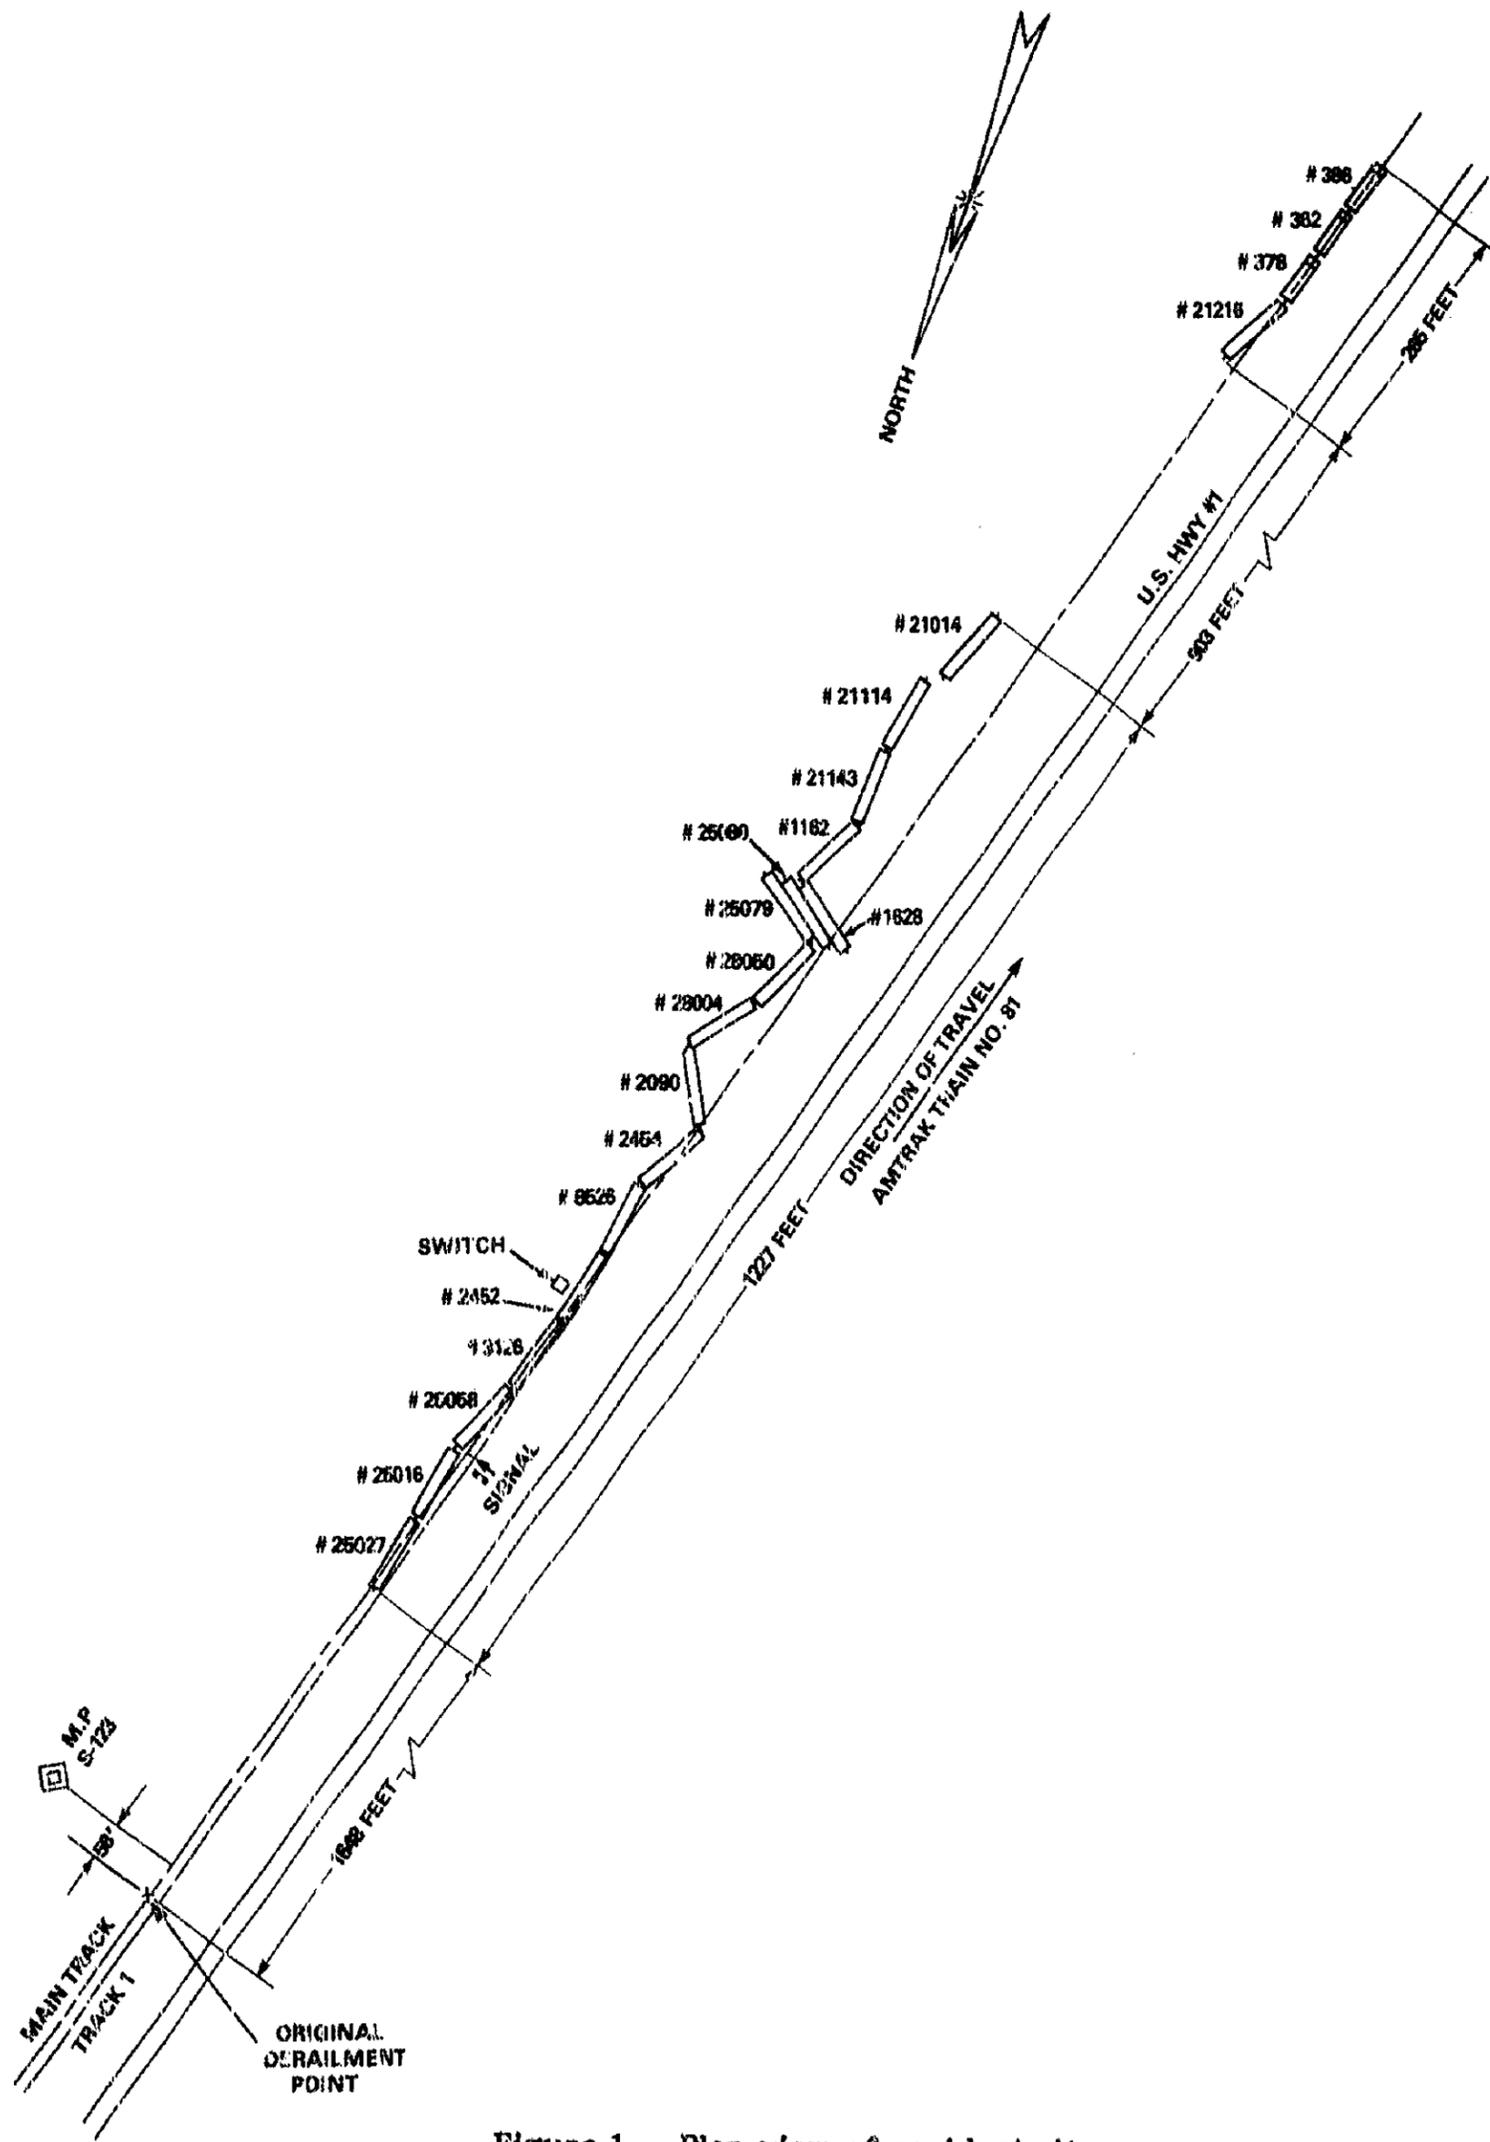
Figure 1.--Plan view of accident site.

The lead locomotive unit stopped at a point 3,998 feet south of MP S-123. The lead locomotive unit and the second unit were not derailed; the third locomotive unit was derailed but remained upright and coupled to the second locomotive unit. The first car in the train (Amcoach No. 21216) was derailed but remained upright and coupled to the third locomotive unit. The second car in the train (Amcoach No. 21014) was derailed and came to rest 903 feet north of the locomotive units and the first car. All of the remaining cars in the train were derailed. (See figure 1.) The engineer notified the chief dispatcher of the derailment by radio and asked for assistance. The traincrew reported inspecting the train en route and said that they neither saw sparks from the train nor observed anything unusual before the derailment.

In the vicinity of the general derailment, approximately 4,000 feet of track was damaged and about 1,000 feet was destroyed.

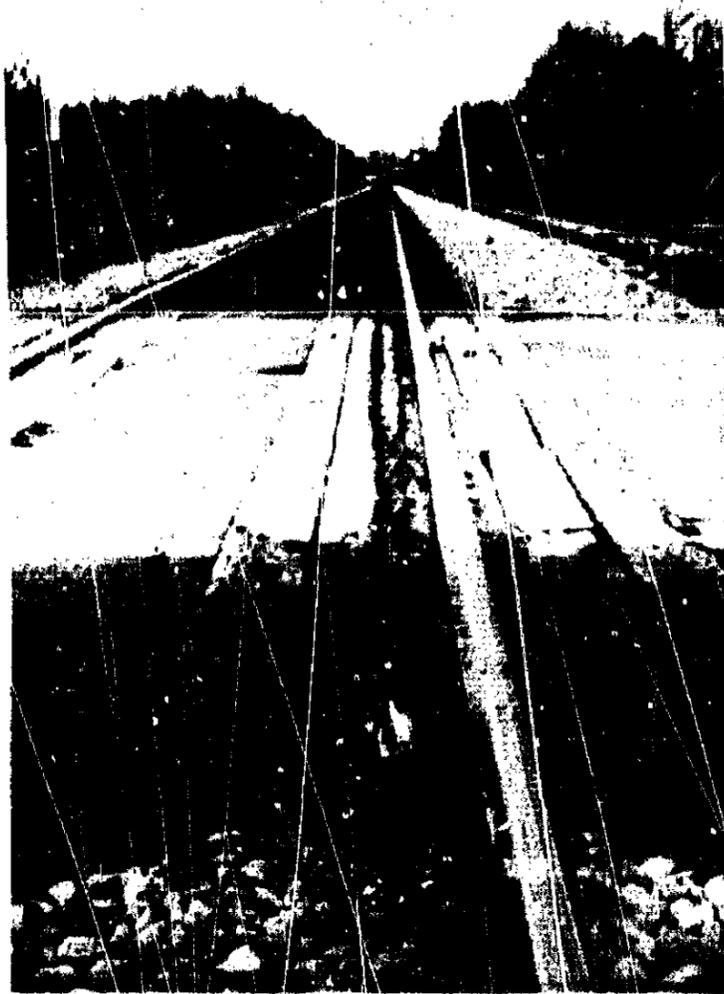
Figure 2.--View of grade crossing north of MP S-123.

The train was being operated in accordance with the operating practices of the SBD. The abrasion marks on the railroad grade crossing planks at Kittrell indicate that the locomotive axle broke north of Kittrell allowing the wheels to become out of gage and the

wheel flanges to strike and abrade the grade crossing planks. The fact that there were no marks on grade crossings north of Kittrell indicates that the axle failure probably occurred within 3 miles of the accident site. Wheel flange marks on the spikes and rail anchors indicate that the initial derailment of the No. 1 axle of Amtrak locomotive unit No. 378 occurred 58 feet north of MP S-123. The general derailment occurred when the derailed wheel on the broken axle struck the siding switch at MP S-123.

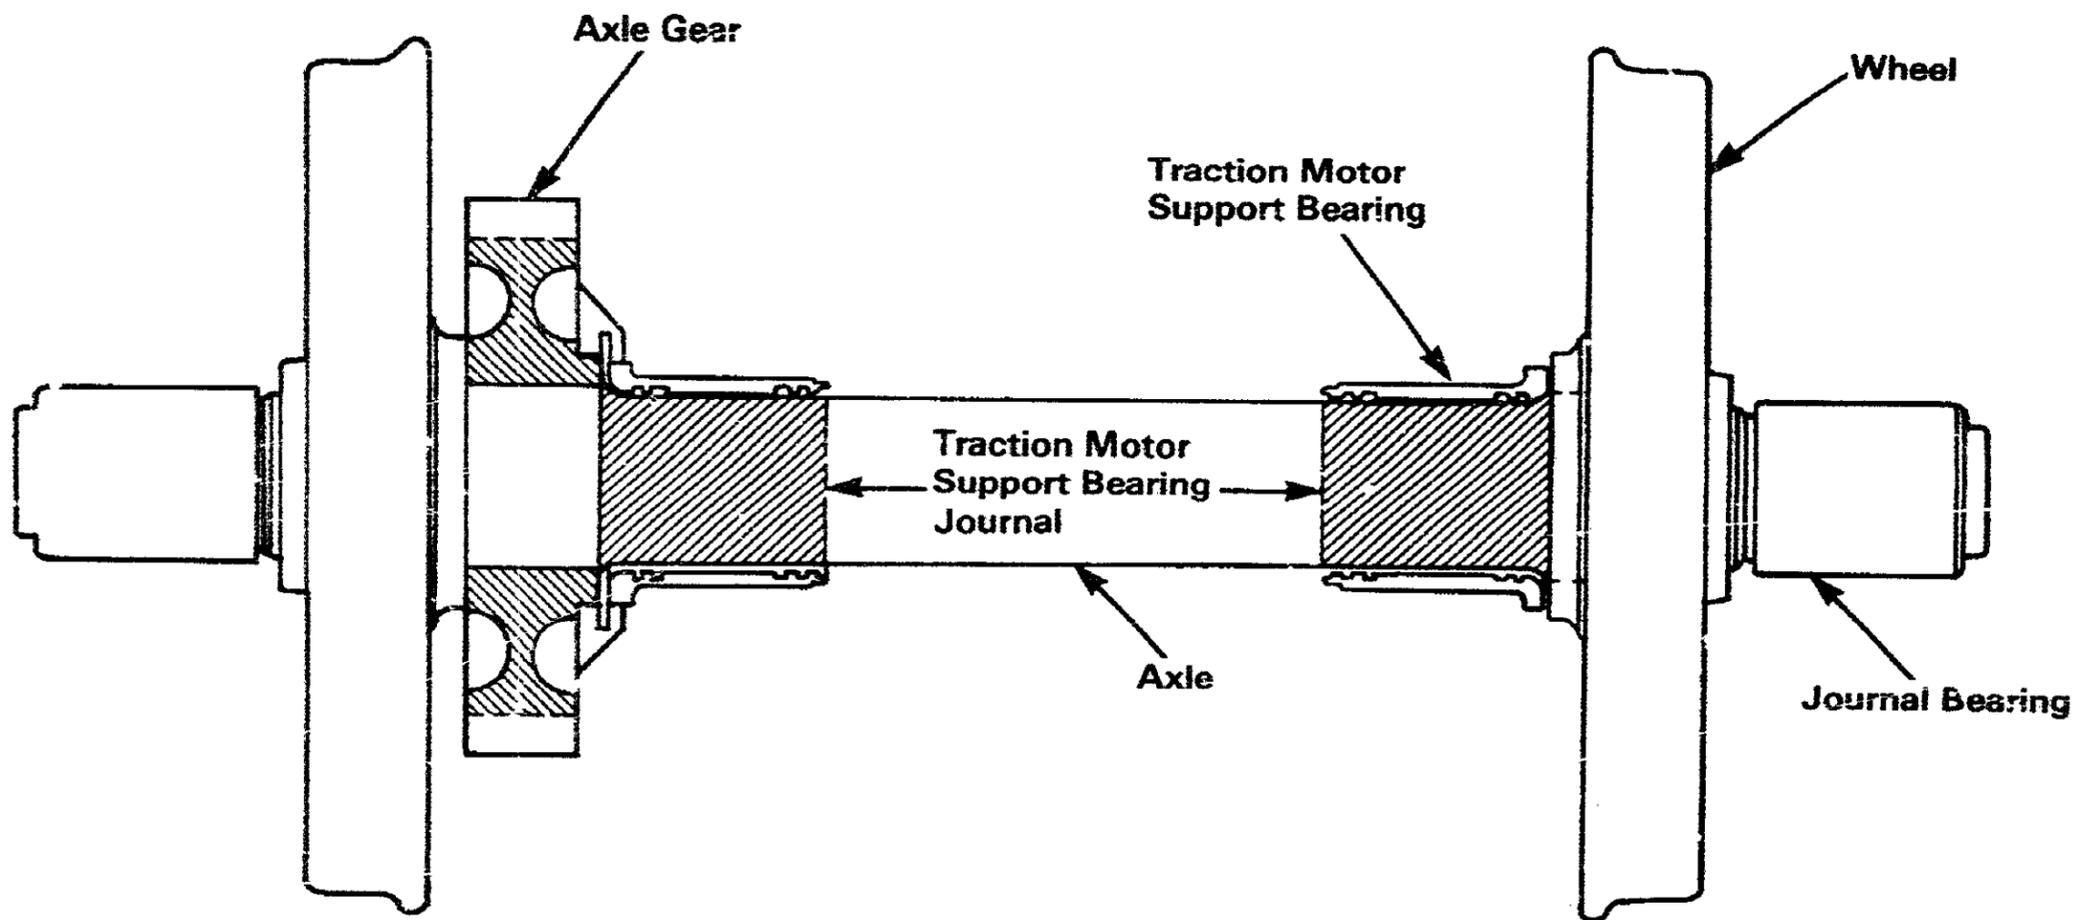
Postaccident inspection revealed that the No. 1 axle of the third locomotive unit (Amtrak No. 378) was broken on the pinion (left) end in the traction motor support bearing area. (See figure 3.) The bearing was destroyed, the lubricator wick was burned and charred, and the axle in the bearing area showed evidence of intense heat. The axle was broken at an uneven angle; the short end was 6 7/8 to 8 inches long when measured from the face of the axle gear hub. (See figure 4.) All other support bearings, lubricator wick assemblies, and axles on the locomotive unit were inspected and found to be lubricated and in good condition.

Figure 3.--Locomotive axle assembly showing gear and bearing locations.
