**NATIONAL  
TRANSPORTATION  
SAFETY  
BOARD**

**RAILROAD ACCIDENT REPORT**

**SEABOARD SYSTEM RAILROAD  
FREIGHT TRAIN FERHL  
DERAILMENT AND FIRE  
MARSHVILLE, NORTH CAROLINA  
APRIL 10, 1984**

**NTSB/RAR-85/05**

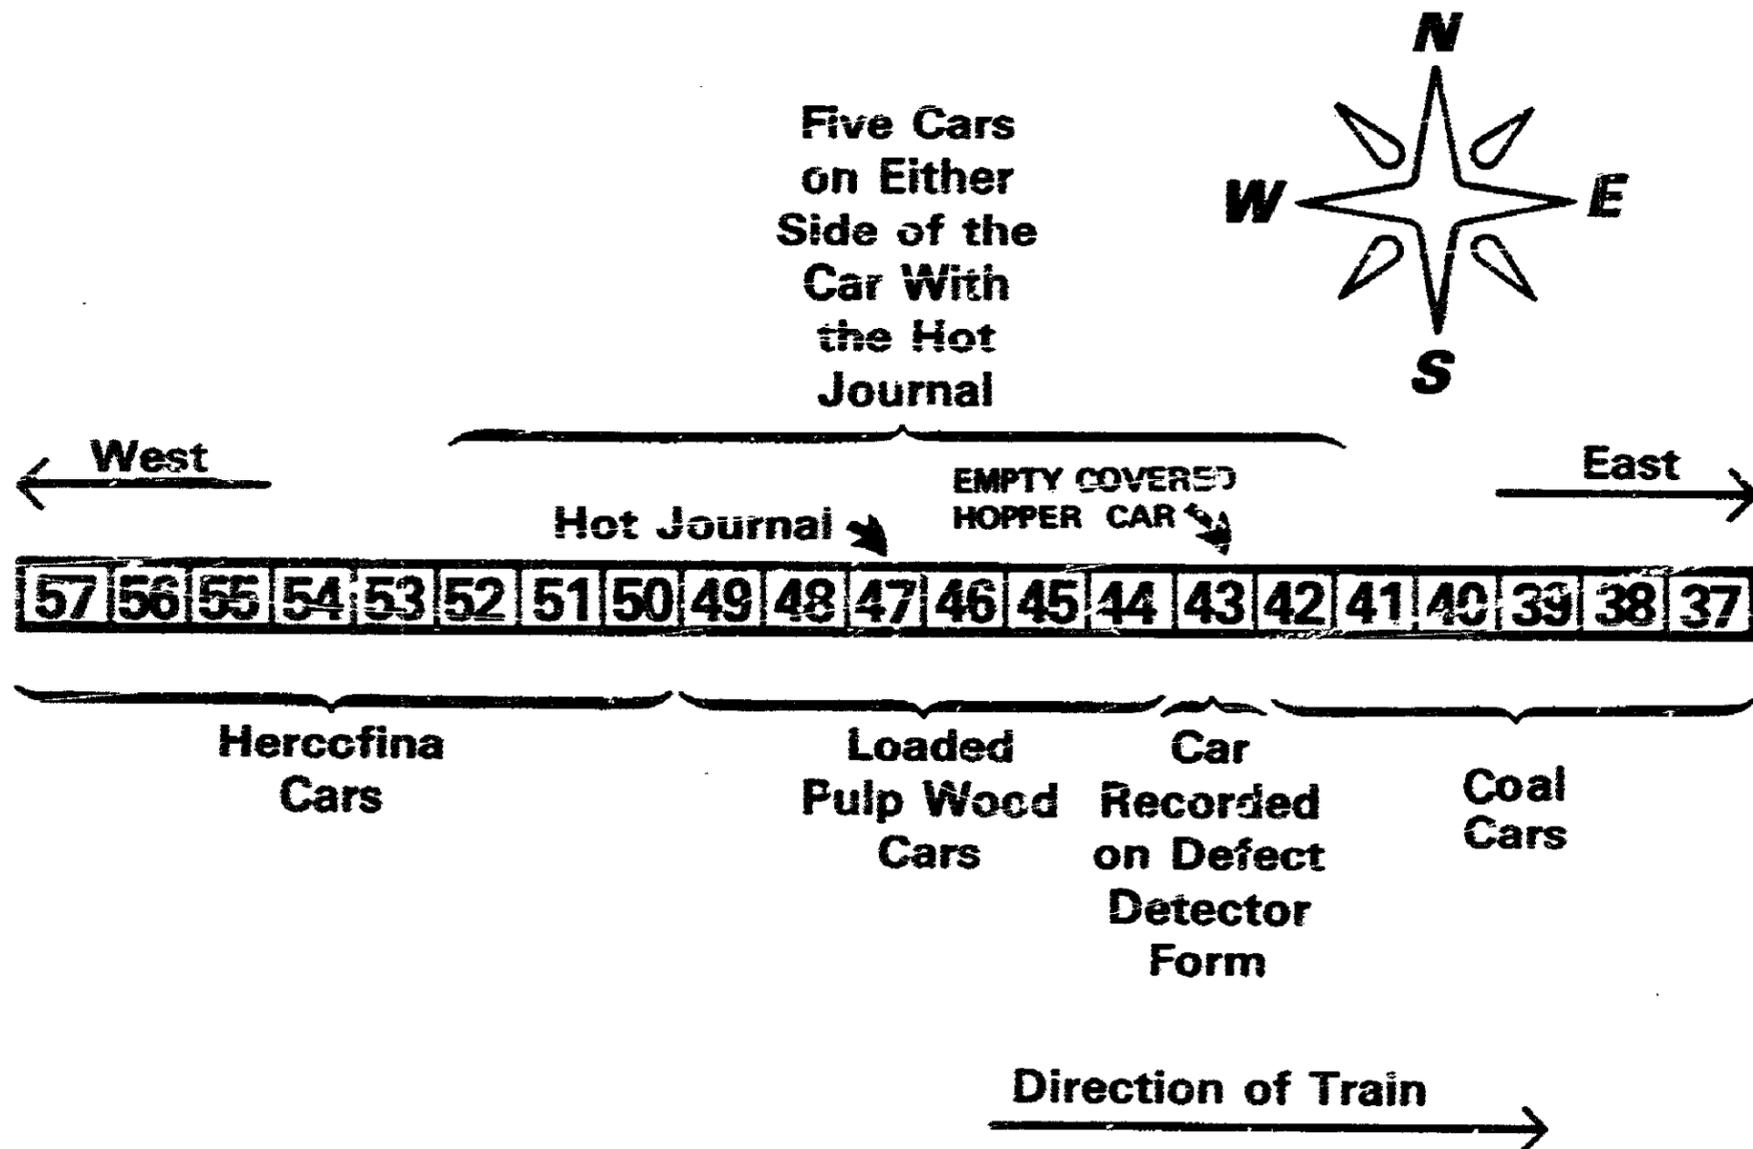
The train continued through the Charlotte Yard and Matthews, North Carolina, and passed a hotbox detector 2.1 miles east of Matthews. An alarm from the hotbox detector was received by the traincrew over the radio. The message advised that there were 362 axles in the train and that the journal on the left side of the 157th axle from the rear of the train was overheated. To determine which car to inspect, the front brakeman said he subtracted 4 axles for each of the three 6-axle locomotive units from 362 (the total number of axles in the train as stated by the alarm) and then subtracted 157 from the result. He divided the remainder by four, the number of axles on each freight car, and determined that the position of the car with the hot journal was the 47th car from the front of the train. (See figure 2.)

Figure 2.—Position of the cars near overheated journal in freight train FERHL at Charlotte and Matthews.

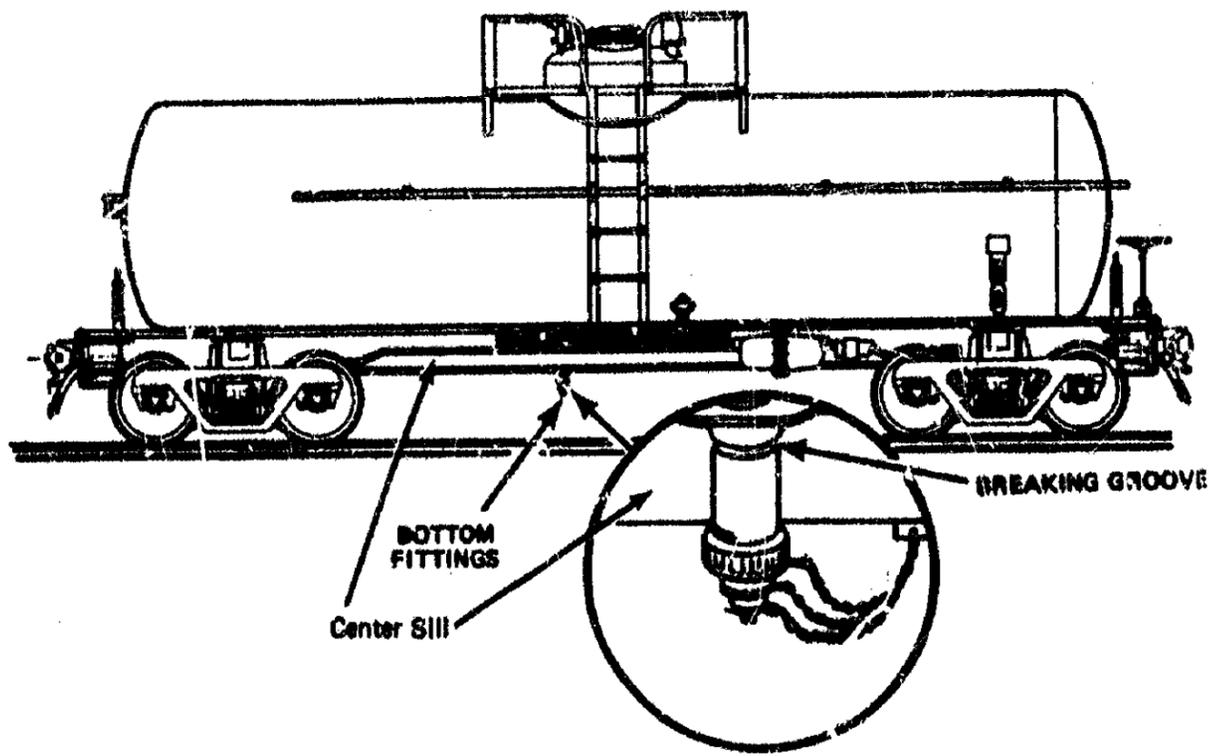
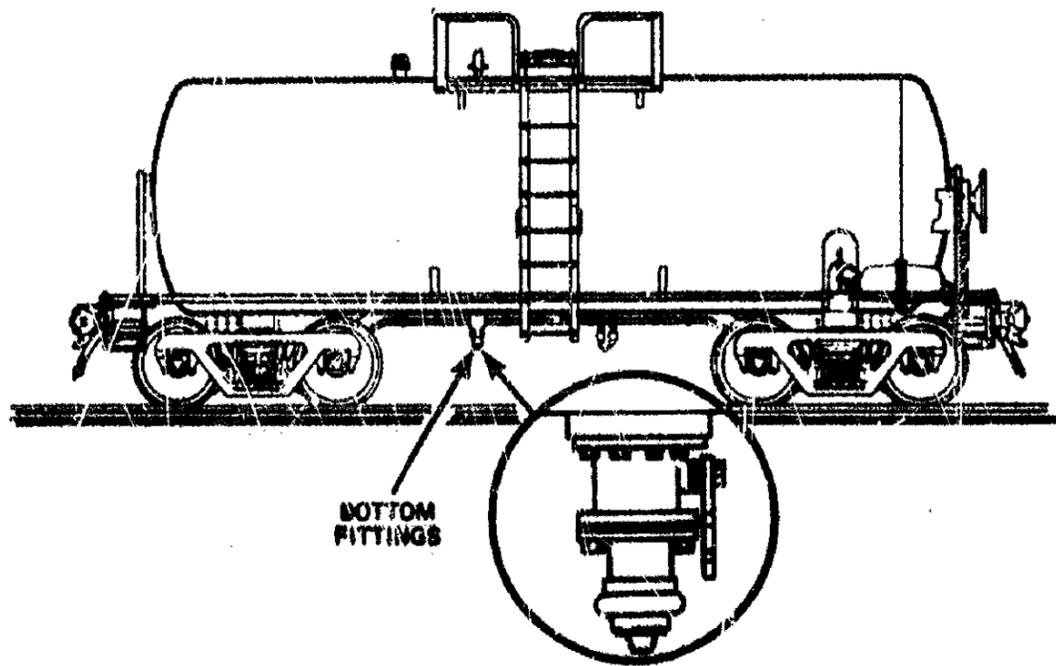
Tank Cars.--In the early 1960's, tank car manufacturers began building tank cars without continuous, full-length center sills. These so-called "stub sill" tank cars use the tank shell to support the loads imposed by the weight of the materials in the tank as well as to absorb the train draft and buffing forces. The bottom outlet and other bottom discontinuities that formerly were protected during derailments by the center sill now were exposed. (See figure 3.) The Federal Railroad Administration (FRA) requirements for protecting bottom outlets of cars with center sills continue to require that breakage grooves in outlets be above the bottom flange of the center sill; however, stub-sill tanks are allowed to have the required breakage grooves up to 15 inches below the bottom of the tank shell (49 CFR 179.200-17).

Figure 3.--Car with continuous full-length center sill (top) and car without continuous full-length center sill (bottom).

In this accident the tank cars transporting methanol were of the "stub sill" design, and their bottom outlets were struck during the derailment. The two tank cars that were not breached had internal valves, and their bottom outlet nozzles had breaking grooves that had been cut into the nozzles near the bottom of the tank. When these nozzles were broken from the tank, the valve seat was not destroyed, nor was a shearing force applied to the tank shell where the valve was attached; consequently, the methanol was contained safely by the tank. The two other tank cars containing methanol had bottom outlet nozzles less than 6 inches in length for which breaking grooves or other protection were not required. When these nozzles were struck during the derailment, the stress was transferred to the tank shells which were torn open, releasing their contents.
