NATIONAL TRANSPORTATION SAFETY BOARD

RAILROAD ACCIDENT REPORT

**HEAD-ON COLLISION OF
BURLINGTON NORTHERN RAILROAD
FREIGHT TRAINS EXTRA 6760 WEST AND
EXTRA 7907 EAST
NEAR MOTLEY, MINNESOTA
JUNE 14, 1984**

NTSB/RAR-85/06

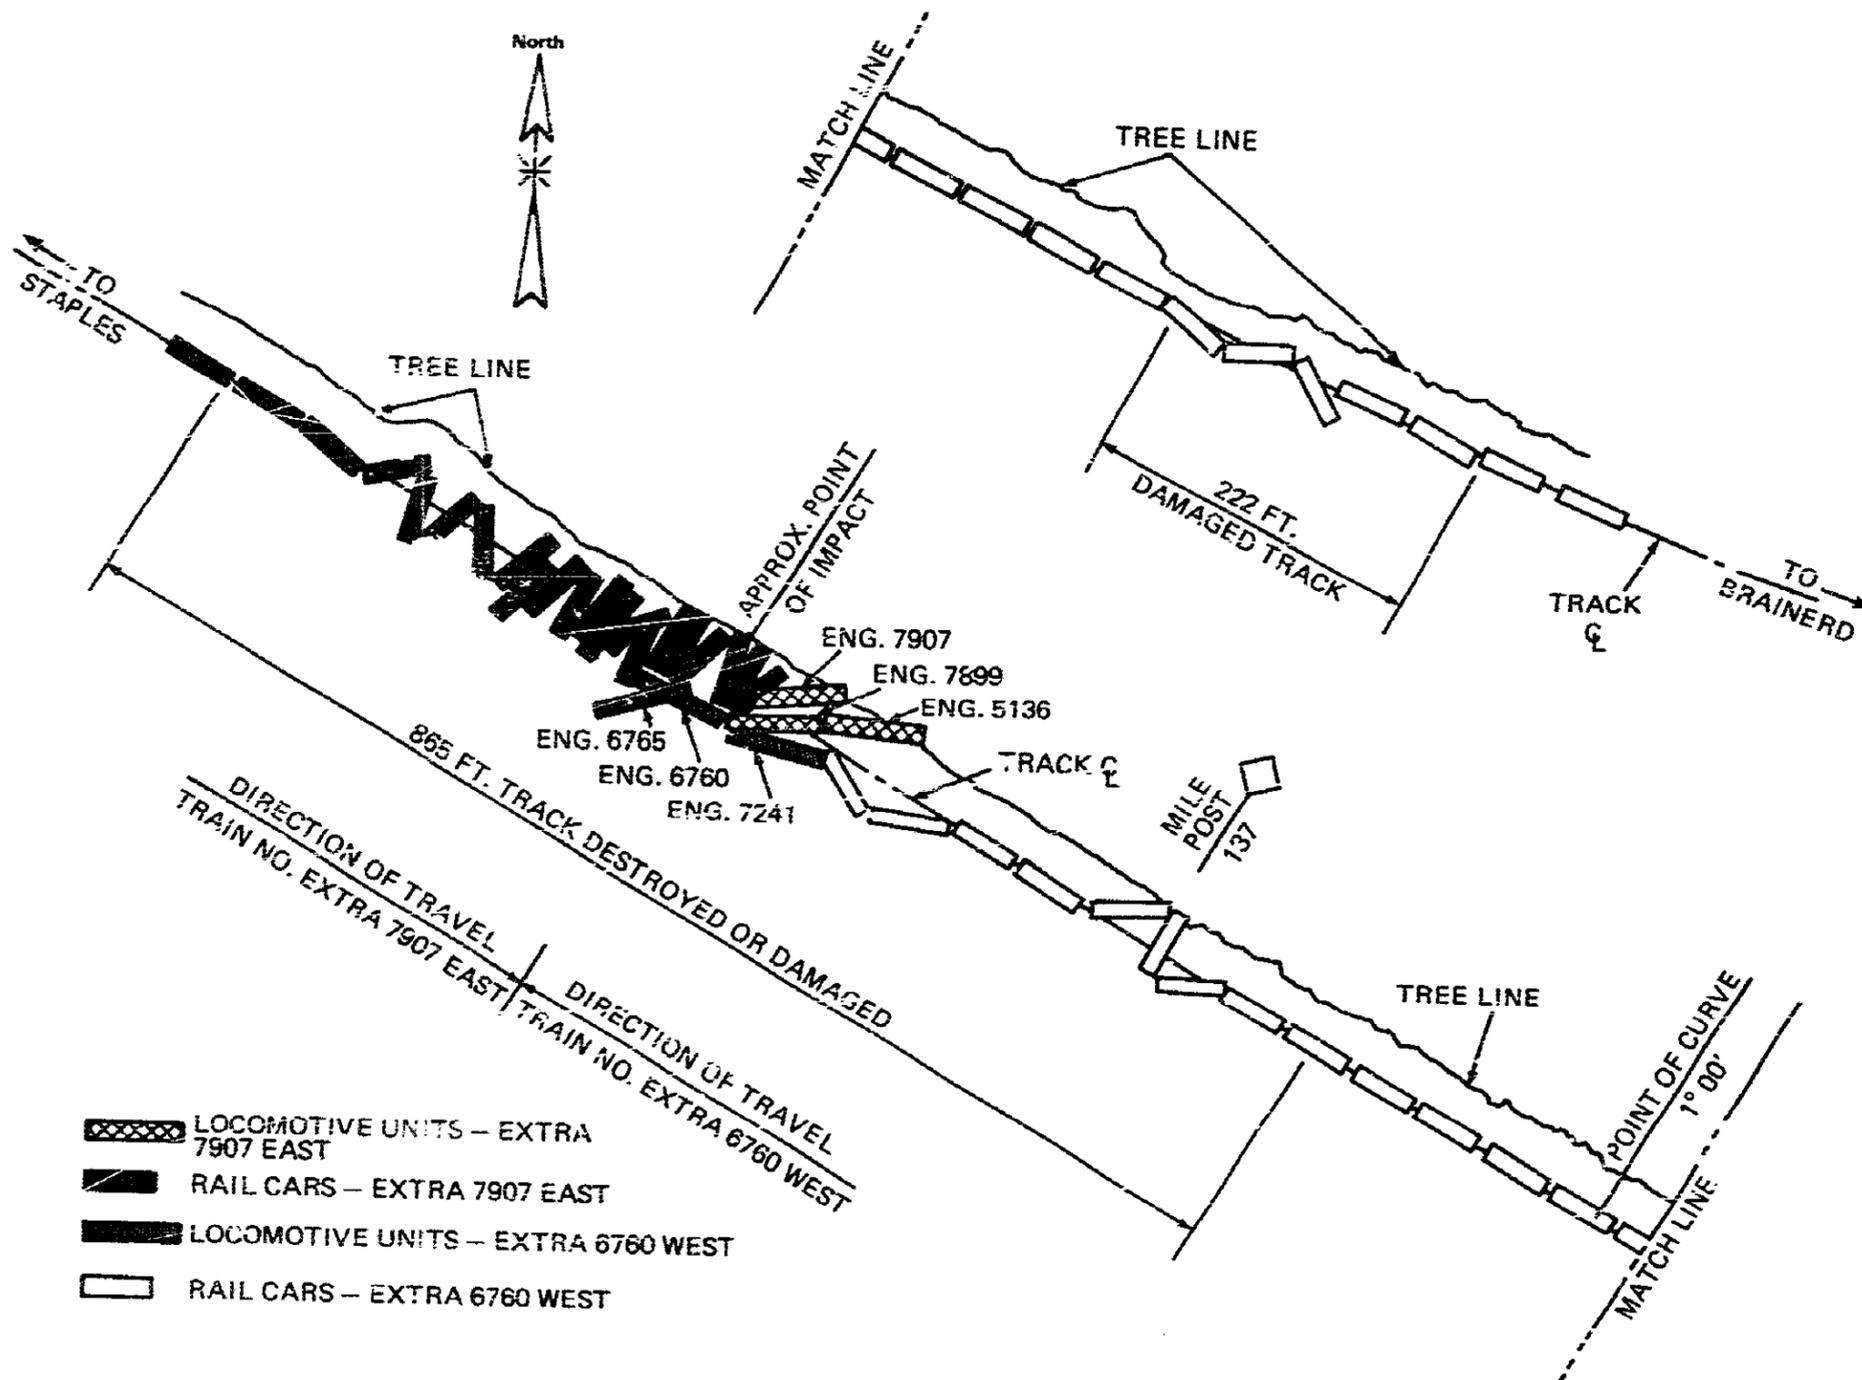
Figure 3.--Plan view of accident site.

When train Extra 6760 West passed through Brainerd, the engineer slowed the train for a 10-mph speed restriction through that vicinity. After having passed Brainerd, the engineer accelerated the train to about 49 mph. (The maximum speed at this location for an empty coal train is 49 mph.) As the locomotive of train Extra 6760 West proceeded through a 1° curve to the right and neared tangent track, the head brakeman noticed light reflecting on the rails ahead of his train. He further stated that he then "... could see another engine that we didn't have (train) orders on, and I didn't know if that engine was in a siding for awhile. It took me awhile to remember the track and realize that there was no siding in that area." The head brakeman stated that he and the engineer applied the emergency brakes at the same time and that he then stepped out onto the front platform of his locomotive unit. He further stated "... I could see it (the oncoming locomotive) was moving, I was reading engine numbers and I decided I better get off, and I jumped." The head brakeman was not able to ascertain whether the engineer also had jumped before the trains collided head on, about 1:00 a.m., near Motley, Minnesota. (See figure 3.)
