# NATIONAL TRANSPORTATION SAFETY BOARD

## RAILROAD ACCIDENT REPORT

VINYL CHLORIDE MONOMER  
RELEASE FROM A  
RAILROAD TANK CAR AND FIRE  
FORMOSA PLASTICS CORPORATION PLANT  
BATON ROUGE, LOUISIANA  
JULY 30, 1983

NTSB/RAR-85/08

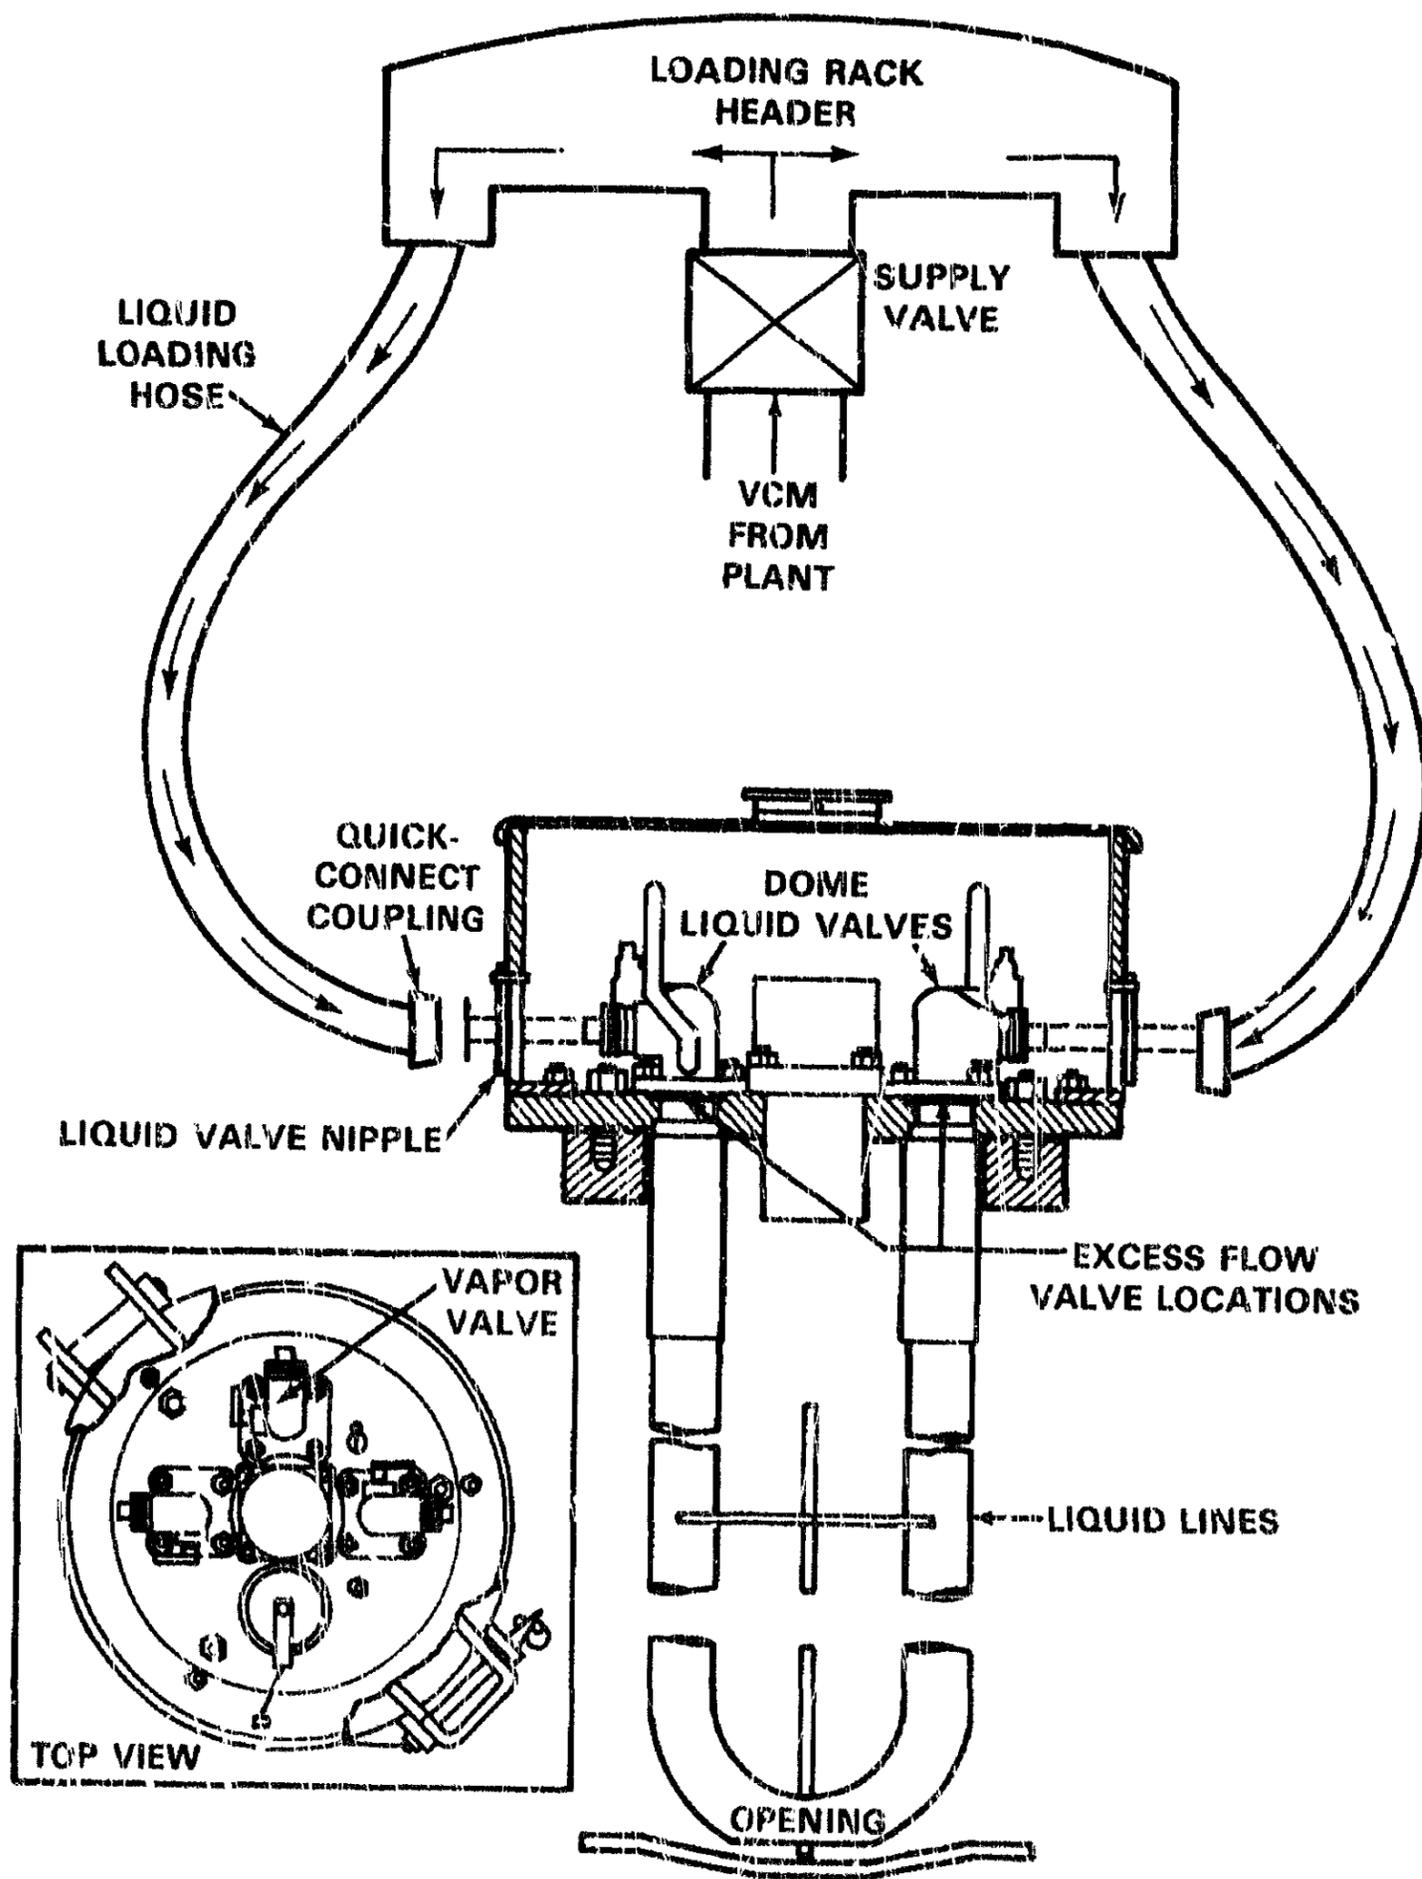
Figure 1.--Side view of tank car with liquid loading hoses attached for loading, and top view (inset) of tank car shown without manway bonnet cover.

Following the accident, investigators found that the safety valve 4/ (see figure 1) on the tank car at station No. 6-2 did not activate during the fire. Loader-1 had laid the seal used to secure the manway bonnet cover on top of the safety valve before the accident, and the seal was not blown away as it would have been if the safety valve had released. Investigators also found that the liquid loading and vapor hoses had been removed from the tank cars at station Nos. 5-1 and 6-1 and that all of the valves and manway covers on these tank cars had been closed before the accident.

Both tank cars had two internal liquid lines through which chemicals could be loaded. The liquid lines extended into the tank from the manway entrance at the car dome. (See figure 1.) Each liquid line was fitted at the manway entrance with a 2-inch-diameter, ball-type, steel-body angle valve containing a stainless steel ball. Directly under each liquid valve was a 3-inch-diameter excess flow valve. Each tank car also contained a vapor line through which chemical vapors could be vented during loading. The vapor line extended into the tank from the manway entrance. The vapor line was fitted at the manway entrance with a 2-inch-diameter, steel-body angle valve containing a stainless steel ball. Directly under the vapor valve was a 2-inch-diameter excess flow valve. Both cars were equipped with a safety valve and were stenciled to indicate that the valve was set at 247 psi. Both tank cars also were equipped with a sampling line, a gauging device, and a thermometer well at the manway entrance.

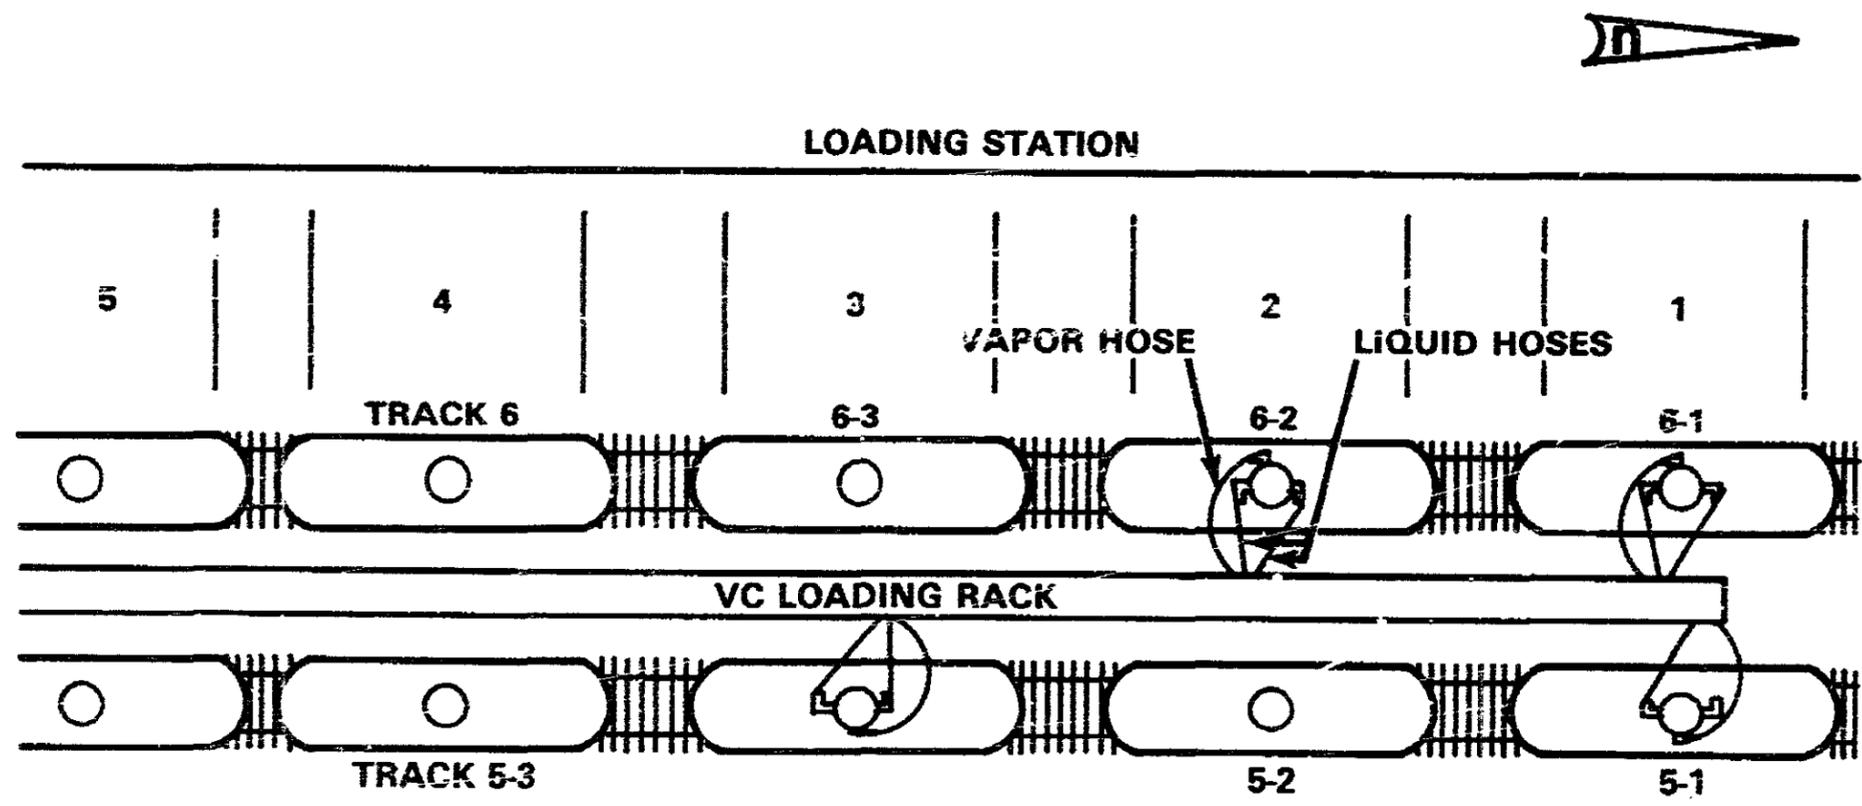
Figure 2.—Tank car locations and hose attachments when loader-1 stopped working at the loading rack.

Loader-2 said that after loader-1 left, he crossed over the bridge from the loading rack onto the dome of the tank car located at station No. 6-2 (see figure 2) and stopped to look at the early morning sky. Loader-2 said that, as he did so, he was struck on the back by one of the VCM liquid loading hoses, which had come loose from its attachment to the tank car. (See figure 1.) Seeing pressurized VCM pouring from the liquid valve nipple and knowing that VCM is combustible, is carcinogenic, and freezes the skin on contact, he ran to the end of the tank car and slid down the side of the car to the ground below. He did not use the bridge from the tank dome to the loading rack to escape because the loose hose was between his position on the tank car and the bridge. The sudden outward flow of VCM was not stopped by the tank car's excess flow valve.<sup>3/</sup> (See figure 1.) VCM accumulated on the ground below and between the tank cars at station Nos. 6-2 and 5-2 and was ignited by an undetermined source; a large billowing fire ensued. VCM spraying from the liquid valve nipple of the tank car at station No. 6-2 was ignited and, because of the angle of the valve nipple, burning VCM sprayed like a torch onto the tank car at station No. 5-2. When the other liquid loading hose on the tank car at station No. 6-2 was burned off, burning VCM also began spraying onto the tank car at station No. 5-2 from the car's other liquid valve nipple.
