NATIONAL TRANSPORTATION SAFETY BOARD

RAILROAD ACCIDENT REPORT

DERAILMENT OF
AMTRAK PASSENGER TRAIN NO. 60,
THE MONTREALER, ON THE
CENTRAL VERMONT RAILWAY
NEAR ESSEX JUNCTION, VERMONT
JULY 7, 1984

NTSB/RAR-85/14

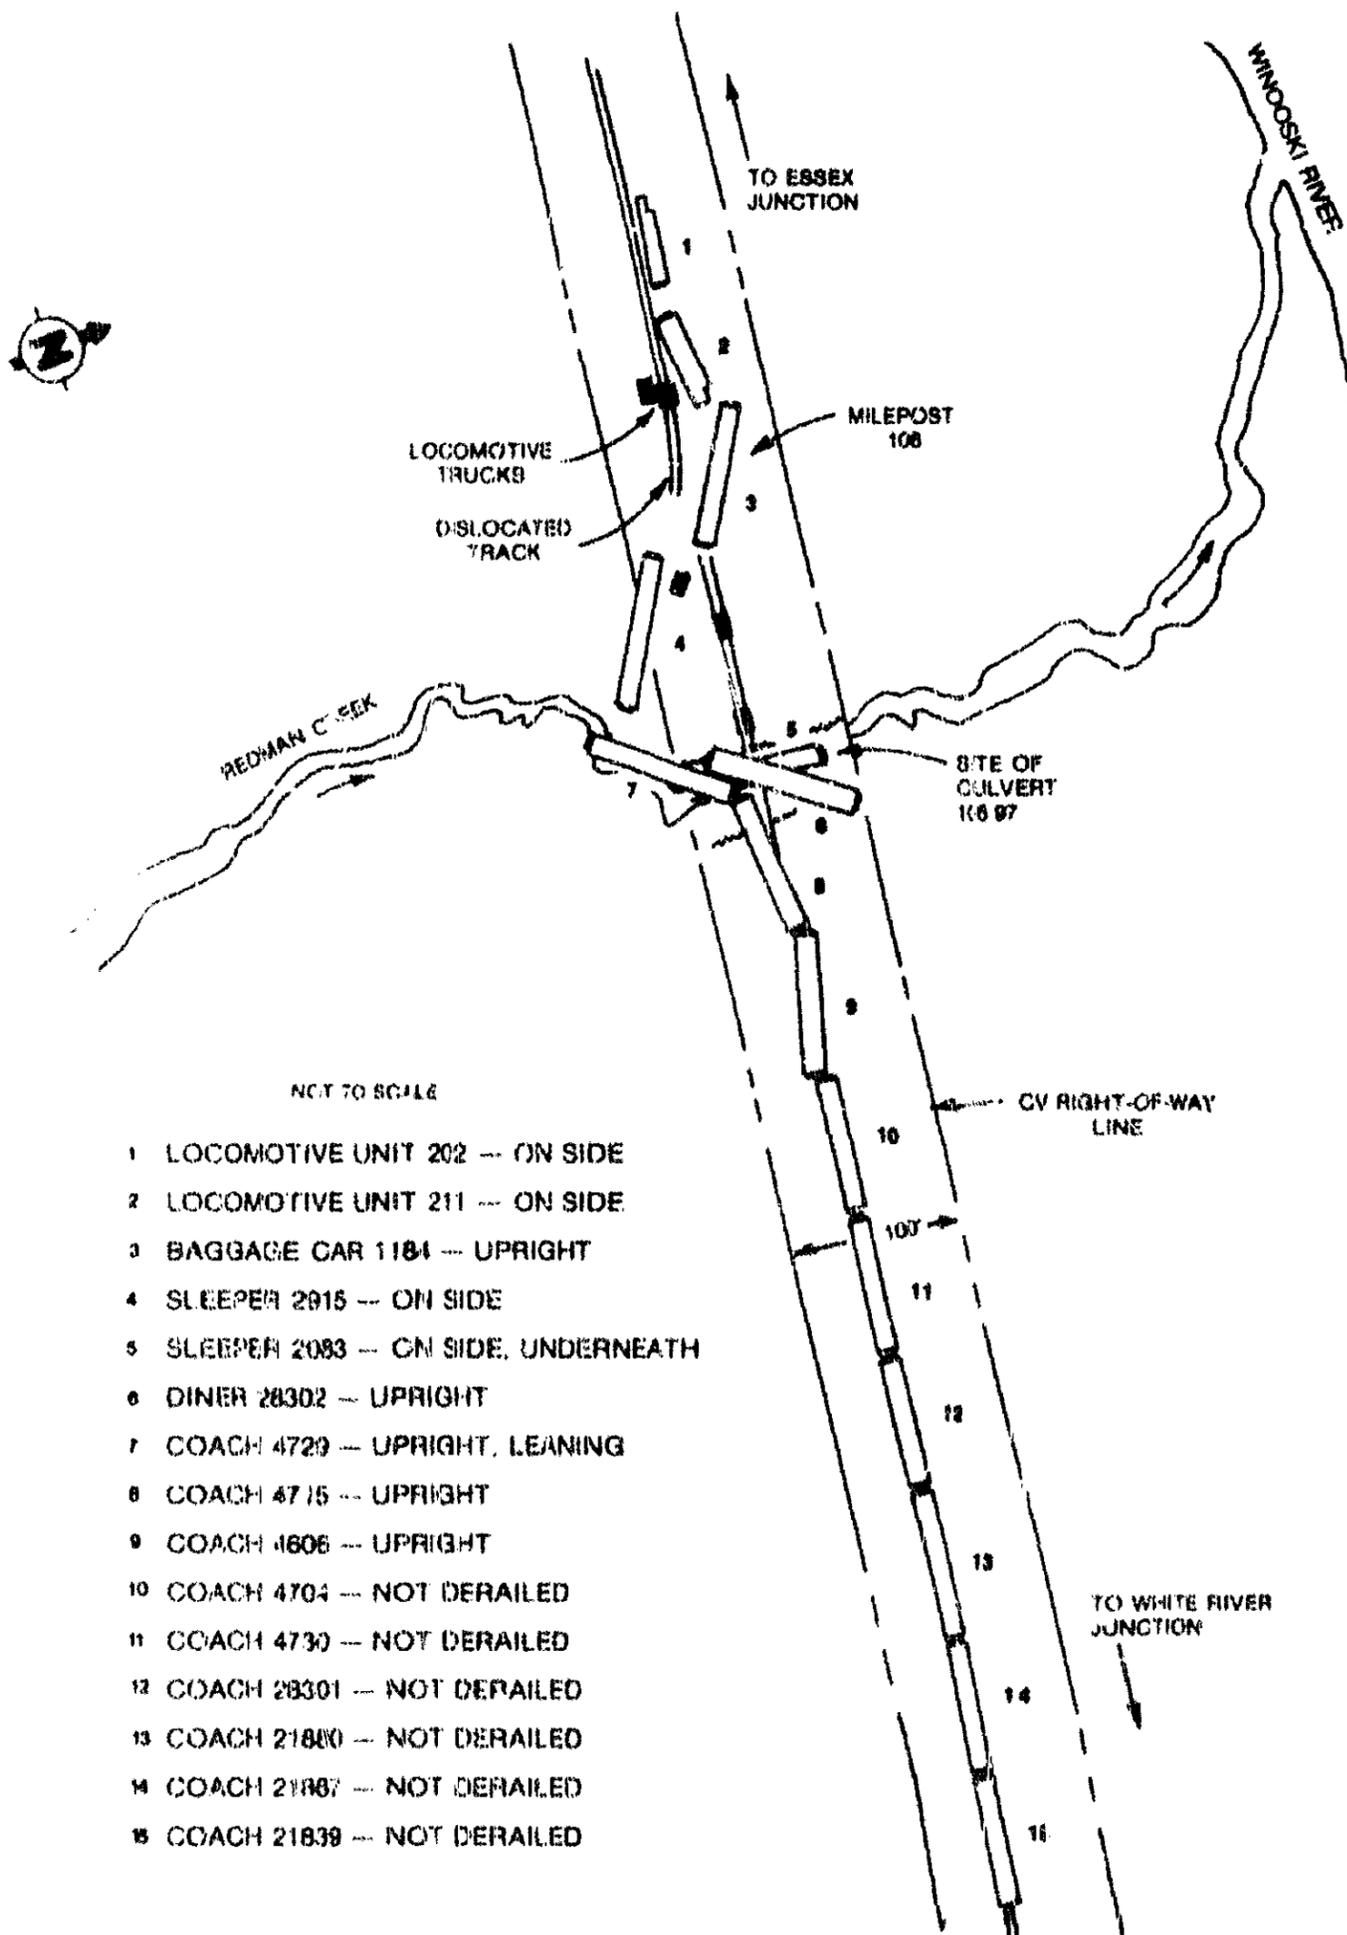
Figure 1.--Plan view of wreckage distribution.

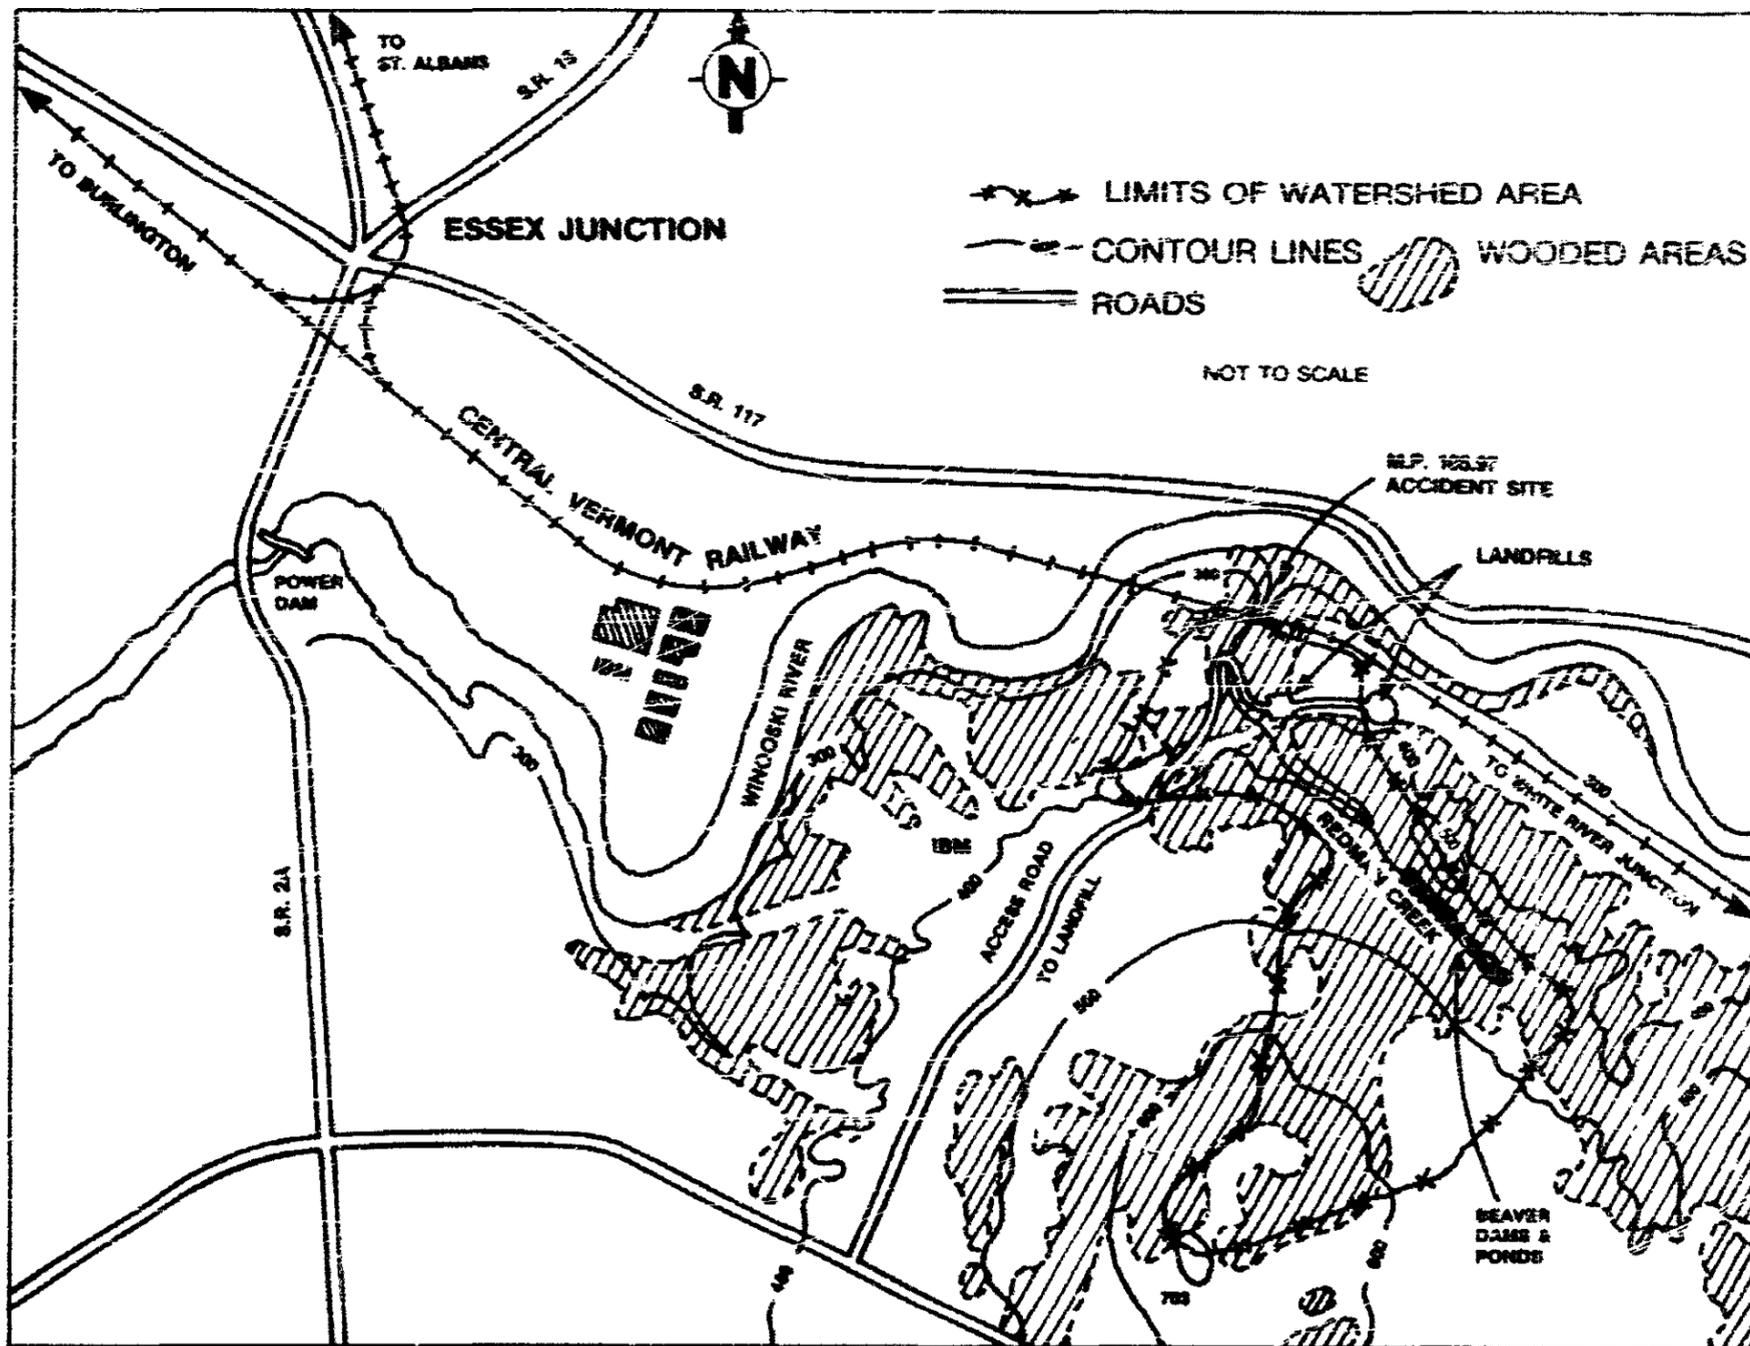
The upper 1,500 to 2,000 feet of Redman Creek consisted of ponds formed by a series of 11 or 12 beaver dams. The nearest of these ponds was 2,000 to 2,500 feet east of the railroad culvert; the main storm track passed over or was a short distance east of the beaver ponds. The largest pond was about 150 feet wide and, when full, had a maximum depth of about 6 feet. (See figure 8.) Only this pond could be seen from the air; the others were concealed by overhanging trees. According to a hydrologist who surveyed the stream course, at least 150,000 cubic feet of water may have been impounded by the beaver dams. The ponds and dams were discovered 5 days after the accident by investigators documenting evidence of high water along the stream course. The dams appeared to have been recently overtopped and ruptured, and beavers had already repaired most of the damage. The stream banks downstream from the beaver dams were severely eroded. Above the banks, high grass was flattened in a downstream direction, and there was much accumulation of silt and debris from the beaver dams.

The Safety Board's investigation revealed that the existence of the beaver colony on Redman Creek was unknown to CV maintenance forces or even to local residents who trapped beavers. A highly detailed topographical map of the area, prepared from aerial photographs in 1983, showed only the largest beaver pond. Beavers are common in Vermont, and in the past, it had been necessary for CV maintenance forces to destroy beaver dams on streams crossed by the railroad. According to the fireman who was operating train No. 60 at the time of the accident, in 1978, the CV had destroyed a large beaver dam across Redman Creek immediately upstream from the railroad's culvert and had destroyed the beavers to prevent their rebuilding the dam. The dam was on the

Figure 7.-- Plan view of Reiman Creek and its watershed area.
