NATIONAL TRANSPORTATION SAFETY BOARD

RAILROAD ACCIDENT REPORT

**REAR-END COLLISION OF TWO
GREATER CLEVELAND
REGIONAL TRANSIT AUTHORITY
RED LINE RAPID TRANSIT TRAINS
NEAR THE 98TH STREET STATION
CLEVELAND, OHIO
JULY 10, 1985**

NTSB/RAR-87/01

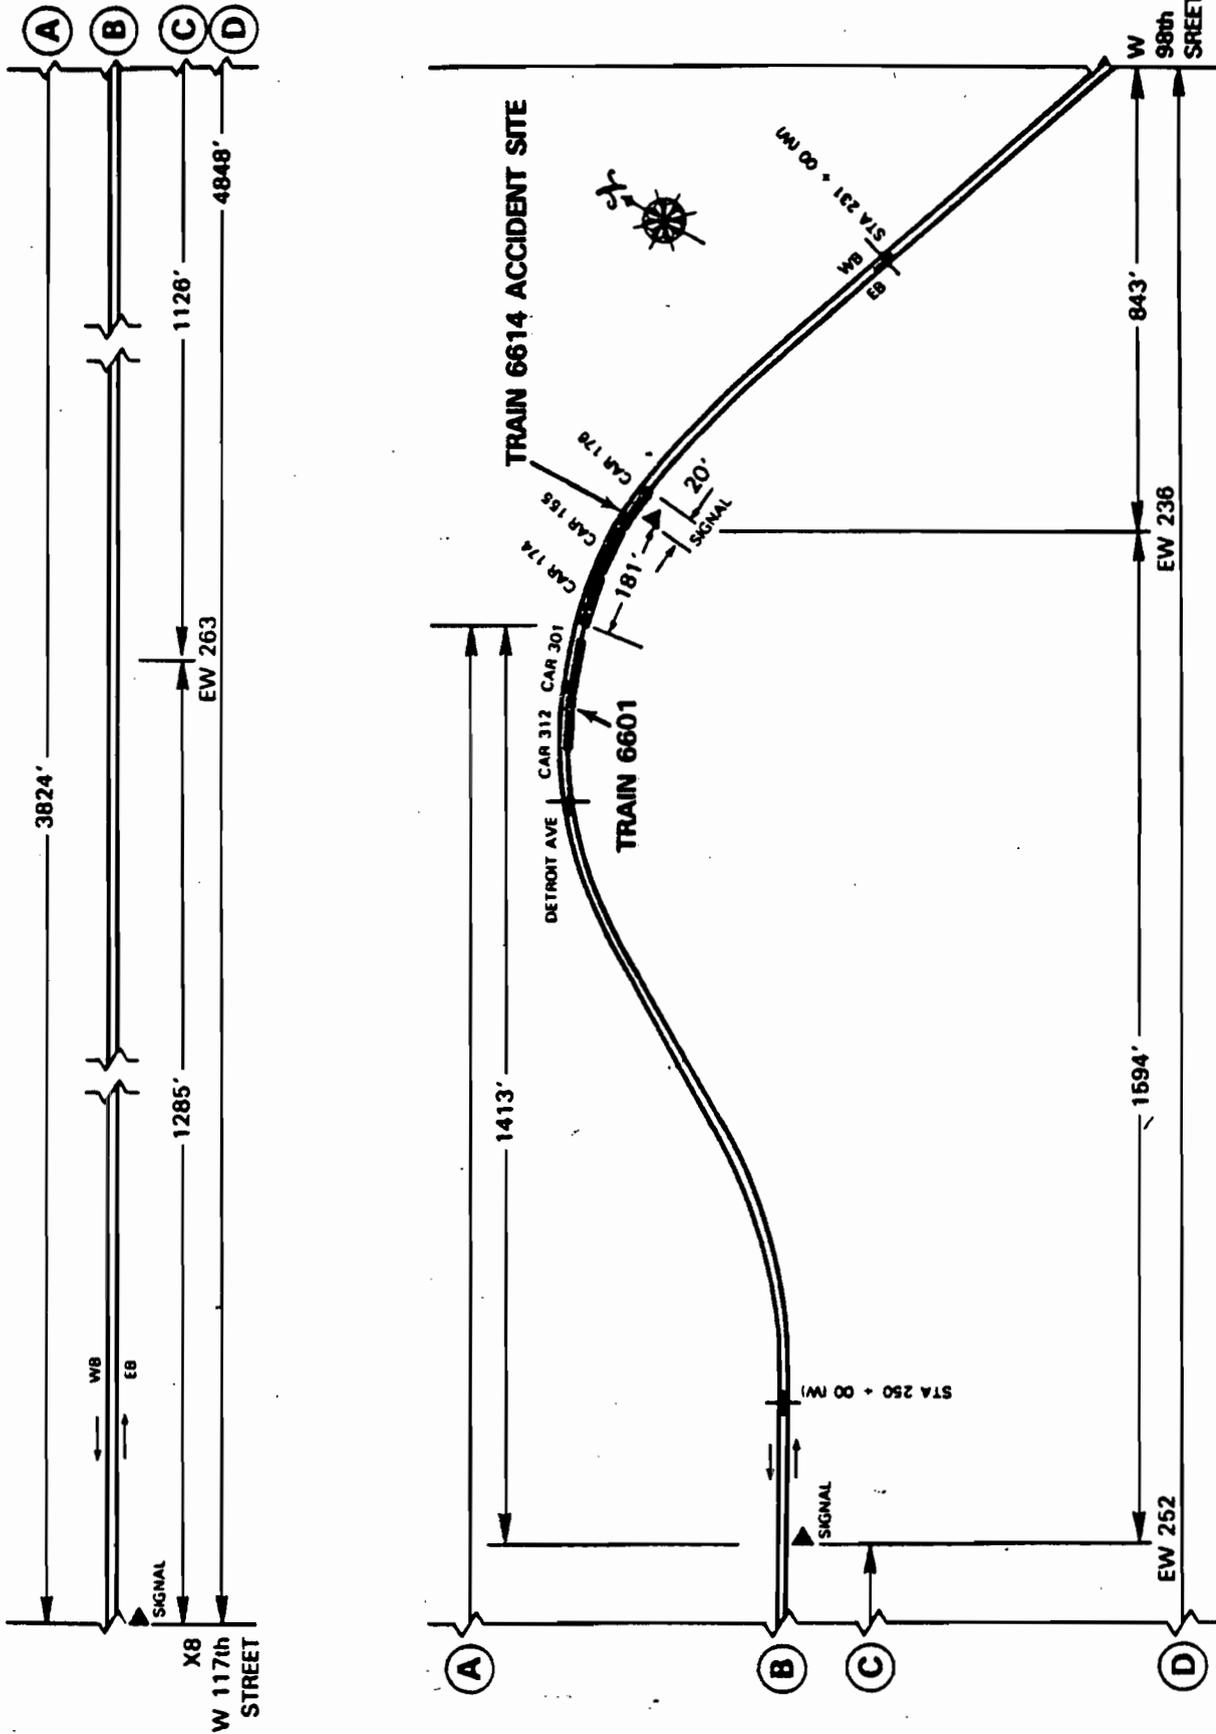
Figure 2.--Track and signal locations from the West 117th Street Station to the West 98th Street Station.

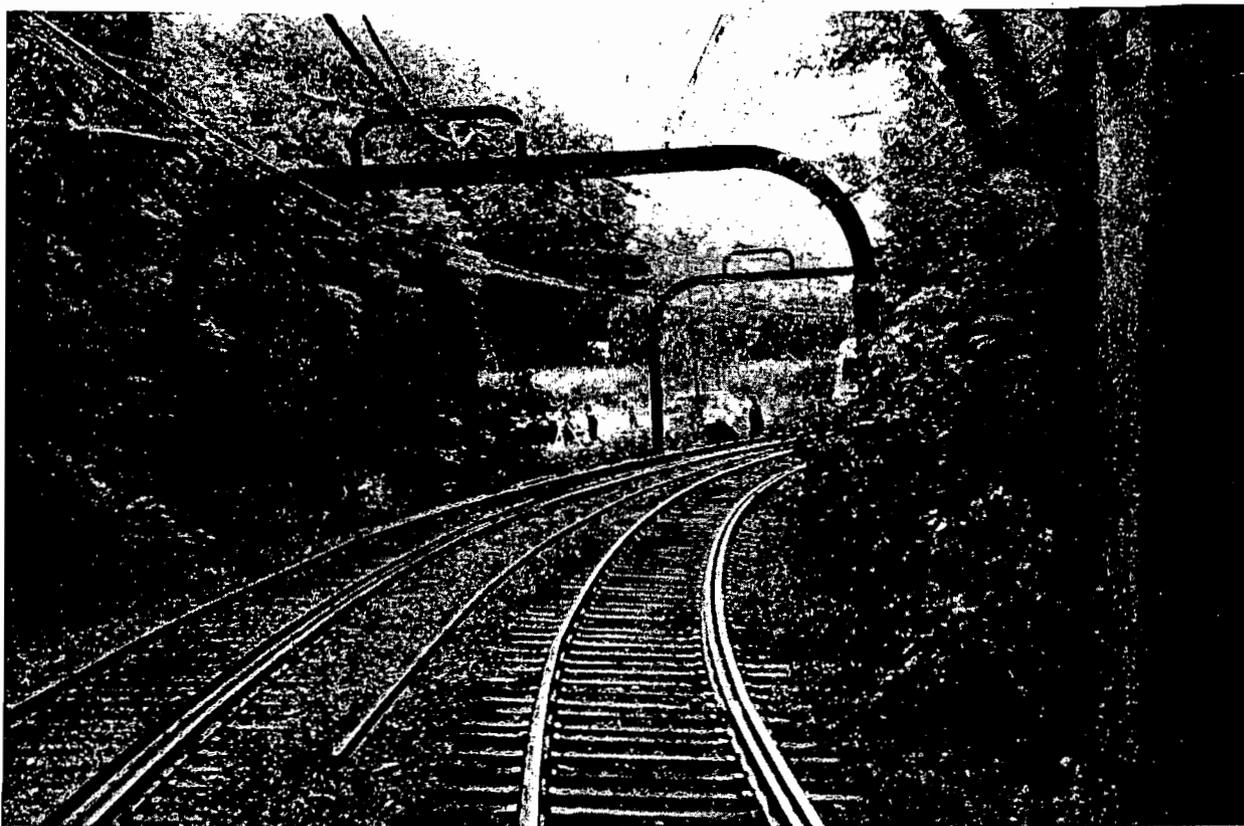
Figure 3.--Train appears at a distance of 266 feet.

Following the accident, a train of "Airporter" cars was placed on the eastbound track where train No. 6614 had been standing at the time of the accident. Sight-distance tests supervised by Safety Board investigators established that the extreme left hand corner of the rear car was visible from the operator's seat of a 300-class car at a point 266 feet west of the point of impact. (See figure 3.) Had the rear of the car not been masked by foliage on the inside of the curve, much of the car would have been visible from at least the 266-foot point. (After the accident, the Safety Board learned that the GCRTA had cut back some of the foliage and had contracted for vegetation control on its right of way.) At a distance of 140 feet, the entire end and a small part of the rear right side of the "Airporter" car was visible. (See figure 4.) At the 140-foot distance, enough of the train and its location on the track was visible to recognize readily that the train was standing on the same track.
