NATIONAL TRANSPORTATION SAFETY BOARD

RAILROAD ACCIDENT REPORT

REAR END COLLISION AND DERAILMENT
OF TWO UNION PACIFIC FREIGHT TRAINS
NEAR NORTH PLATTE, NEBRASKA
ON JULY 10, 1986

NTSB/RAR-87/03

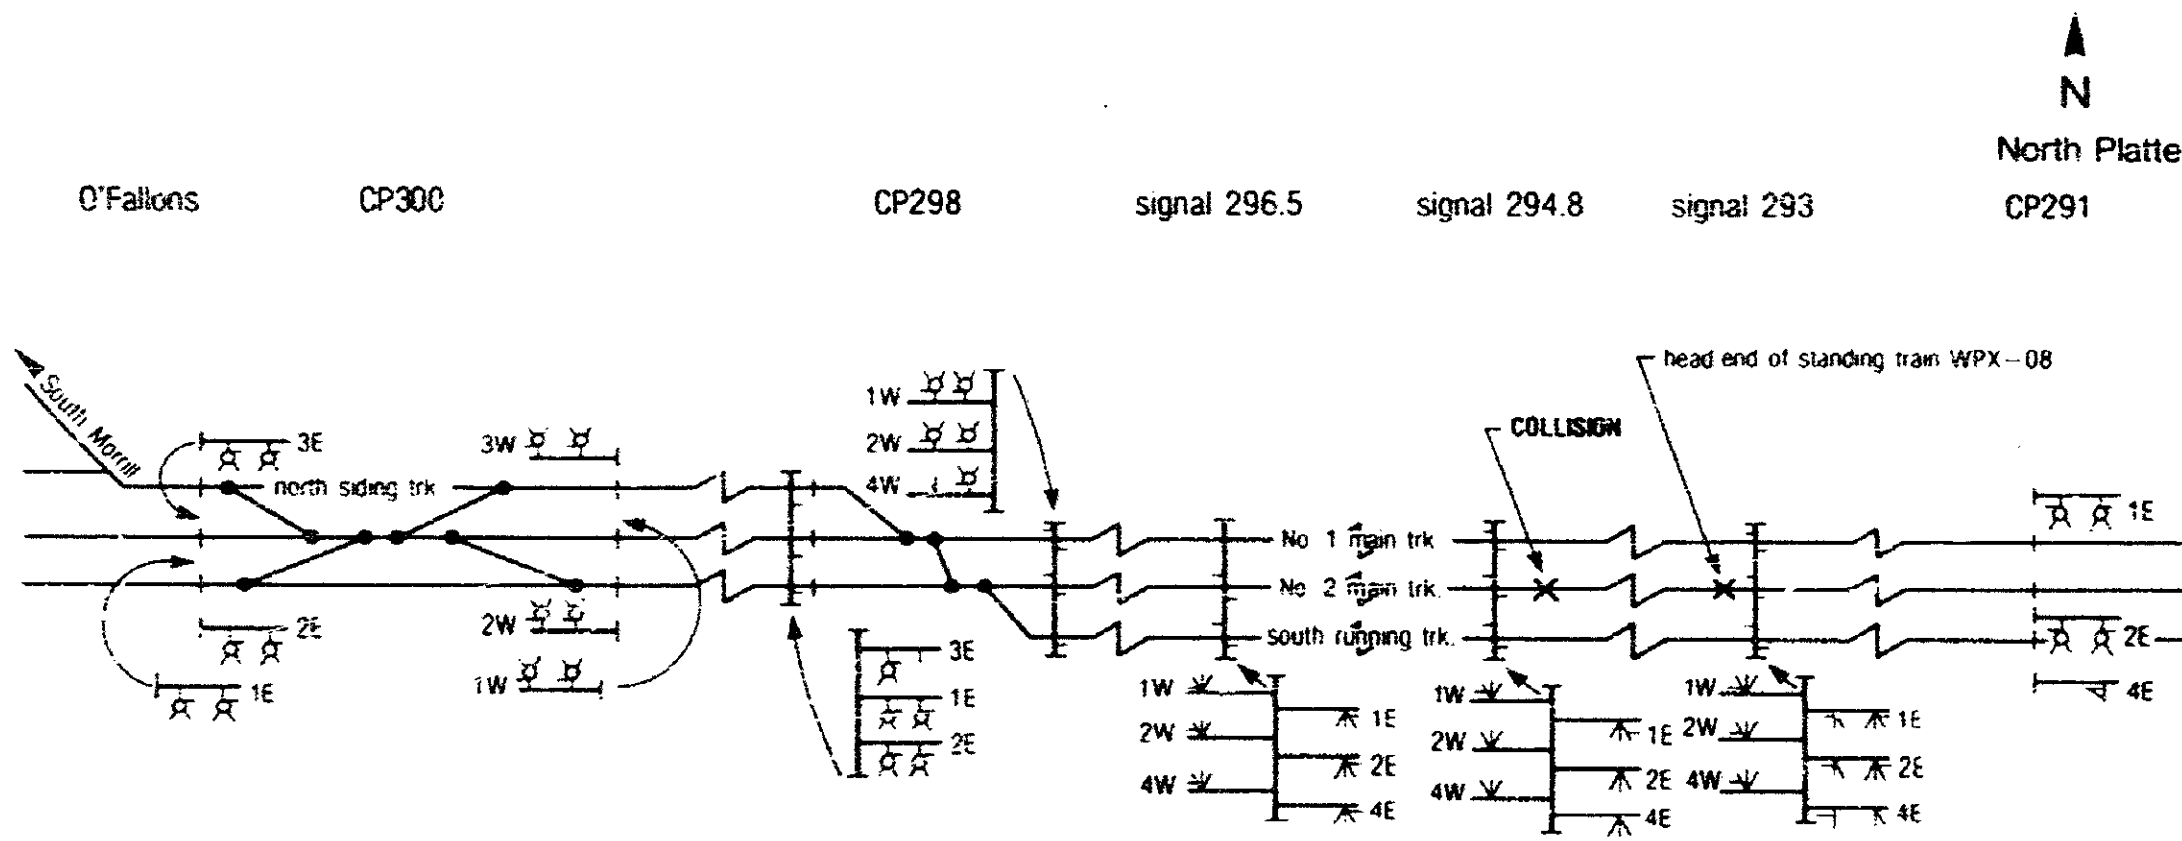
Figure 2. — Signal arrangement O'Fallon's to North Platte.

From the crossover at O'Fallons to the point of collision, there are four signals: one at milepost (m.p.) 300, which the engineer stated was green; one at m.p. 298; another at m.p. 296.5; and one before the point of collision, at m.p. 294.8. (See figure 2.) The engineer stated that he did not remember what the last three signals indicated, and that he did not know what was displayed on the cab signal indicator for signals CP 298 and 296.5. The head brakeman said he recalled seeing a yellow signal (approach). The engineer said that for signal 294.8 the cab signal indicator bounced up and down and stayed at the red over yellow indication (restricting). He also stated he "...knew something was
