NATIONAL TRANSPORTATION SAFETY BOARD

RAILROAD ACCIDENT REPORT

**REAR-END COLLISION OF
AMTRAK PASSENGER TRAIN 94, THE COLONIAL
AND CONSOLIDATED RAIL CORPORATION
FREIGHT TRAIN ENS-121,
ON THE NORTHEAST CORRIDOR
CHASE, MARYLAND
JANUARY 4, 1987**

NTSB/RAR-88/01

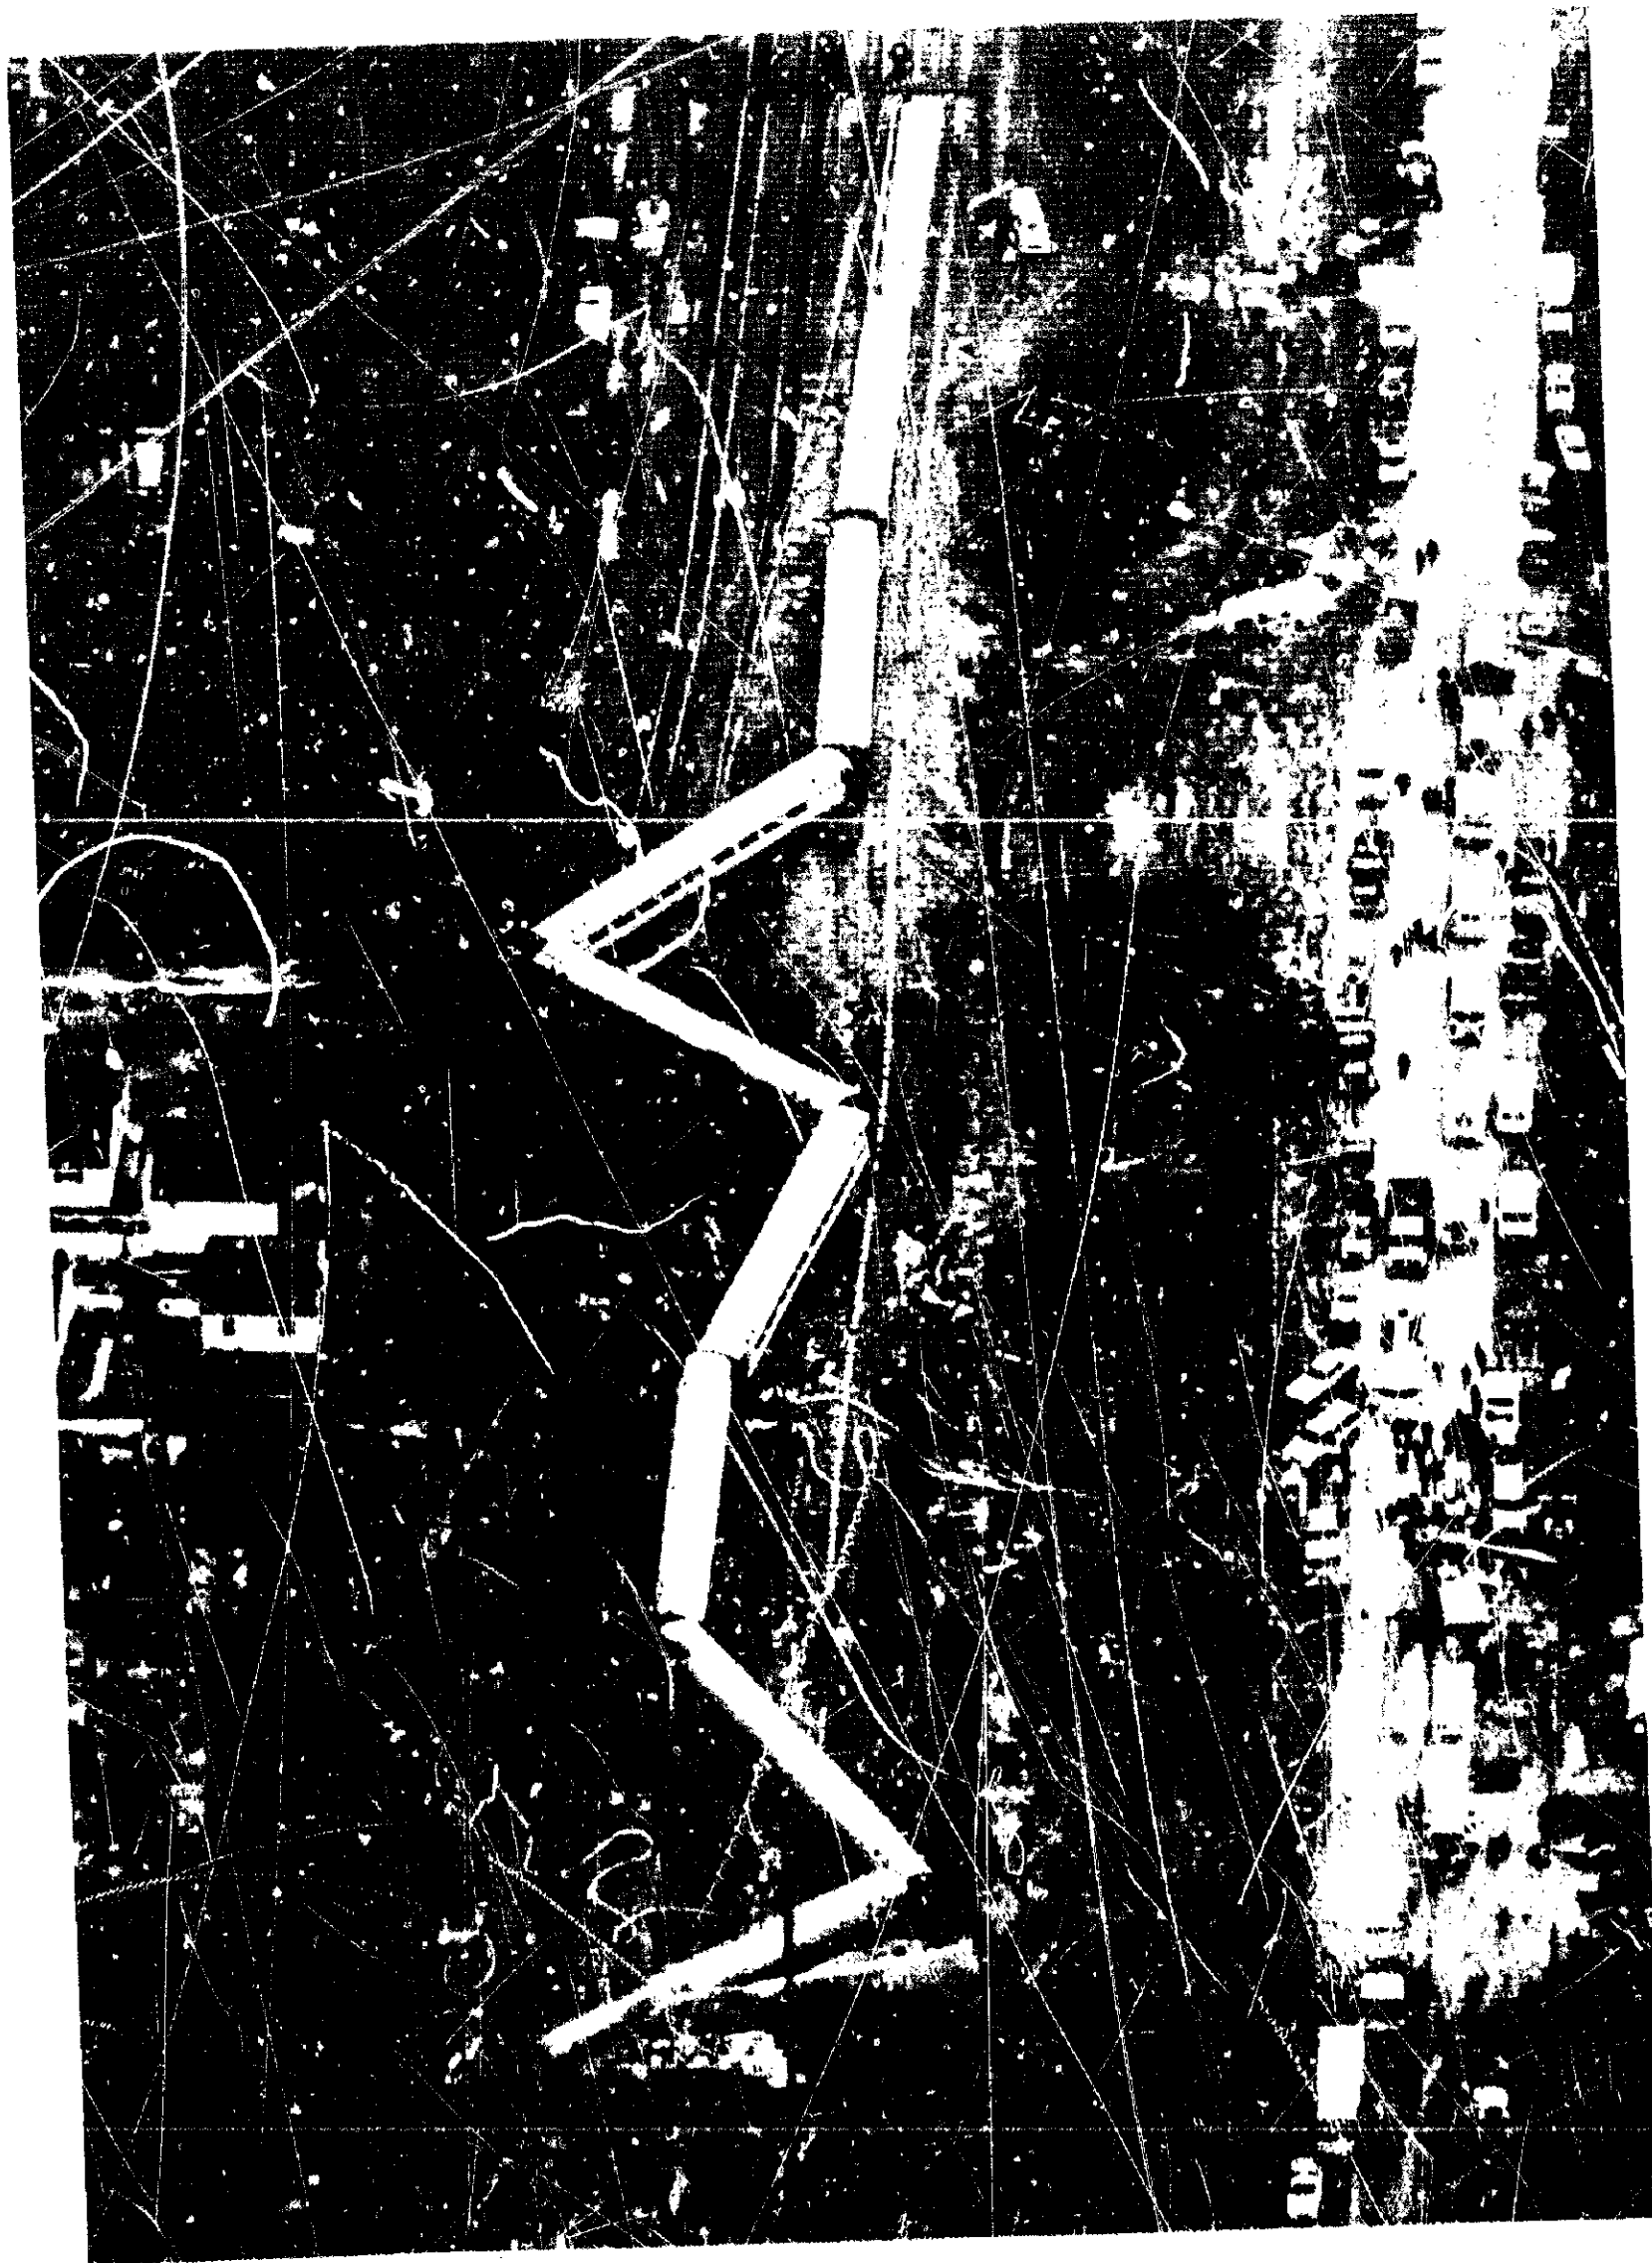
The forward cab and superstructure of the lead Amtrak locomotive unit was crushed downward and inward to the underframe. Separated from the trucks, the remains of the car body came to rest west of the tracks about 400 feet north of the collision point. The trailing Amtrak unit remained in line with the track, although separated from its trucks, and came to rest leaning about 45° to the right at a point about 450 feet north of the collision point (see figure 3).

Figure 3. Aerial view of the accident site.

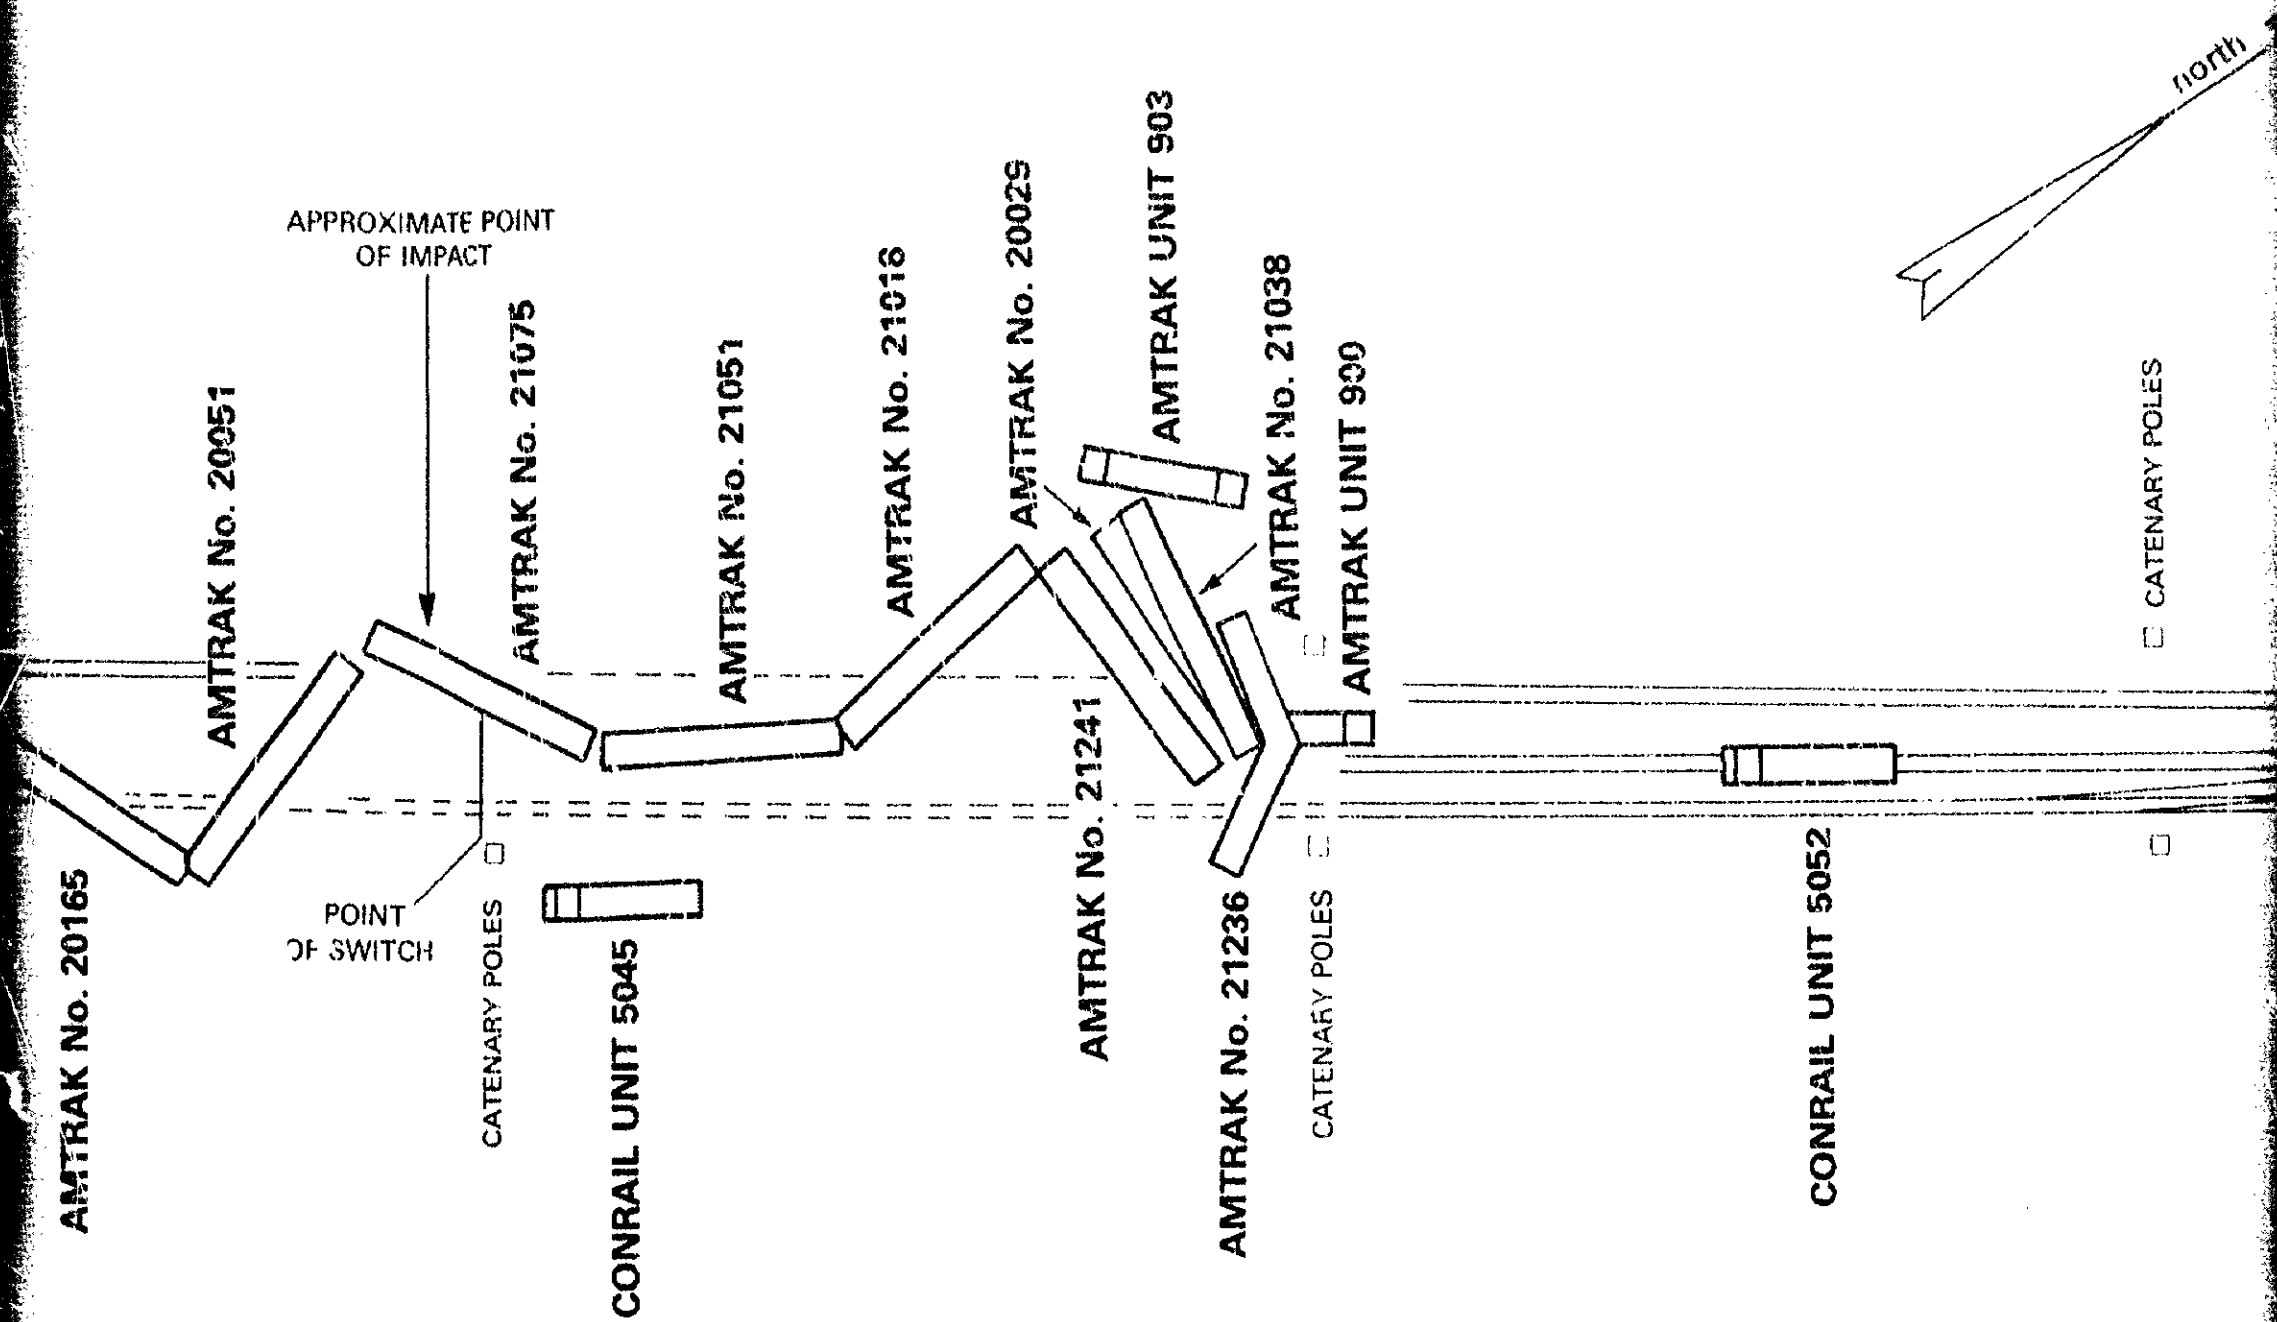
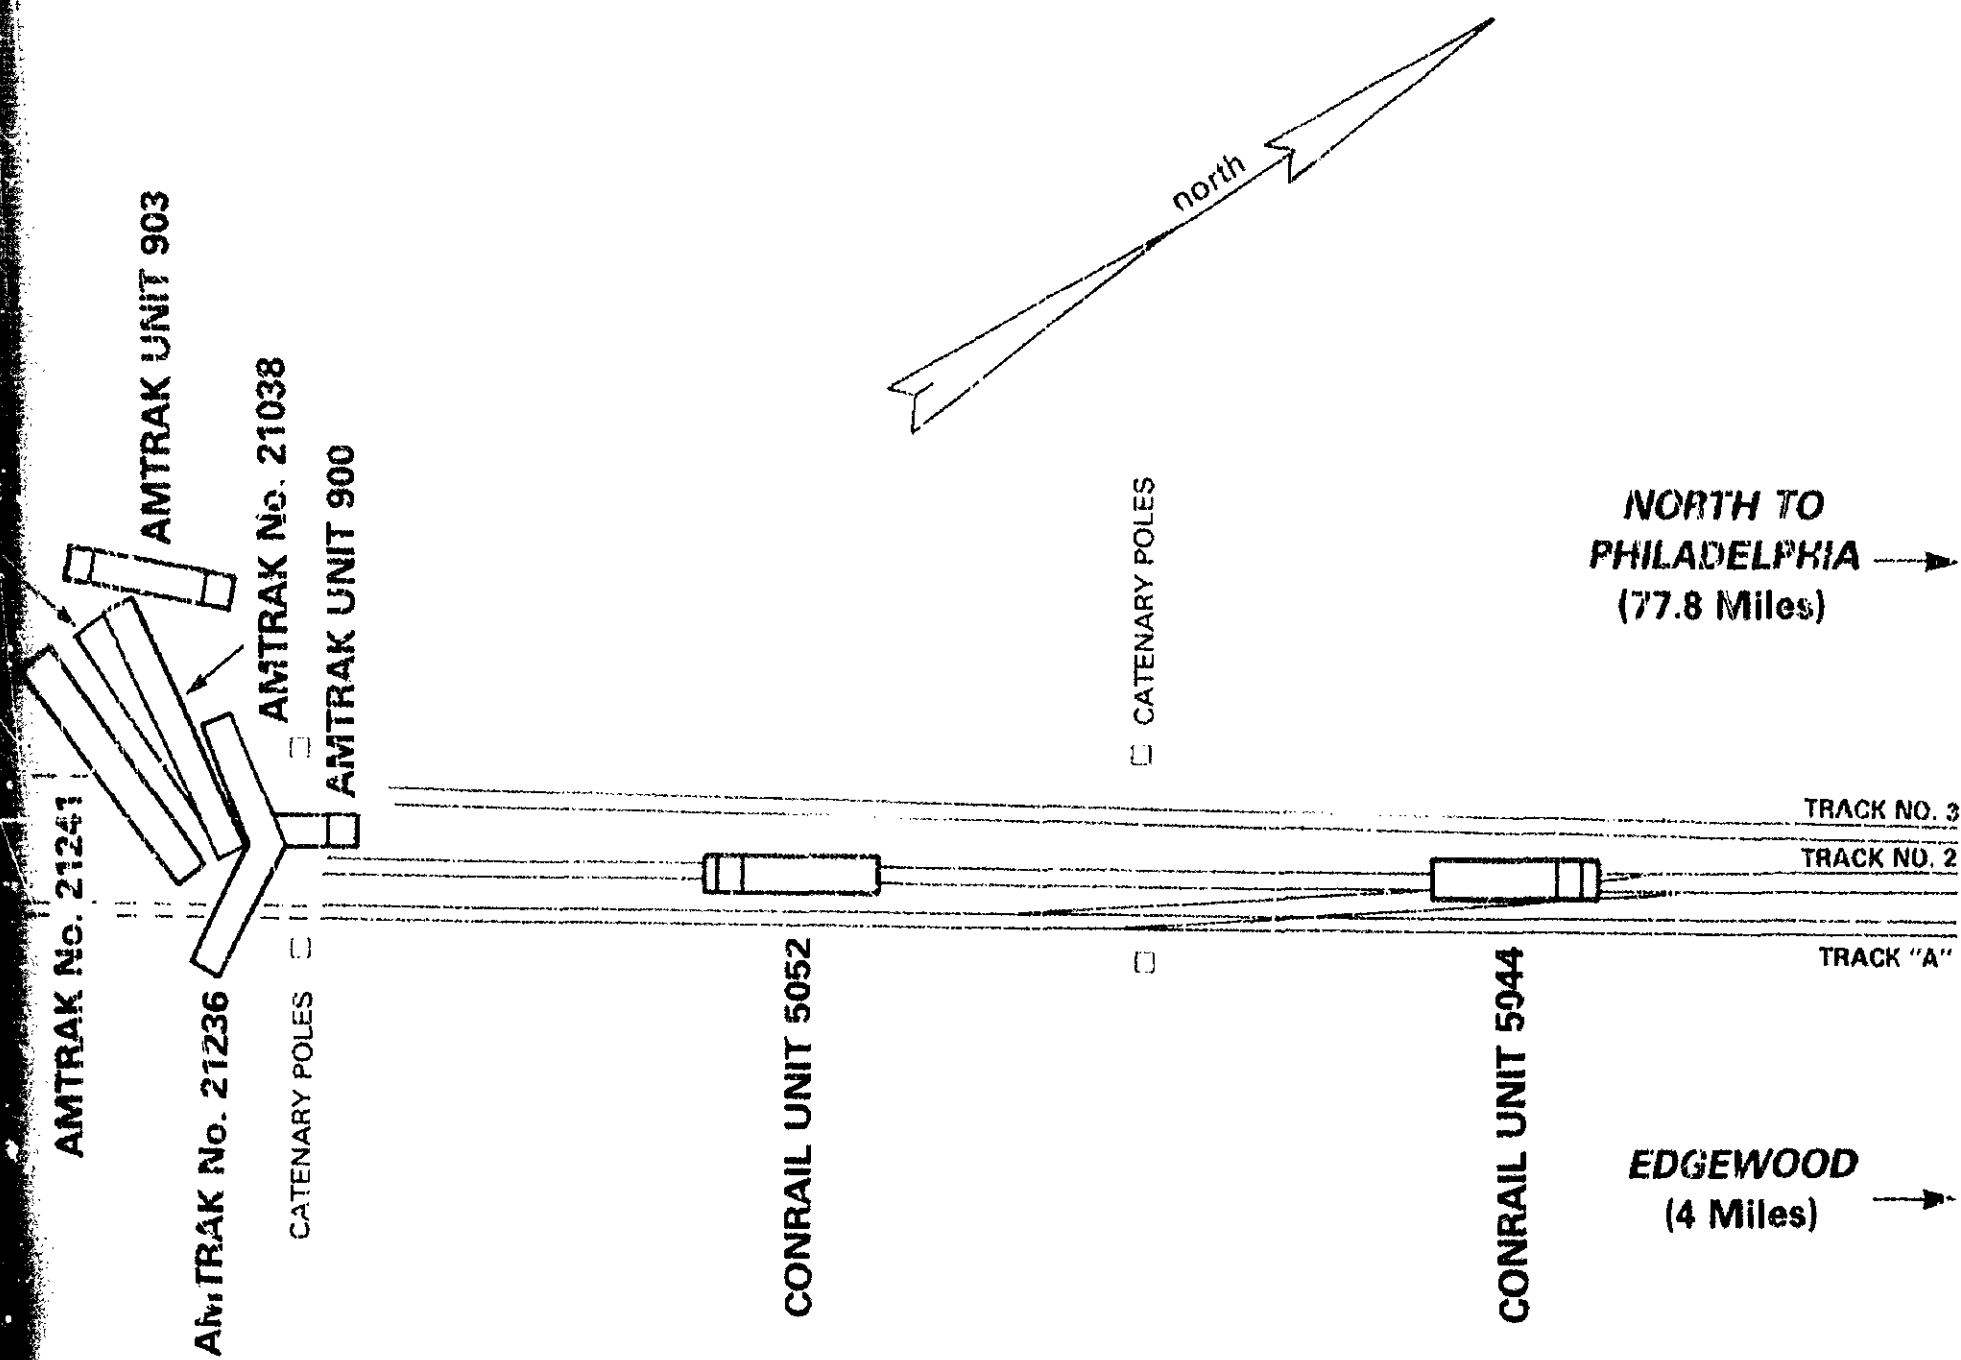
Figure 4. Wreckage Diagram.

The rear Conrail unit was virtually disintegrated with parts scattered across the tracks and property east of the tracks. The largest piece of wreckage came to rest about 150 feet northeast of the collision point. The rear of the middle Conrail unit was crushed by the rear unit. Uncoupled from the lead unit, it was propelled forward on track 2 for about 700 feet. Only the rear truck of this unit derailed. The lead Conrail unit sustained relatively superficial damage, although driven forward about 900 feet, it was the only piece of equipment in the two trains that was not derailed.

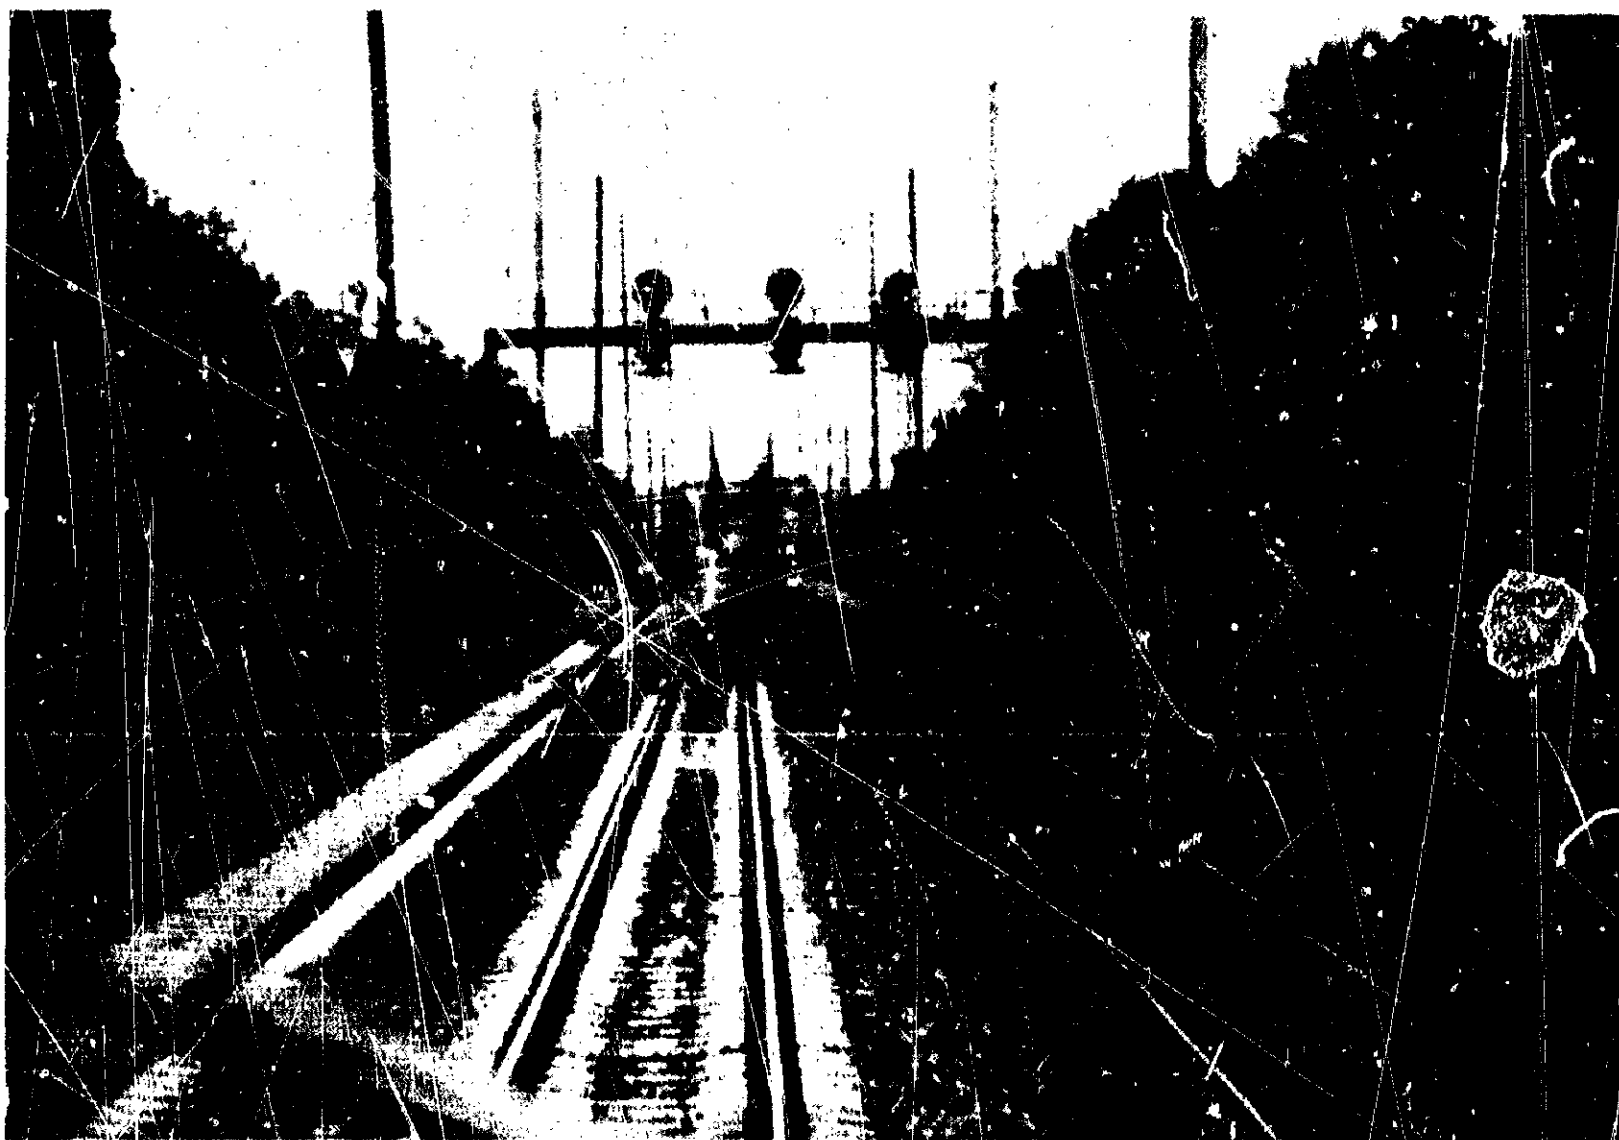
Figure 6. The northbound home signals at Gunpow as viewed from a northbound train moving at 125 mph on track 2. The aspect displayed for the train by signal 2N is "clear;" those displayed for the other tracks are "stop." From left to right, the tracks are 3, 2, 1, and A.

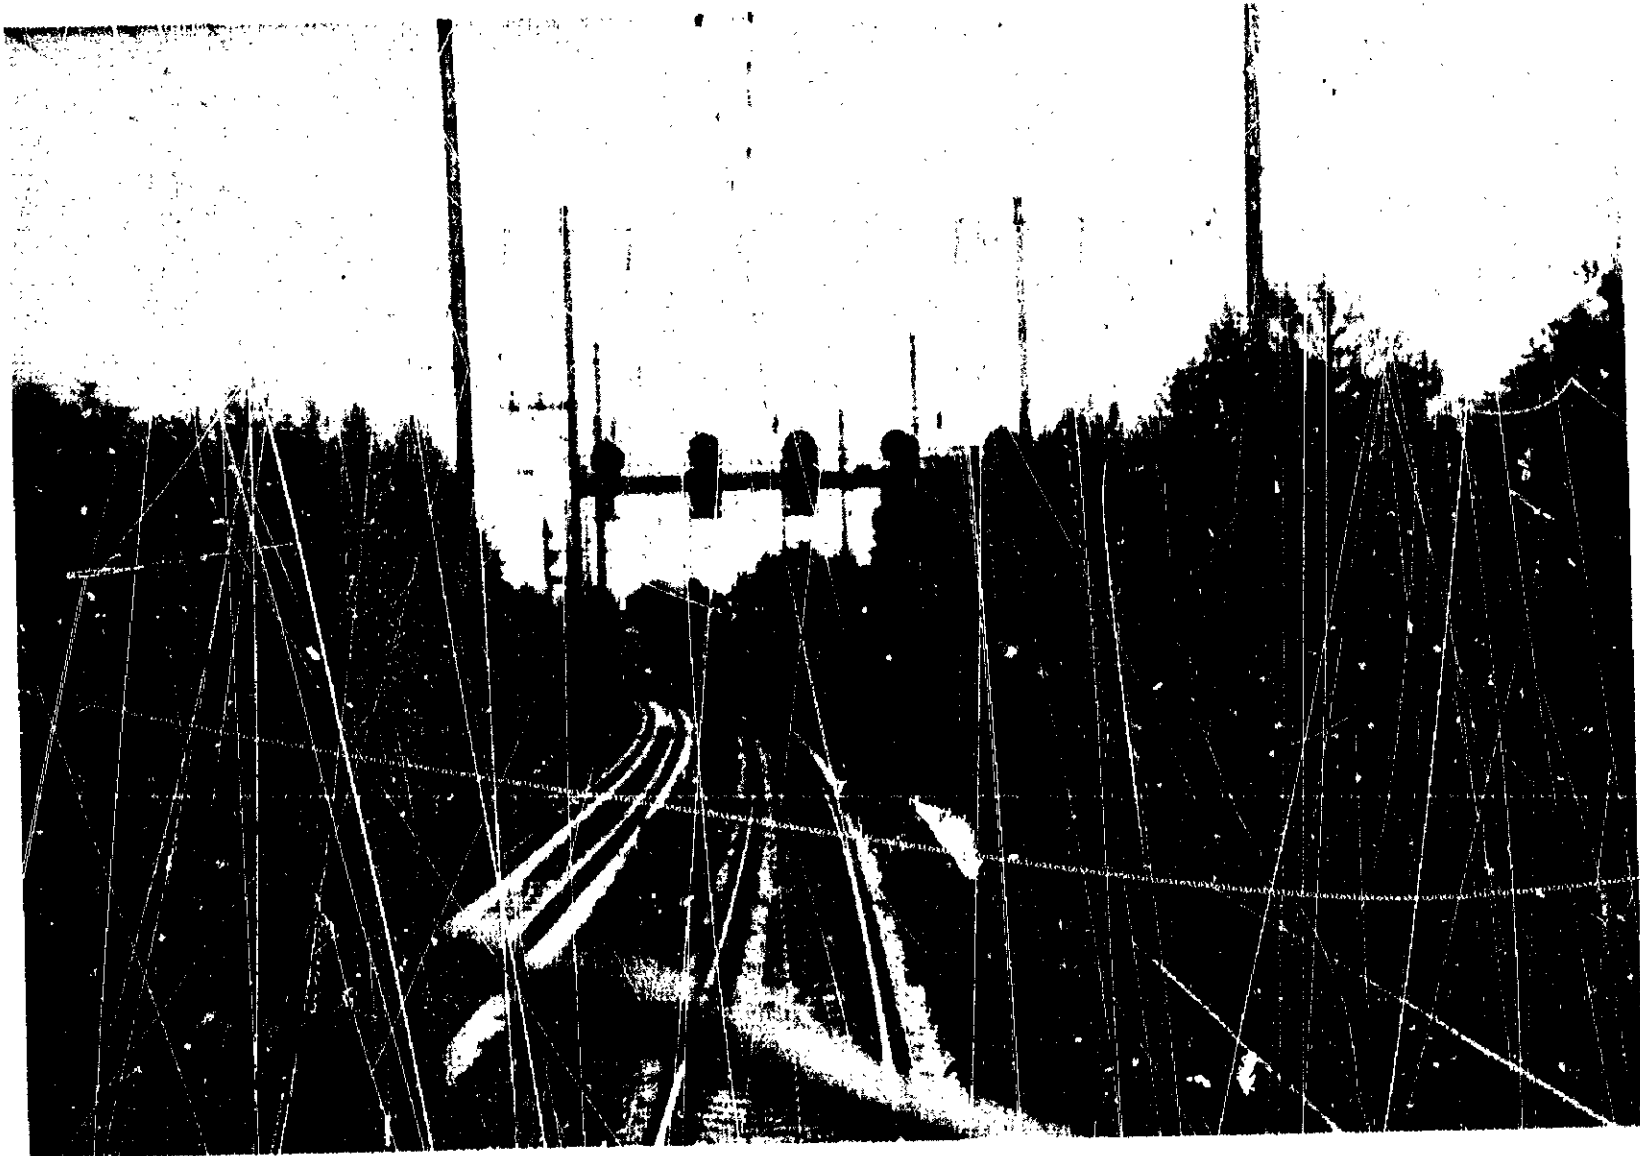
Figure 7. Distant signal 816/817 located 10,318 feet south of the home signals at Gunpow, as viewed from a northbound train moving at 125 mph on track 2. The aspect displayed for the train by signal 816-2 is "clear;" the aspects displayed for track 1 and track A to the right are "approach." A stop aspect is displayed for track 3 because the track is set up for a southbound train.

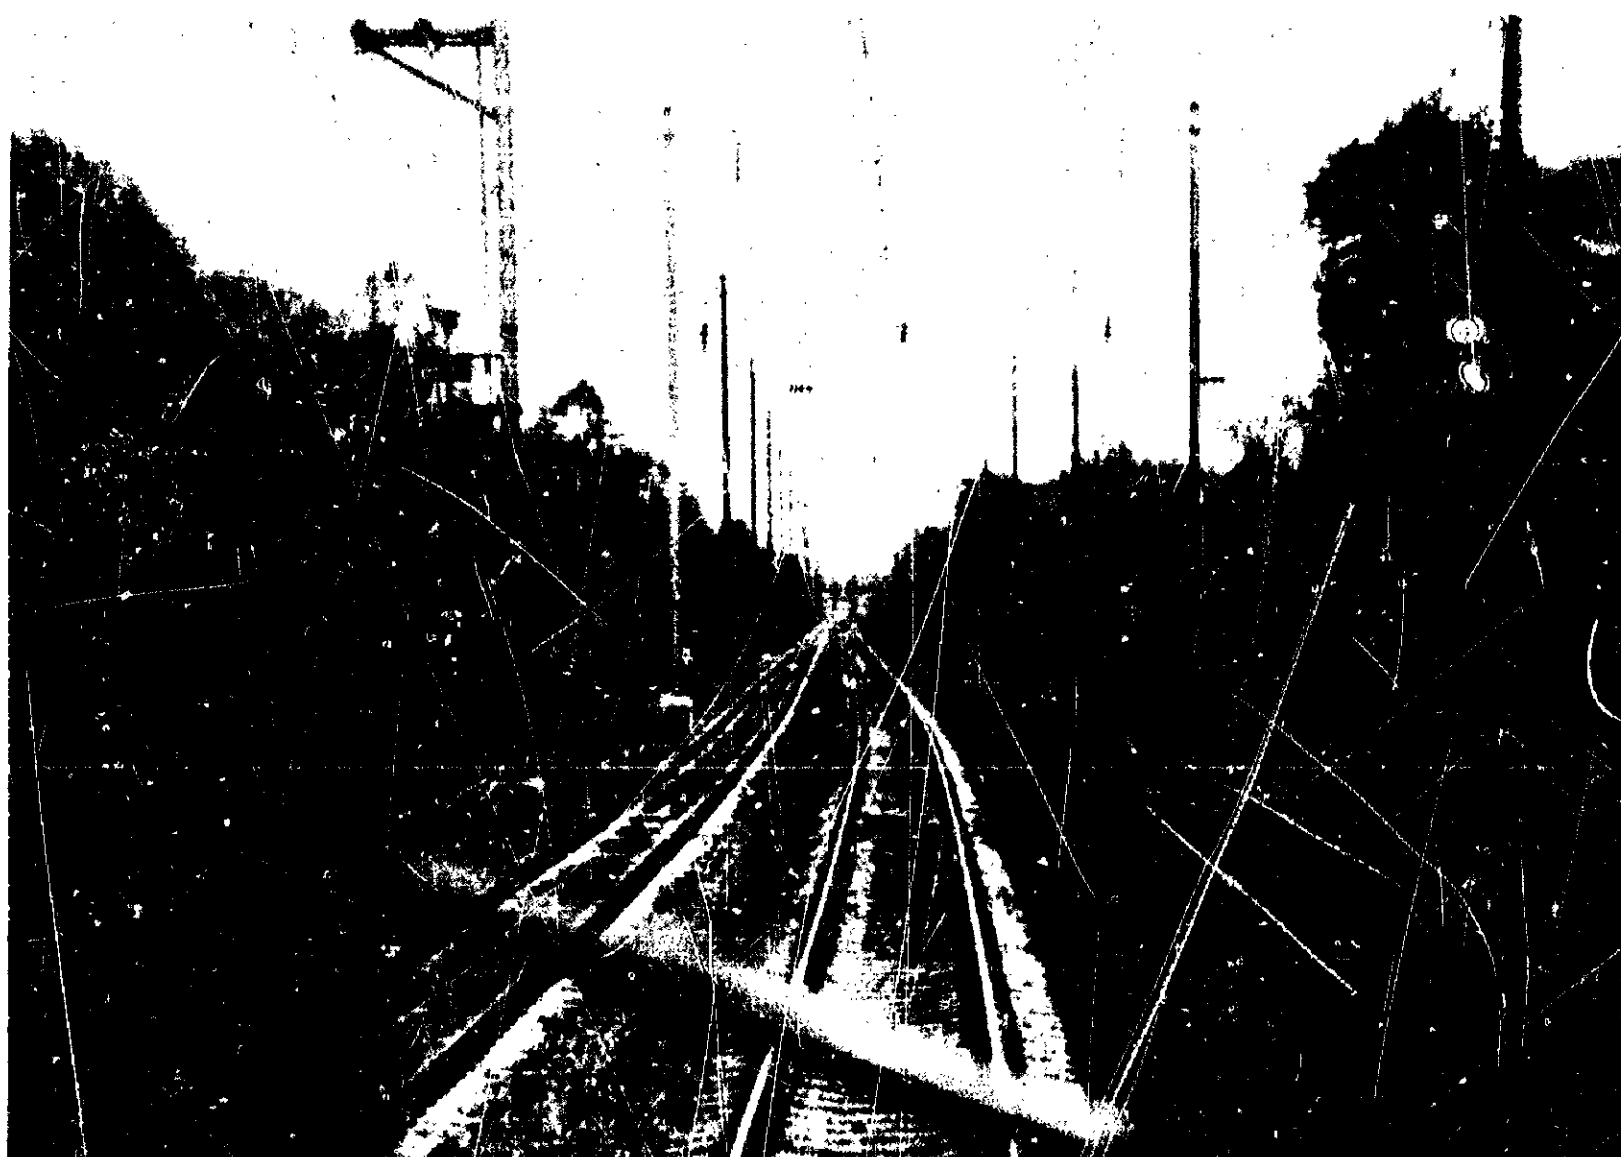
Figure 10. Code chande point CS-806 as seen from a northbound train on track 2. Th nearest catenary support poles mark the location of the code change point. The Gunpow home signals are in the distance.

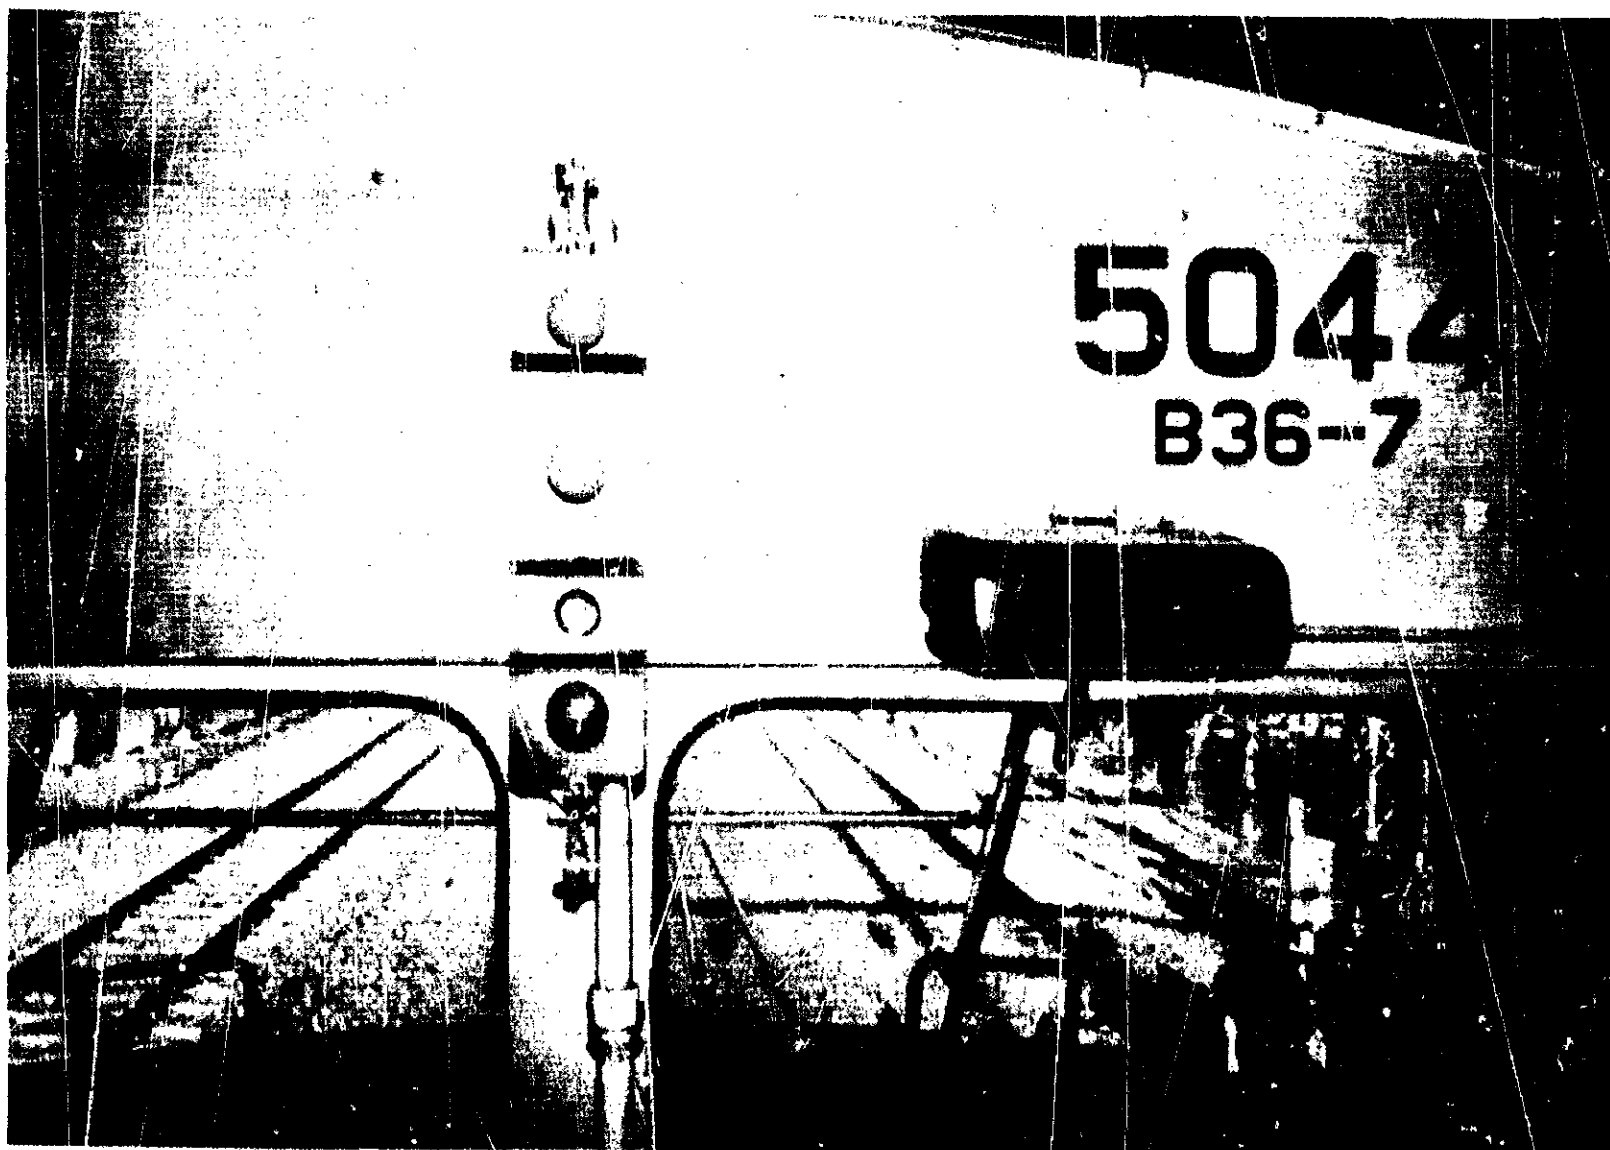
The four-aspect cab signal of unit 5044 was of the same configuration as the Amtrak AEM-7 locomotives; it was mounted in the middle of the forward cab bulkhead at the top of the windshield. The hinged cover had two sets of aspect ports set at oblique angles so that one could be viewed from each side of the cab. The top port was the "clear" aspect, the next two below were the "approach medium" aspect, the next below was the "approach" aspect, and the bottom port was the "restricting" aspect. There were screw-in receptacles in the signal box for four small white bulbs--one for each aspect. An examination of the signal box after the accident revealed that the bulb for the "approach" aspect was missing (see figure 13). All the other aspects had operative bulbs that were properly inserted.

Figure 13. Cab signal of Conrail unit 5044 with the cover removed; the bulb for the "approach" aspect is missing.

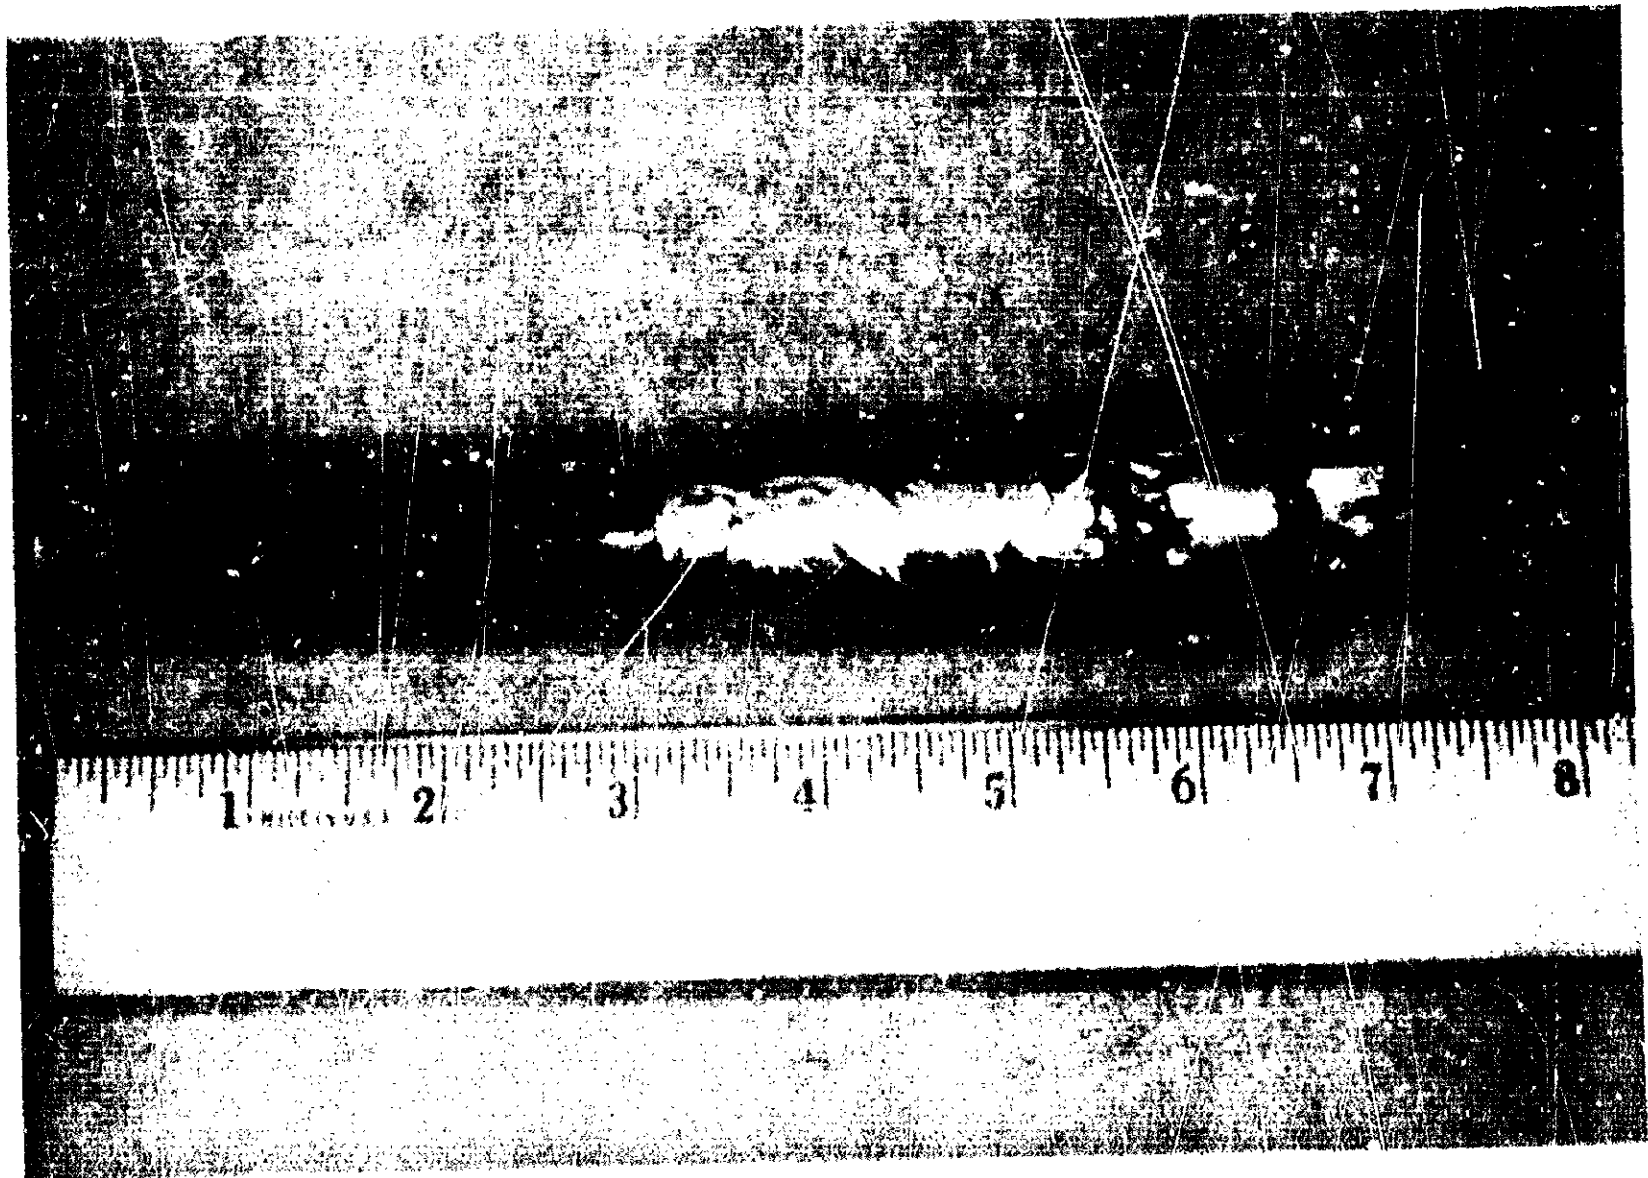
The 6 1/2-inch cab signal whistle was mounted in the airbrake control stand and could be accessed by unsnapping six latches that held the back cover in place. Following the accident, investigators removed the cover from the airbrake control stand of unit 5044 and found the port of the whistle wrapped tightly with duct tape (see figure 14). In this

Figure 14. The cab signal whistle removed from Conrail 5044 with the port covered by duct tape.

condition, no sound could be heard over the sound of the idling engine of an adjacent locomotive. When the tape was slit at the port, the whistle emitted sound at a normal 95- to 105-decibel level.

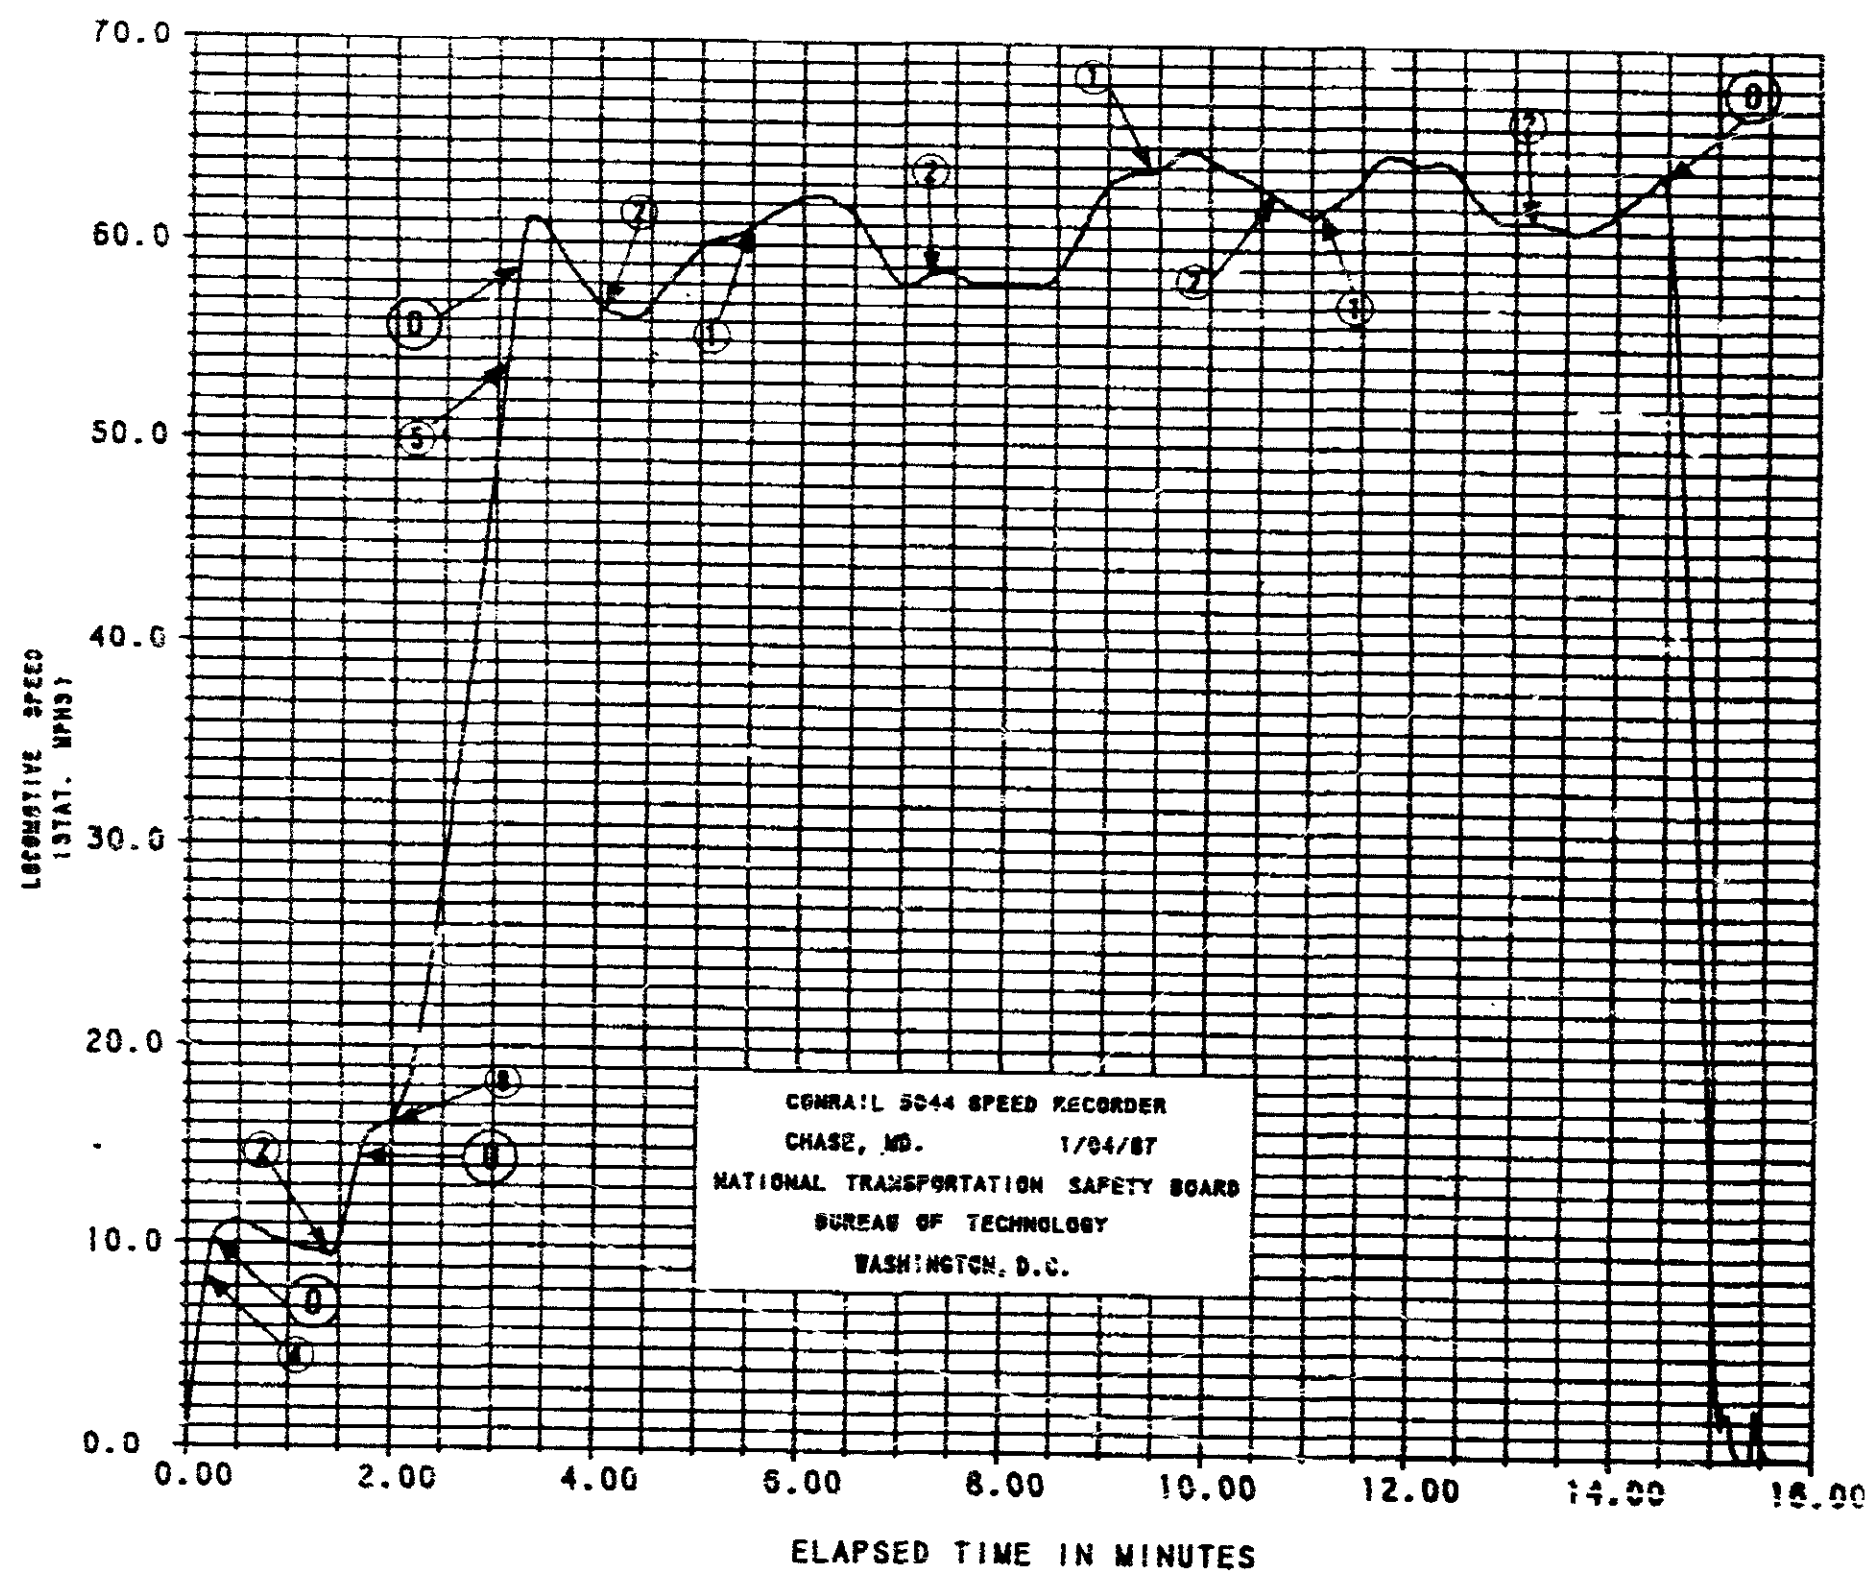
Figure 20: Speed data from the event recorder on Conrail locomotive 5044, the lead unit of train ENS-121, as reproduced in enhanced graphic form. The locations of changes in the throttle setting have been plotted on the graph. Throttle settings are 0 (idle) through 8 (fully open).

The data from the lead unit's recorder indicated that 15 minutes 15 seconds passed between the time train ENS-121 left the vicinity of Bay View yard office and the time it stopped at Gunpow. The times 1:15:15 and 1:30:30 were used as reference points for the start and stop times. At 1:17:15, 2 minutes after the start, the throttle was opened to the eighth or full throttle position; at the time, the train was moving at about 15.5 mph. At 1:18:20 and 57 mph, the throttle was reduced from the eighth to the fifth position, and 10 seconds later, at 57 mph, the throttle was reduced to idle. Acceleration ceased and deceleration began at about 60 mph; at about 56 mph, the throttle was opened to the second position.
