# NATIONAL TRANSPORTATION SAFETY BOARD

## RAILWAY ACCIDENT REPORT

HEAD-ON COLLISION OF SOUTHERN PACIFIC  
TRANSPORTATION COMPANY FREIGHT TRAINS  
YUMA, ARIZONA  
JUNE 15, 1987

NTSB/RA-87-07

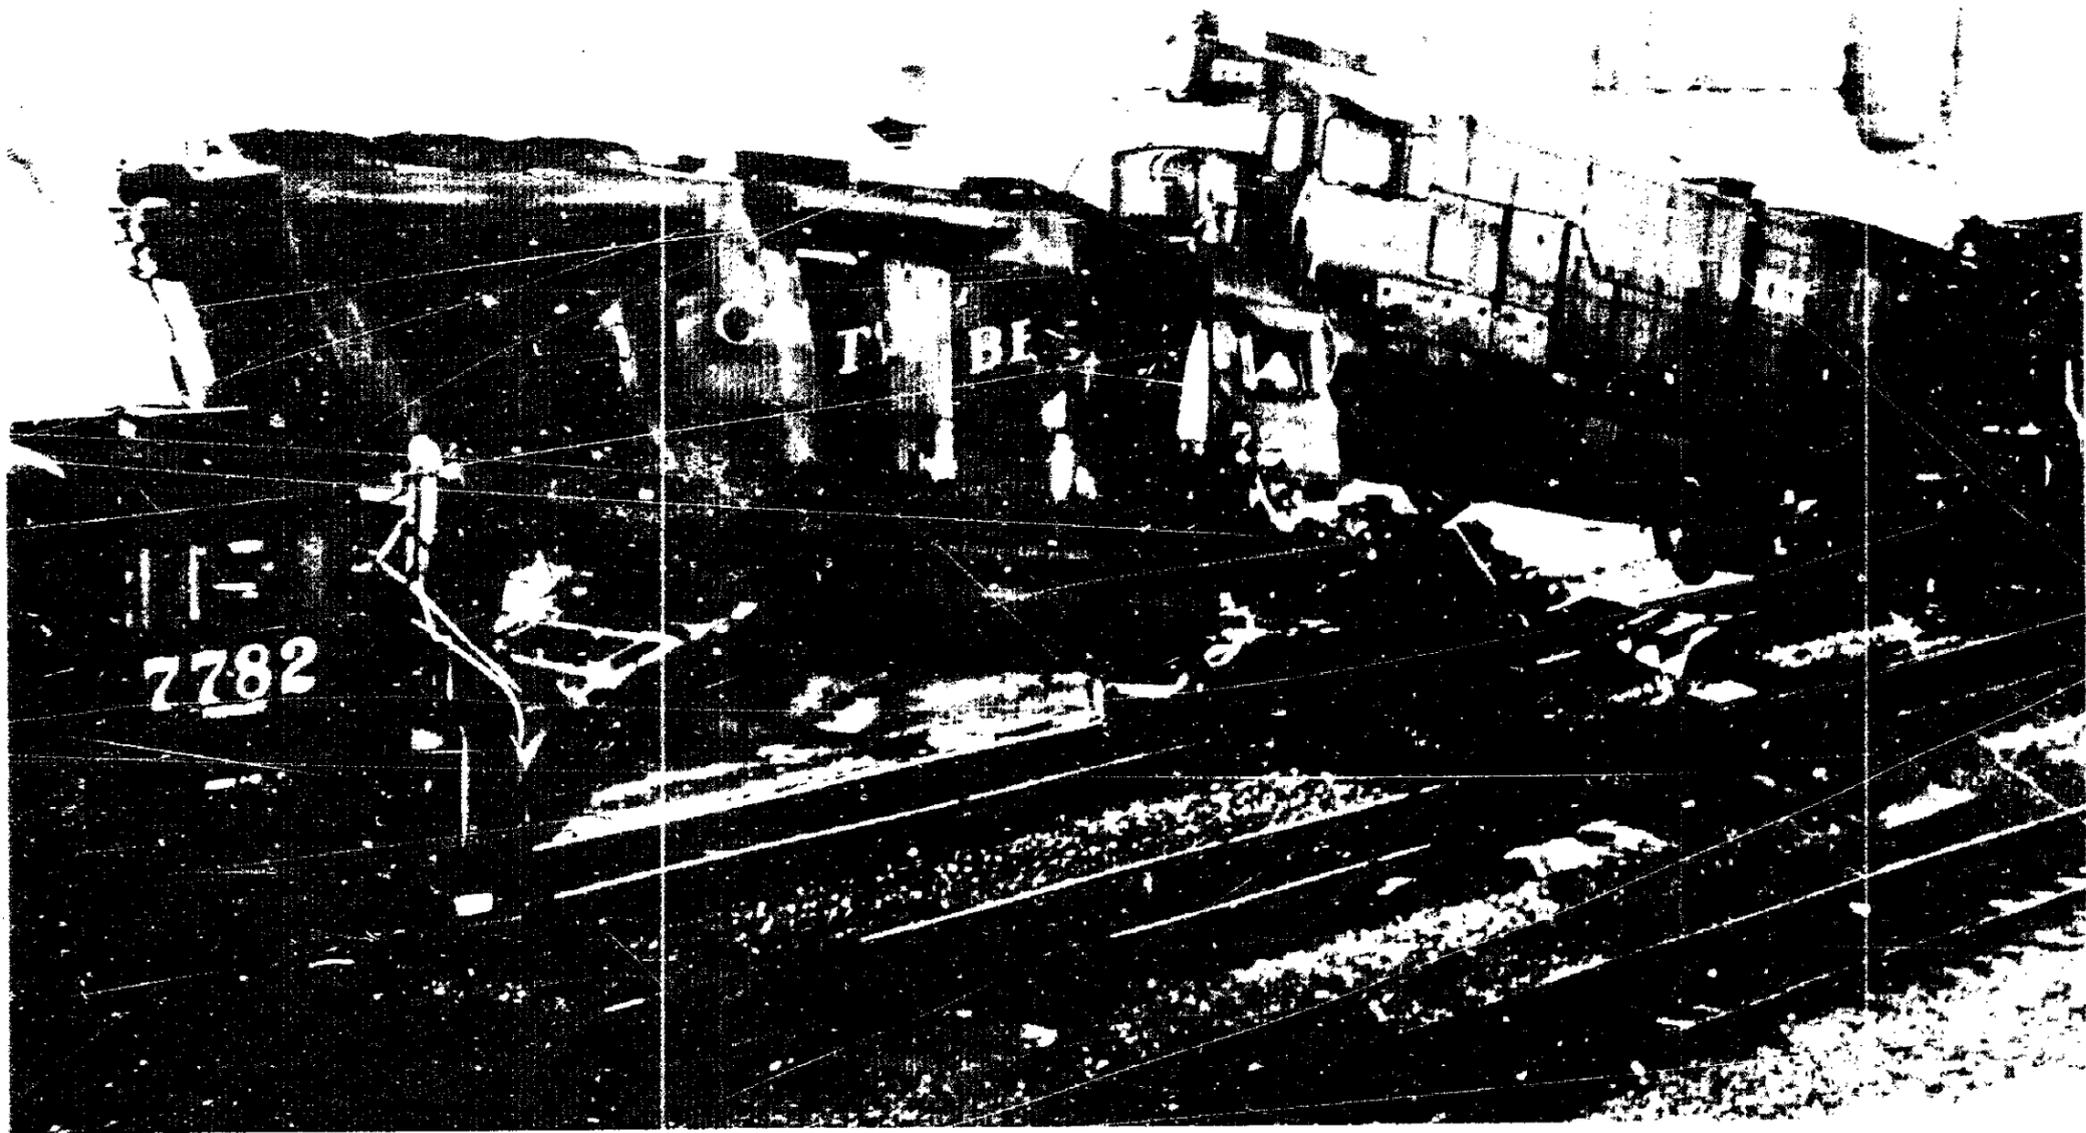
Figure 3.--Point of collision.

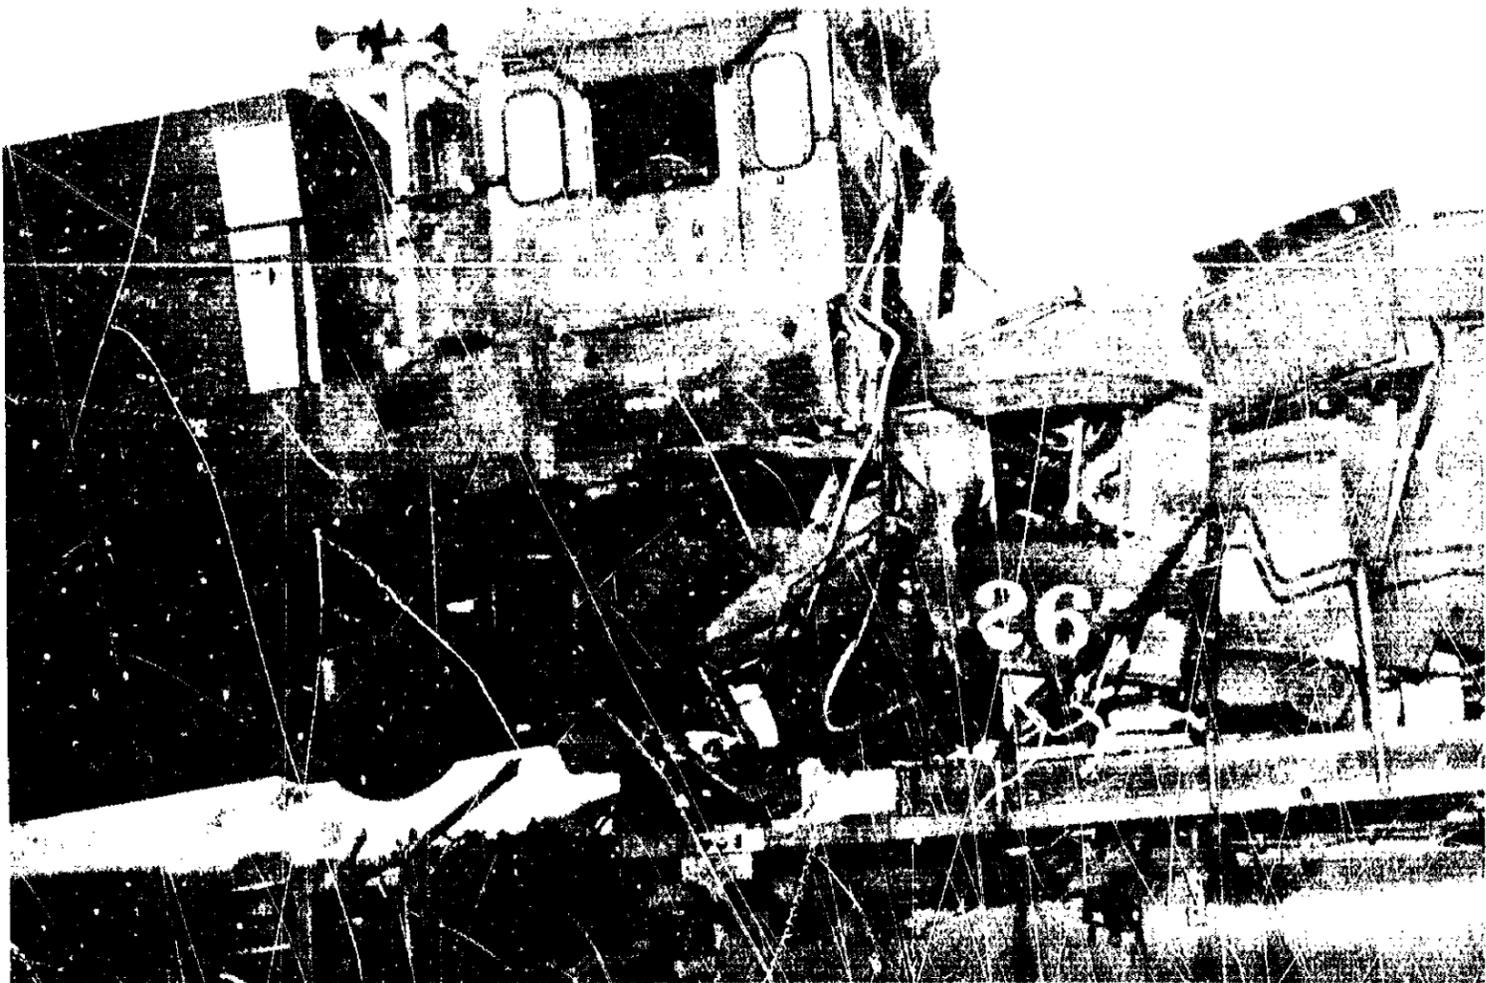
SP locomotive unit 7267 was destroyed in the accident. Three other locomotive units sustained moderate to severe damage. The 28th and 29th head cars in train Extra 7267 East were destroyed, the 30th head car was moderately damaged, and the 60th head car derailed one wheel.

Figure 4 --Over/underride viewed from opposite sides

16. Following the collision, there was no survivable space left in the control compartment of Extra 7267.
17. The crews of both trains involved in this accident were improperly placed according to SP operating rules.

The circumstances of the Yuma accident again highlight the need for improved and standardized locomotives designed to provide protection to on-board personnel. Therefore, the Safety Board reiterates its position that the FRA should promptly require locomotive operating compartments to be designed to provide crash protection for occupants of locomotive control compartments. In the meantime, Safety Recommendation R-87-23 is being held in an "Open--Unacceptable Action" status.
