RAILROAD ACCIDENT REPORT

HEAD-END COLLISION
OF CONSOLIDATED RAIL CORPORATION
FREIGHT TRAINS UBT-506 AND TV-61
NEAR THOMPSONTOWN, PENNSYLVANIA
JANUARY 14, 1988

NTSB/RAR-89/02

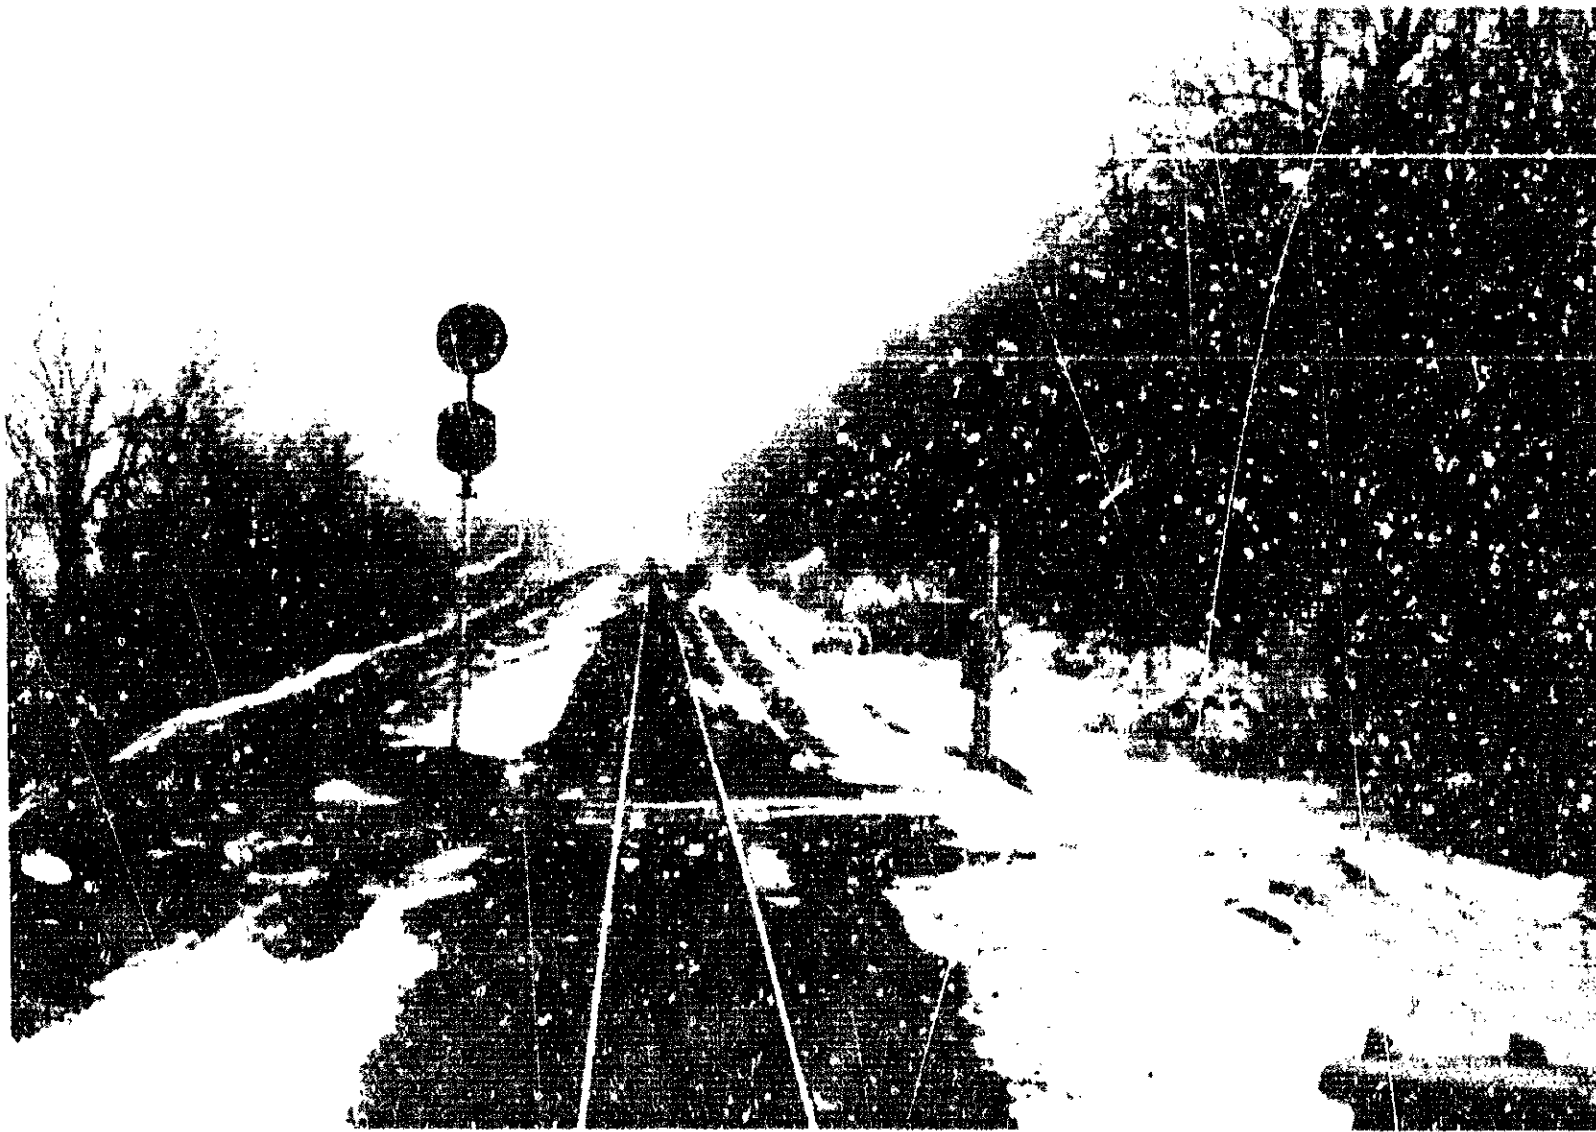
Figure 3.—CP Thompson interlocking with signal 2E in foreground and switch 1E beyond, as viewed from an eastbound train on track 1

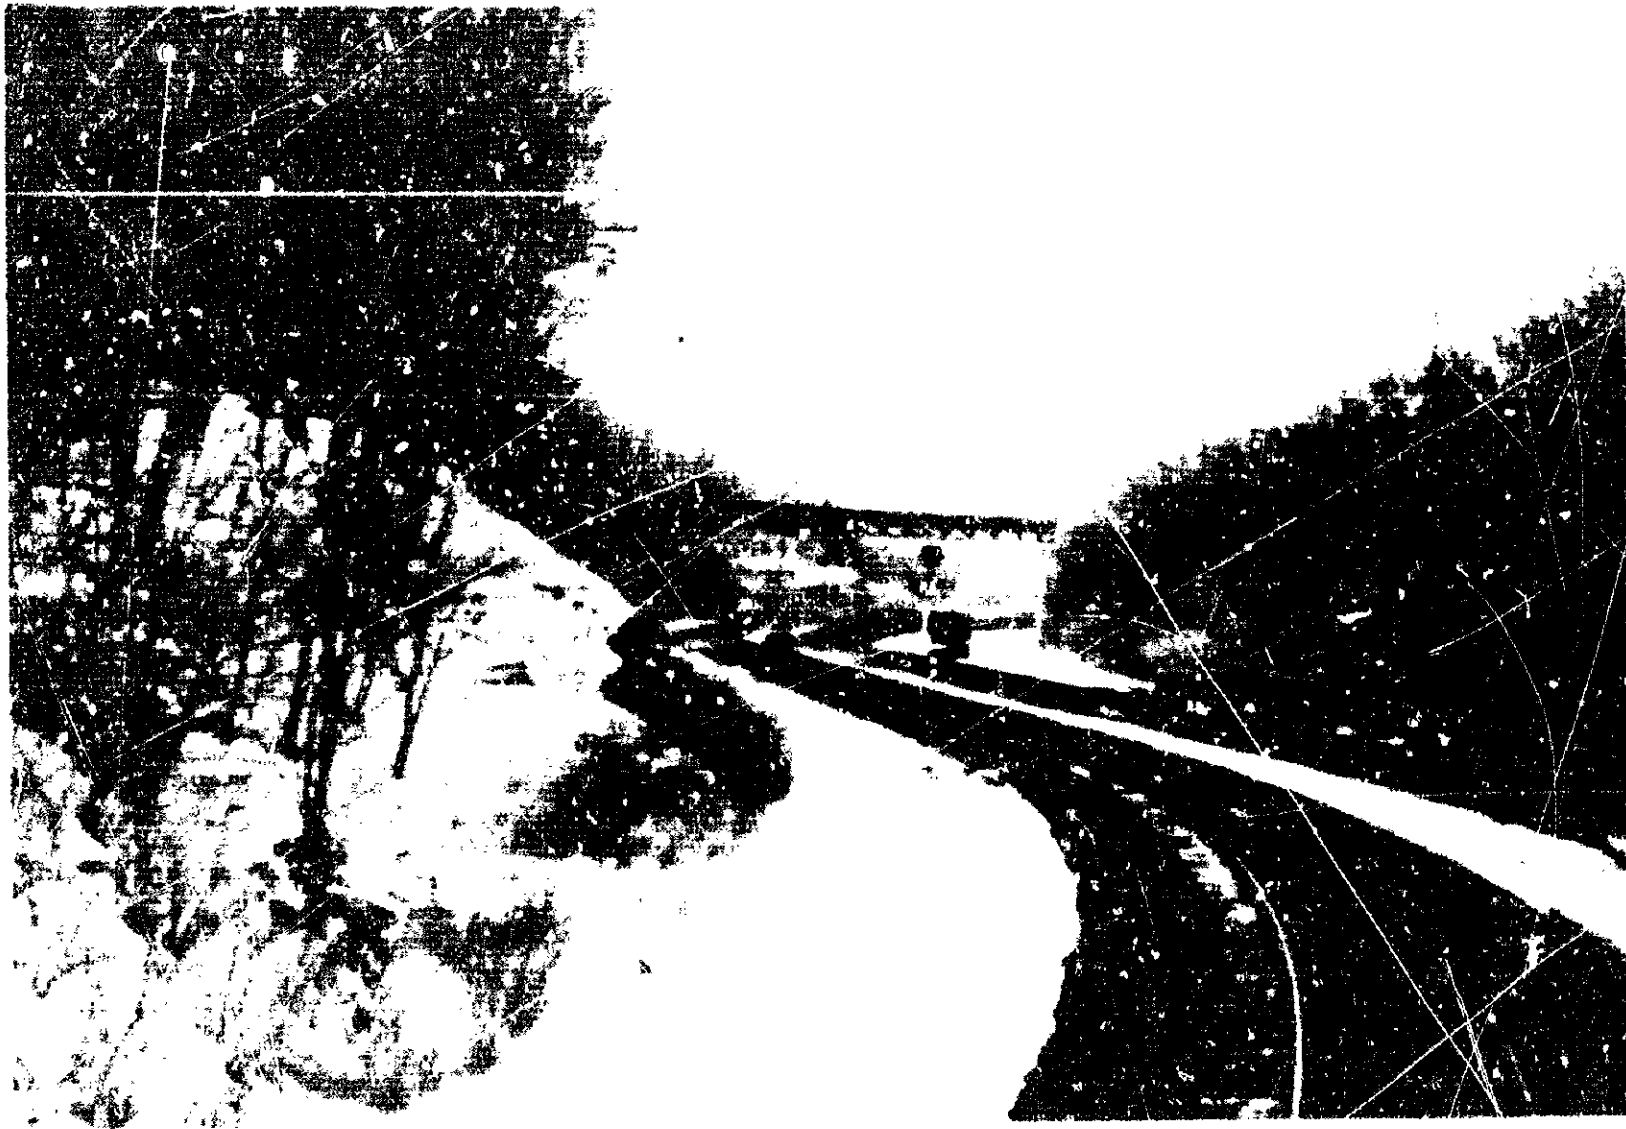
Distant signal 1421W, 11,573 feet east of switch 1E at CP Thompson, should have displayed "approach limited," and home signal 2W at CP Thompson should have displayed "limited clear." As at CP Port, TV-61 was restricted to a maximum of 40 mph through the interlocking. (See figure 4.)

Figure 4 - Westbound distant signal 1421W, located 11,573 feet east of switch 1E at CP Thompson, as viewed from a westbound train on track 1

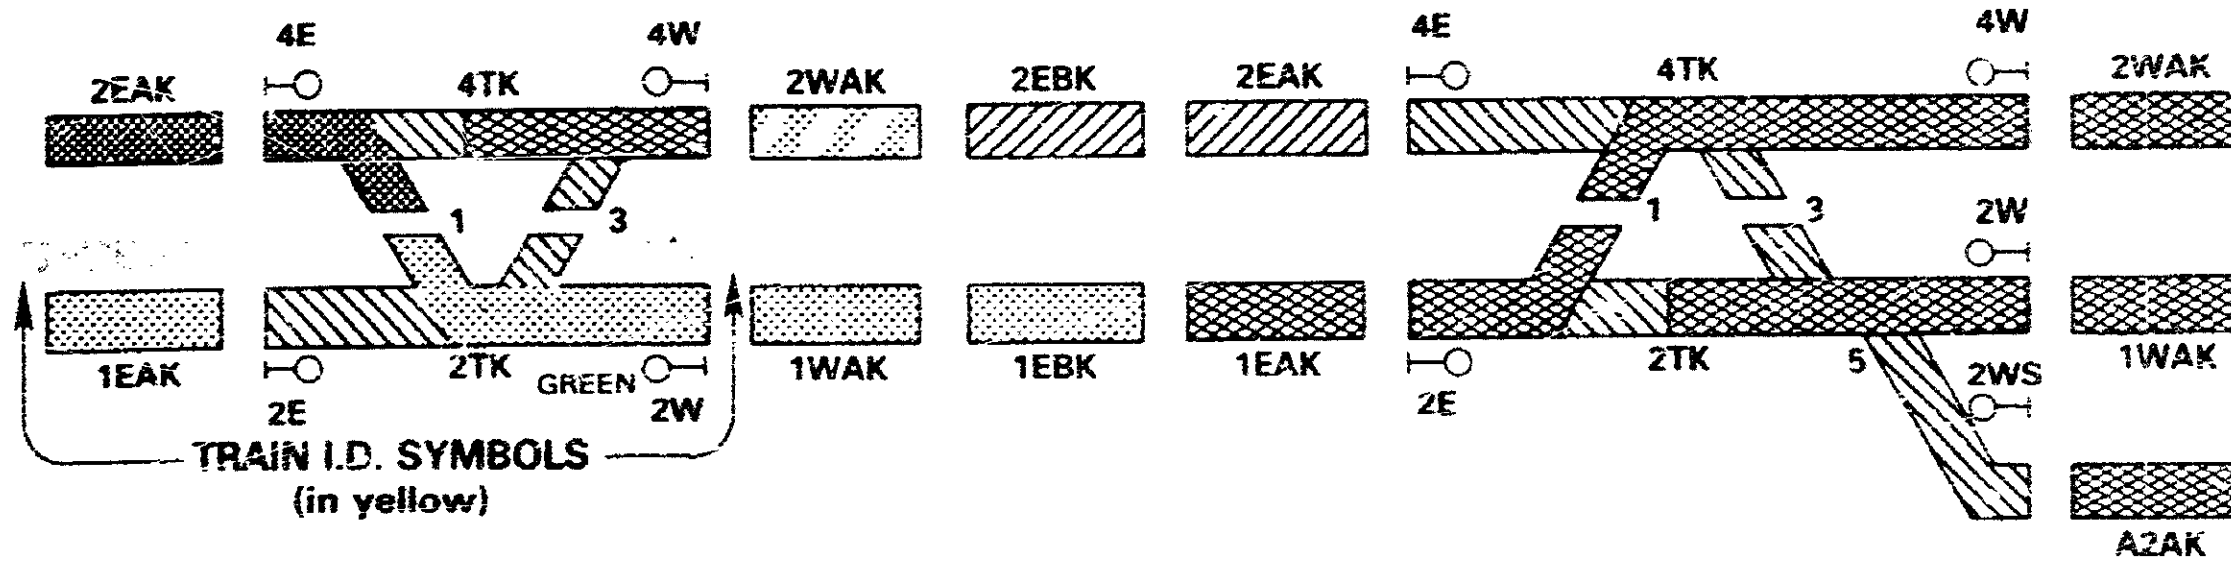
Figure 5.—The CRT display for CP Thompson and CP Port interlockings and the tracks connecting them at the Altoona dispatching center at 7:53:37 a.m., on , January 14, 1988. Track 1 is represented by the lower row of track circuits. Train UBT-506 had just passed home signal 2E and entered circuit 2TK causing the display for the crossover segment of the circuit to change from green to red, indicating that it was now occupied.
