NATIONAL TRANSPORTATION SAFETY BOARD

RAILROAD ACCIDENT REPORT

DERAILMENT OF
NATIONAL RAILROAD PASSENGER CORPORATION
TRAIN 7
ON BURLINGTON NORTHERN RAILROAD
NEAR SACO, MONTANA
AUGUST 5, 1988

NTSB/RAR-89/03

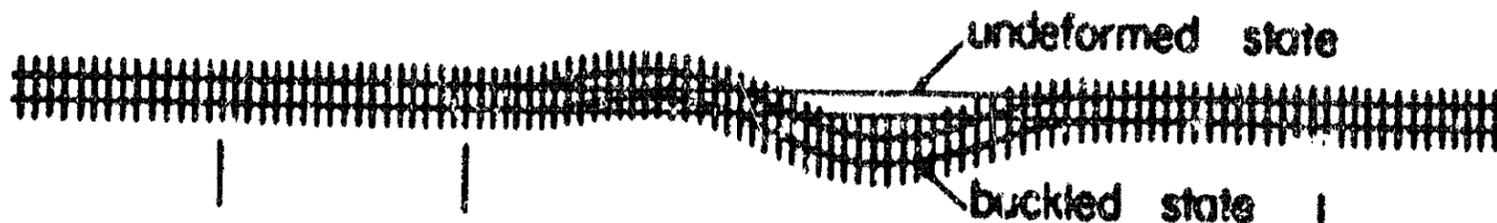
Figure 2.--Sketch of sun kink

signal as train 7 was passing through Sacu ". . . for the next couple of seconds I really don't know where I focused my eyes. Then [the engineer] let out an exclamation, and I looked at him to see what he was looking at, and then I [saw] he was looking straight down the track, so I looked down the track, and then that's when I [saw] the sun kink."

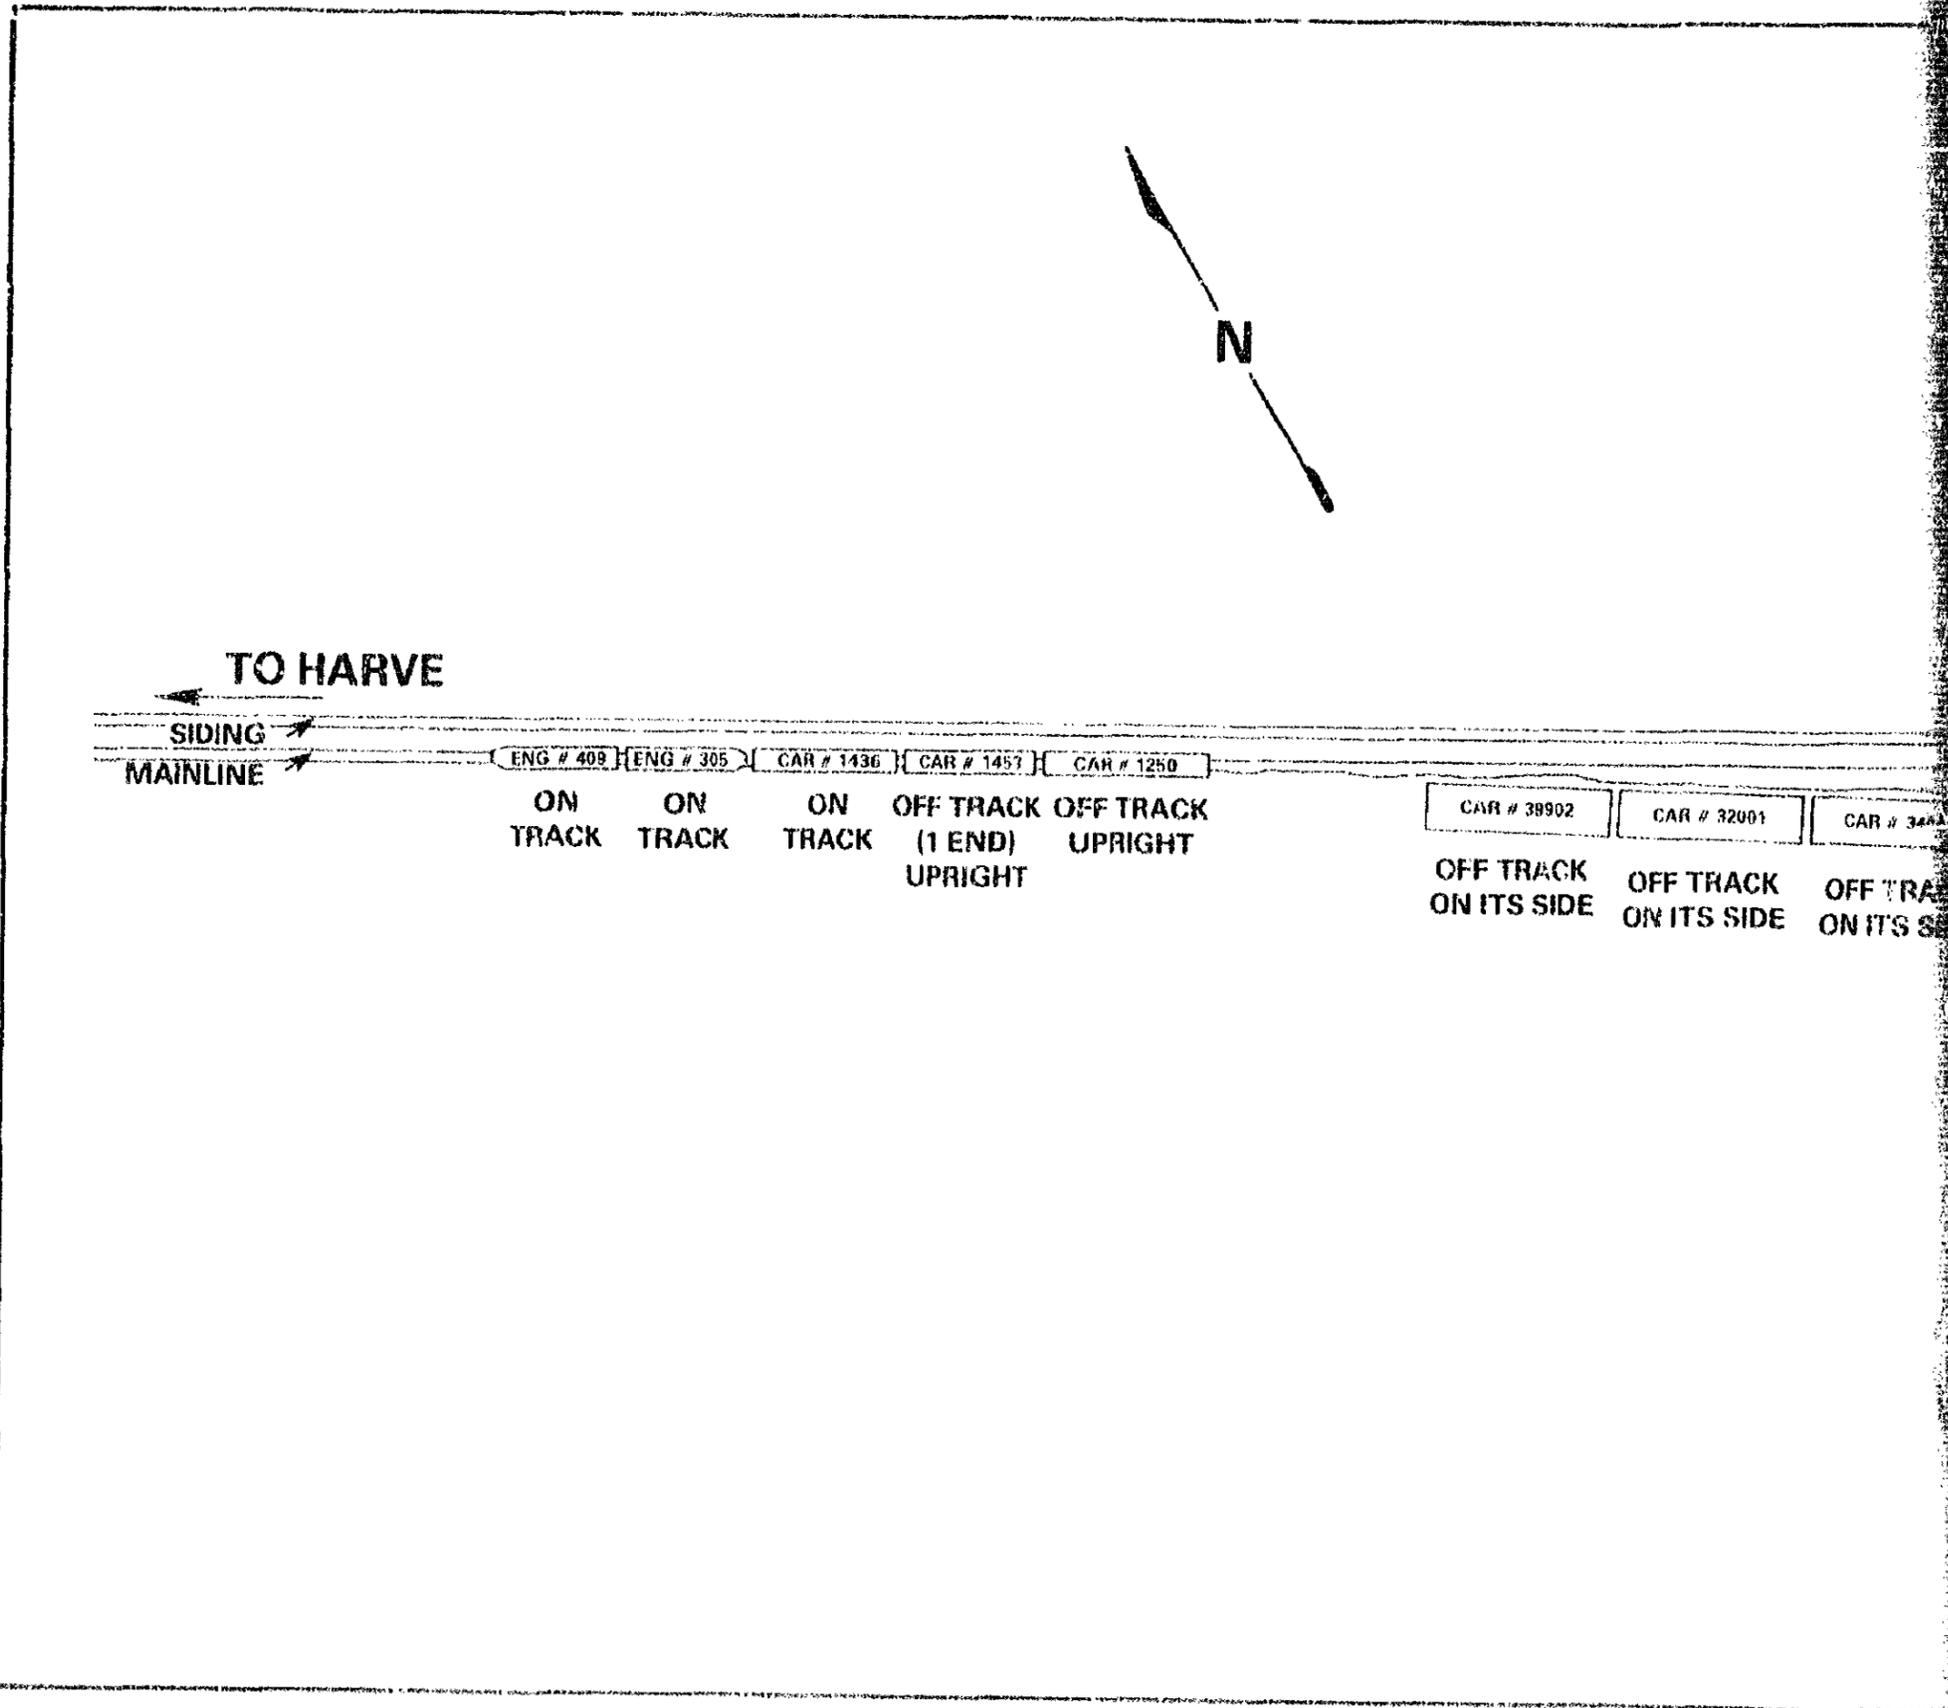
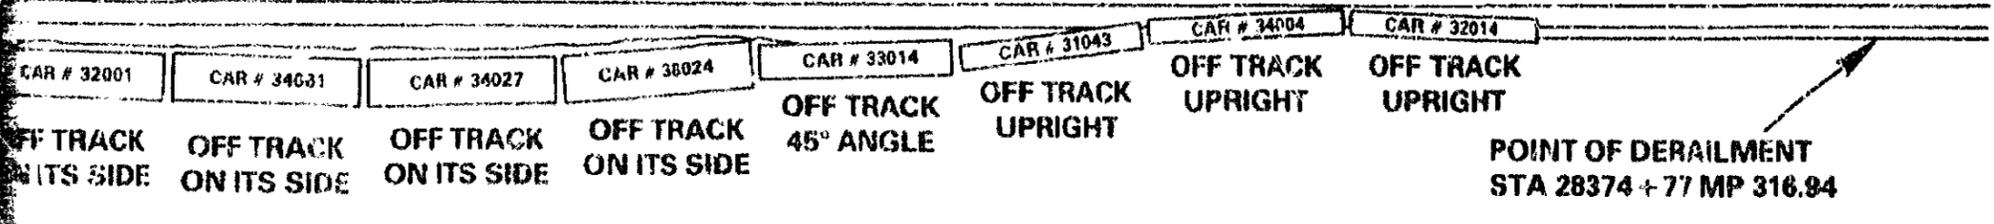
Figure 3. - - Plan view

Eleven cars derailed in the accident. (See appendix B.) About 468 feet of main track was destroyed, and 450 feet of main track was damaged. The damage began at the point of derailment (mp 316.94) and continued westward.

BURLINGTON NORTHERN RAILROAD COMPANY
 MONTANA DIVISION WILLISTON TO JULIEN
 1ST SUBDIVISION 1 & 35
 DERAILMENT SKETCH OF WESTBOUND AMTRAK
 1007 ON 8-5-88 AT SACO MONTANA
 F27 88-MT-019A
 DATE: 8-8-88
 DIVISION ENGINEER: CCK HARVE, MONTANA

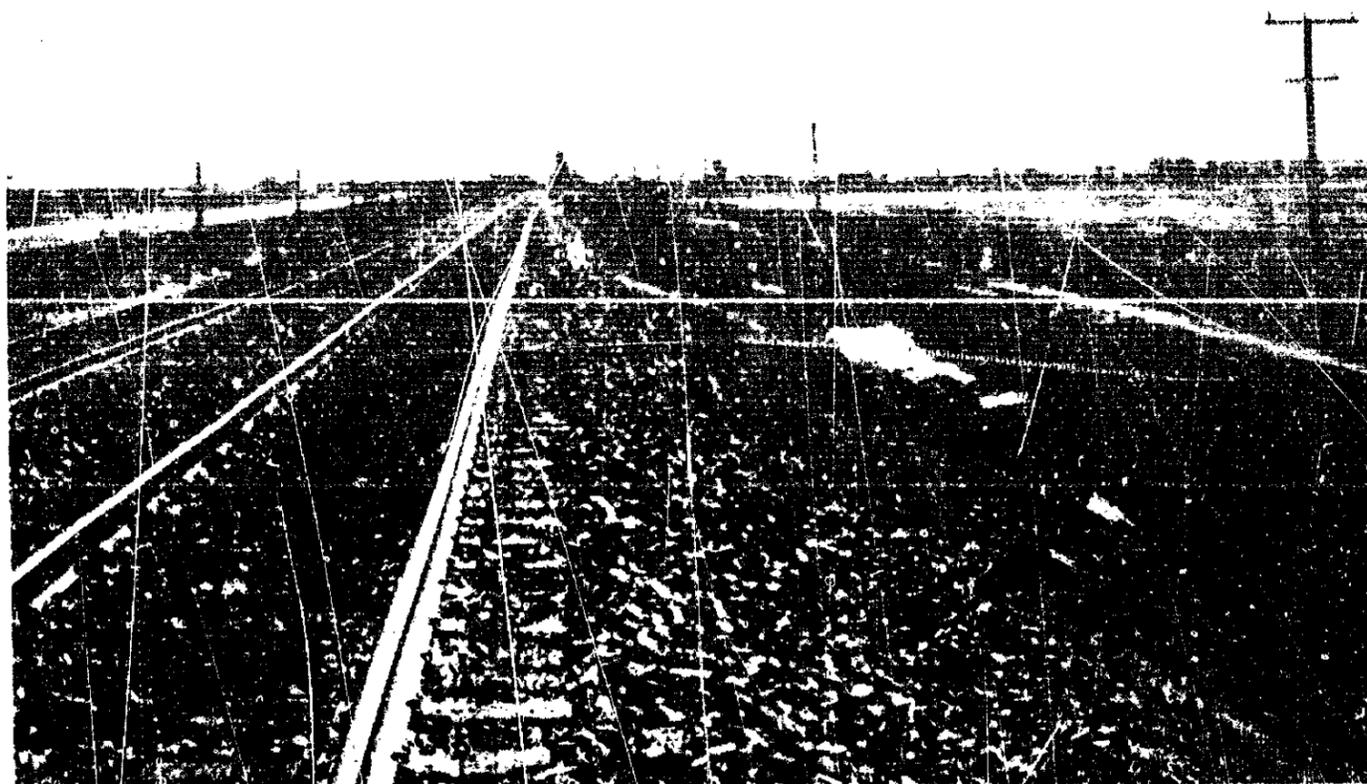
Figure 10.--Eastward view of accident site after track restoration
