NATIONAL TRANSPORTATION SAFETY BOARD

RAILROAD ACCIDENT REPORT

HEAD-ON COLLISION BETWEEN
IOWA INTERSTATE RAILROAD EXTRA 470 WEST
AND EXTRA 406 EAST WITH RELEASE OF
HAZARDOUS MATERIALS
NEAR ALTOONA, IOWA
JULY 30, 1988

NTSB/RAR-89/04

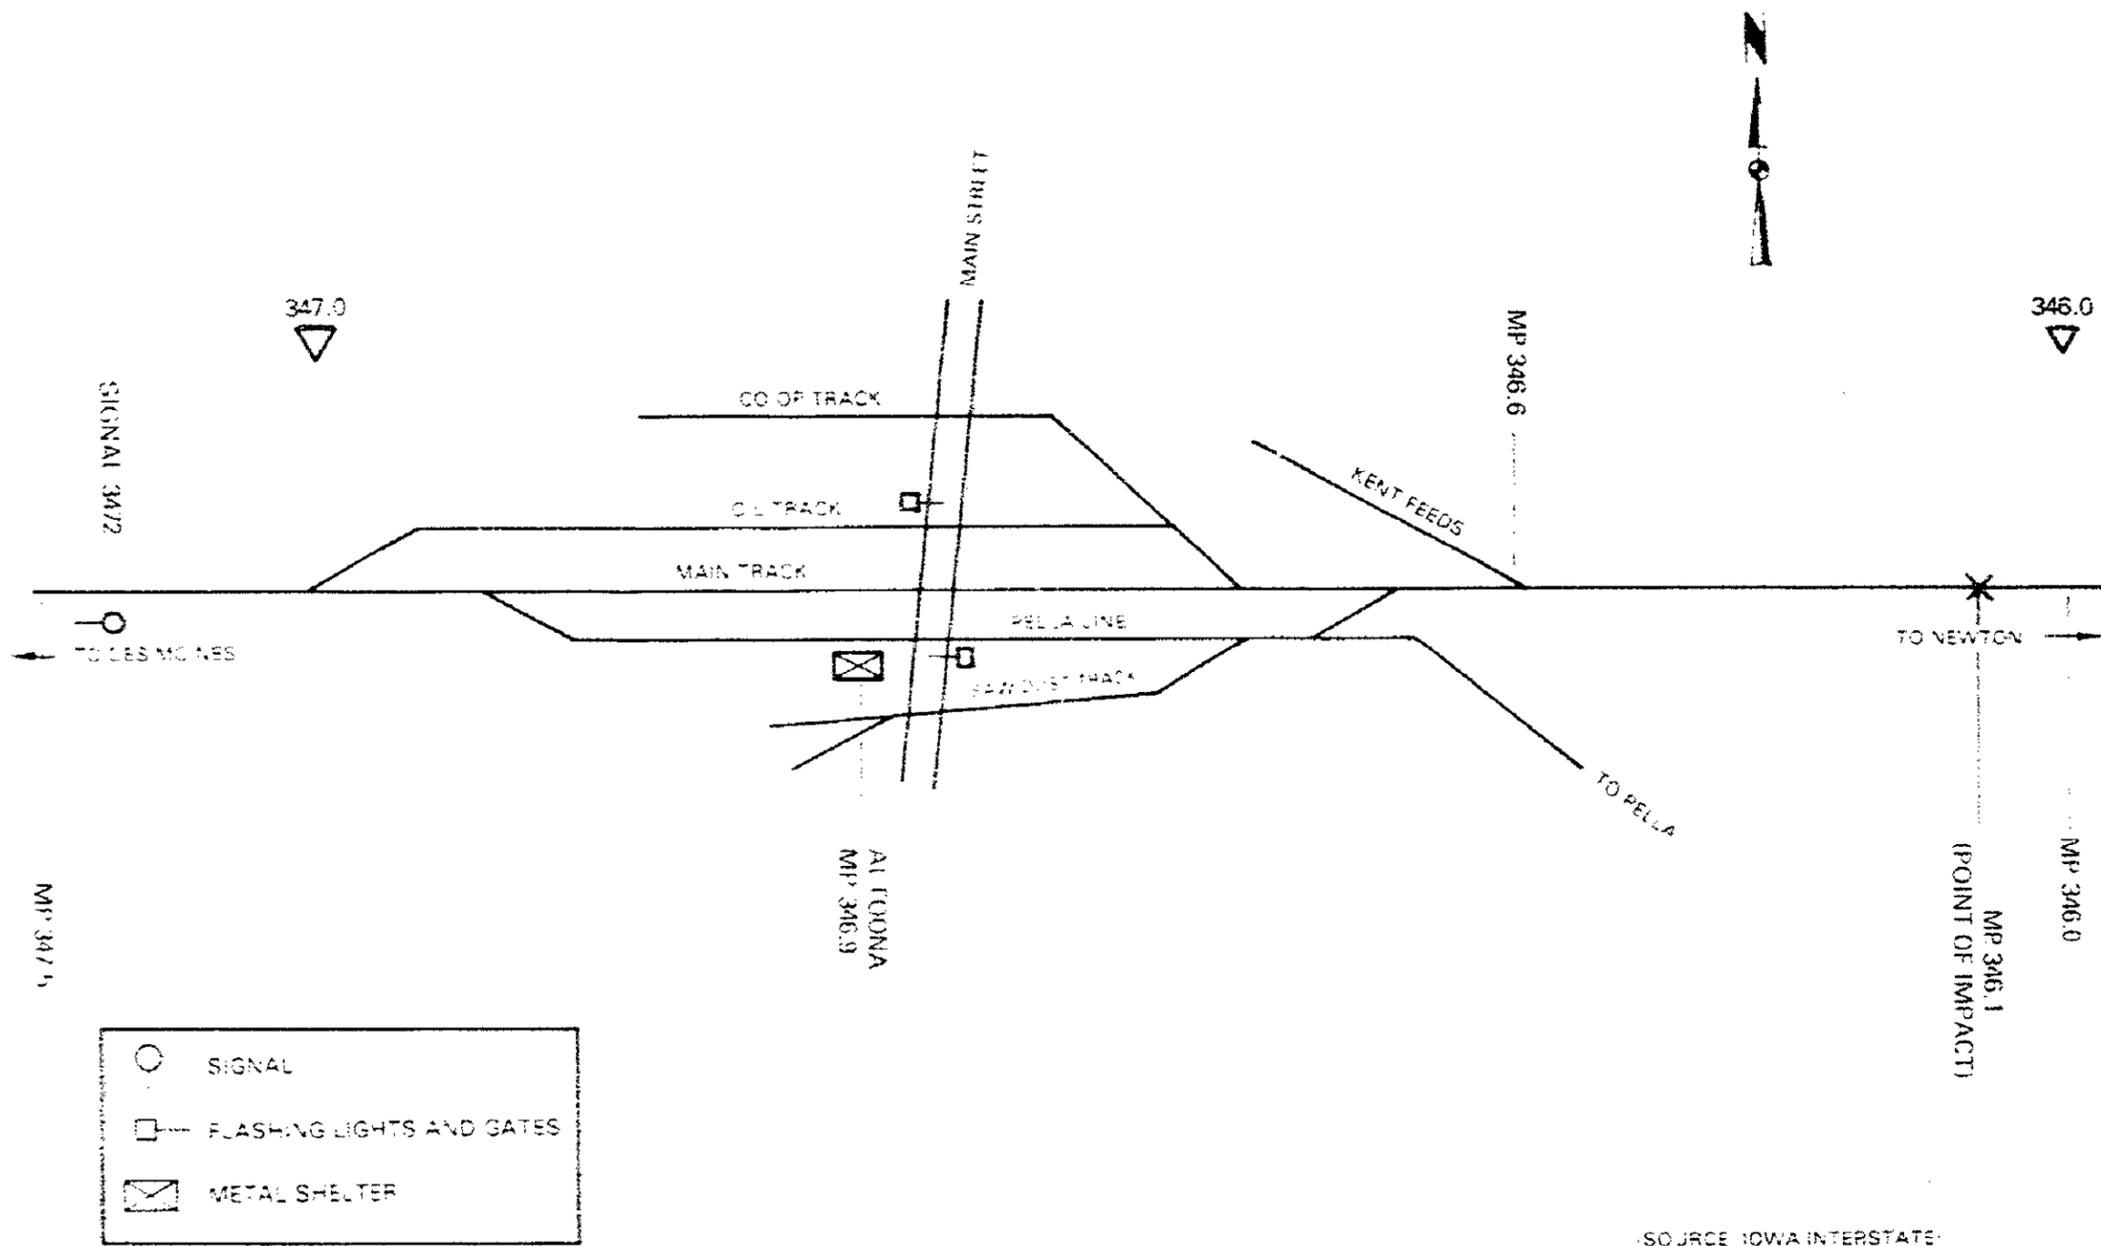
Figure 2.--Layout of Altoona Yard Track.

Safety Board investigators observed that signal No. 3472, located approximately 0.3 mile west of the Altoona station (see figure 2), had not been removed, covered, or turned away from the track.

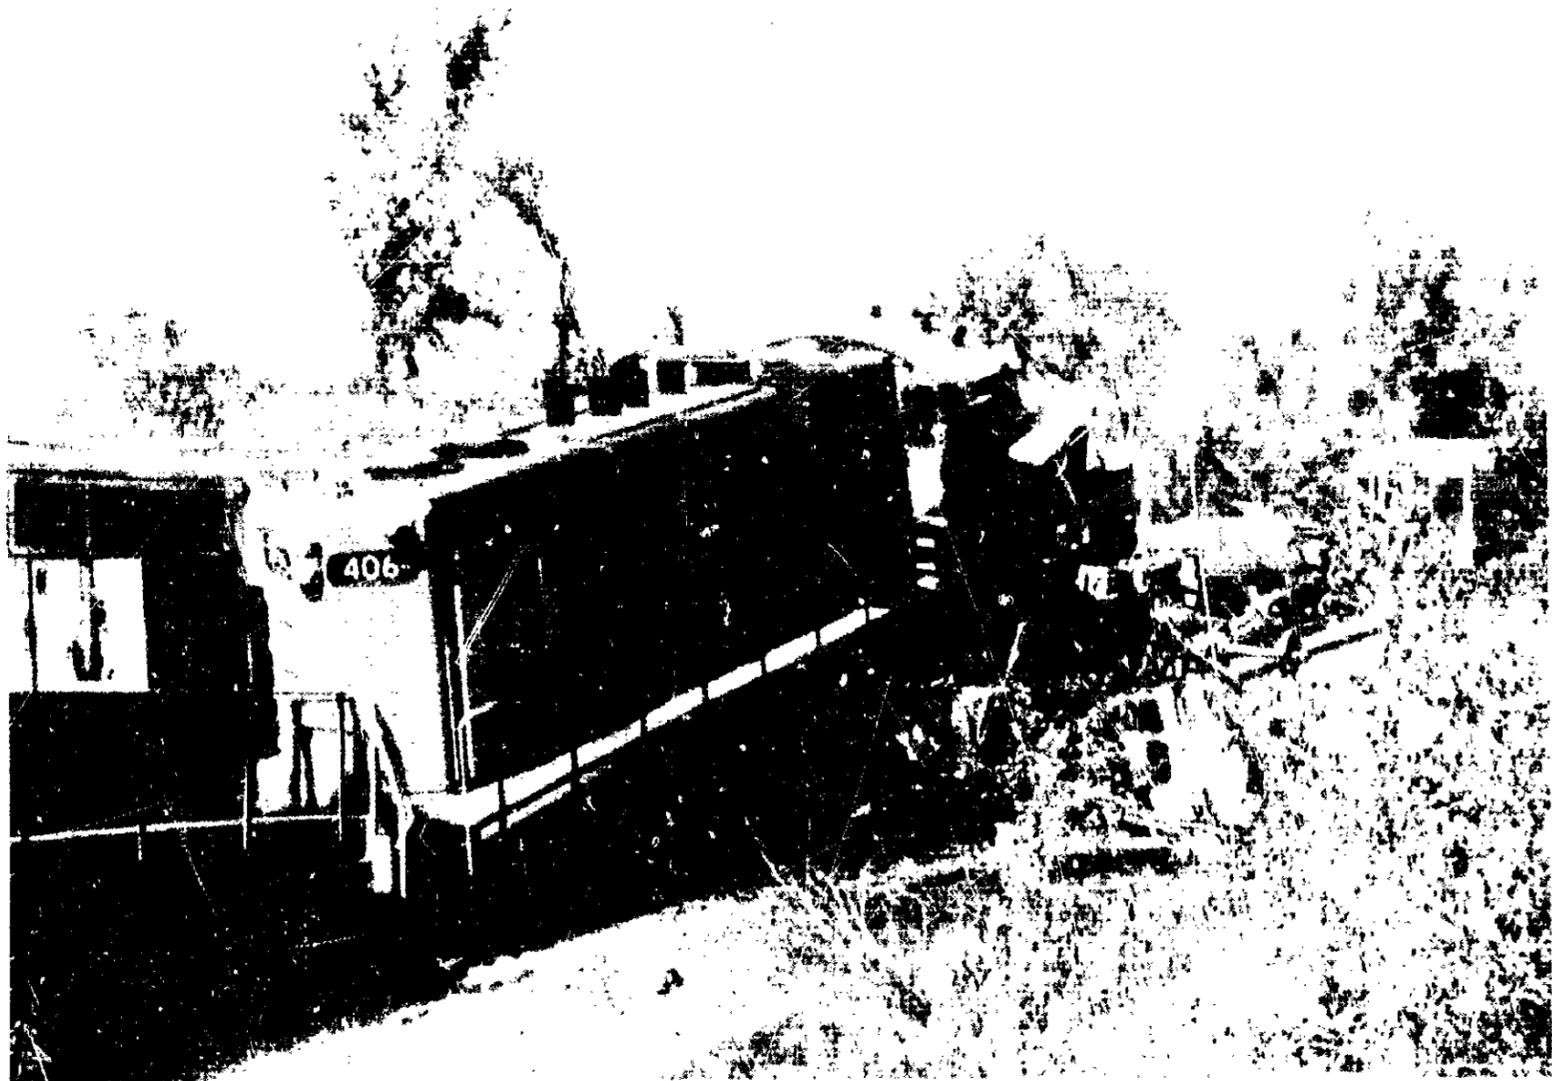
Figure 4.--Unit 406 Overriding Unit of 470 West.

was operating westbound with its long hood forward. As a result, the fuel tank on unit 406 was damaged. With the exception of slight deformation to the rear cab door, the cab compartment structure remained intact. The postcollision fire, however, destroyed the interior of the cab compartment.
