PB91-916301
NTSB/RAR-91/01

RAILROAD ACCIDENT REPORT

**DERAILMENT OF
SOUTHEASTERN PENNSYLVANIA
TRANSPORTATION AUTHORITY (SEPTA)
COMMUTER TRAIN 61
PHILADELPHIA, PENNSYLVANIA
MARCH 7, 1990**

Abstract: This report explains the derailment of Southeastern Pennsylvania Transportation Authority (SEPTA) commuter train 61 in Philadelphia, Pennsylvania, on March 7, 1990. The safety issues discussed in the report are mechanical inspection procedures and maintenance practice oversight, supervision and training of SEPTA employees responsible for transit equipment, failure of the motor support bolt assembly, Federal and State regulatory requirements for mass transit operating practices and mechanical equipment inspectors, effectiveness of SEPTA's drug and alcohol testing program, and emergency communication between operating crews, tower personnel, and emergency response personnel. Recommendations concerning these issues were made to SEPTA, the Governor of Pennsylvania, the Transport Workers Union, and the City of Philadelphia Fire Department.

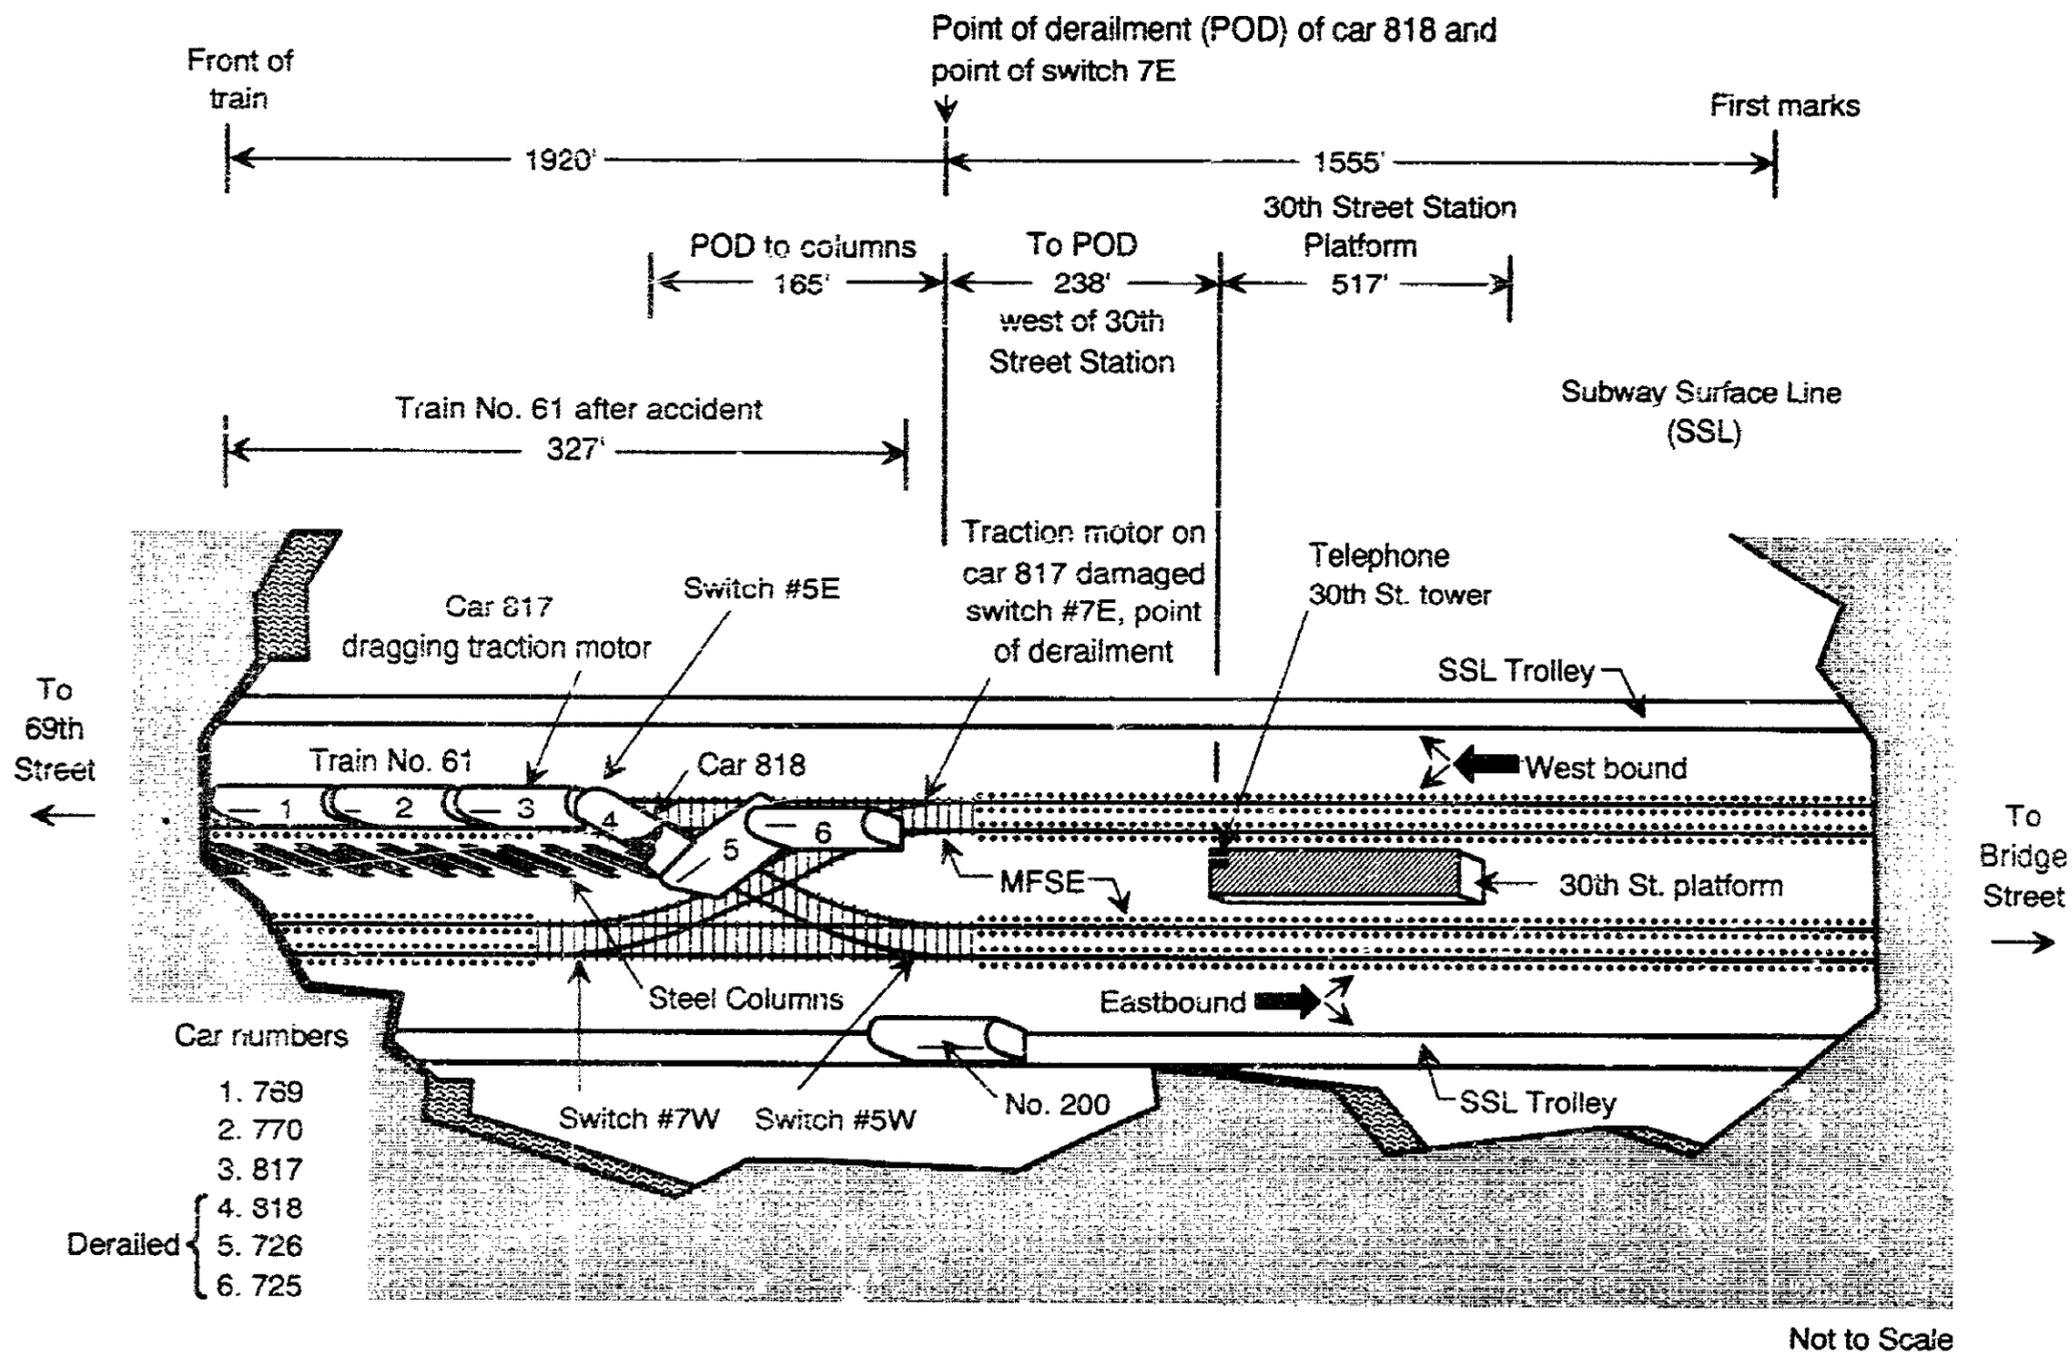
Figure 2.--View of the accident scene at the SEPTA MFSE 30th Street station.

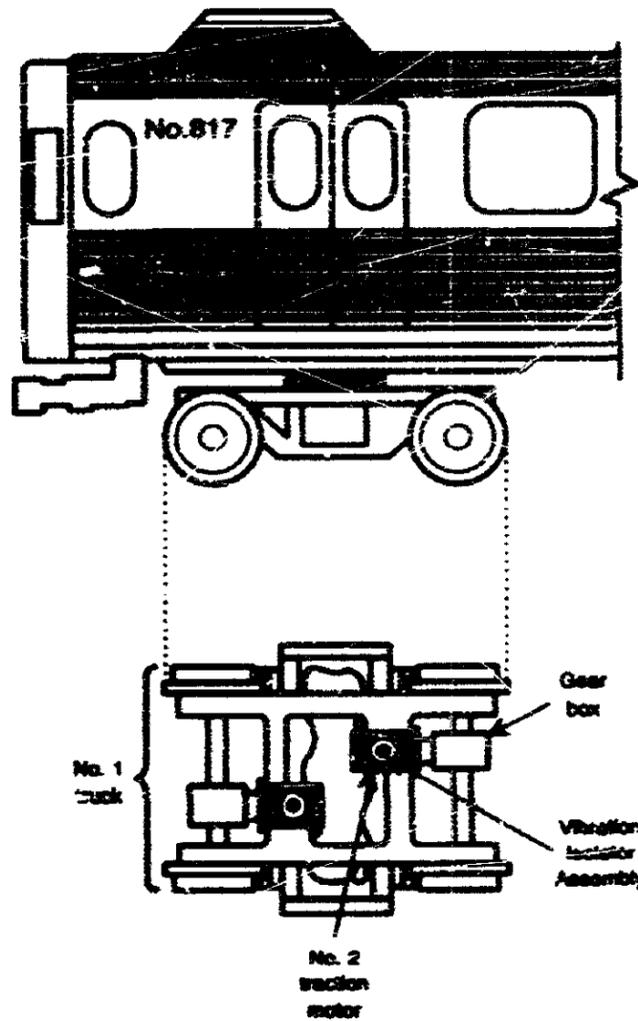
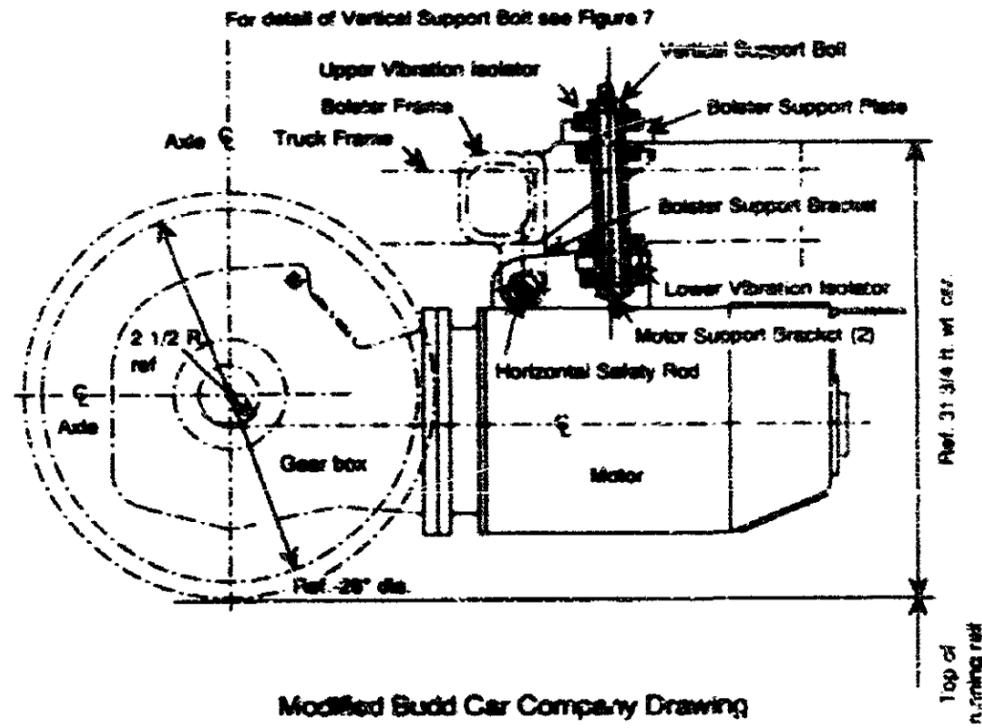
Figure 5.—Truck assembly and traction motor support attachment to truck assembly.

Safety Rod and Traction Motor Support Brackets.--The shank of the horizontal safety rod was extensively worn in two spots. On assembly, the two spots corresponded to the positions of the two vertical members of the motor support brackets. (See figure 5.)

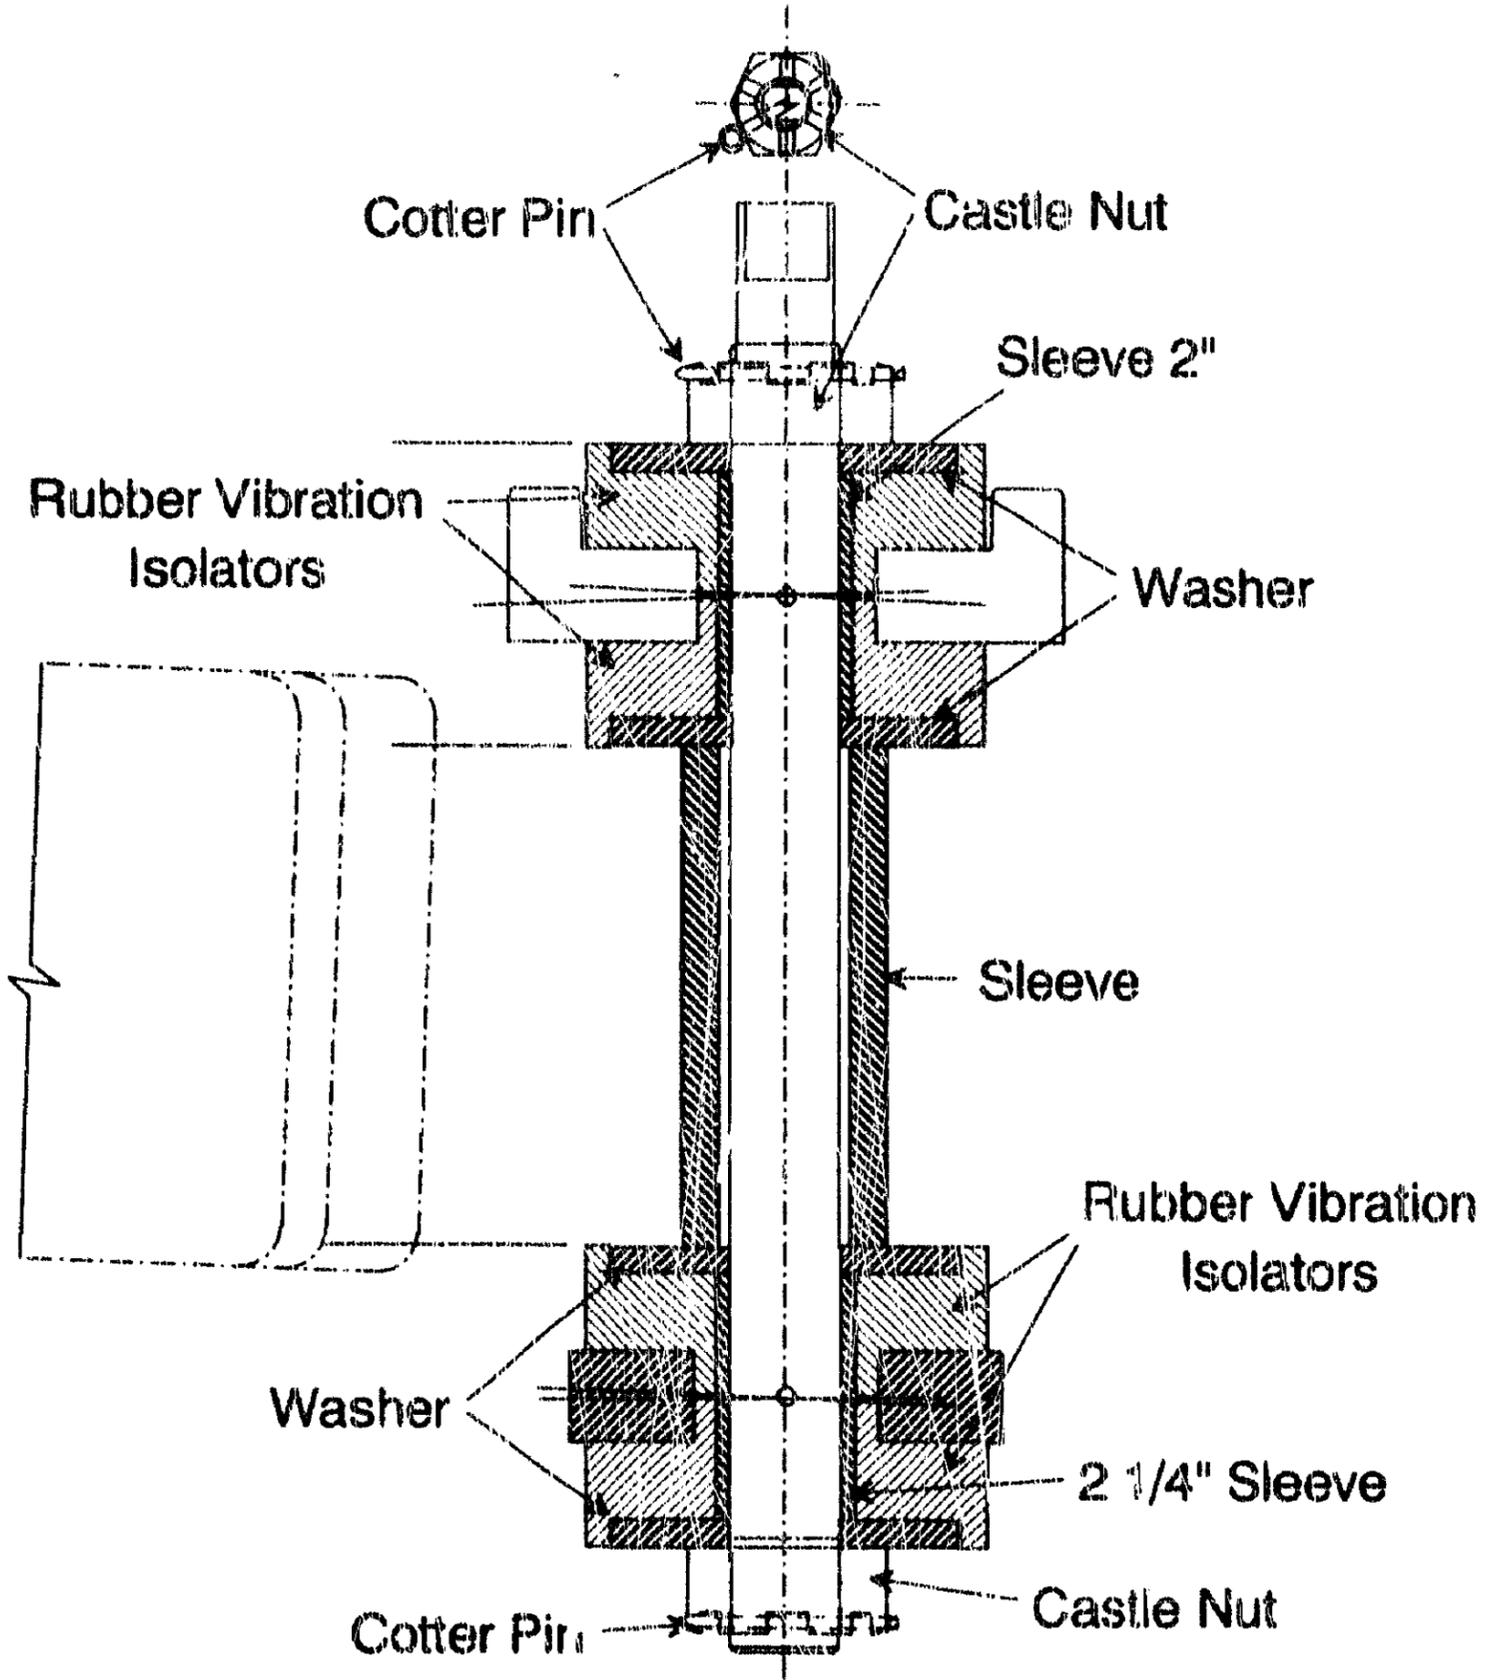
Figure 7.-Budd Car Company vertical support bolt drawing.

Vertical Support Bolt Assembly.--The upper threads on the top portion of the support bolt where it passes through the truck bolster mounting plate were damaged. Fractures indicative of fatigue were noted through numerous thread crowns near and below the cotter pin hole in the bolt. The thread cracking appeared to begin on the downside of the thread with the cracks spreading upward and inward toward the next thread root above. Some cracks clearly began at the thread flank, with cracking almost through to the thread root above. However, in other areas the fatigue fractures were partially obliterated by postfracture mechanical damage. The separated thread crowns in localized areas were moved and deformed into the next higher thread root.

Longitudinal cross sections through the damaged threads in the upper area of the vertical support bolt showed some evidence of thread deformation directions. For the threads above the cotter pin at the top of the vertical support bolt, thread deformation was in both directions. The first appeared in the upward direction, followed by deformation in the downward direction. For those threads below the cotter pin hole at the top of the bolt, the deformation was in the upward direction against the thread flank.

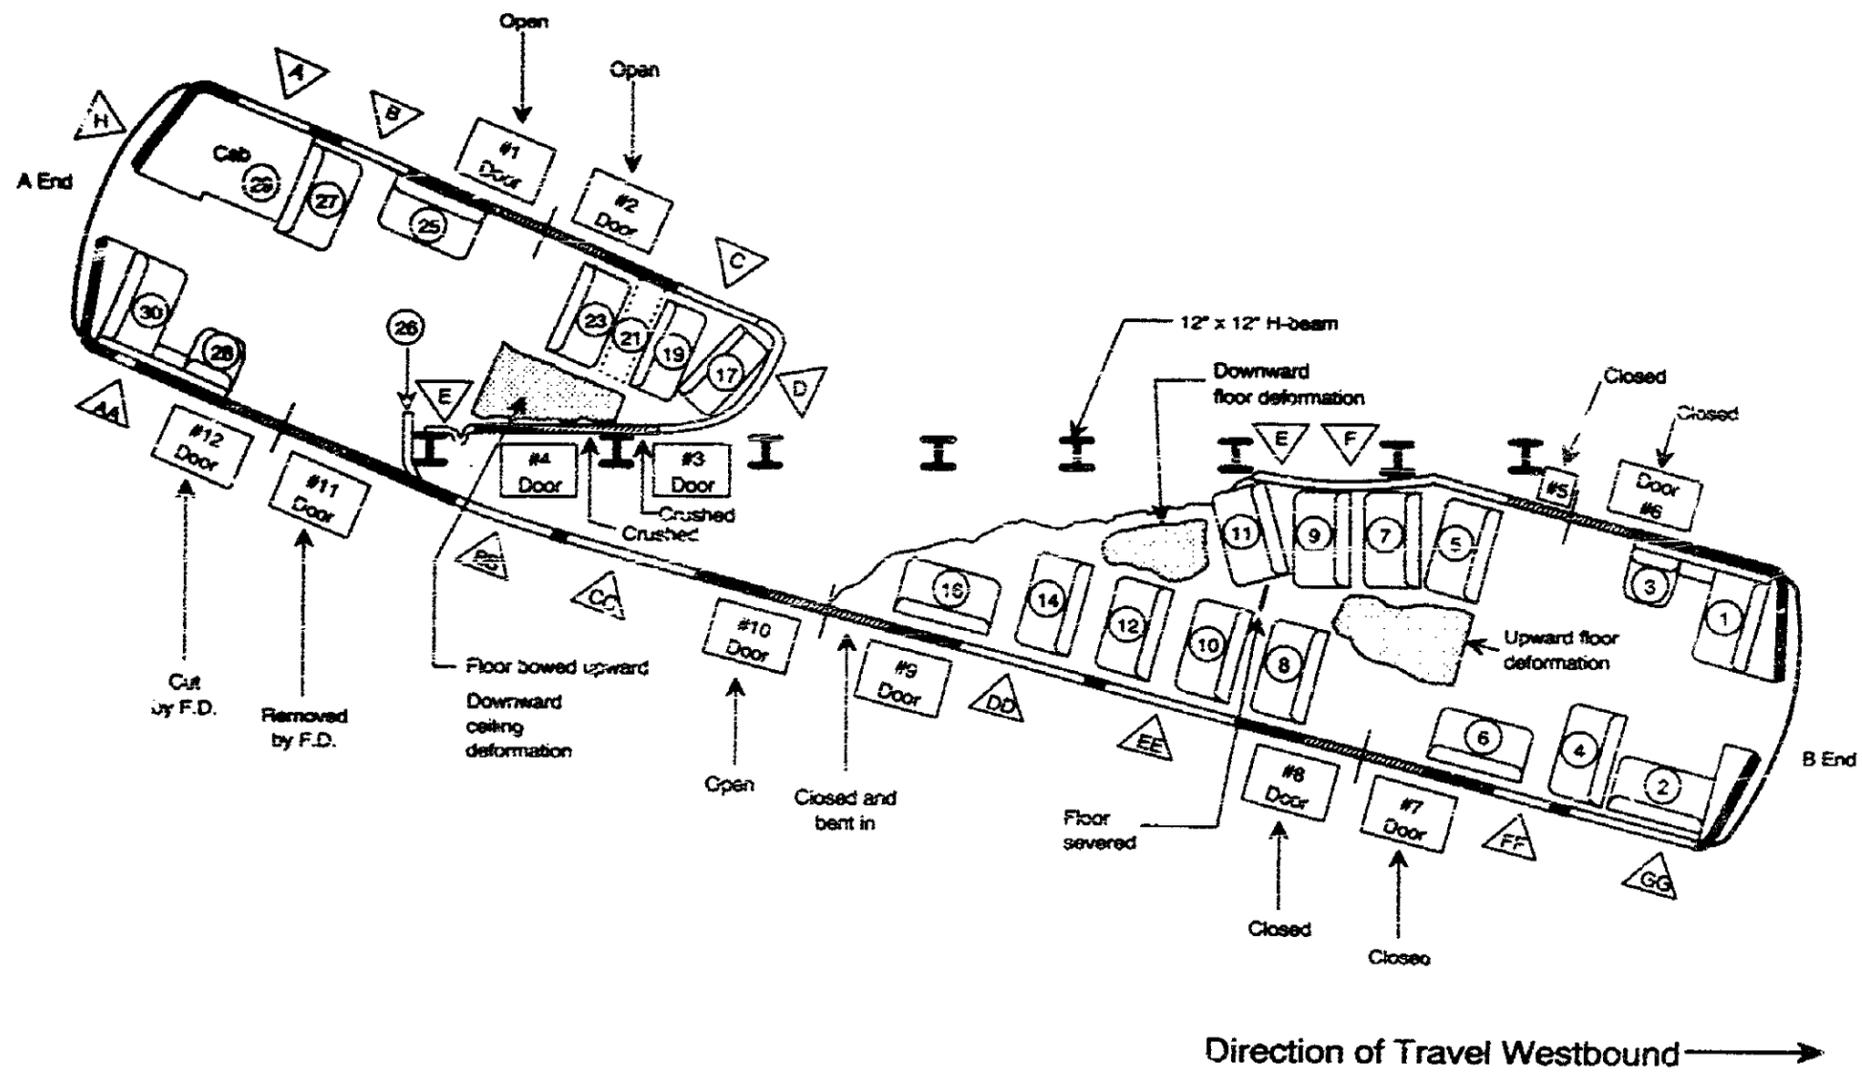
The first three cars (769, 770, and 817) were not derailed. The fourth car (818) derailed in the crossover between the eastbound and the westbound tracks. The lead truck wheels of the sixth car (725) were derailed in the crossover on the westbound track. This car's rear truck wheels were on the closure rails of the turnout. The fifth car (726) was derailed in the crossover. The left side of car 818 (the fourth car) collided with steel 12-inch by 12-inch H beam uprights that were 165 feet west of switch 7E. The car's body was sheared open for 30 feet and was almost severed near the midpoint. (See figures 8 and 9.)

The ceiling panels of car 818 had several cracks between the B end and the first vent fan. The ceiling between the first and second fan had cracks on the right panel. The left panel was missing. Insulation and roof structure were hanging into the

Figure 8.--Damage profile of car 818.

passenger compartment. The ceiling panels between the third and fourth fans were destroyed, and the roof structure was hanging into the passenger compartment. The roof had been pushed down until it was only 55 inches (a little more than 4 1/2 feet) above the floor. The panel between the fourth fan and the A end showed minor cracking. Ninety percent of the interior lights were shattered or missing. The only vertical grab rails that remained secured to the ceiling were between the fourth ceiling fan and the A end.
