PB91-916304  
NTSB/RAR-91/04

# NATIONAL TRANSPORTATION SAFETY BOARD

## RAILROAD ACCIDENT REPORT

DERAILMENT OF  
CSX TRANSPORTATION INC. FREIGHT TRAIN  
AND HAZARDOUS MATERIALS RELEASE  
NEAR FREELAND, MICHIGAN  
ON JULY 22, 1989

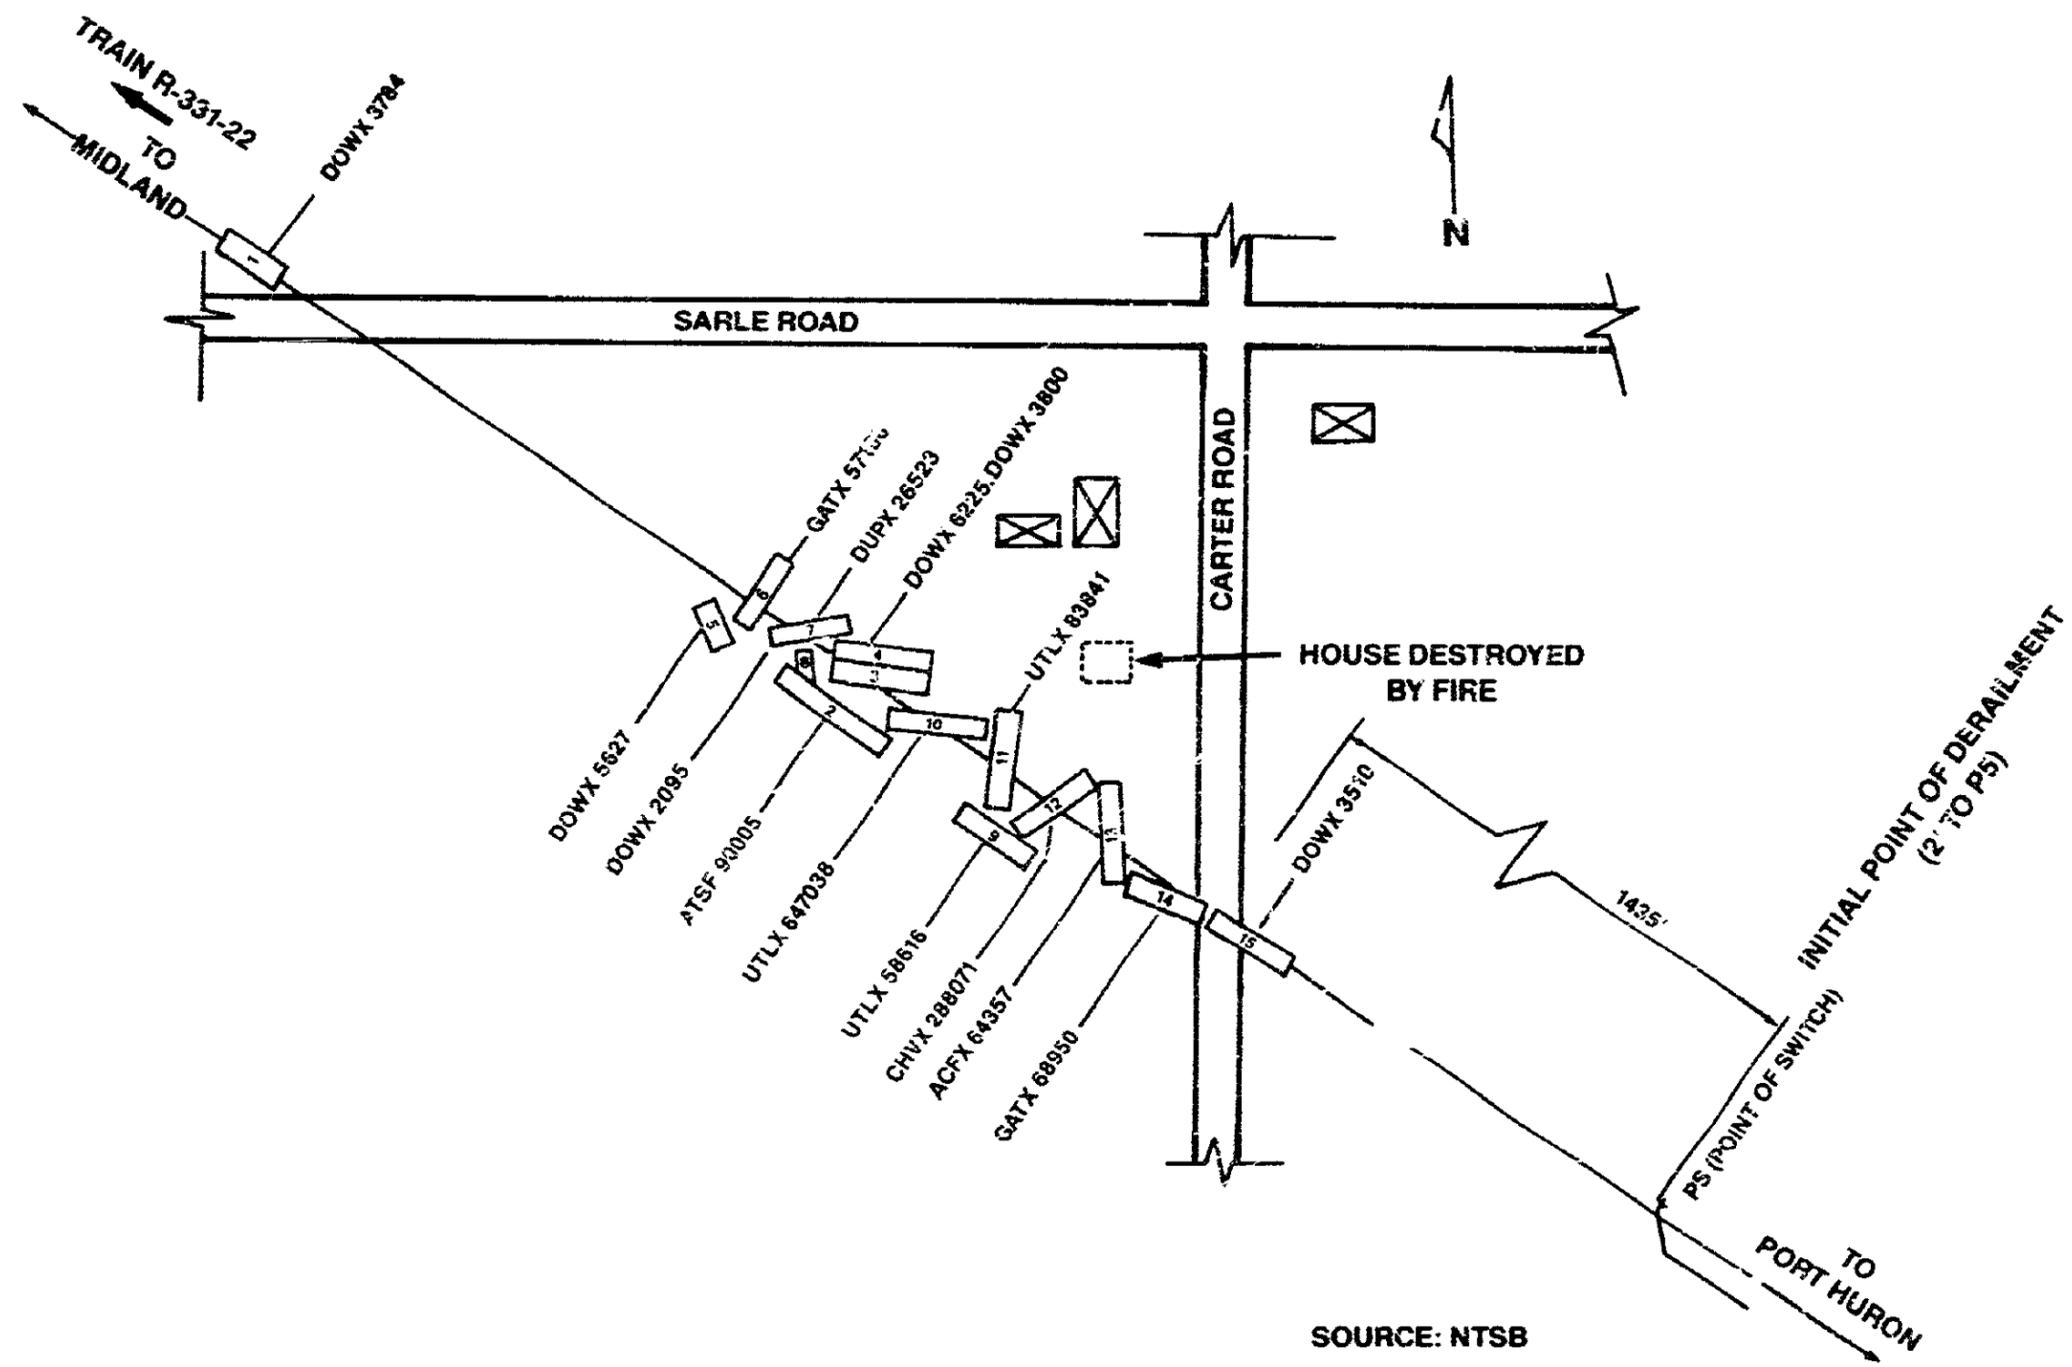
Figure 4.--Identification of derailed cars, freight train R-331-22.

GATX 57100, DOT 111A100W (6th car), was not equipped with a head shield (a supplemental heavy steel plate on the end(s) of a car) or a jacket (a thin outer shell used to contain insulating material wrapped around the tank); the underframe and the left side at the B-end were severely dented and scraped, the outer leg for the bottom outlet was missing (the leg failed at the shear bolts that attached it to the tank), the A-end head was dented above the center line of the car and the B-end was dented below the centerline of the car, the A-end sill was broken, one coupler was disengaged, and one coupler was broken. The trucks were destroyed.

DUPX 26523, DOT 112A200W (7th car), was not equipped with head shields or a jacket; both ends and the tank shell were dented and scraped (the dent in the A-end head was 14 inches deep and 5 feet in diameter), the A-end sill was bent and buckled, the A-end coupler was disengaged, the B-end knuckle was broken, and the B-end body bolster was bent. Both trucks were derailed.

UTLX 647038, DOT 111A100W6 (10th car), was not equipped with head shields and had a jacket and thermal insulation; the right side of the tank had a 3-inch by 6-inch hole near the B-end (about 2 inches from the seam), the A-end stub sill was bent downward and spread open, the jacket had deep dents in both ends, the jacket was torn near the B-end saddle bracket and at the middle of the car, burn damage to the jacket was extensive,

UTLX 83841, DOT 105A300W (11th car), was not equipped with a head shield but did have a jacket. Both stub sills were damaged, the B-end sill was broken off and missing beyond the end of the car, and the A-end sill was bent downward at approximately a 20-degree angle. Almost all of the B-end head above the centerline of the car was punctured, and the head was severely dented below the centerline. Fire damage to the jacket was extensive. Both couplers were broken, and both trucks were destroyed.

CHVX 288071, DOT 111A100W1 (12th car), was not equipped with head shields but did have a jacket and thermal insulation; the B-end tank head had a 10-inch by 14-inch puncture below the centerline of the car and was dented above and below the centerline, the A-end tank head was dented above and below the centerline of the car, the jacket was dented and scraped near the sill on the B-end, and the jacket was extensively burned on the B-end and partially burned on the A-end. Both couplers were disengaged. The trucks were destroyed.

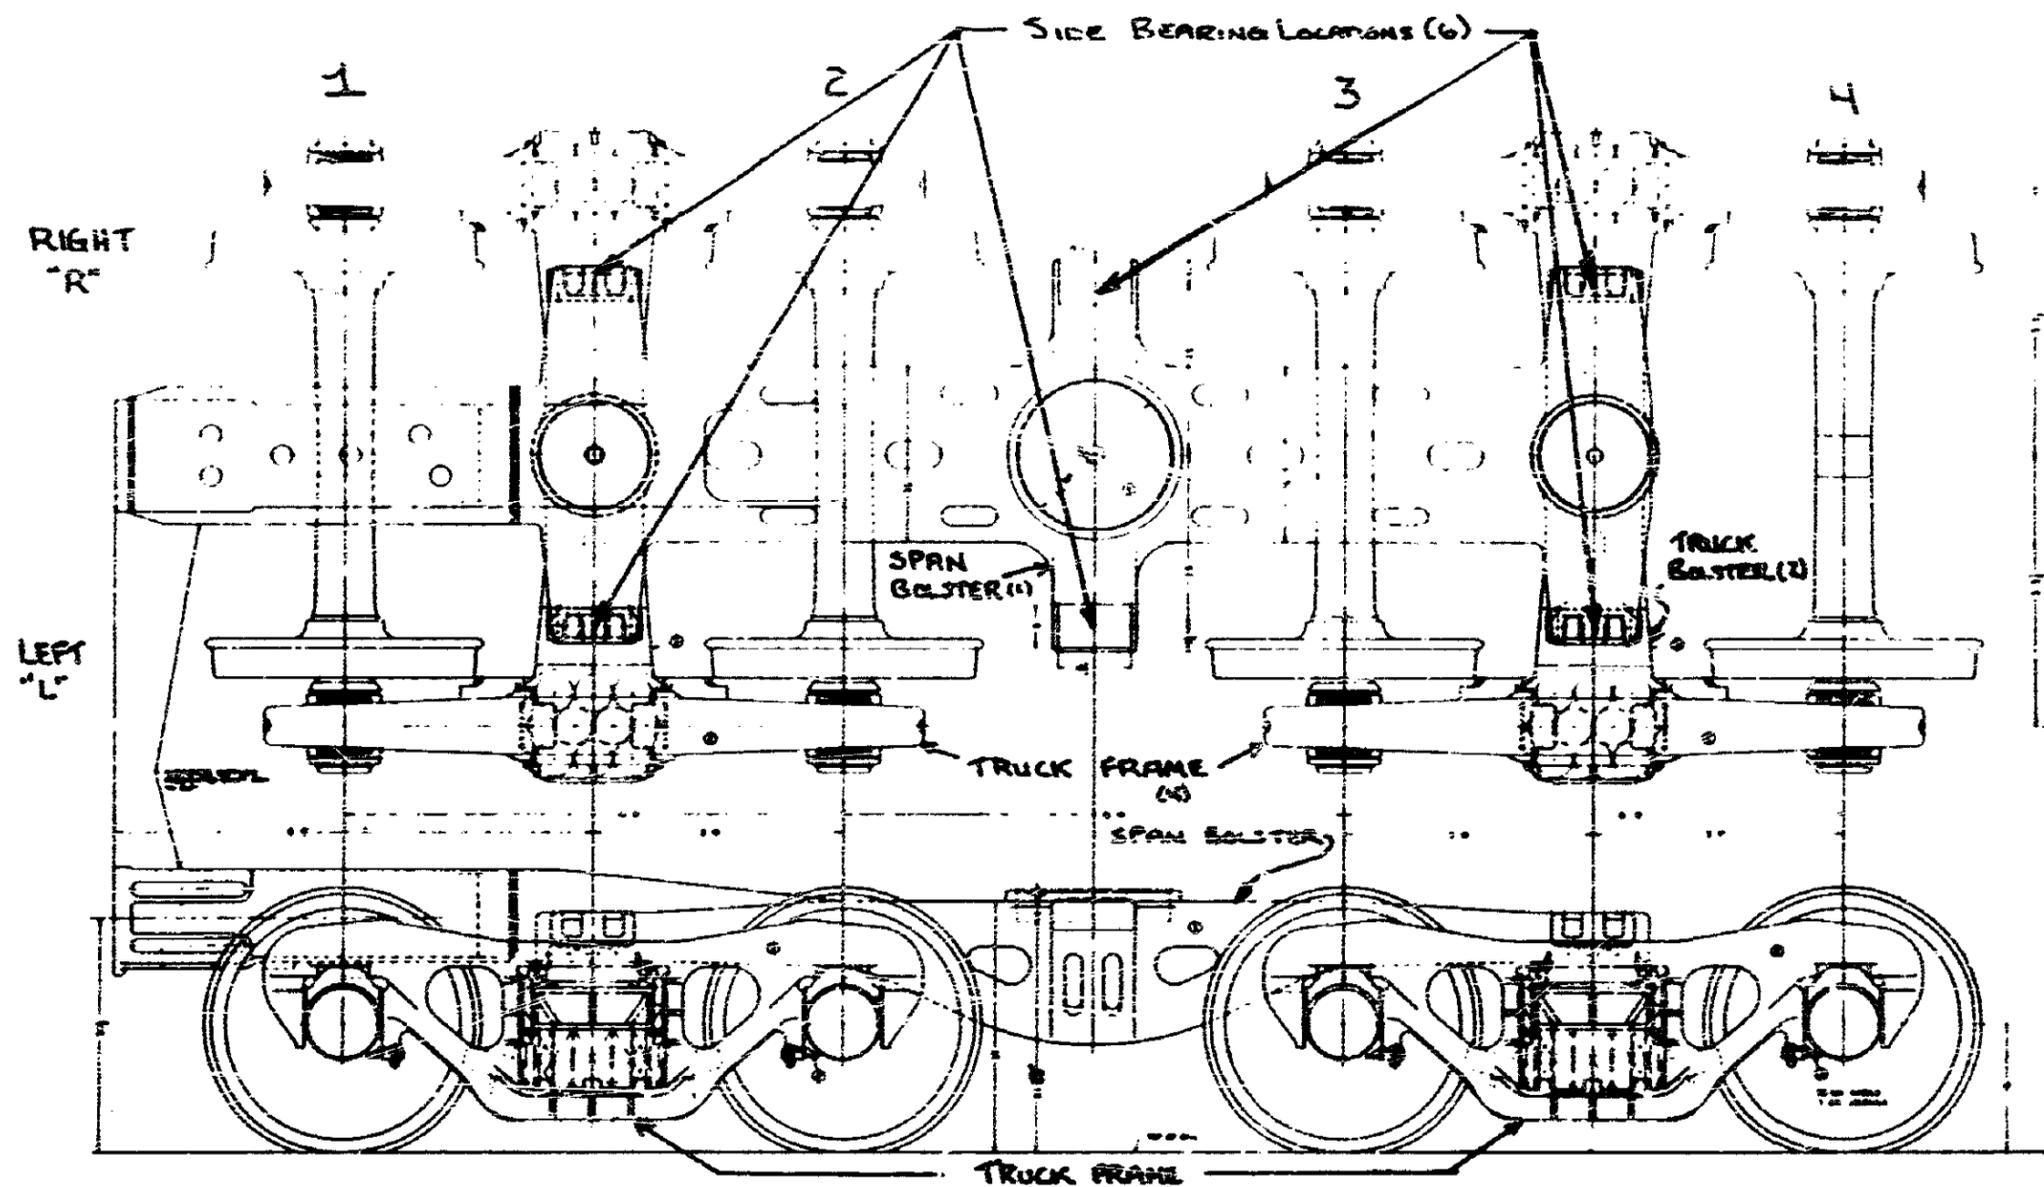
The car had hanger-type brake beams. The brake shoes on both B-end trucks had been overriding.<sup>7</sup> The R1, L2, R3, and L4 had been overriding the wheel flanges; the L1, R2, L3, and R4 had been overriding the outside edge of the wheel rims. The overriding brake shoes were at diagonally opposite locations on each truck. The shoes contacting the wheel flanges had contoured to the flange profile, and some were worn about 50 percent cross-sectionally through the brake shoe.

Part of the R2 wheel flange had worn away continuously around the circumference at the point of wheel-rail interface. The wear angle formed at the juncture of the tread and flange was sharply defined, and no metal extruded onto the flange. Wear began near the apex of the wheel flange, extended inward toward the hub, and ended about 3/8 inch above the tread surface at the throat of the flange. The wear surface face was smooth, and the fracture surface of the interior wear surface edge was irregular. The interior edge was about 1/16 inch from a perpendicular at the base of the wheel flange.

When ATSF 90005 was rebuilt in February 1989, according to information provided by ATSF, "it was necessary to place three-sixteenths (3/16) inch to one-quarter (1/4) inch shims in the center bowl of the span bolster on the end of the car that had no side bearing clearance." ATSF stated that "this was done after the original record of repairs was completed and, through inadvertence, no supplemental or amended record was made." No shims were found during the investigation and reassembly of the trucks following the accident.

Figure 7.--Railcar truck assembly configuration.

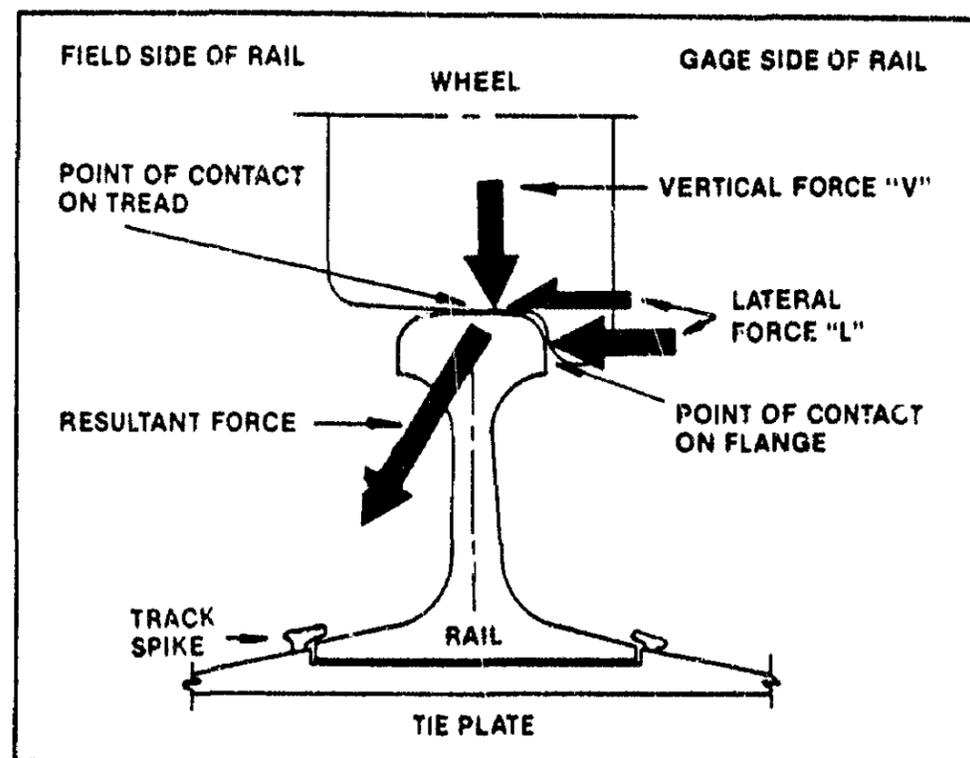
According to the AAR Steering Committee for the Track Train Dynamics Program,<sup>30</sup> wheel lift derailments, which are related to the forces present at the wheel-rail interface, may be associated with track-train dynamics (see figure 9):

The reaction of forces at the wheel-rail interface will determine the tendency for a wheel to derail. The term commonly used to identify this reaction is  $L/V$  (L over V) [lateral to vertical force] ratio as shown in [figure 9]. The greater this ratio becomes, the greater the likelihood of derailment.

Figure 9.--Lateral to vertical force relationship between rail and wheel.
