PB91-916305  
NTSB/RAR-91/05

**RAILROAD ACCIDENT REPORT**

**DERAILMENT OF AMTRAK TRAIN NO. 6  
ON THE BURLINGTON NORTHERN RAILROAD  
BATAVIA, IOWA  
APRIL 23, 1990**

**Abstract:** This report explains the derailment of Amtrak Train No. 6 on the Burlington Northern Railroad at Batavia, Iowa, on April 23, 1990. The safety issues discussed in this report are: the lack of consistency, continuity, and comprehensiveness in Burlington Northern's Maintenance of Way Standard Practice Circulars; the efficacy of the rail expansion and contraction tables in Burlington Northern's Maintenance of Way Rules for in-track electric flash butt-welding operations; the propriety of conducting in-track electric flash butt-welding operations and out of face maintenance operations in cold weather; the effectiveness of Burlington Northern's track buckling prevention seminar for the in-track electric flash butt-welding operation; the adequacy of Burlington Northern's supervision of in-track electric flash butt-welding operations and implementation of maintenance of way standards; the ambiguity of Burlington Northern's rail temperature record form; and the lack of temperature quality control measures such

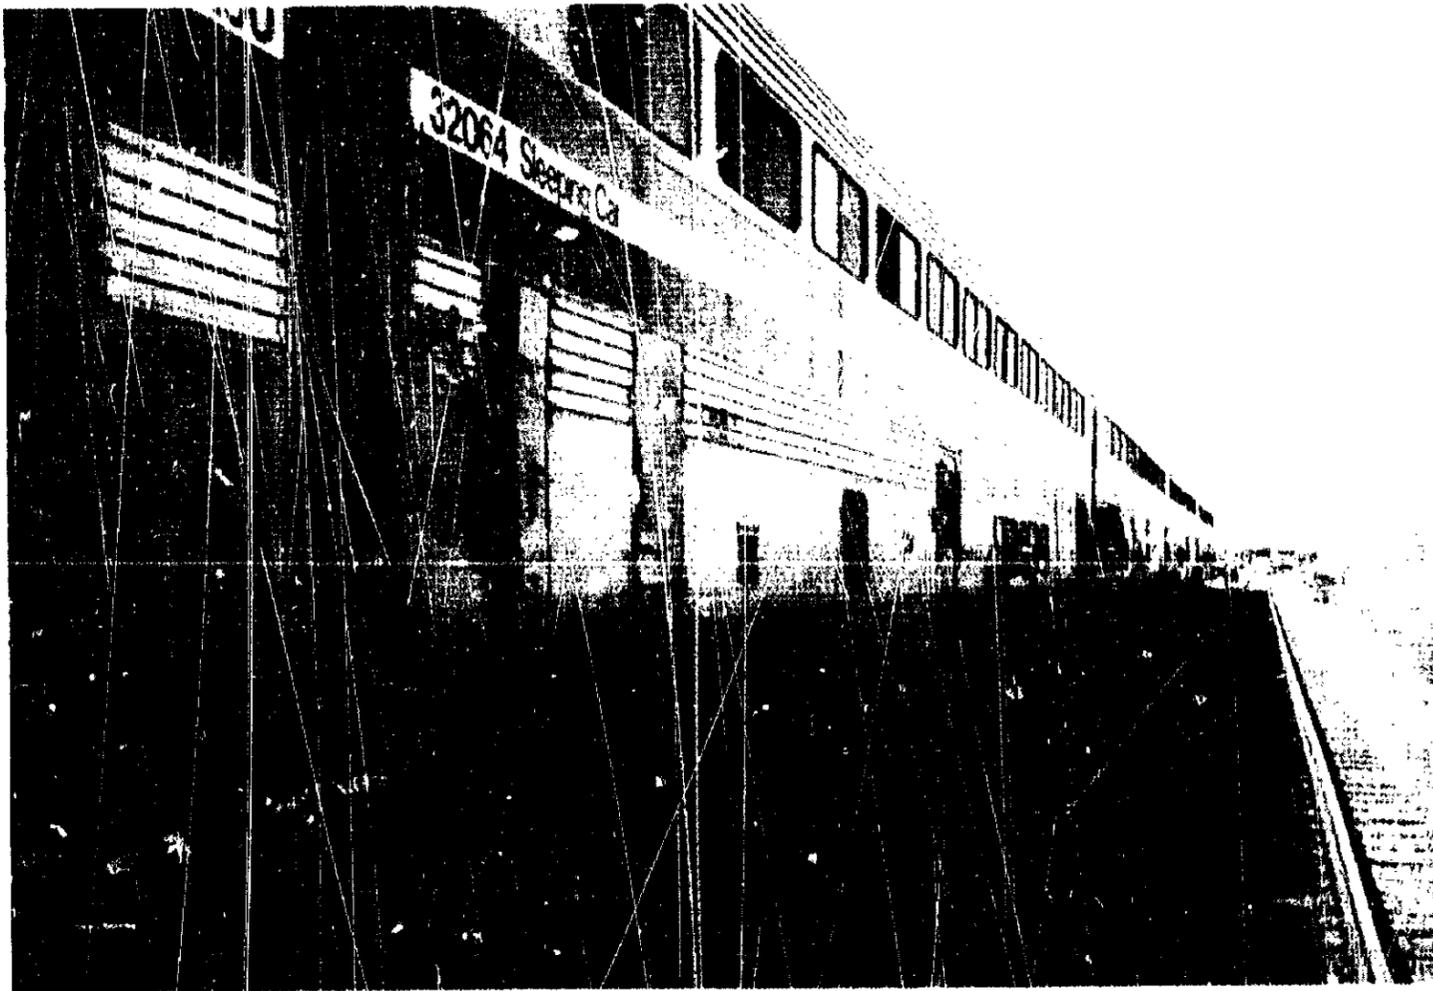
Figure 5.--Damage to coach and sleeping cars.

the gondola ripped large gashes in the trailing half of the last two cars on their south sides just below the top/lower deck separation. (See figure 5.)

These last two cars, coach No. 34001 and sleeping car No. 32046, had significant interior damage. Coach No. 34001 had interior and exterior wall damage from the upper level floor starting at seats 75-76 on the right (south) side and continuing to seats 83-84 at the end of the car. In sleeping car No. 32046, the interior and exterior walls of rooms 14 and 15 were destroyed, along with the car's stairwell.

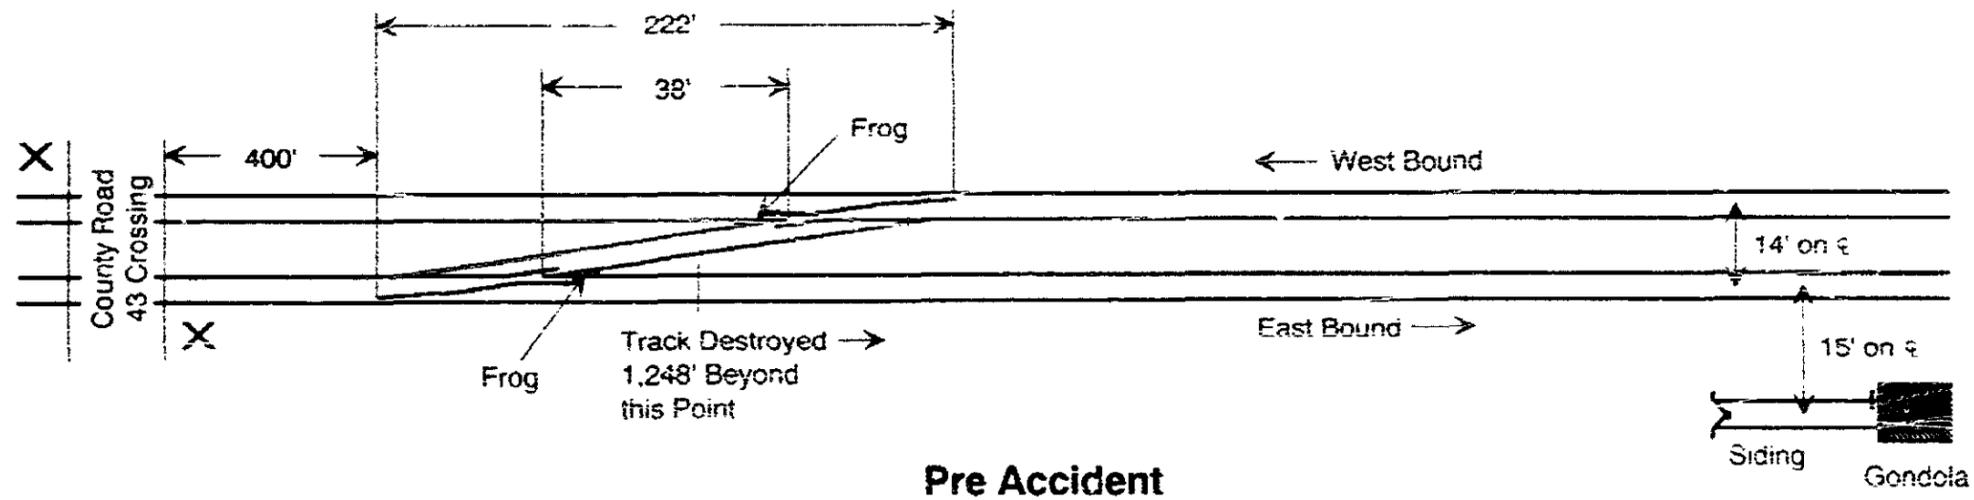
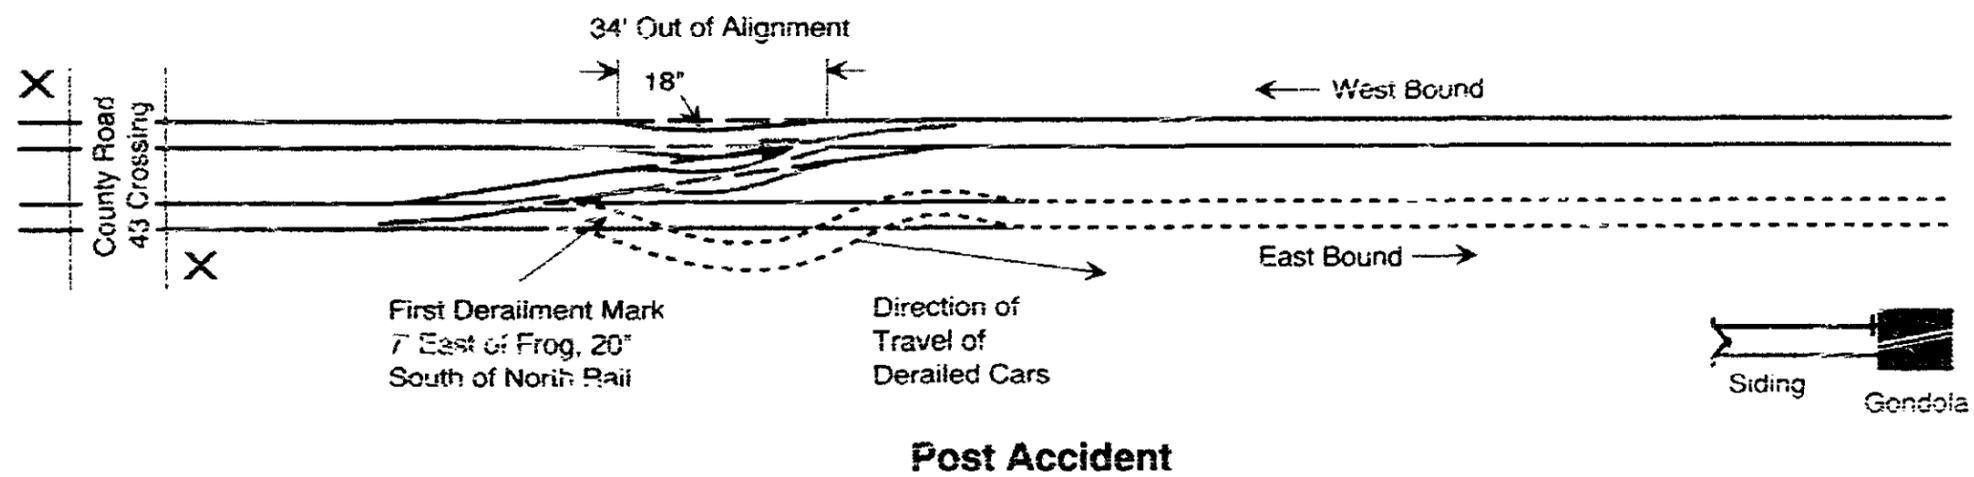
Figure 8.--Accident site track alignment.

**Postaccident Track Inspection.**--About 3 hours after the derailment, an IDOT track inspector arrived at the accident site. He had been a State track inspector since 1974 and was familiar with the Batavia area. The IDOT inspector noted that the ties near the frog of the crossover turnout on the eastbound main were out of alignment and had been 12 inches further south before being pulled back toward their original position by the derailing train. This side movement included about 30 feet of track structure on either side of the frog. Based on this evidence, he concluded that the derailment had occurred underneath the train and that the force of the train's forward movement had tended to straighten the track back into alignment. (See figure 8.)
