**NATIONAL
TRANSPORTATION
SAFETY
BOARD**

**RAILROAD ACCIDENT/INCIDENT
SUMMARY REPORT**

KNOX, INDIANA - SEPTEMBER 17, 1991

Accident Number: DCA-91-MR-010
Location: Knox, Indiana
Date and Time: September 17, 1991, 8 a.m.
Railroad: central daylight time (CDT)
Type of Trains: Norfolk Southern (NS)
Persons on Board: Train 277, container-on-flat-car;
Injuries: train 629, molten sulphur tank cars
Damage: Train 277 and train 629 had three crewmembers
Type of Occurrence: each
Phase of Operation: One death, one serious injury, and four minor
injuries
\$3.5 million
Head-on collision, derailment, and hazardous-
materials release
Train 277--en route west on single main track; train
629--en route east

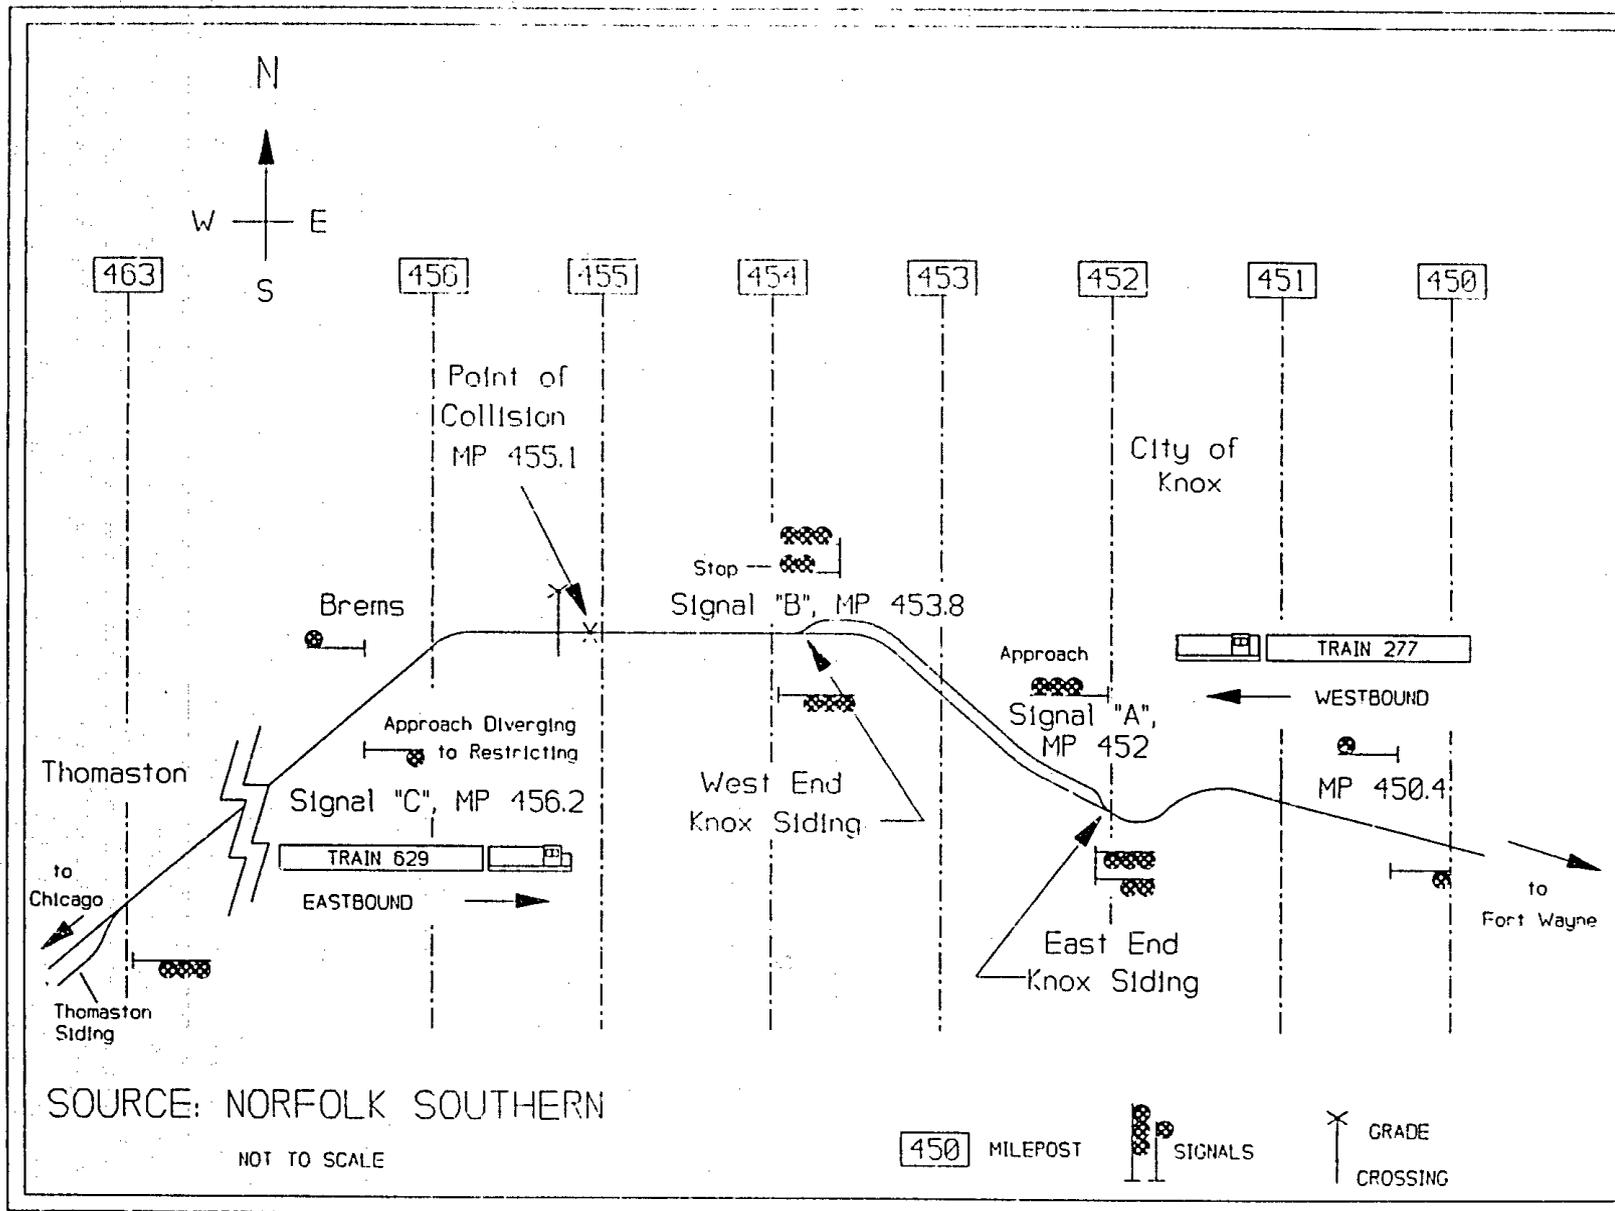
Figure 1.-- Knox siding.

As train 629 neared signal C (MP 456.2), the "approach signal" for the west end of the Knox siding (see figure 1), the signal changed unexpectedly from "approach diverging" (the traincrew should be prepared to enter the siding at 25 mph) to "restricting" (the train should not exceed 15 mph and the traincrew should be prepared to stop the train short of an obstruction or another train). The unexpected signal change indicated that there was a problem, such as a broken rail or another train, between the signal and the west end of the siding. The engineer stated that the train was traveling about 46 mph when he first saw the "approach diverging" signal and applied the dynamic brake. To comply with the "restricting" signal, he increased the dynamic brake and later applied the automatic brake.

The student engineer said that he saw signal A (MP 452; see figure 1), the "approach" signal for the east end of the Knox siding, and thought it was clear, he did not describe the combination of colors that the signal showed. He also said he assumed the engineer saw the signal because the engineer was standing behind him. According to the student engineer, neither he nor the engineer called out the signal as required by operating rule 34. The student engineer stated that "as far as I know" (but he was not sure), the conductor called the signal clear.

Signal B (MP 453.8), the signal for the west end of the Knox siding, was clear, according to the student engineer. The investigation showed, however, that signal B, which is a "remote control" signal controlled by the dispatcher, displayed a "stop" signal. Train 277 should have stopped at signal B, which governs movement of trains on the main track at the west end of the siding. The student engineer stated that he observed "green over red" (the color combination that signifies clear) on the left column of signal lights. He said that neither he nor the engineer, who was in the middle of the cab at the time, called the signal. The conductor had moved from the rear seat to the front seat on the left side, and he called "clear," according to the student engineer, who said the signal was clear as the train passed it. The student engineer reported that he did not notice which way the switch was lined (whether it was set to allow train 277 to proceed on the main track or to allow train 629 to enter the siding). He estimated the train's speed at 35 mph and increasing when the locomotive passed the signal and switch.

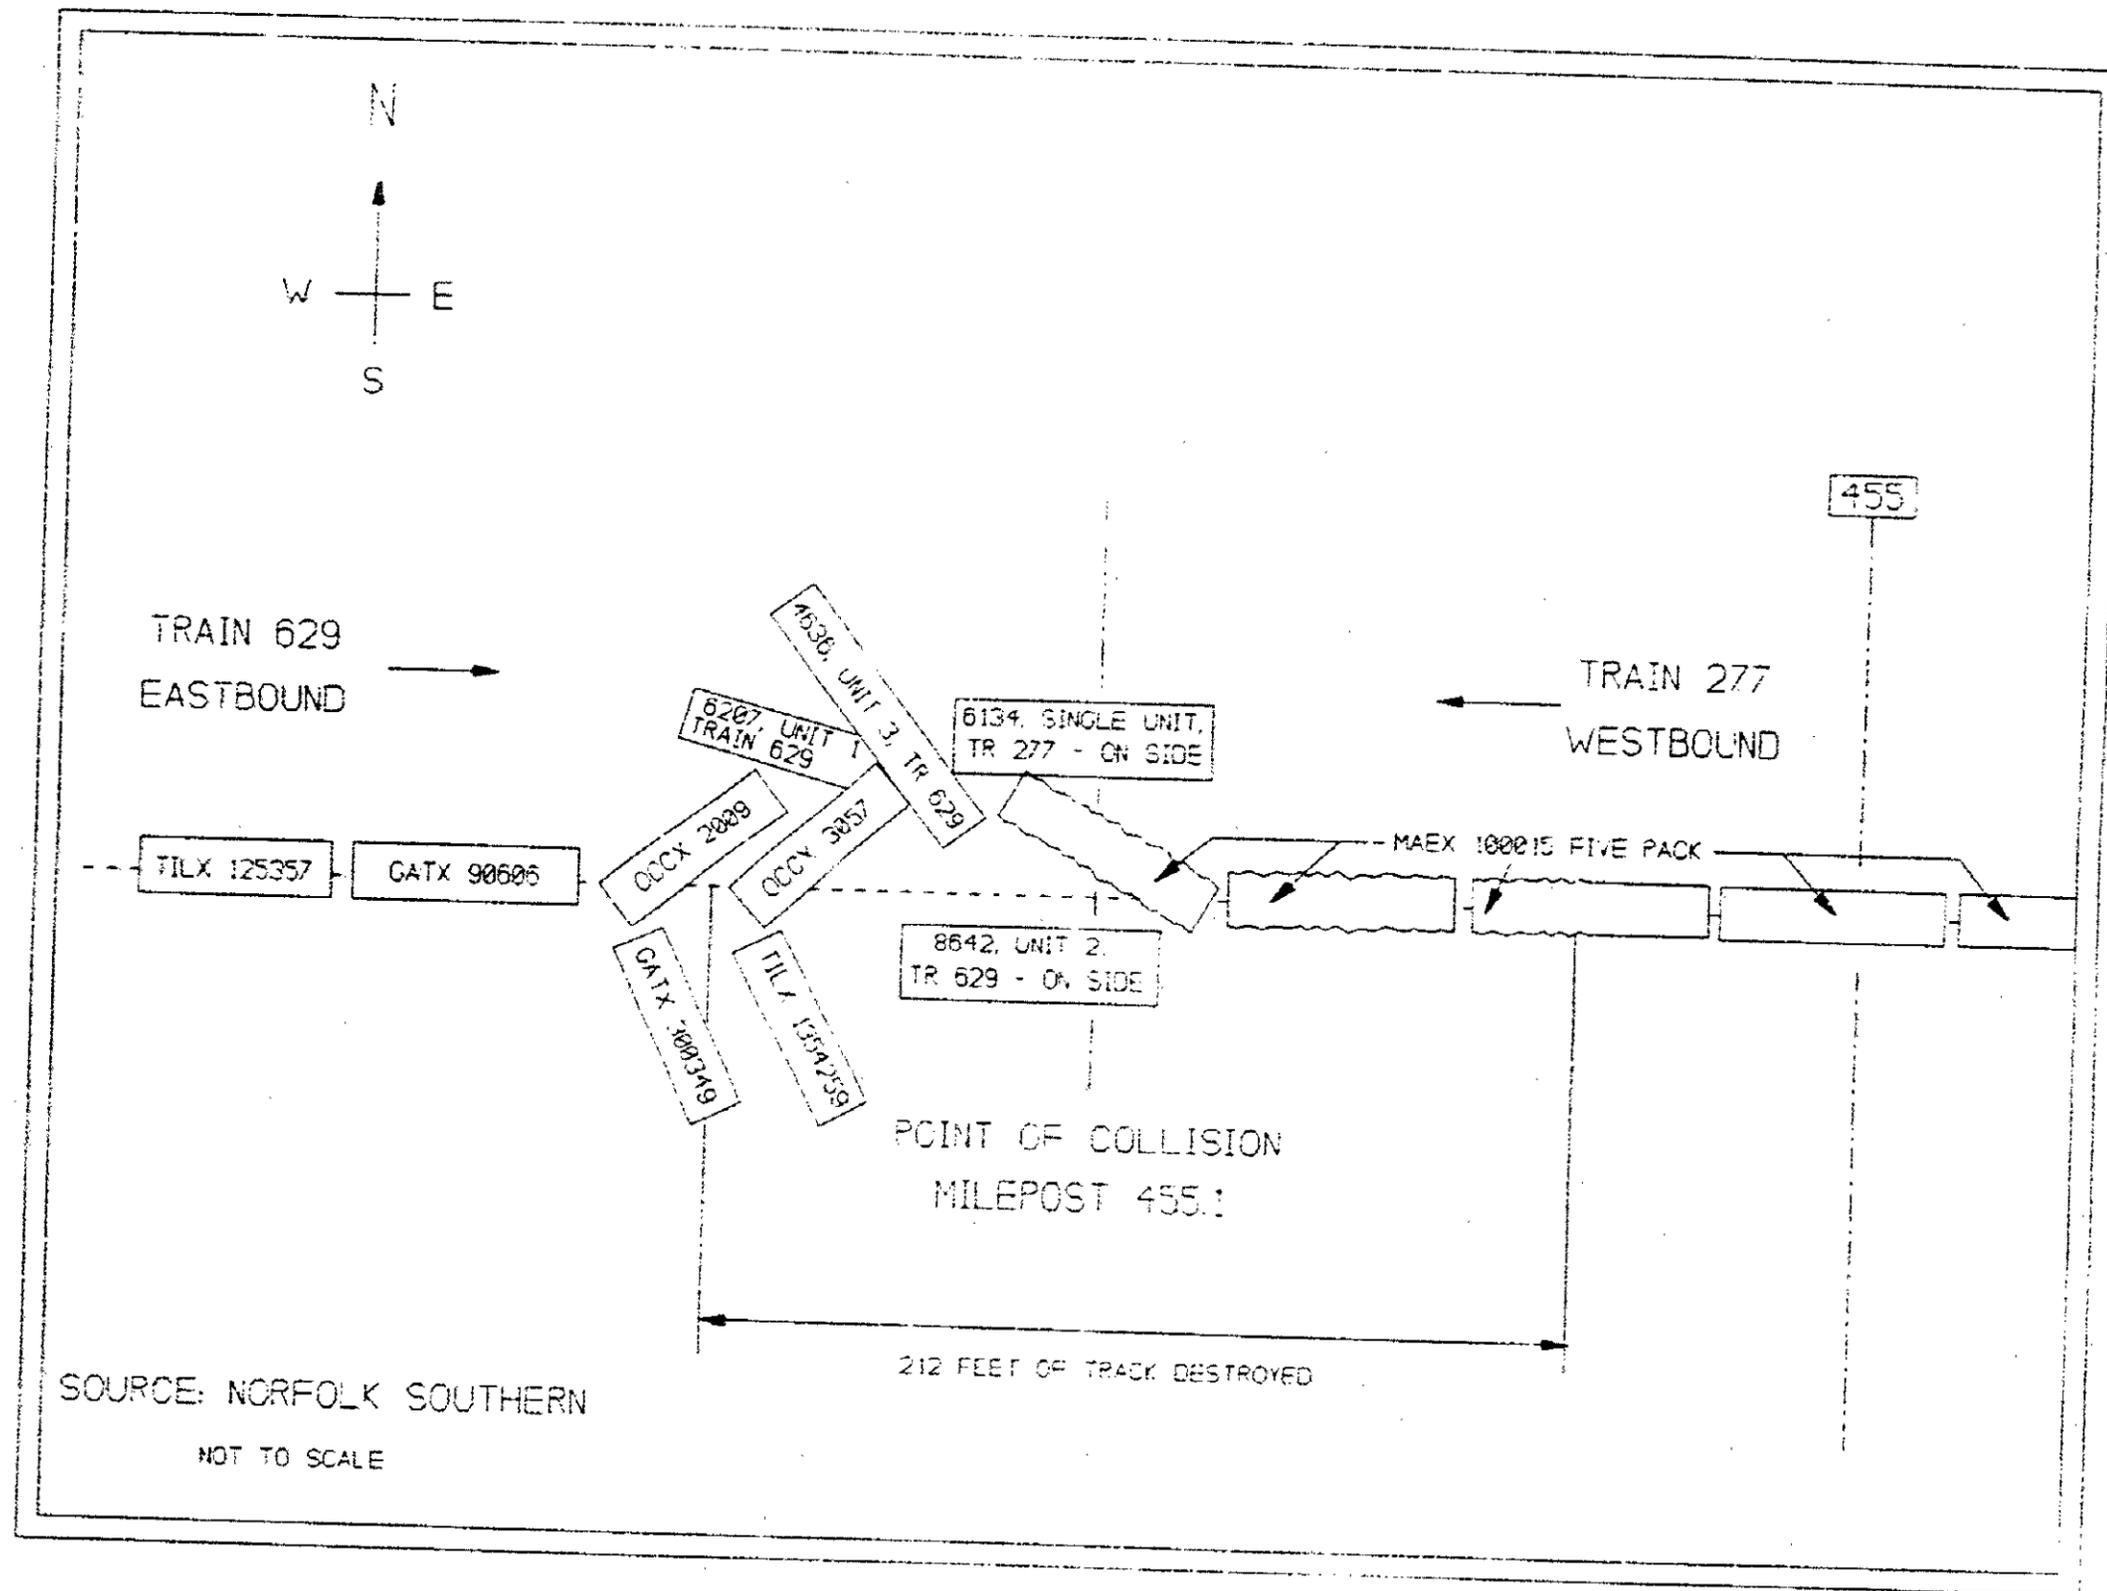
Figure 3.-- Collision site.

fuel ignited and burned the wreckage. The switch at the west end of the Knox siding and 212 feet of track at the point of the collision were destroyed. (See figure 3.)

The Safety Board's investigation team determined that the switch had been destroyed when train 277 passed through it while it was lined to allow train 629 to enter the siding. Train 277 bent the points and throw rods on the switch assembly.
