RAILROAD ACCIDENT REPORT

DERAILMENT AND SUBSEQUENT COLLISION
OF AMTRAK TRAIN 82 WITH RAIL CARS
ON DUPONT SIDING OF CSX TRANSPORTATION INC.
AT LUGOFF, SOUTH CAROLINA, ON JULY 31, 1991

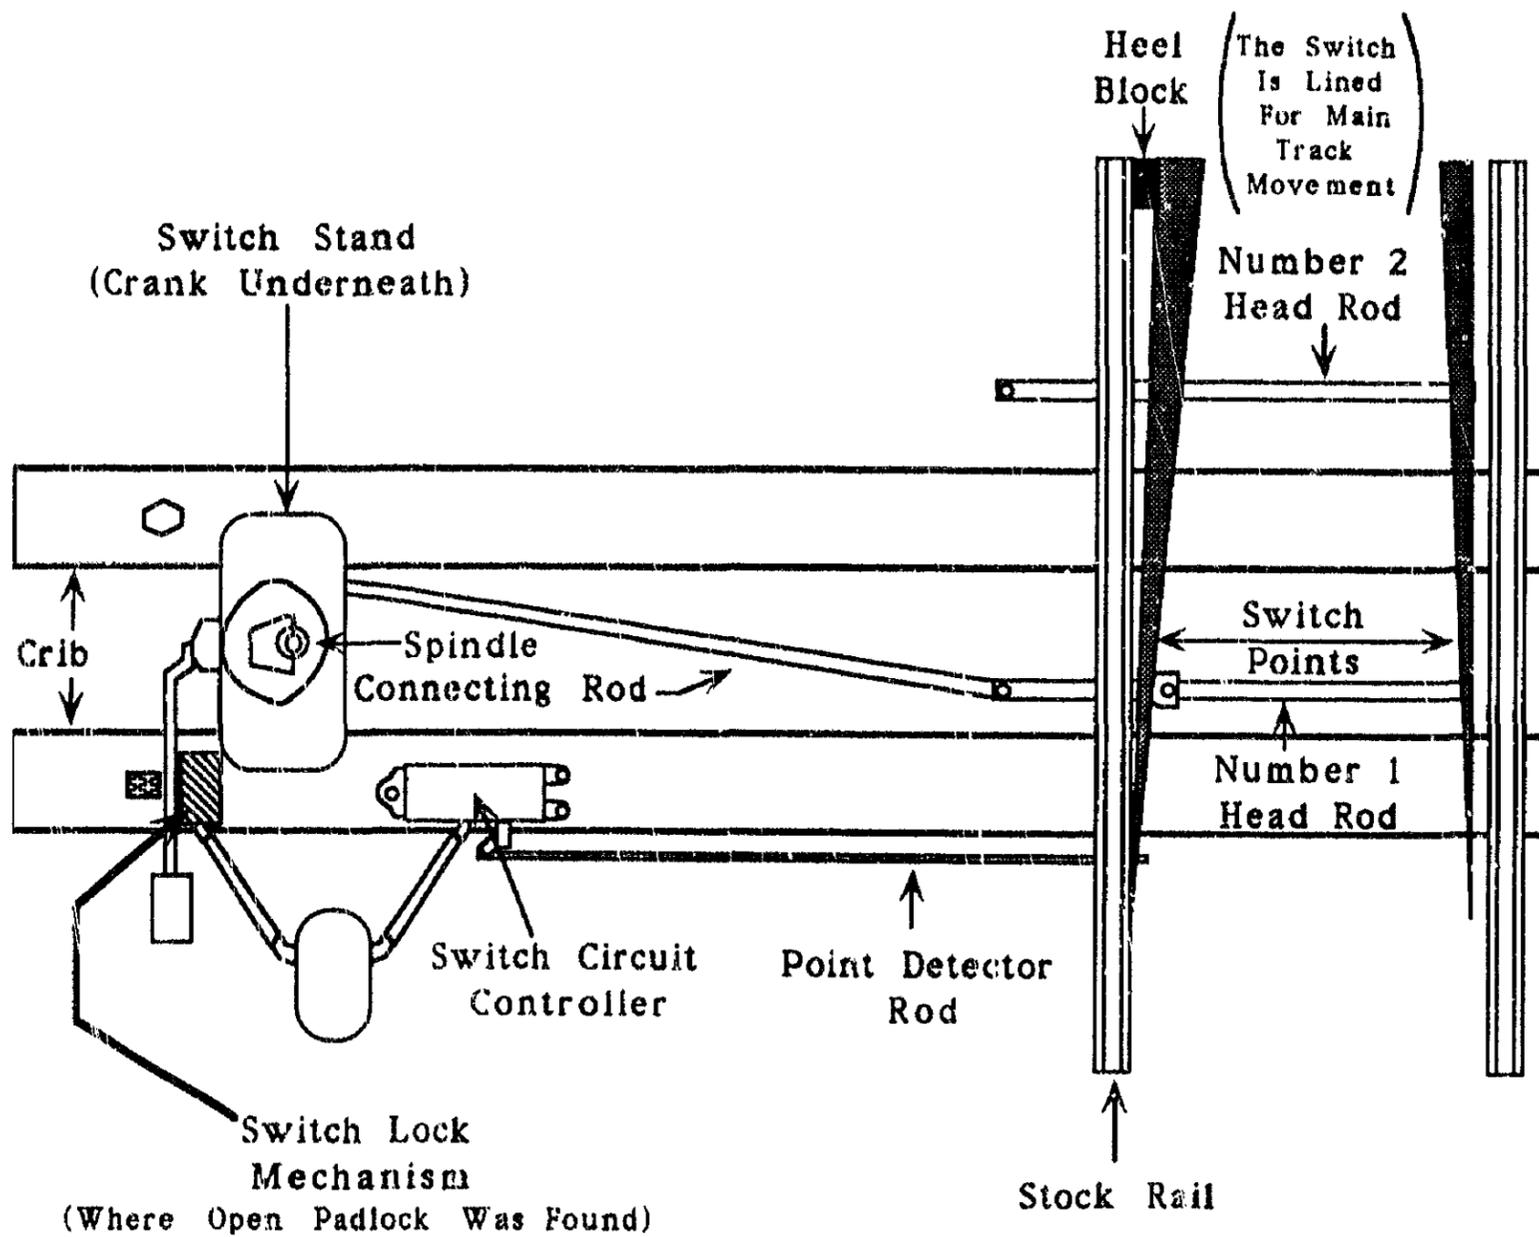
Figure 2.--Diagram of switch stand.

After the accident, the main track crossover was found to have the connecting rod disconnected from the switch stand crank. The switch point was not secured to the stock rail, the cross pin that attached the switch stand crank to its spindle was not in place, and the crank had dropped onto the safety plate. The cross pin was found near the switch stand. (See figure 2.)

The crank was lower than it should have been because the missing cross pin allowed the crank to drop down on the spindle to the safety plate. The safety plate performed its intended function of keeping the spindle and crank engaged, although the cross pin was missing. If a normal amount of ballast had been in the crib, the switch connecting rod would have been positioned farther down the crank lug. However, the ballast was high enough that the connecting rod had been pushed up and was rubbing the underside of the switch stand.

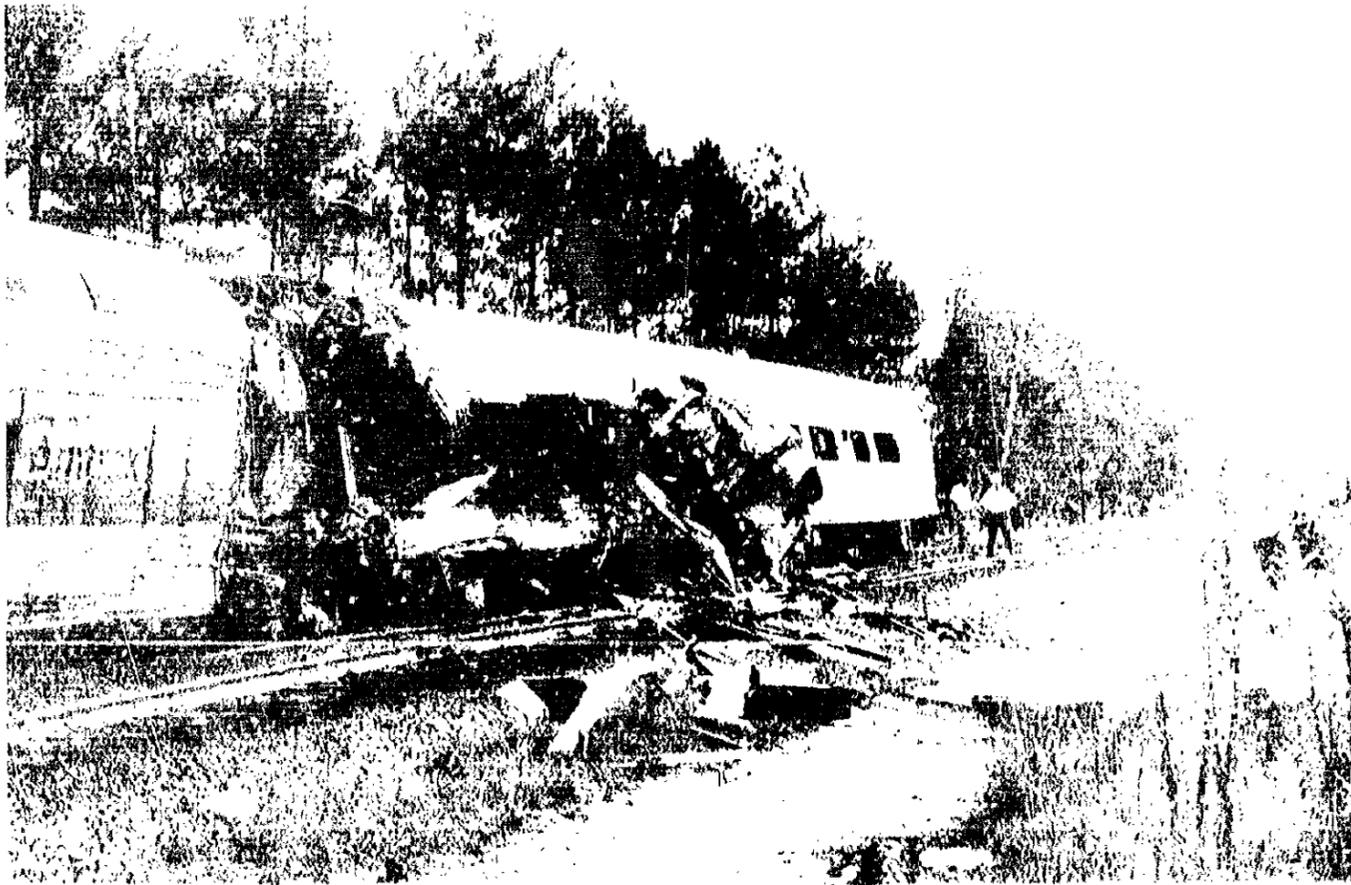
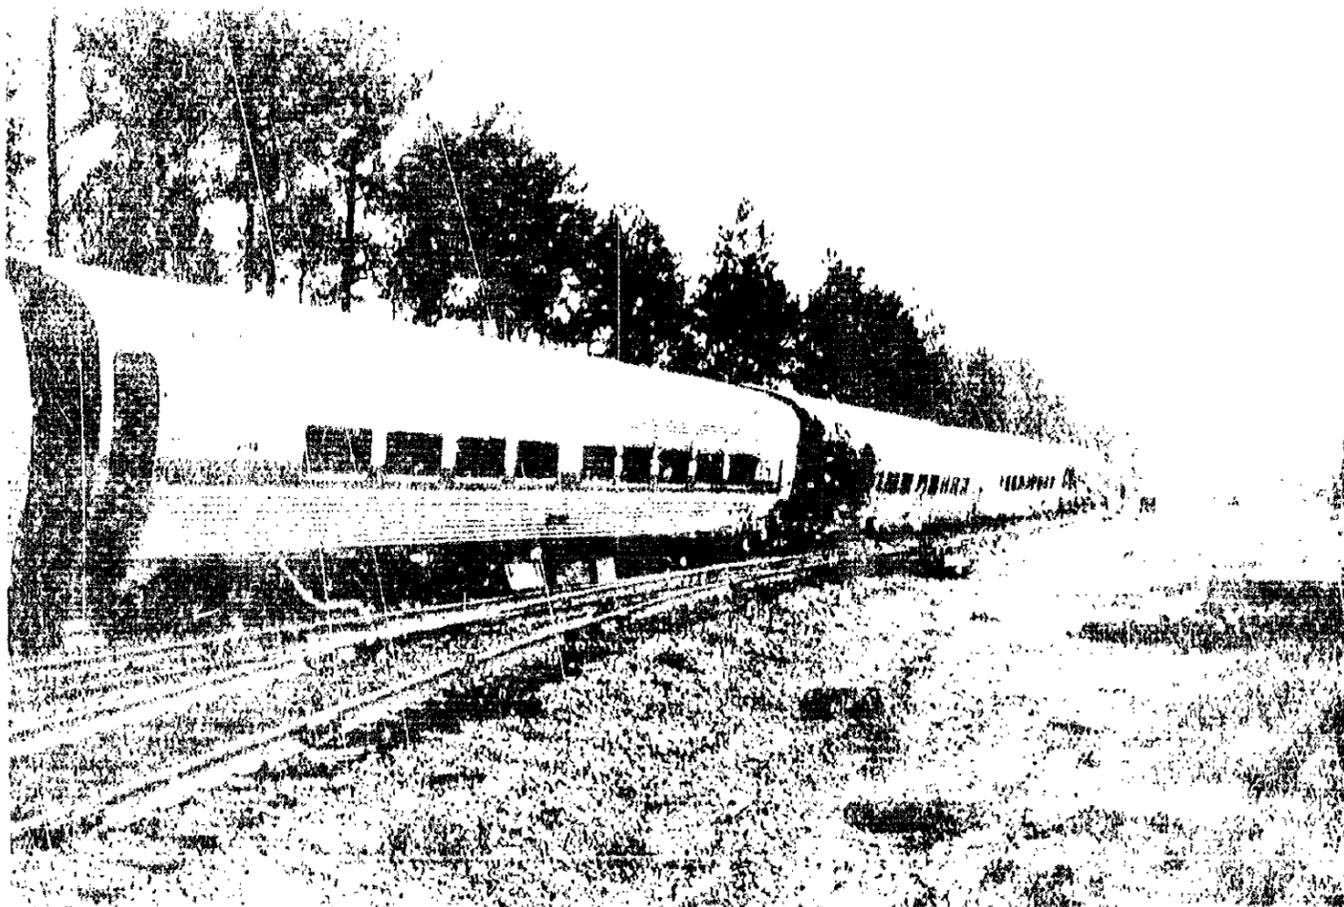
Figure 4. Photographs of derailed cars

The last six passenger cars derailed. The 13th car showed minor damage, and the 14th, 15th, and 17th cars showed substantial damage. The left (west) sides of coaches 25060 and 26002, the 16th and 18th cars, respectively, were severely damaged. Coach 26002 had a wheel set in its left midsection. (See figure 4.) The first two hopper cars were damaged on their east sides and undercarriages.

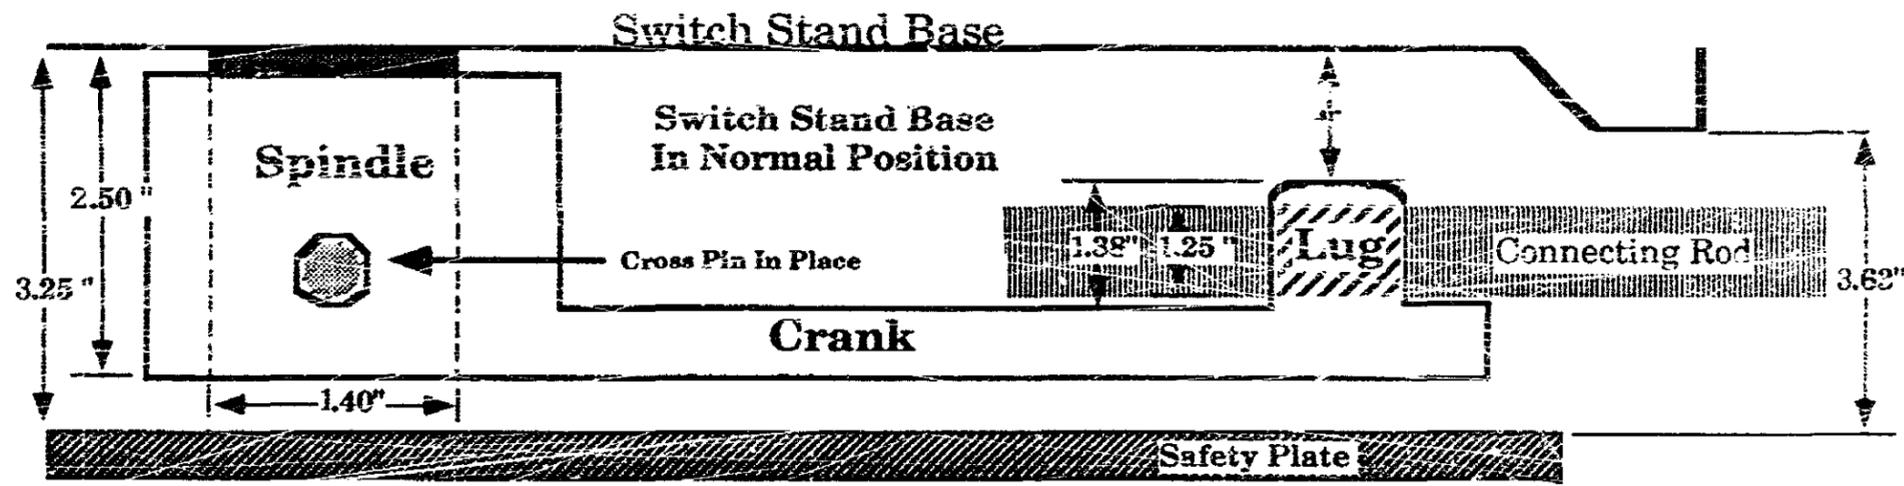
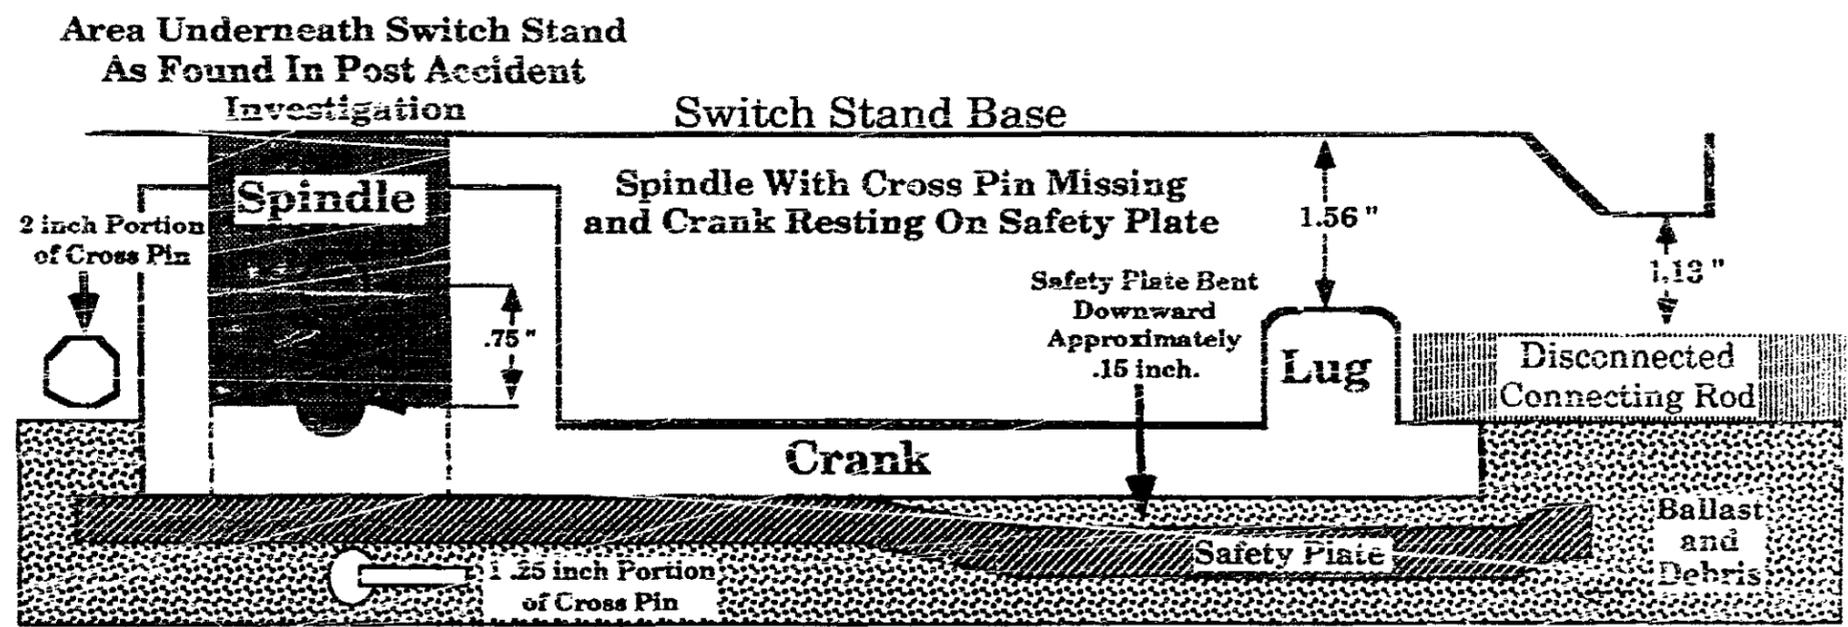
Figure 5.--Diagram of crank showing spindle and connecting rod.

When initially examined at the accident scene, the connecting rod was not connected to the lug on the end of the crank, but was found on the ballast next to the crank. Rub marks were evident on the underside of the switch stand housing and on top of the connecting rod.

Because the connecting rod was higher than it should have been and the crank was lower than it should have been, the lug end of the crank and the connecting rod were minimally engaged. The motion, induced by the train, was intensified by the cross level deficiency of the track, which caused the connecting rod and crank to overcome the minimal connection and separate as train 82 passed over the switch.

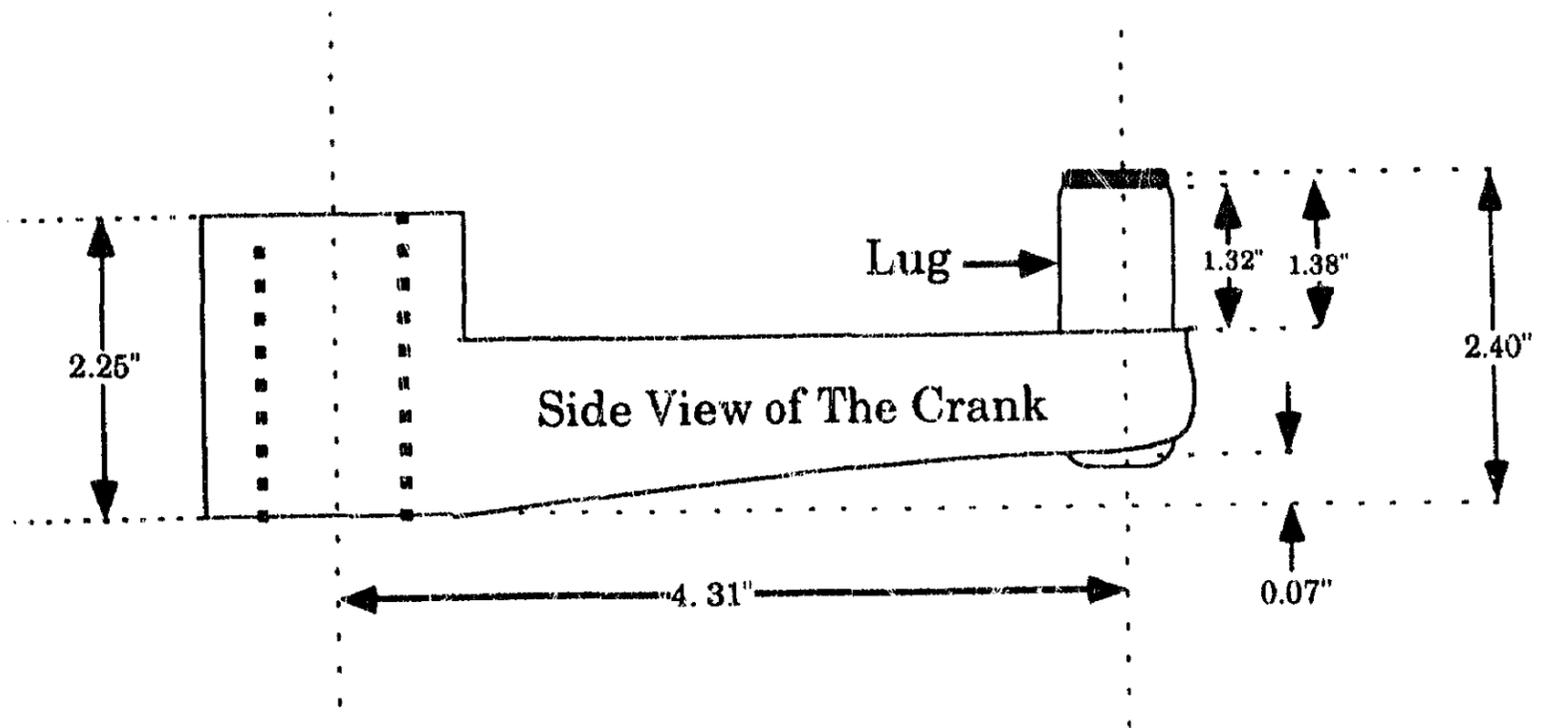
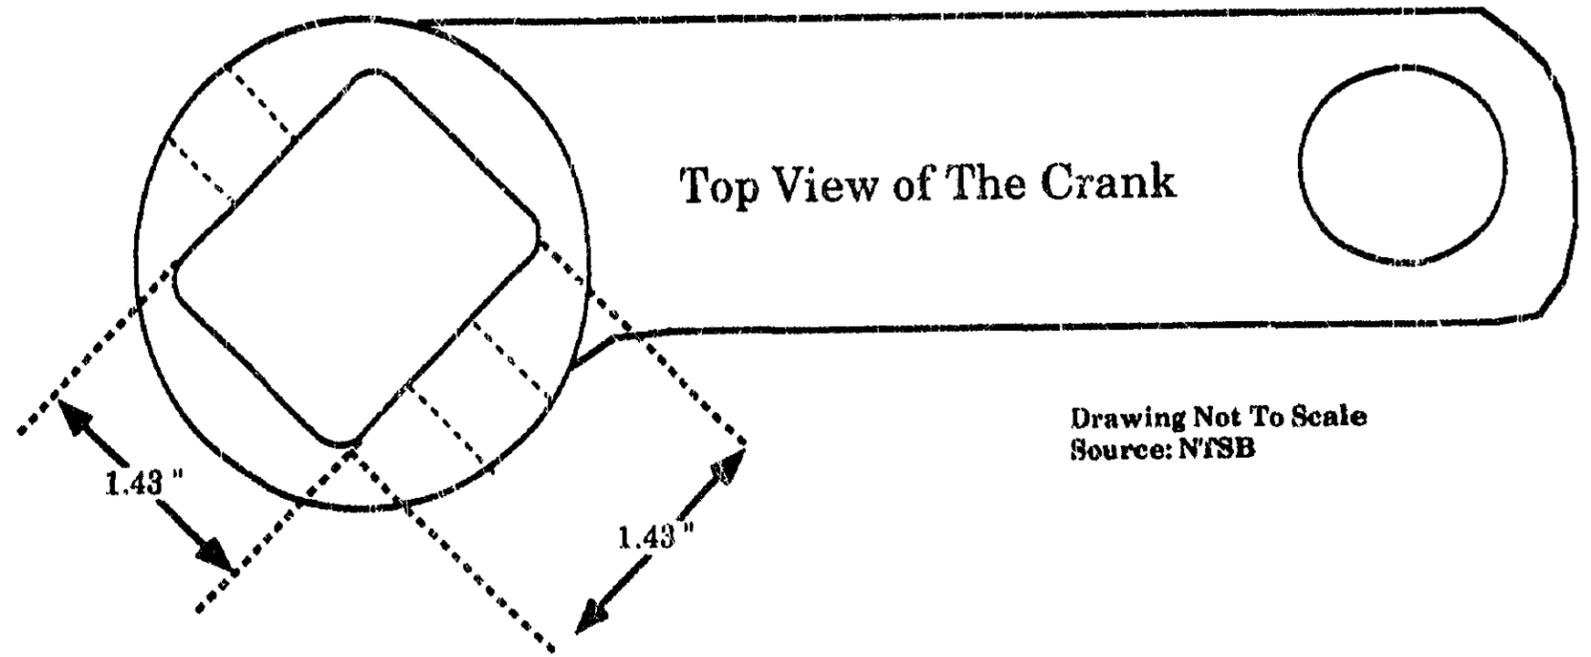
Figure 7.--Crank and connecting rod.

Investigators reattached the connecting rod to the crank (see figure 7) and duplicated the switch connection that existed at MP S329.6. They found that after the connecting rod was attached as it had been before the accident, it could be manually separated from the crank.

The bolt that connected the connecting rod to the number 1 head rod should have been secured by a cotter pin. Instead, it was secured by a nail. A cotter pin was also missing from the bolt that fastened the head rod to the left-hand switch clip.
