PB93-916304
NTSB/RAR-93/03

RAILROAD ACCIDENT REPORT

COLLISION BETWEEN NORTHERN INDIANA
COMMUTER TRANSPORTATION DISTRICT
EASTBOUND TRAIN 7 AND WESTBOUND TRAIN 12
NEAR GARY, INDIANA, ON JANUARY 18, 1993

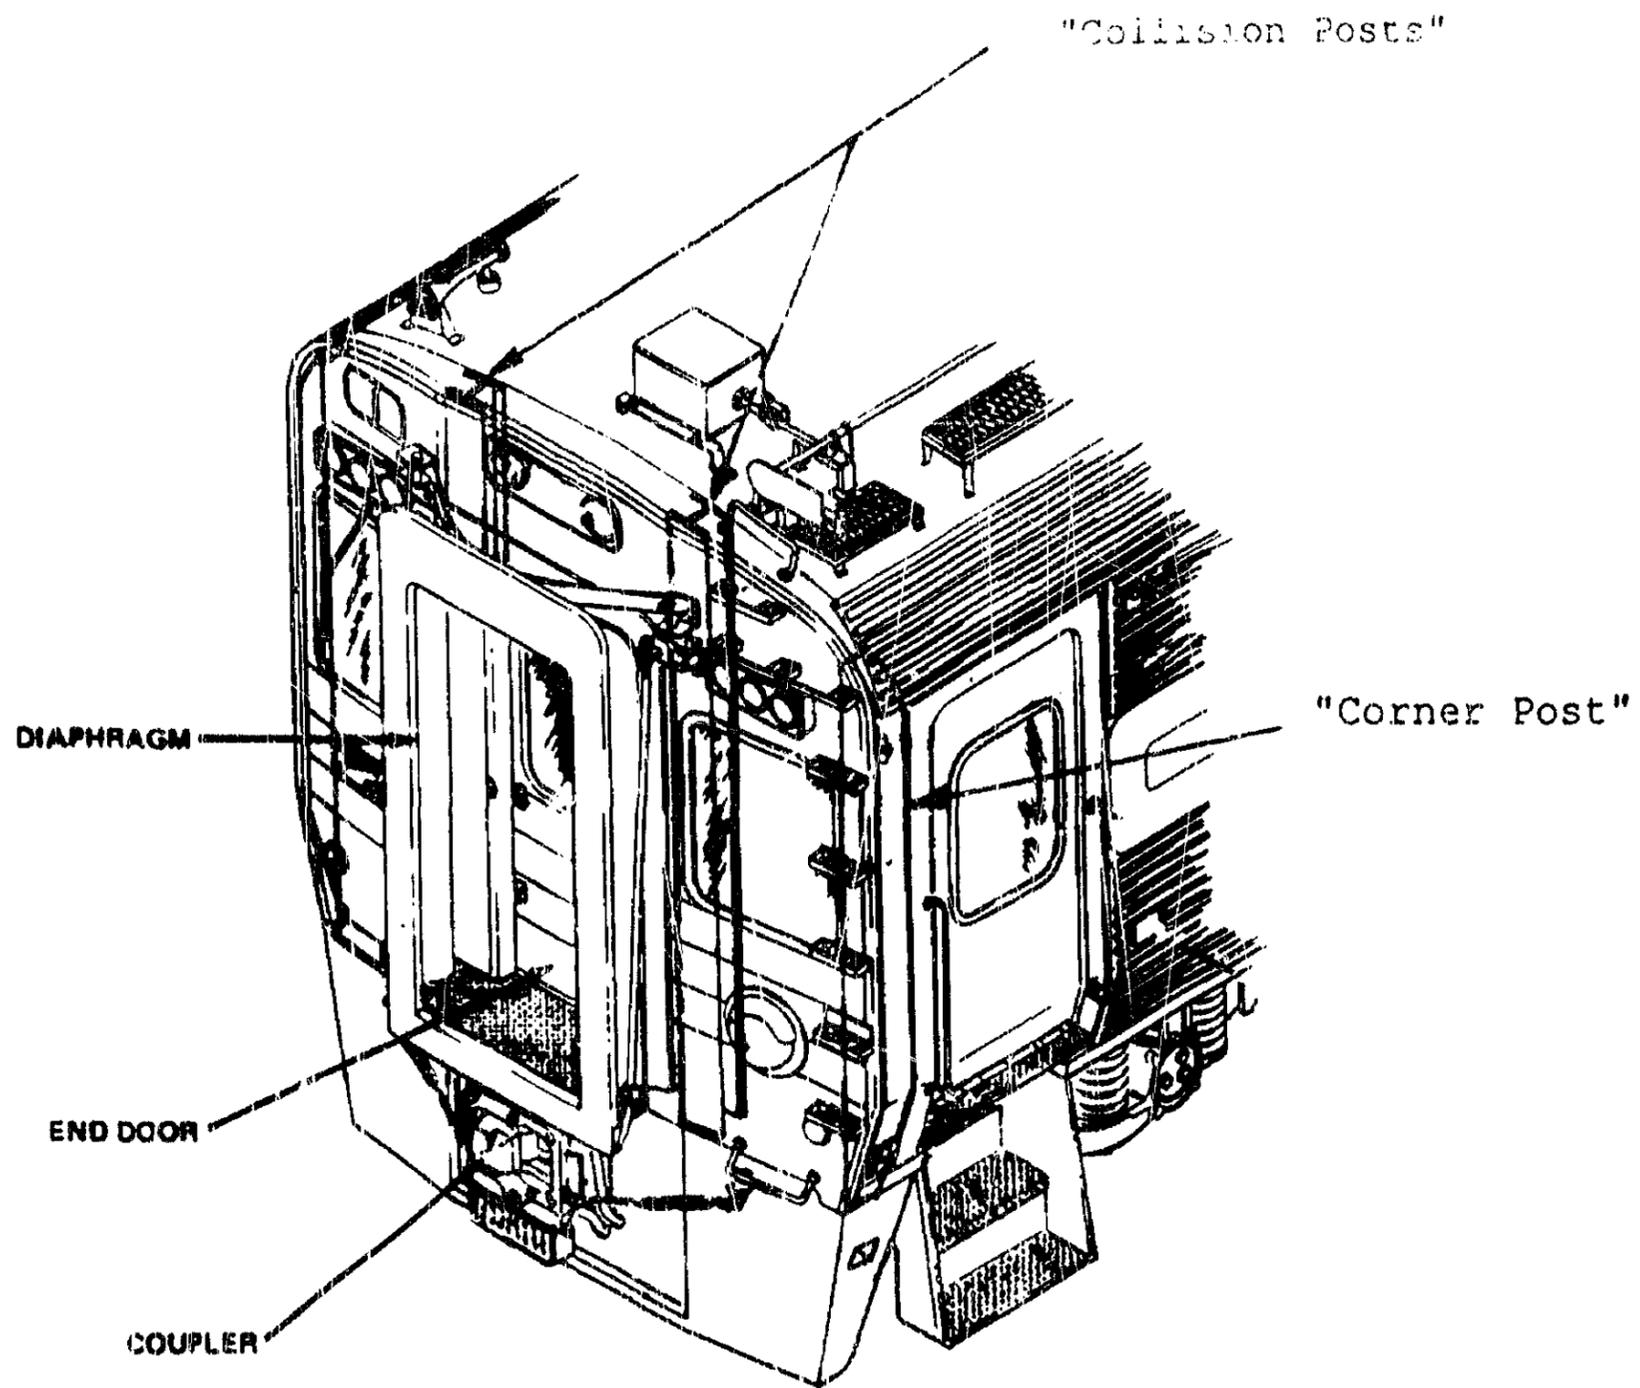
Figure 5.--Diagram showing position of collision posts and corner post on passenger rail car.

"structural post" refers to a structural element that attaches the end bulkhead (partition) to the end door and should not be confused with a structural corner post that is designed specifically for collision energy absorption and to resist car body intrusion in the corner areas.

As noted above, the design requirements in 49 CFR 229.141 do not address car body corner post structural requirements. Because this accident was the second collision within a 2-year period to involve corner-to-corner impact and it resulted in numerous fatalities and serious injuries that may have been prevented, the corner post design requirements of MU locomotives have become a significant crashworthiness issue of particular interest to the Safety Board. MU locomotive passenger cars that are built without adequate collision energy absorption structures in the corner post assemblies are vulnerable to car body intrusion in noncoupler-to-coupler collisions. The use of an energy absorption structure in the corner post assembly, similar to the collision post that is required on each side of the control compartment door, would have provided significant additional resistance to impact intrusion.
