NATIONAL TRANSPORTATION SAFETY BOARD

RAILROAD-MARINE ACCIDENT REPORT

**DERAILMENT OF AMTRAK TRAIN NO. 2
ON THE CSXT BIG BAYOU CANOT BRIDGE
NEAR MOBILE, ALABAMA
SEPTEMBER 22, 1993**

**Adopted: September 19, 1994
Notation 6167B**

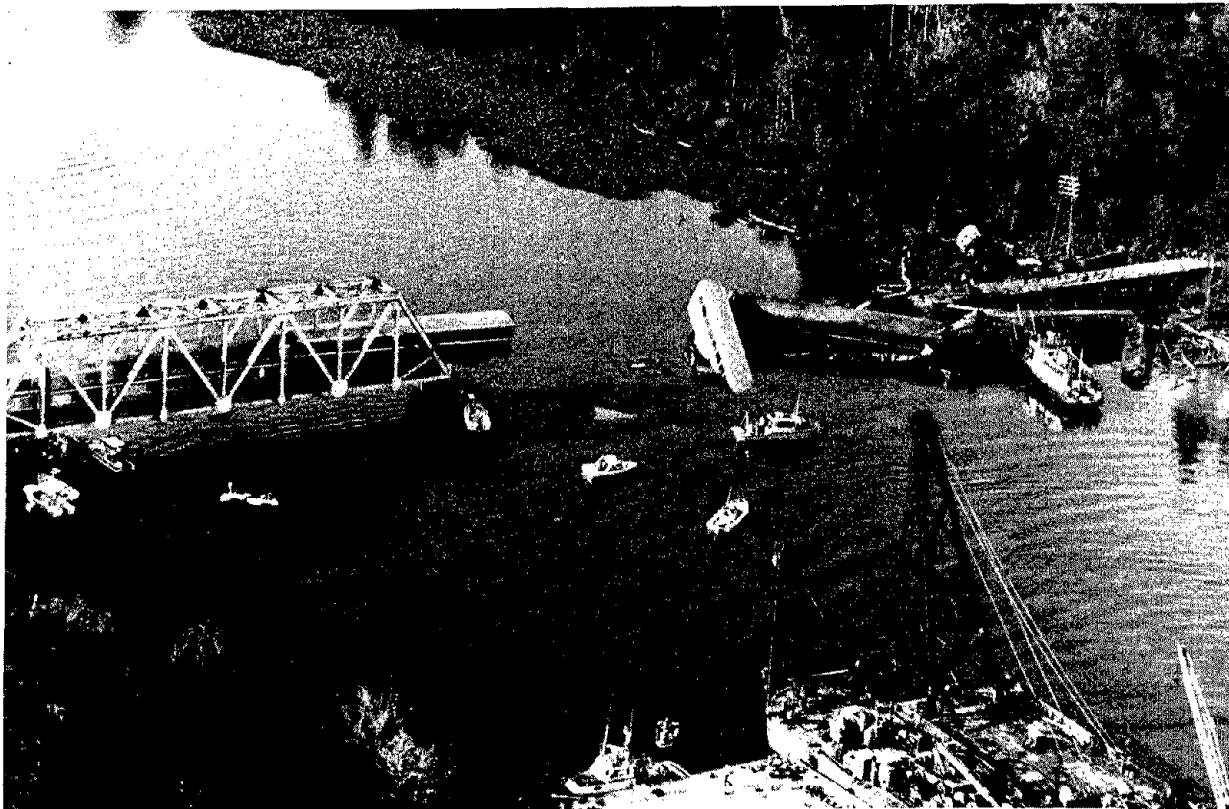
Figure 5.--Photograph of accident site.

Following the derailment, the three locomotive units came to rest on the east side of the bayou. Part of the lead unit, 819, was buried in about 46 feet of mud, and the part protruding above the embankment burned. The second unit, 262, also burned. The fuel tank of the third unit, 312, separated from it, and all equipment along the bottom of the unit below the frame was sheared off.

Baggage car 1139 and dorm-coach 39908, also on the east side of the bayou, were gutted by fire, and parts of both cars sustained major structural damage. About half of coach 34083, which rested against the bridge after the accident, was submerged, and coach 34068 was almost totally submerged. The next four cars, coach 34040, lounge 39973, diner 38030, and sleeper 32067, remained on the bridge. All passenger cars were double-decker cars. (See figure 6.)

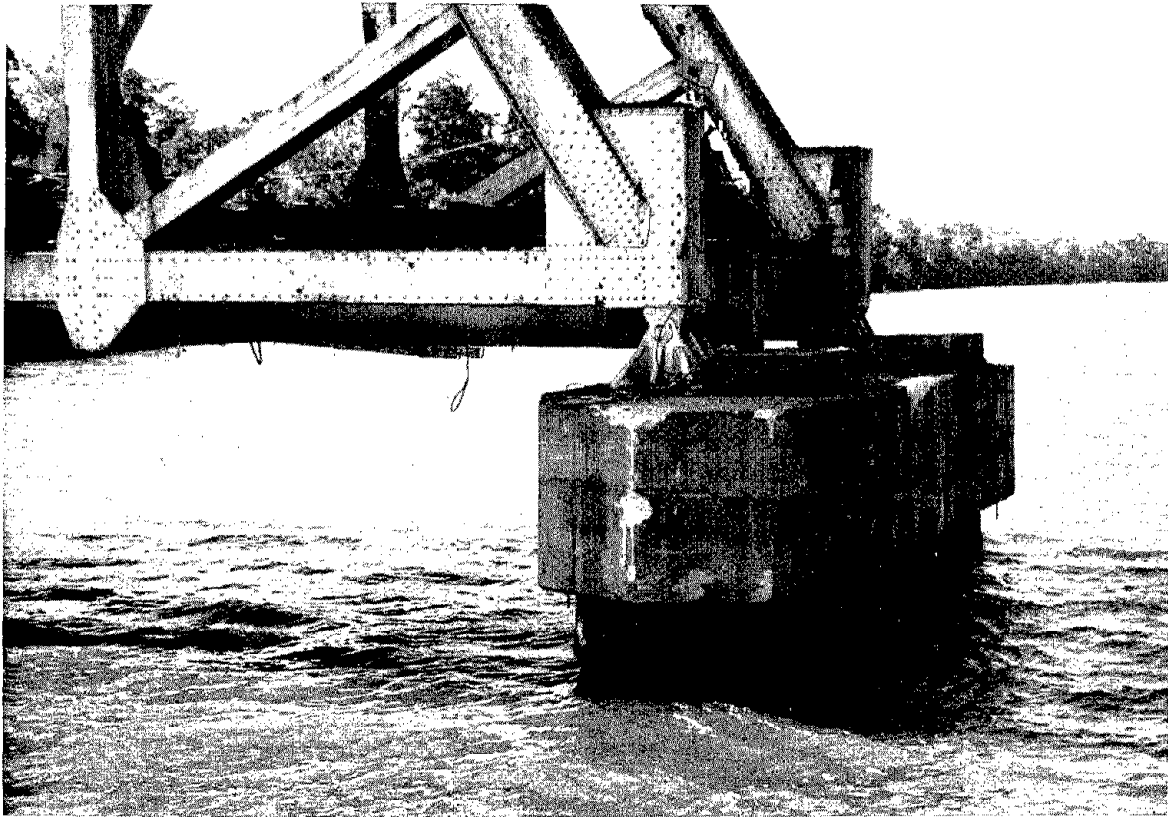
Figure 7.--Collision marks on Big Bayou Canot bridge.

The nose of the south pier sustained some concrete spalling (chipping or scaling) from the MAUVILLA's lead port barge (see figure 7). The east edge of the sole and filler plates for the east girder's south bearing came to rest on the west edge of the east pedestal and the west edge of the pier cap plates. The west girder plates were found on the pier cap adjacent to the west edge of the west pedestal. The bottom of the east girder sole plate had large radius lateral striations (grooves or channels), and the west sole plate had straight lateral striations.

About 15 feet of the top flange of the east girder, beginning at the south girder face, was separated from the web. Part of the top of the plate over this 15-foot section was "accordianed"; the rest of the top flange was comparatively undamaged. The web sustained two tears, one extending from the top to the bottom flange and a large horizontal tear between the fourteenth and seventeenth stiffeners. The bottom flange had two indentations, 21 inches and 22 inches wide, respectively, on the bottom east side.

The girders, which were about 40 feet apart laterally at the widest point, were displaced some 70 feet to the north. The northernmost and two southernmost floorbeams remained connected to both girders. The other eight floorbeams were severed from the east girder but remained connected to the west girder. The stringers remained connected to the floorbeams. Concrete had broken off the east angular nose of the pier that supported the south end of the girders and off part of the north edge of the pier cap. Surface evidence indicated the fractures were recent.
