PB94-916302
NTSB/RAR-94/02

RAILROAD ACCIDENT REPORT

HEAD-ON COLLISION AND DERAILMENT OF
BURLINGTON NORTHERN FREIGHT TRAIN
WITH UNION PACIFIC FREIGHT TRAIN
KELSO, WASHINGTON
NOVEMBER 11, 1993

Adopted: November 15, 1994
Notation 6247A

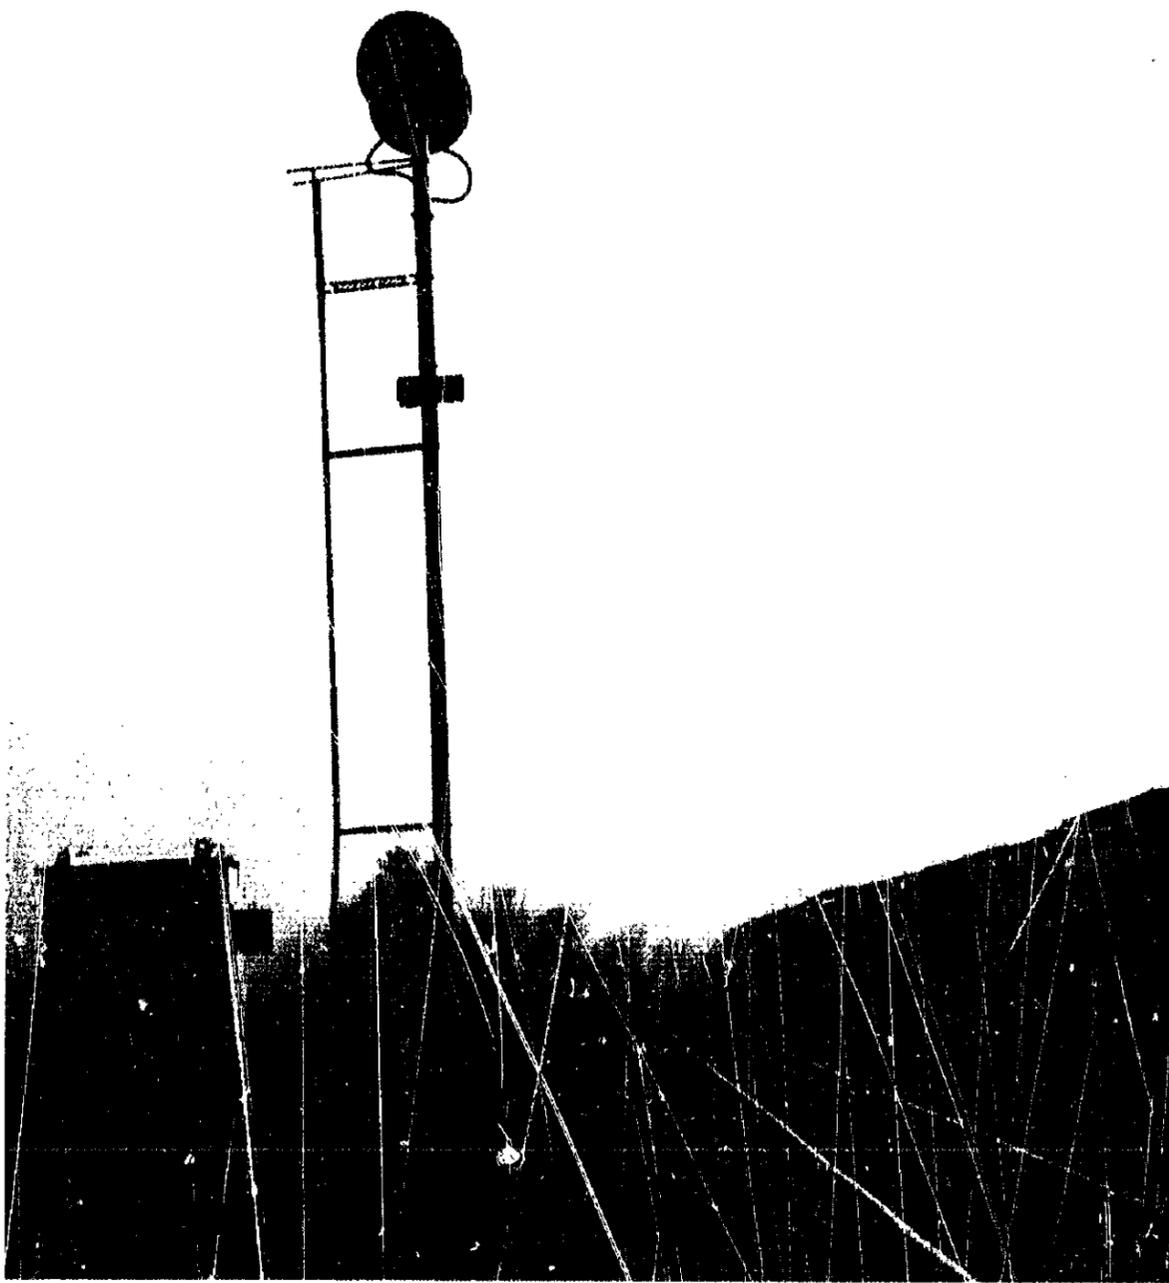
Figure 9.--Intermediate signal, looking south.

The engineer of train 59 reported to investigators what he thought was a problem with the intermediate signal. He stated that on one of his trips after the accident, he had passed the signal. When he looked back at it, he noticed that it was not lit. He was expecting to see a red signal. After he reported the signal, its manufacturer, Harmon Industries, sent one of its field engineers to test the track circuit components and found that the system was operating in accordance with the specifications. A BN signal engineer stated that the intermediate signal is controlled by electronic coded track circuits (Electro Code Signal System). The signal is one of several automatic block signals on the BN system that are located within yard limits; and for many yard train activities, it is designed to display a signal indication only when required for the appropriate train movement and to remain unlighted at other times.

The conductor of train 59 testified that 3 months after the accident he was traveling south on main track 2 in conditions similar to those on the night of the accident. He stated that the intermediate signal "being high in the fog and looking out in the fog with the headlights shining, your visibility is greatly decreased. The block [signal] is visible for just a few brief moments."
