# **NATIONAL TRANSPORTATION SAFETY BOARD**

## **RAILROAD ACCIDENT REPORT**

**AMTRAK TRAIN 87 DERAILMENT  
AFTER COLLIDING WITH INTERMODAL TRAILER  
FROM CSXT TRAIN 176  
SELMA, NORTH CAROLINA  
MAY 16, 1994**

Adopted: March 21, 1995  
Notation 6420A

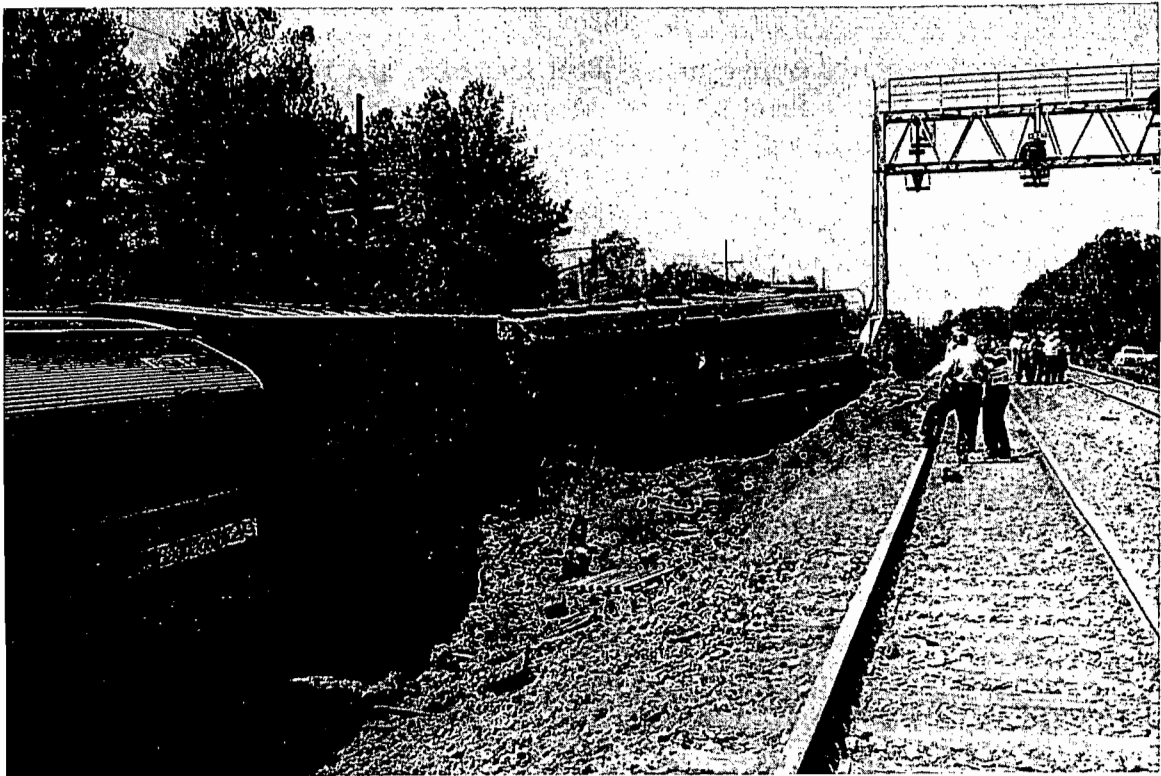
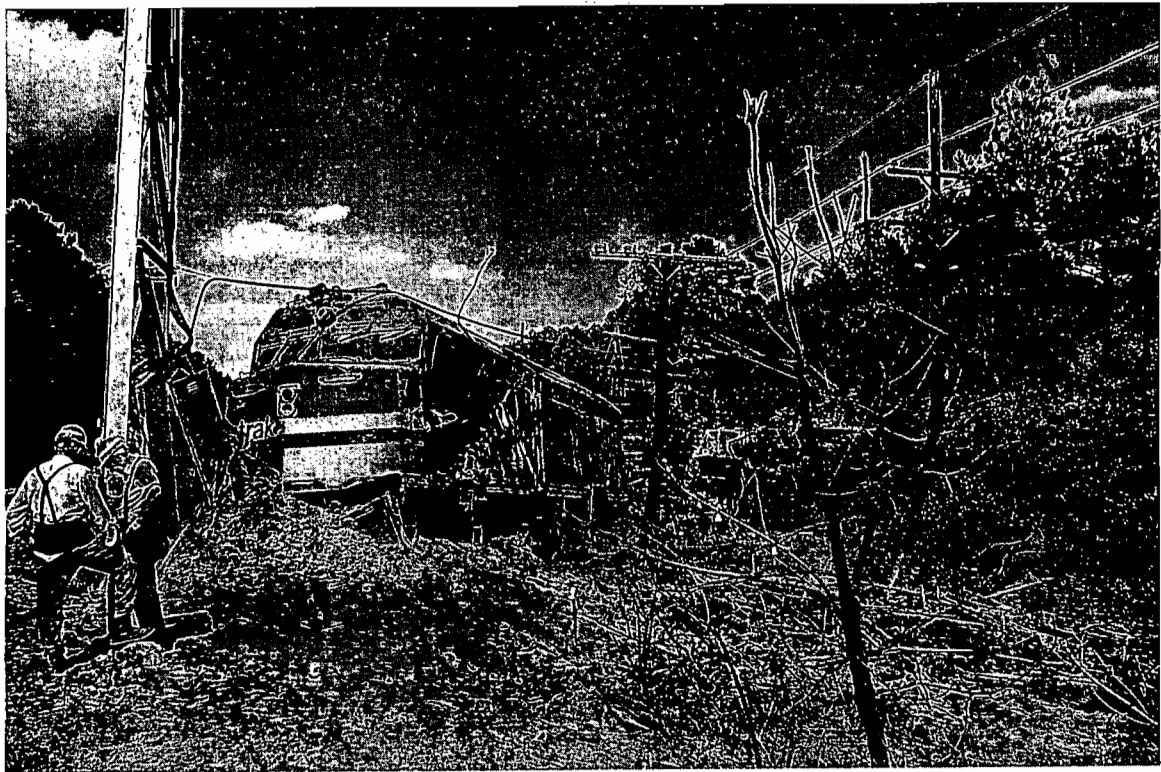
Figure 3. -- View of accident scene.

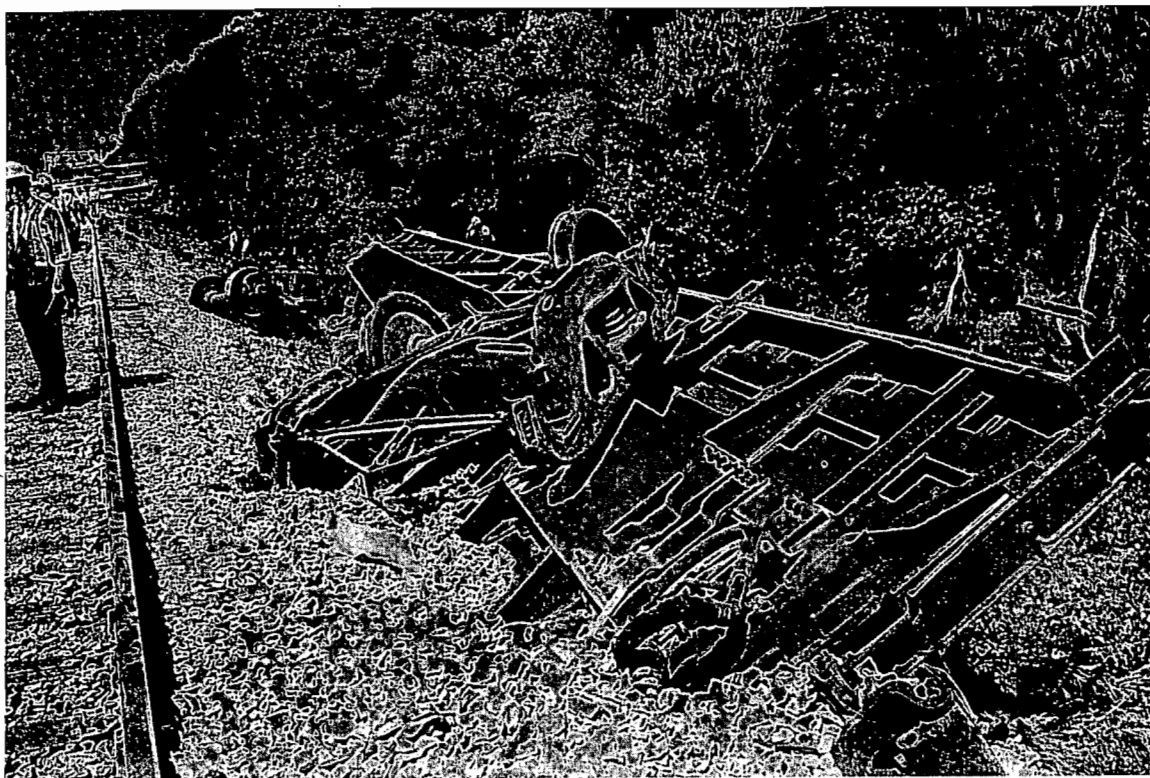
Flat car KTTX 251988 was found 40 feet north of the point of impact on its side and angled to the west side of track 1. (See figure 6.) Its A- and B-end were 4 and 24 feet, respectively, from the track. The flat car was righted and examined on-scene. The A-end hitch locking indicator pin was in the open position, and the remains of the second trailer, CSXZ 238848, was still attached to the B-end hitch. On May 17, 1994, Safety Board investigators examined the A-end hitch of KTTX 251988, on which the intermodal trailer REAZ 232980 had been mounted. Shiny marks were found on the front of the "vee notch" of the hitch throat; no other unusual signs of wear were noted. The jaws were closed, and the handle was in the full unlocked position (indicator pin extended about 1 1/4 inches). The hitch, which was laying in the road bed, was completely packed with rock, mud, and debris. The jaws were found in the locked position after the debris and mud were removed, and the hitch handle indicator pin was in the full unlocked position.

Figure 6. -- Fifty-first car KTTX 251988 of CSXT 176.

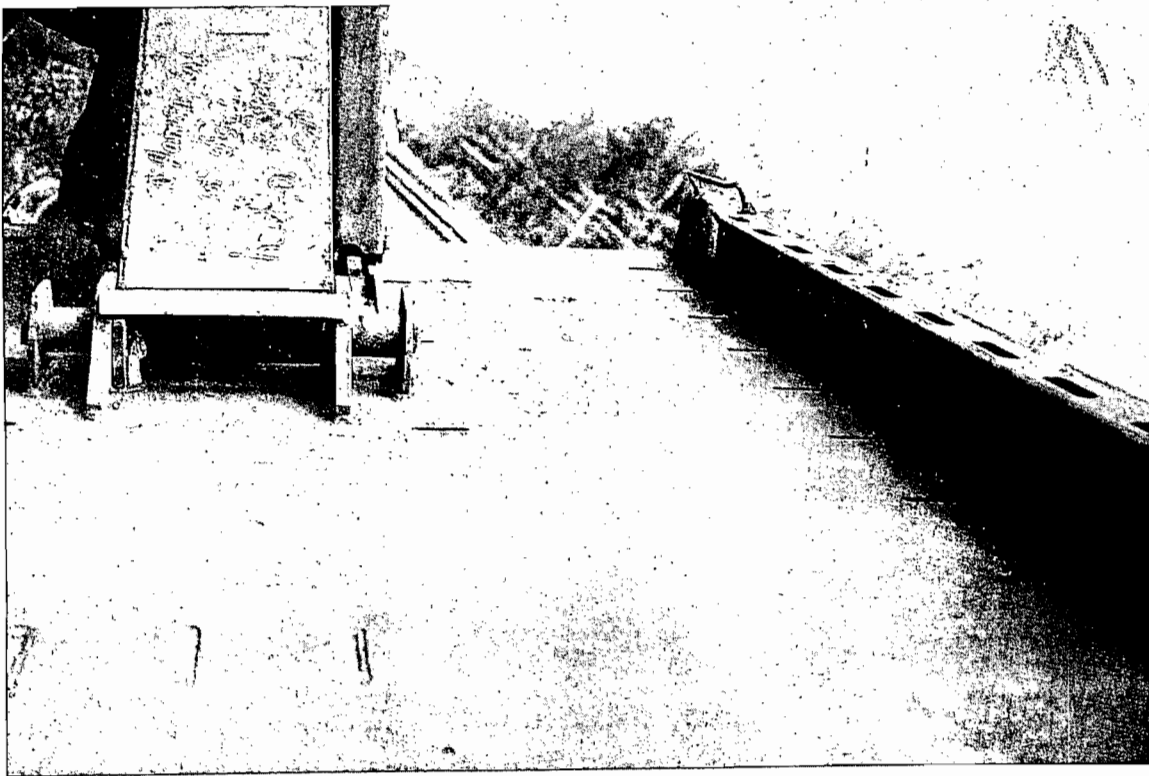
Marks were found on the platform of the derailed car KTTX 251988 where the foot plates of the REAZ 232980 landing gear contacted the deck, moved to the right side of the car, and marked a shallow indentation several inches in diameter into the metal on the car side "rub rail." The entire length of this rub rail had been painted yellow; however, paint was missing from the area containing the indentation mark. The bare metal was exposed about 7 1/4 feet along the rub rail of the car from the center of the hitch locking position. The Safety Board metallurgist noted that the exposed metal surface contained no corrosion. Smaller indentation marks, exposing bare metal surface, were noted near this indentation mark. Scrape marks were also noted on the floor of the railroad car. (See figure 7.)

Figure 7. -- Photographs of marks found on rub rail.

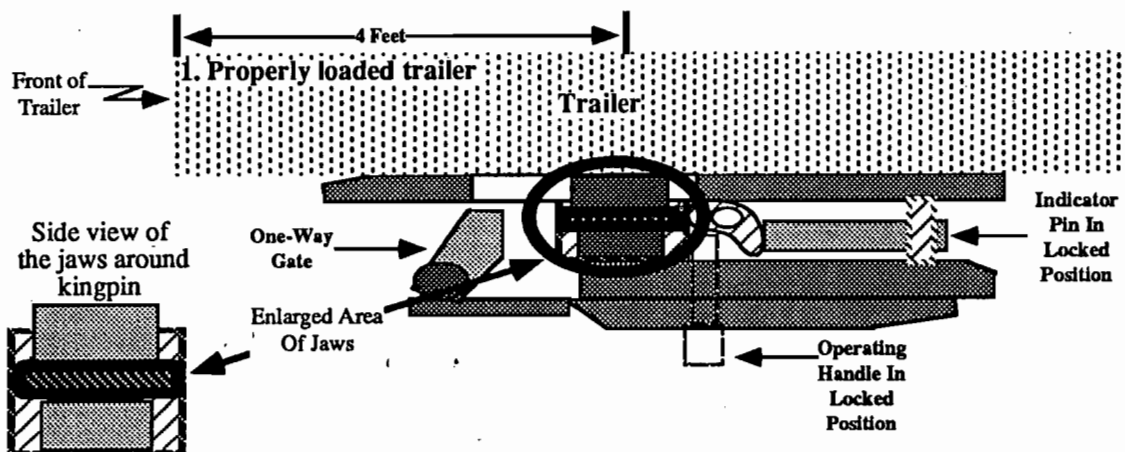
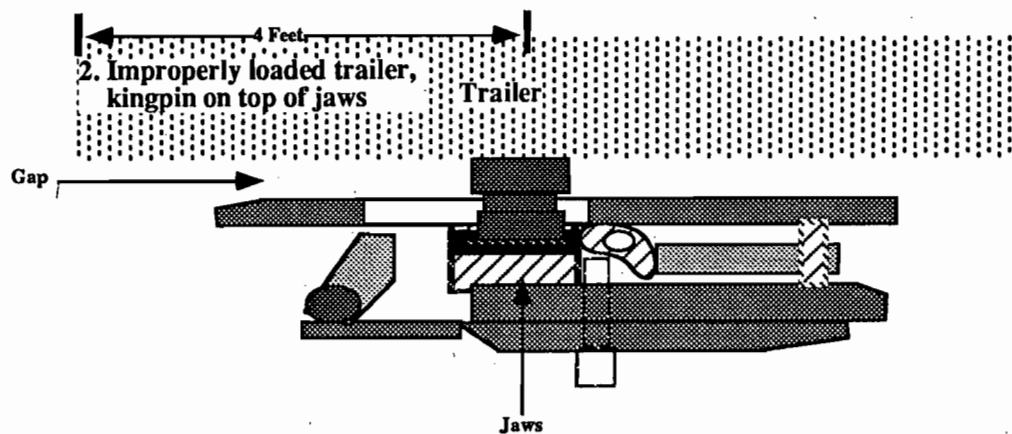
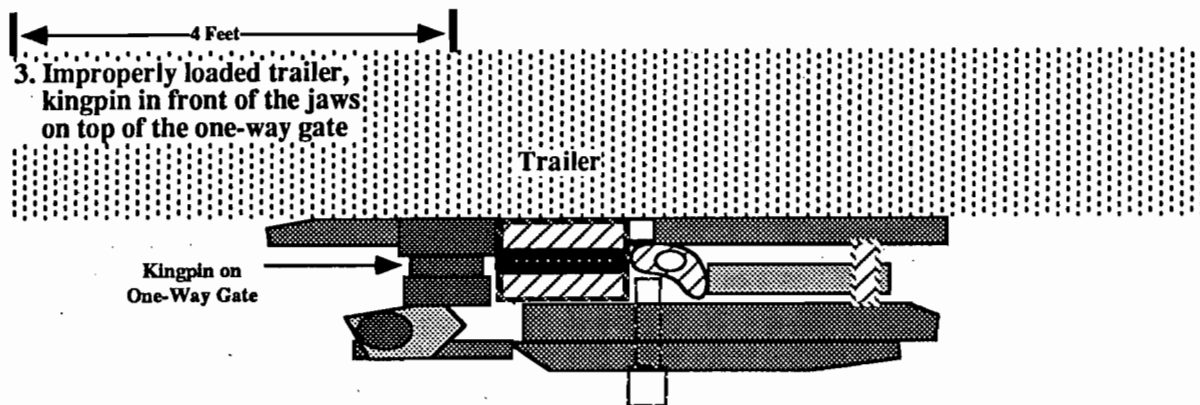
To determine why the kingpin was not locked and properly secured within the locking jaws and its retaining ring when the trailer was loaded, the Safety Board considered three possibilities: first, the locking jaws were already closed when the trailer was loaded; second, a mislock could have occurred; and finally, a combination of the previous two possibilities. (See figure 9.)

Figure 9. -- Side views of trailer locked and mislocked on an intermodal hitch.

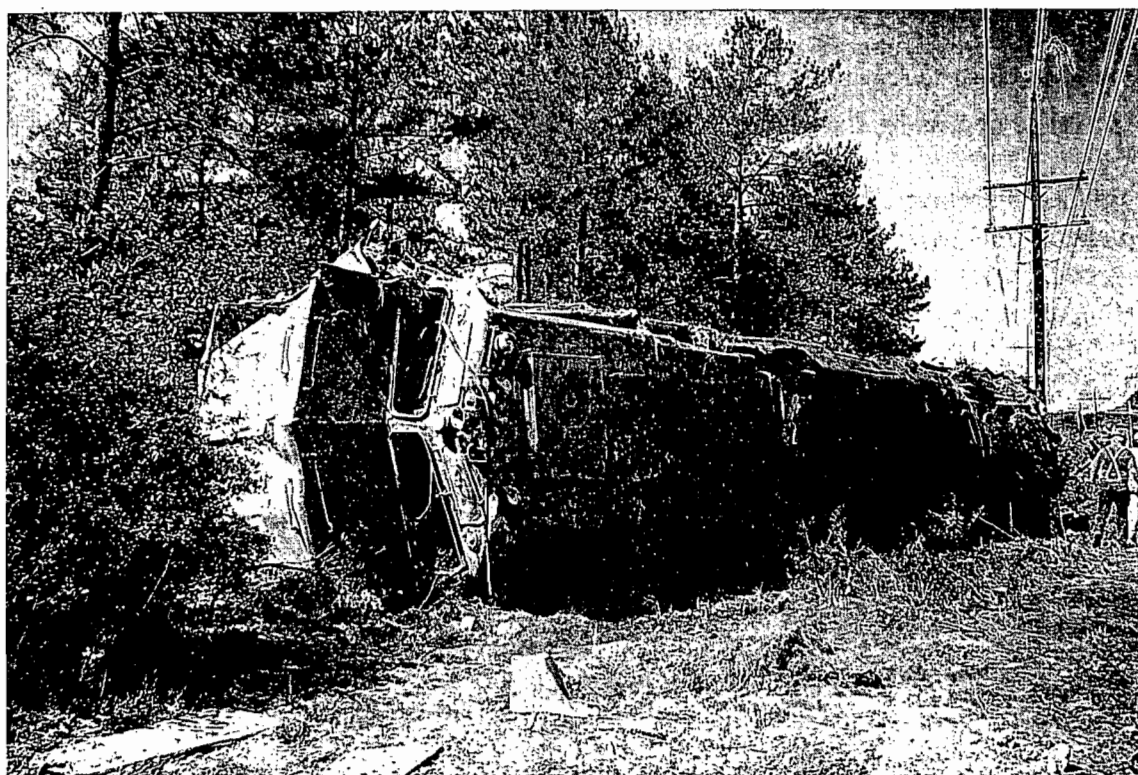
The lead unit front hood showed contact damage from the right front corner extending inward toward the center line for 9 inches. The sheet metal that covered the right side of the front hood and the control compartment was torn and collapsed inward 1.5 feet. All windows, except on the left side of the control compartment, and both windshields were missing. The seats for the engineer and the assistant engineer had separated from their attachment points. The automatic brake and the emergency valve levers were found in the emergency position.

In the Selma accident, the Amtrak train 87 assistant engineer was killed and the engineer was severely injured within the locomotive operating compartment as the unit derailed and overturned. (See figure 10.) The Safety Board could not conclude whether the death and the severe injury were caused by impact with the trailer, striking or being struck by objects within the operating compartment, or a combination of both. However, after examination of the control compartment interior, Safety Board investigators noted that the radio bracket, as positioned, was a potential contact-injury producing mechanism. Amtrak is removing, as a precaution, all radio brackets from its locomotive control compartments.

Figure 10. -- Lead unit of Amtrak train 87 locomotive at accident scene.
