NTSB/RAR-95/03

# NATIONAL TRANSPORTATION SAFETY BOARD

## RAILROAD ACCIDENT REPORT

COLLISION AND DERAILMENT INVOLVING  
THREE BURLINGTON NORTHERN FREIGHT  
TRAINS NEAR THEDFORD, NEBRASKA  
JUNE 8, 1994

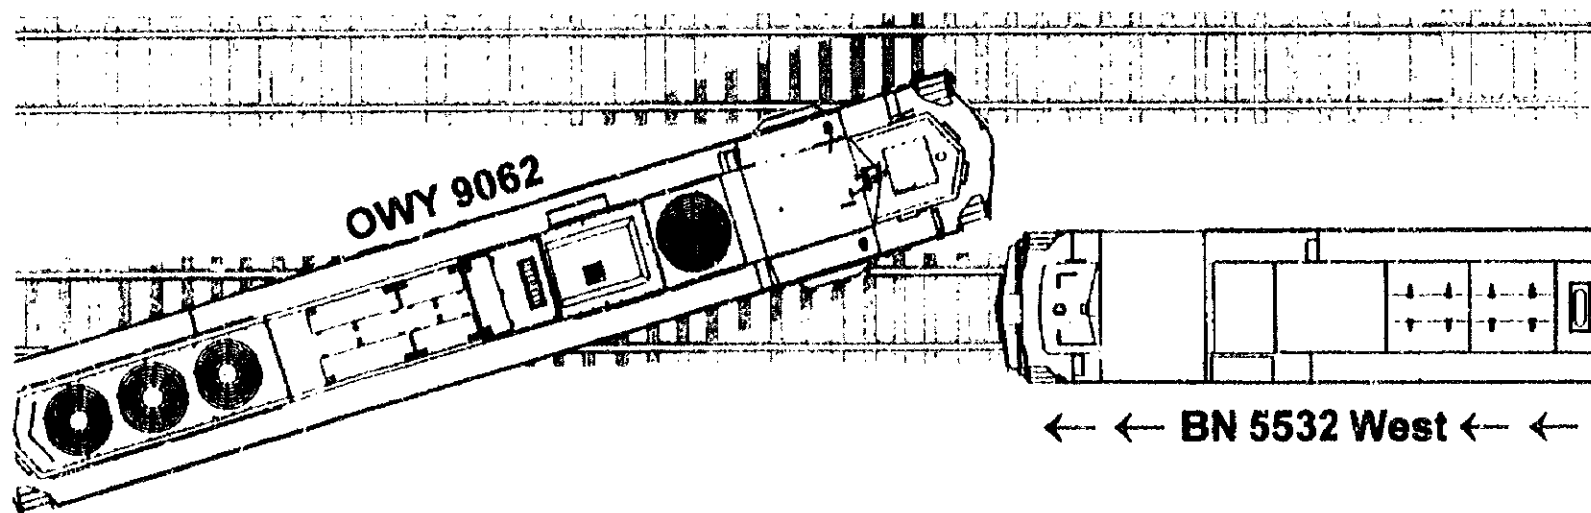
OWY 9062 East had struck the rear of stopped BN 6782 East at MP 252.1. The lead unit of OWY 9062 East derailed and came to rest angled across and obstructing the adjacent main track no. 2. The engineer of BN 5532 West stated that he was about 15 to 20 car lengths (about 900 to 1,200 feet) away when he saw OWY 9062 East collide with the rear of the stopped BN 6782 East. He then placed his train into emergency and both he and the conductor jumped from the fireman's (left) side of the train. BN 5532 West was moving about 25 mph when it struck the engineer's side of the OWY 9062 cab (figure 4).

Figure 4 -- The illustration shows the approximate angle of impact into the cab of OWY 9062.
