NATIONAL TRANSPORTATION SAFETY BOARD

WASHINGTON, DC 20594

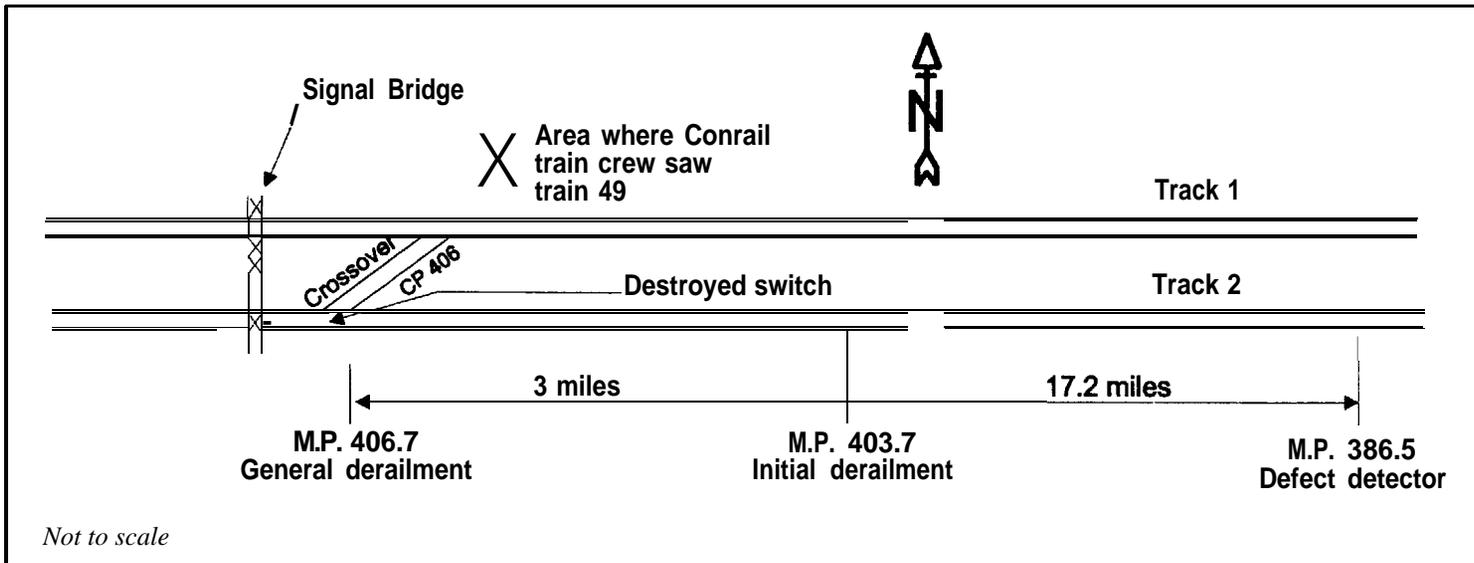
Figure 2 — Profile of defect detector and initial and general derailment sites.

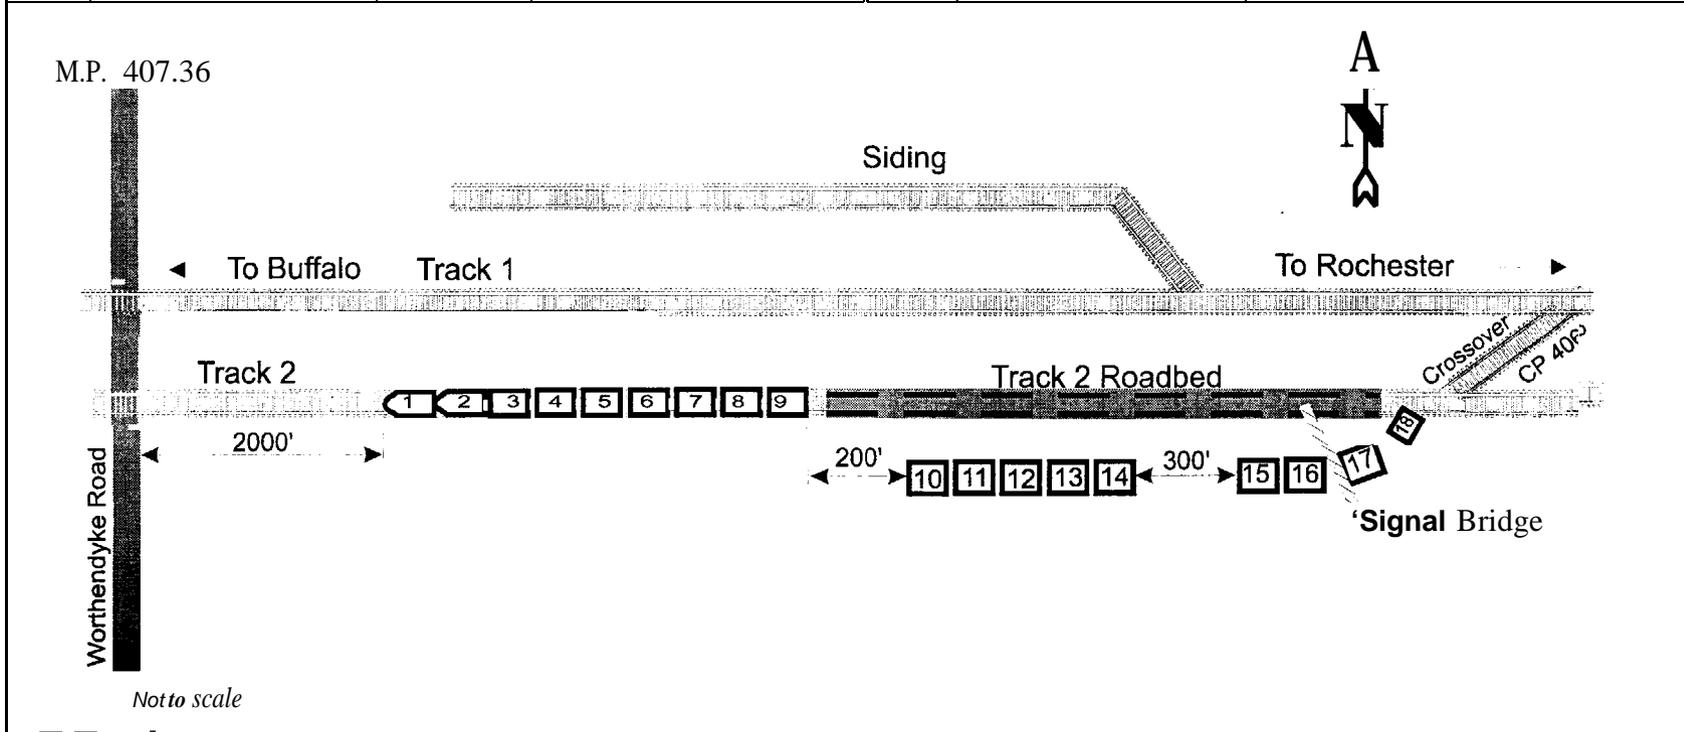
Figure 5 – Location of cars after accident.

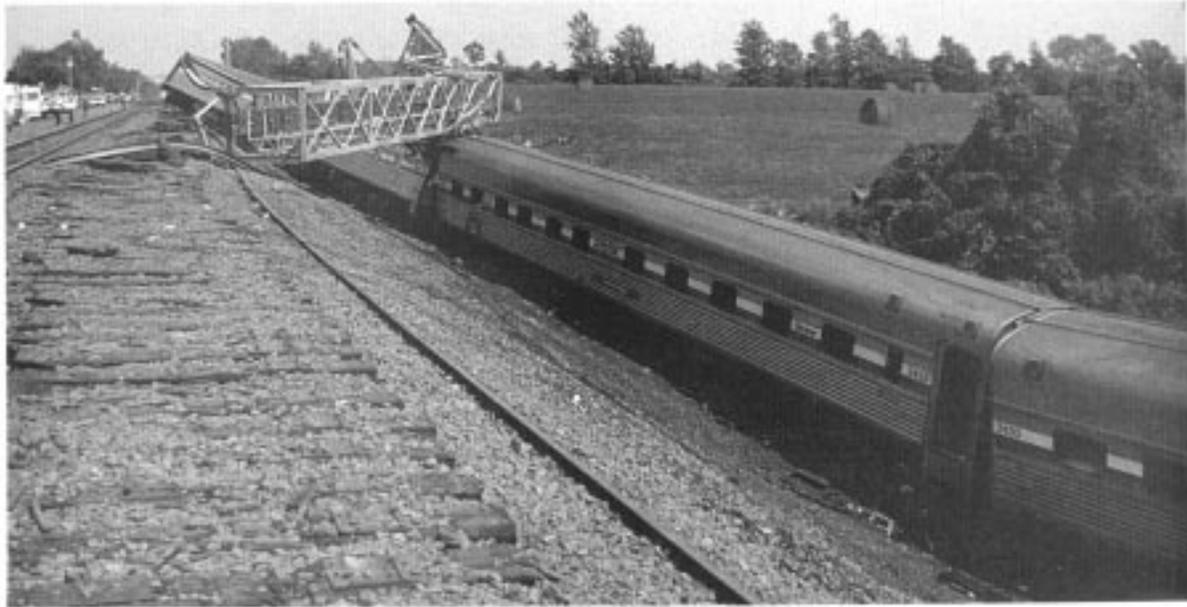
Figure 6 — Signal bridge.

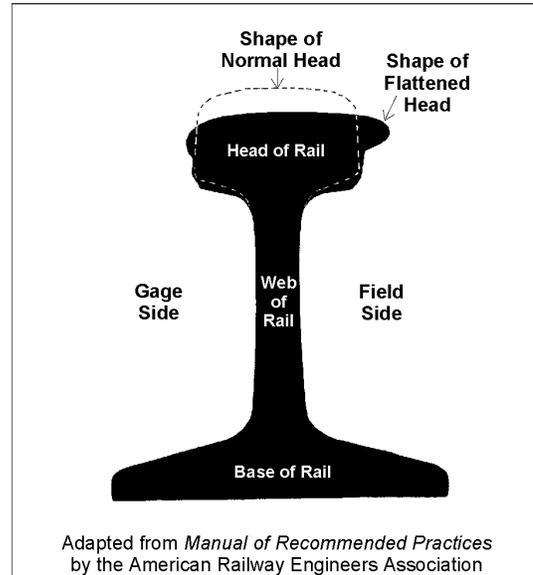
Figure 7 — View of normal and flattened rail heads.

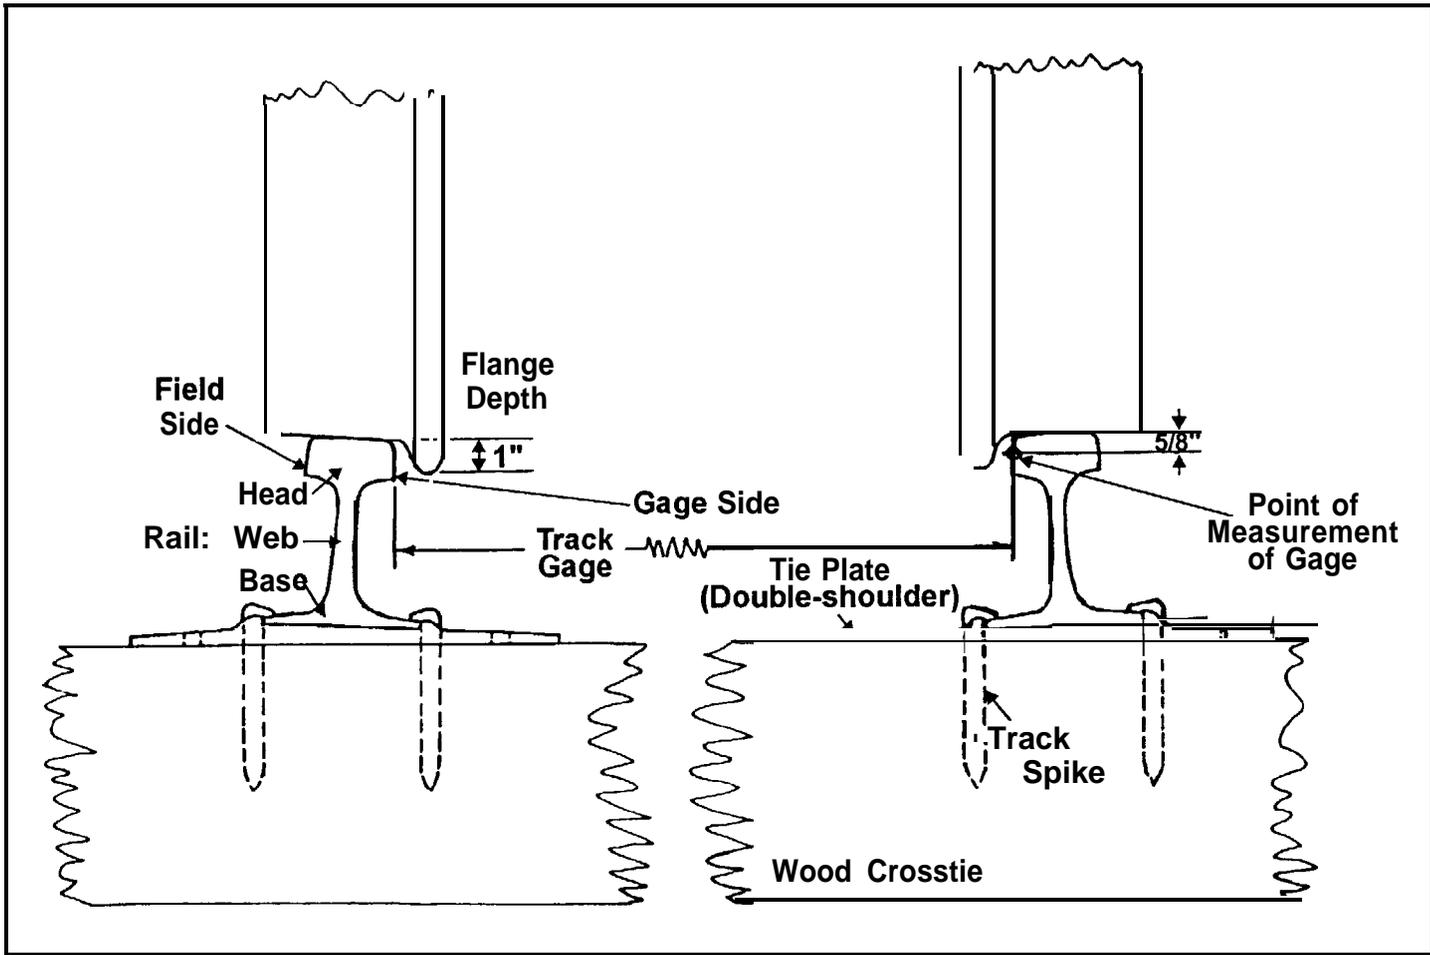
Figure 12 — Wheel/Rail interface.

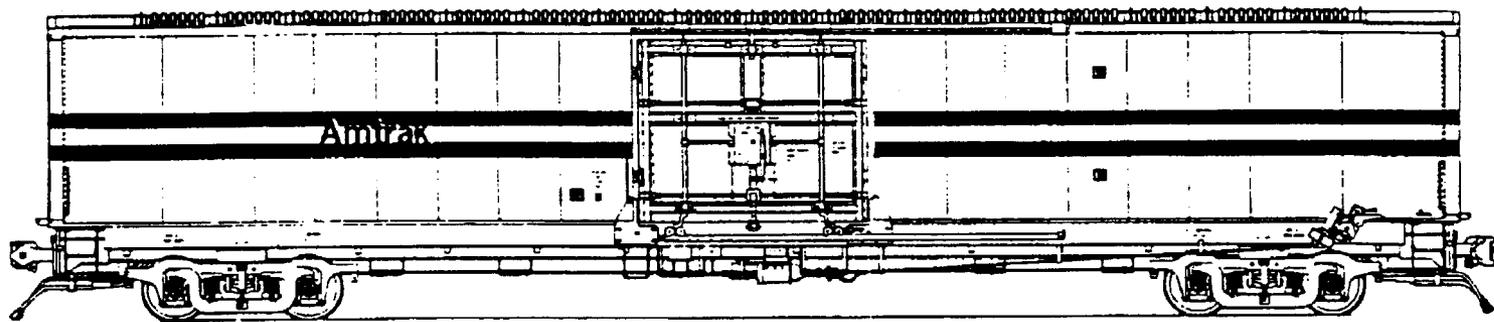
Figure 14 — Material handling car of 1500-series.

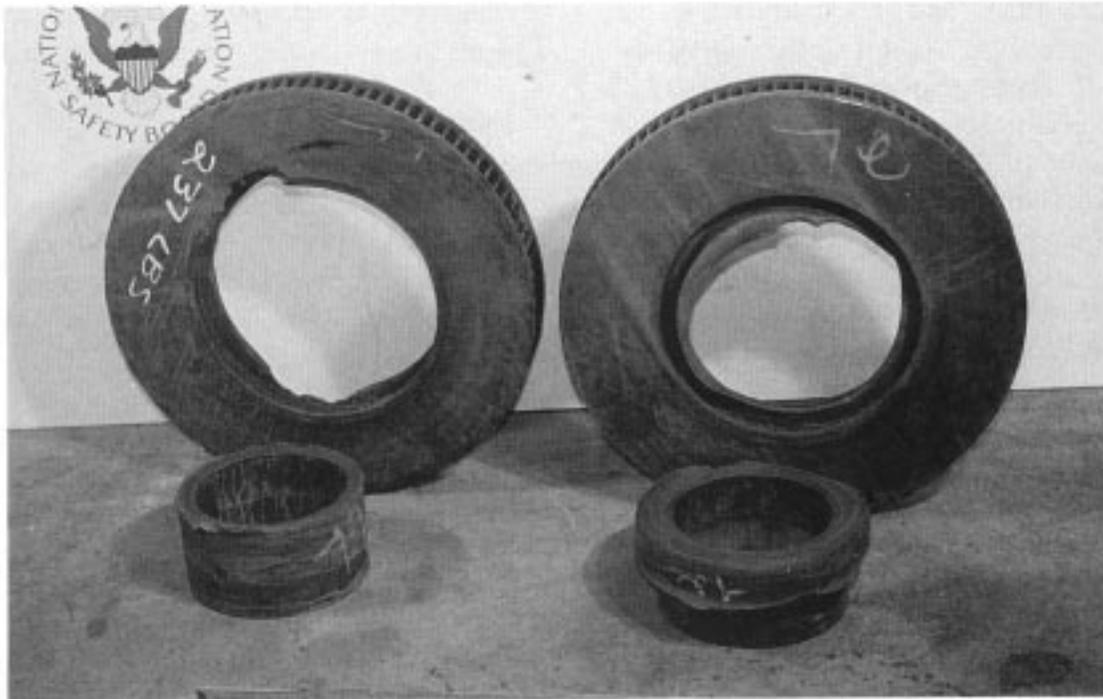
Figure 16 — Broken brake discs.

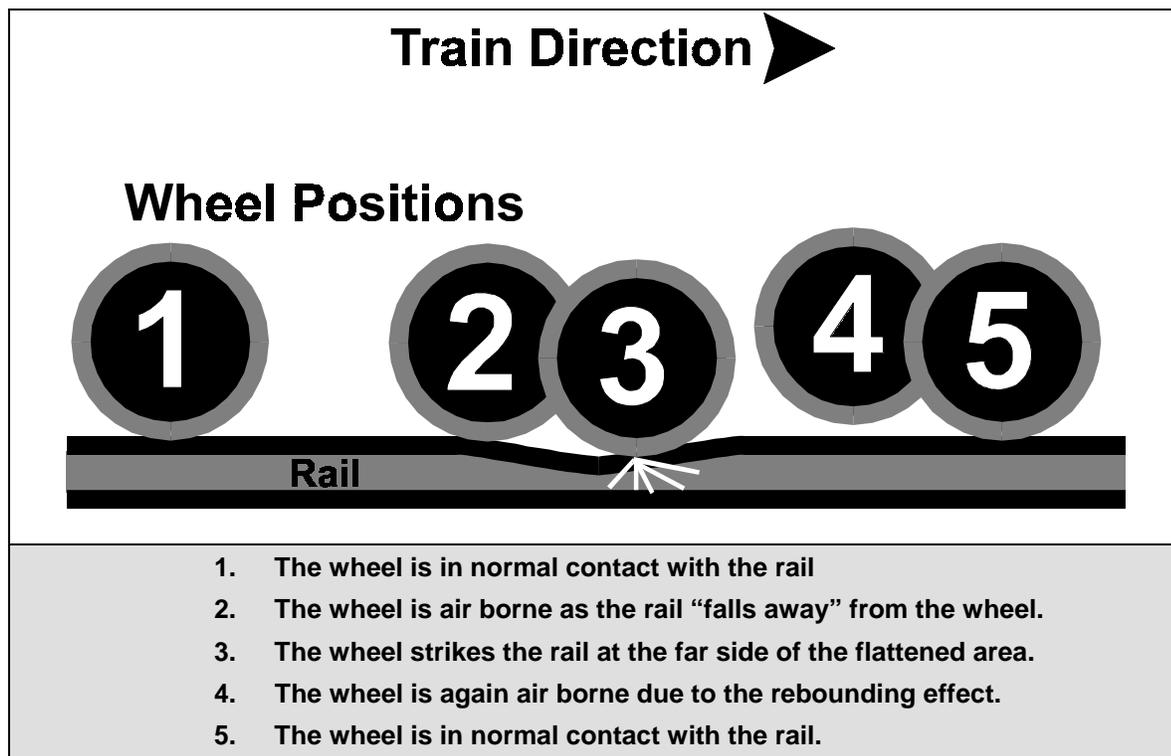
Figure 17 — Movement of wheel on flattened rail head.
