NATIONAL TRANSPORTATION SAFETY BOARD

RAILROAD ACCIDENT REPORT

COLLISION INVOLVING TWO NEW YORK CITY
SUBWAY TRAINS ON THE WILLIAMSBURG BRIDGE
IN BROOKLYN, NEW YORK
JUNE 5, 1995

Adopted: September 4, 1996

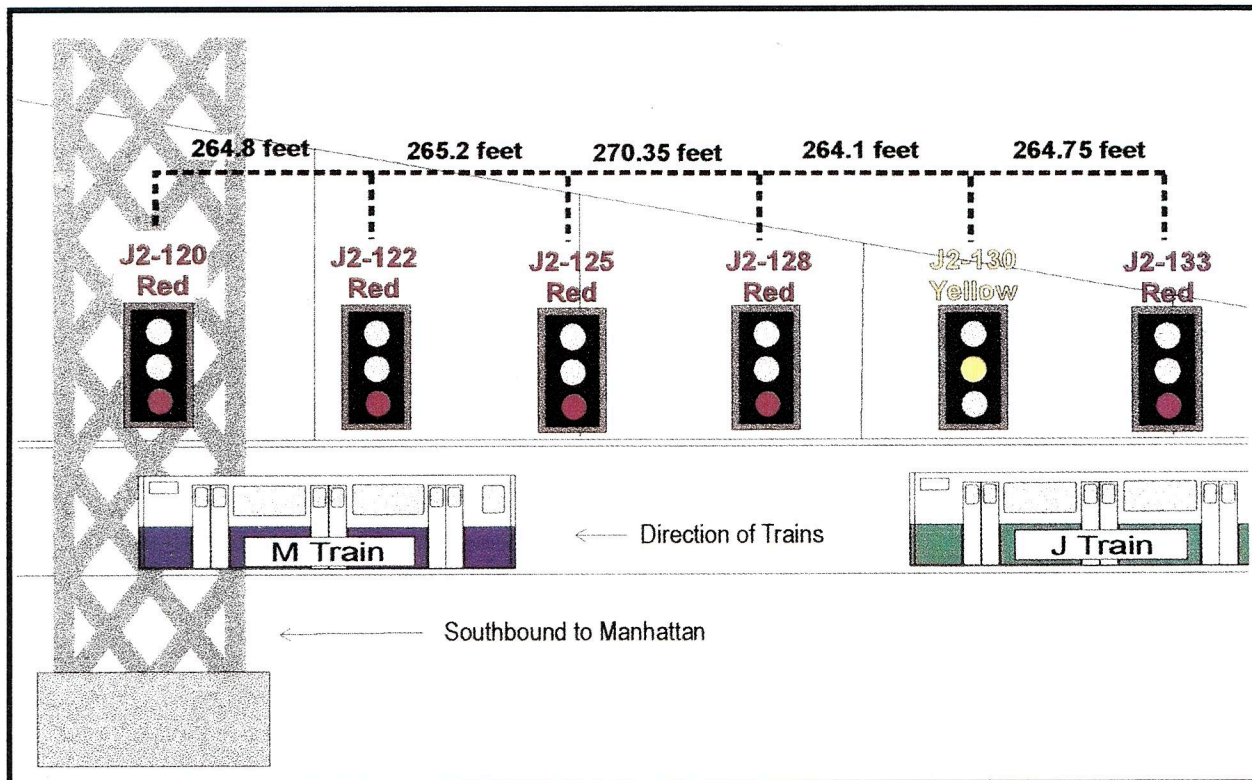
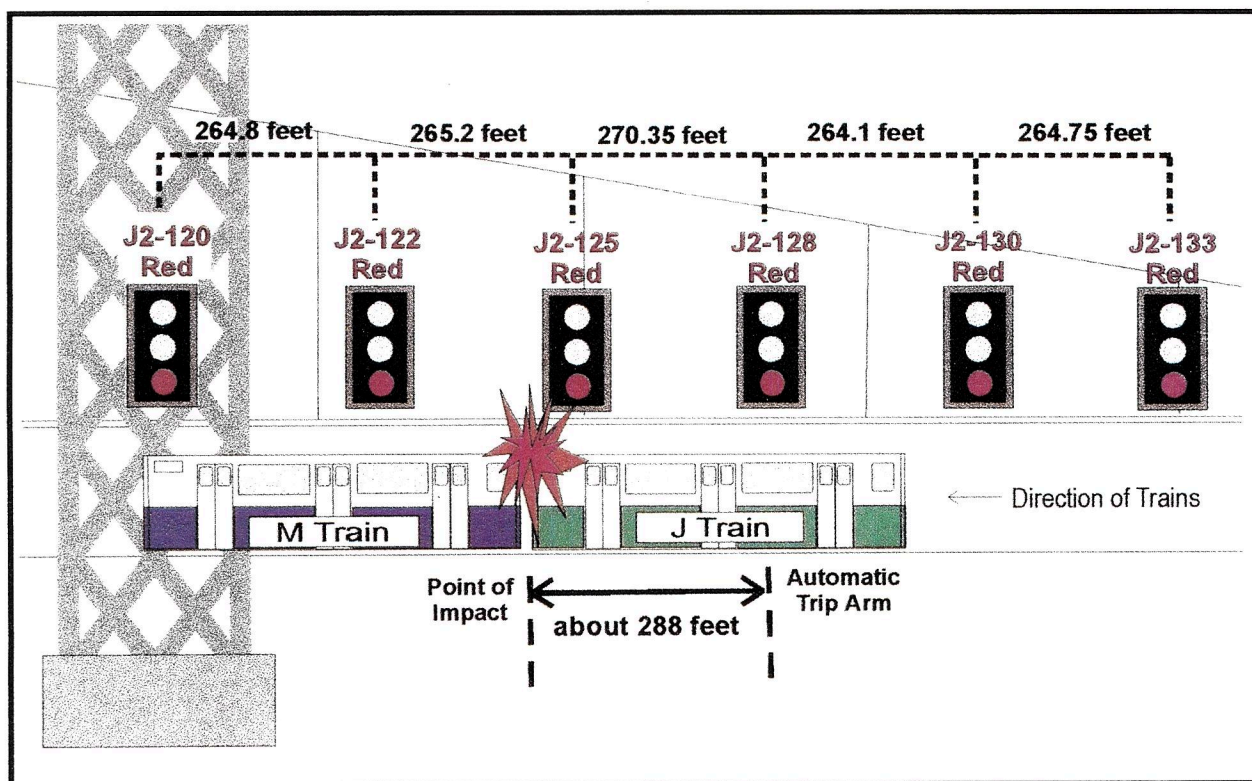
Figure 2 — (Top) The M train was stopped at Signal J2-120 when the J train proceeded past a yellow caution light at Signal J2-130 traveling about 34-36 mph. (Bottom) Although the automatic trip arm at red Signal J2-128 properly activated the emergency braking of the J train, it failed to stop within the 270-foot-long block and struck the rear of the M train, which was 16 feet beyond Signal J2-125.

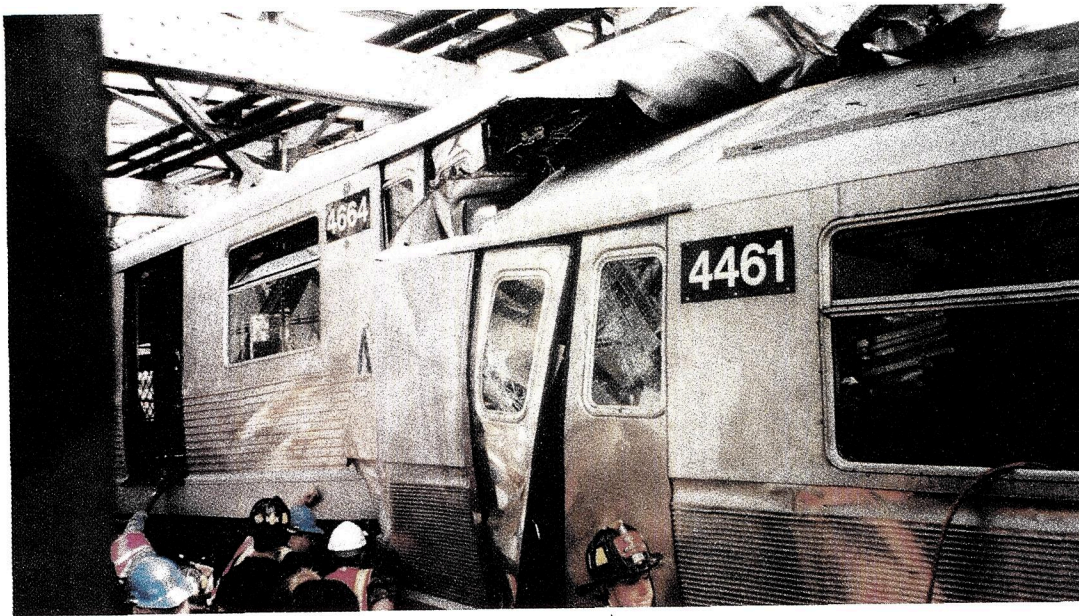
Figure 3 — The accident site.

None of the 16 cars from the two trains derailed from the impact, but the lead car of the J train penetrated the rear car of the M train resulting in extensive damage to these two cars (figure 3) and the fatal injury of the J train operator. When the off-duty train operator on the J train noticed smoke coming from the front end, he instructed other passengers to run from the car and then assisted in evacuating people from the train. Within 5 minutes of the collision, a bystander called the New York Police Department (NYPD) 911 dispatcher, reporting that a train collision had occurred on the bridge. The NYPD immediately notified the Fire Department of New York (FDNY) and dispatched police and rescue personnel to the scene. Initial emergency responders arrived on scene within 5 minutes of the 911 notification call. They arranged to have a transit bus and 47 ambulances transport 55 injured passengers and crewmembers to 11 area hospitals. Several individuals with minor injuries either were treated and released at the scene or sought treatment elsewhere. Additional information about the response effort appears in the *Survival Factors* section of this report.

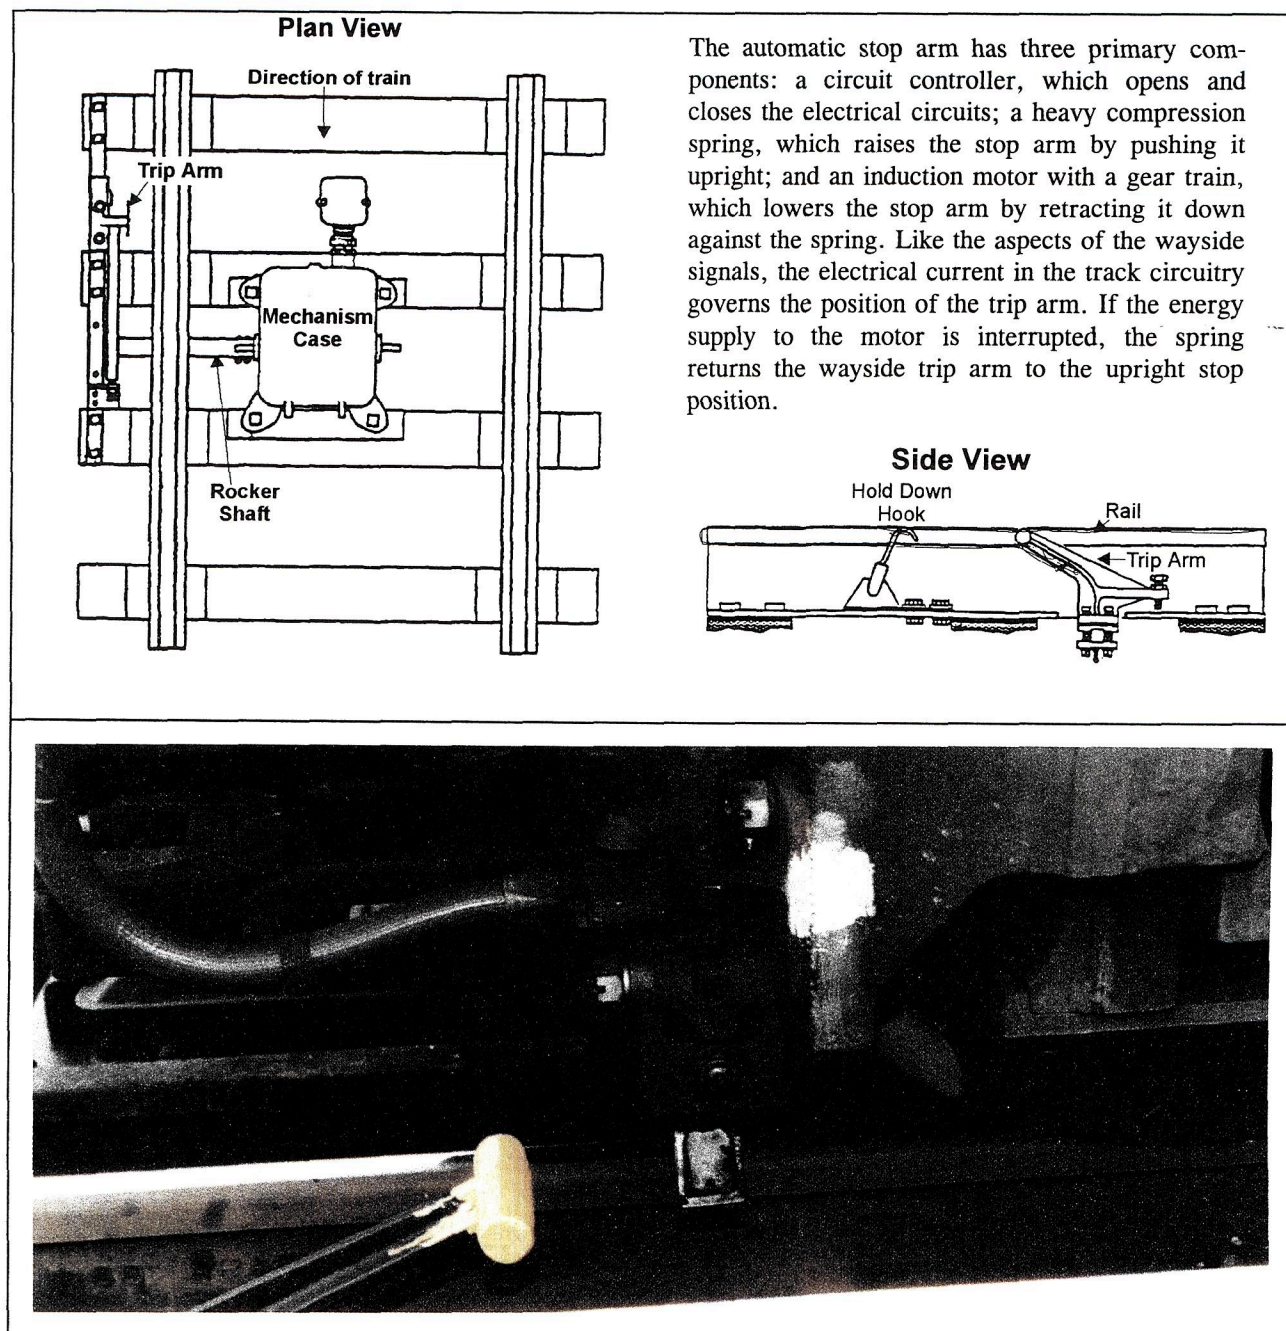
Investigators examined the trip cock arm on the No. 1 end of car 4461 and observed a small amount of yellow paint near the end of the arm. They measured the distance of the trip cock arm to the rail and determined that the arm was about 1-1/4 inches above the rail, which was within the NYCT standard. Investigators had

the trip cock assembly removed and taken to the NYCT Coney Island Pneumatic Shop, where new and rebuilt trip cocks are qualified on a test rack. The trip cock functioned as designed in a series of tests, including a leakage test and a 45-pound pull test. When testers displaced the valve 18 degrees from vertical in either direction, it activated properly. During visual examination, investigators noted that the trip cock had been rebuilt by a worker with the initials "KE" on the night shift in June 1994.

Figure 5 — Top illustrations show plan and side view of a wayside trip arm.
Photograph shows a lowered trip arm (painted yellow) in front of a train trip cock.

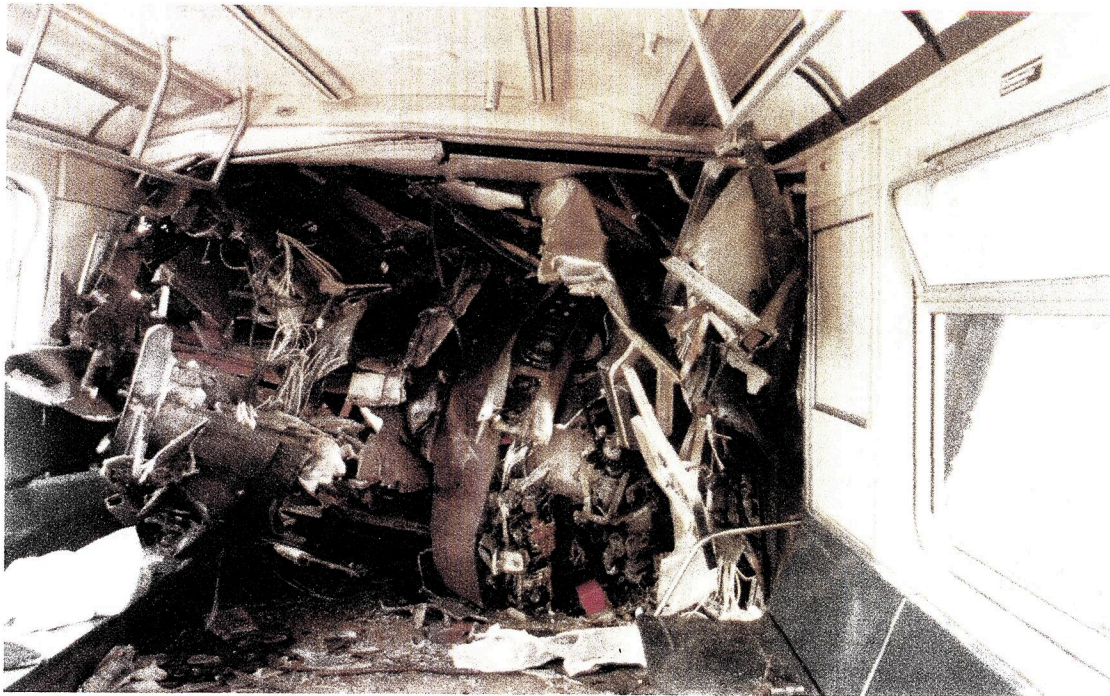
Wreckage — The lead car of the J train, 4461, partially telescoped about 17 feet into car 4664. The rear truck of car 4664 had been knocked off its center casting and had been moved forward about 7 feet, raising the car body about 6 feet into the air. The front end and operating compartment of car 4461 had collapsed inward (see figure 7). A summary of the damage to the individual cars follows.

J train damage — All eight cars suffered some degree of damage. The lead car, which struck the rear car of the M train, experienced massive carbody intrusion on the operator's cab end. The antilclimber and front structure was pushed in about 7 feet. The interior floor was penetrated, and had buckled upward and inward. The entire end of the car was essentially destroyed up to the horizontal cross member over the center pin. The front seat opposite the operator's cab was totally crushed. The operator's cab was totally crushed with no

Figure 7 — Interior damage to the lead car of the J train.

survival space remaining, and the rear wall of the cab was displaced backward. The remaining cars suffered damage to the draft gear (yoke and drawbar) and related parts, cracked bonnets, and bent anticlimbers (flanges).
