# **NATIONAL TRANSPORTATION SAFETY BOARD**

## **RAILROAD ACCIDENT REPORT**

**NEAR HEAD-ON COLLISION AND DERAILMENT OF  
TWO NEW JERSEY TRANSIT COMMUTER TRAINS  
NEAR SECAUCUS, NEW JERSEY  
FEBRUARY 9, 1996**

**Adopted: March 25, 1997  
Notation 6674A**

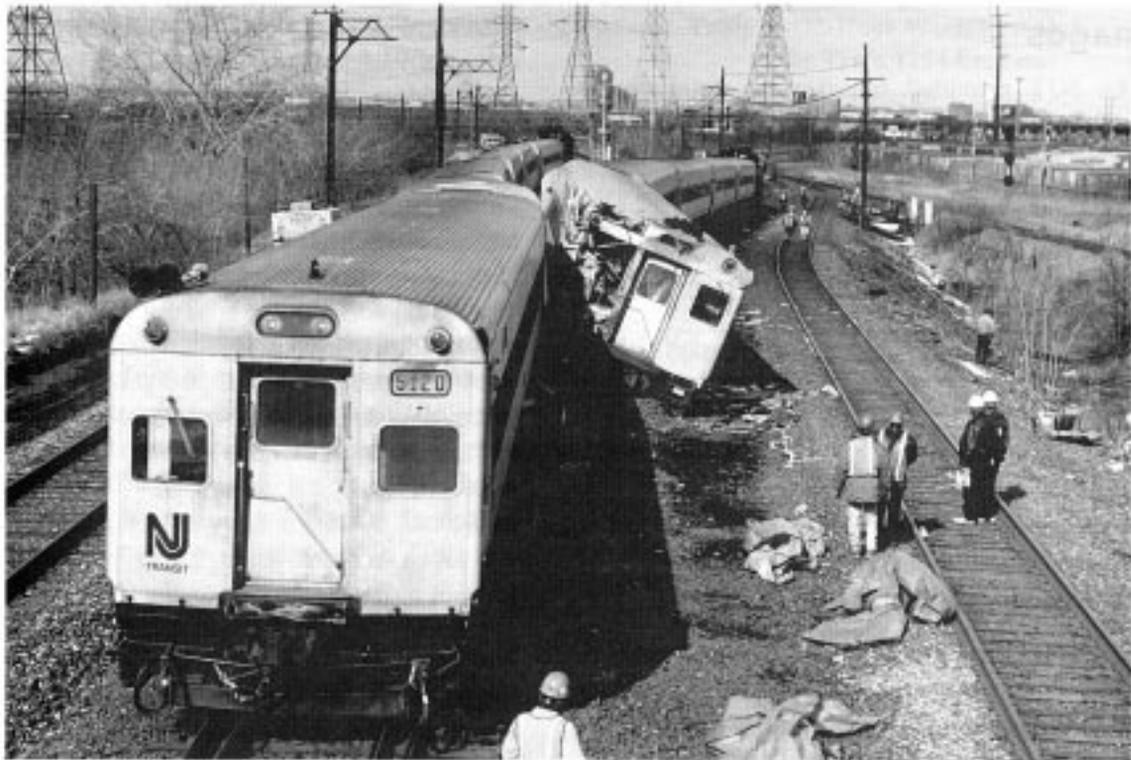
Figure 3—Accident site (looking west). Unit 5120 is the last car in the train 1107 consist. Derailed unit at right is the cab car of train 1254. Photograph courtesy of Jim Mardigian.

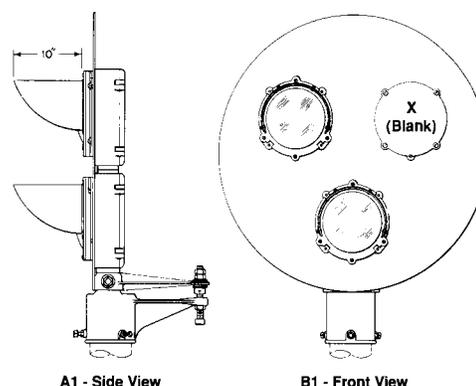
Figure 4—Type of light unit at Signal 28E-1.

Signal 28E-1 is a pole-mounted, long-range color-light-type device having three heads arrayed vertically. The top head has one lens, which is always illuminated red, and the two lower heads have two "active" lenses, yellow and red, which are illuminated depending on the signal indication. An enlargement of the lower head is below.

As manufactured, this model of signal head has three lenses: green at upper right, yellow at upper left, and red at lower middle. However, a carrier using two-aspect combinations in its signal system, such as NJT, can order the signal head with a blank lens.

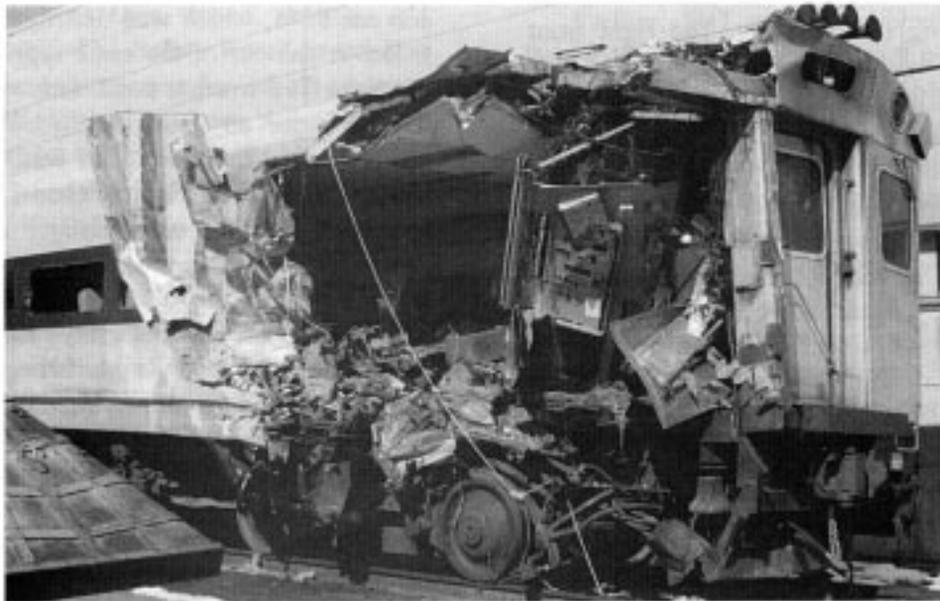
Figure 8—Photograph of unit 5146, the cab car of train 1254

**Wreckage**—The lead truck of train 1254's cab car, unit 5146, had derailed about 4 to 5 feet off of the rail. The roof of the car was sheared off on the right side near the front end. Train 1107's locomotive unit, NJT 4148, sustained major intrusion and crush damage to the engineer's side of the locomotive.

**Train 1254**—All five cars sustained damages; the locomotive unit had no reported damages. The lead unit, cab car 5146, which was a Comet II type car (figure 7) with a body constructed primarily of aluminum extrusions and aluminum sheet metal, suffered major damage. The right<sup>11</sup> buffer wing, which is attached to the corner post stub, had separated from the car. The end sheet had separated from the car. The floor in the engineer's compartment had been sheared off. The trap door and stairwell were missing. The right side of the compartment roof, outboard of the collision post, had been sheared off. A 10-foot section of roof rail had broken off and lodged in the locomotive cab of train 1107. The interior bulkhead directly behind the engineer had been pushed rearward at the bottom and pulled down at the top. The engineer's seat had folded back into the bulkhead. The first two seats aft of the bulkhead, where the deceased passenger had been sitting, had been pushed rearward into the seats behind them. The space normally occupied by these seats was filled with debris.

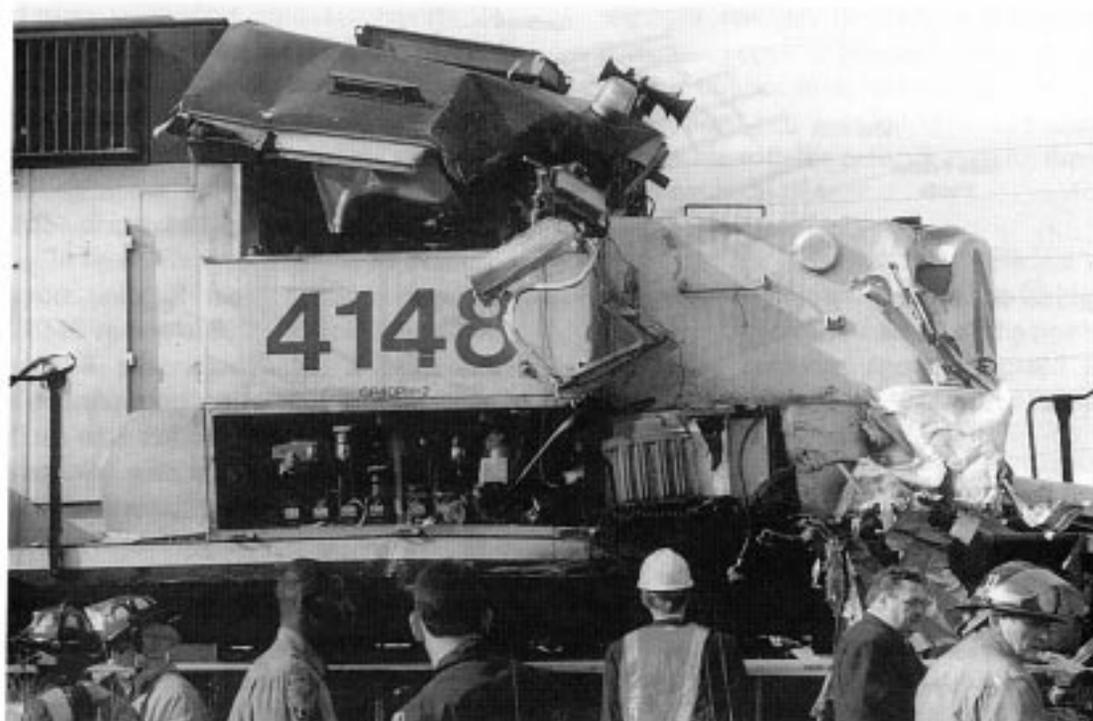
Figure 9—Photograph of unit 4148, the locomotive of train 1107

*Train 1107*—Five of the six cars suffered some degree of damage; the locomotive (figure 9) sustained damage to the end plate, plow, and short hood on the engineer's side. Several feet of the cat walk on that side of the locomotive received impact damage, and collision debris was piled along the walkway. The right front collision post within the short hood compartment was still intact. However, the right corner of the short hood compartment enclosure was pressed into the nose compartment about 12 inches. The windshield corner post on the right side was pushed inward and the side of the cab roof was pulled down. The maximum roof deflection was 26 inches. A 10-foot section of the roof rail from the cab car of train 1254 was found lodged diagonally across the cab of the locomotive unit. One end of the roof rail was lodged against the bottom inboard side of the windshield corner post. The other end was imbedded into the electrical control panel directly above the fold down seat. This section of roof rail had struck the engineer's control stand, rotating it about 40 degrees aft.
