RAILROAD ACCIDENT REPORT

COLLISION AND DERAILMENT
OF MARYLAND RAIL COMMUTER MARC TRAIN 286 AND
NATIONAL RAILROAD PASSENGER CORPORATION
AMTRAK TRAIN 29
NEAR SILVER SPRING, MARYLAND
ON FEBRUARY 16, 1996

**Adopted: July 3, 1997
Notation 6664C**

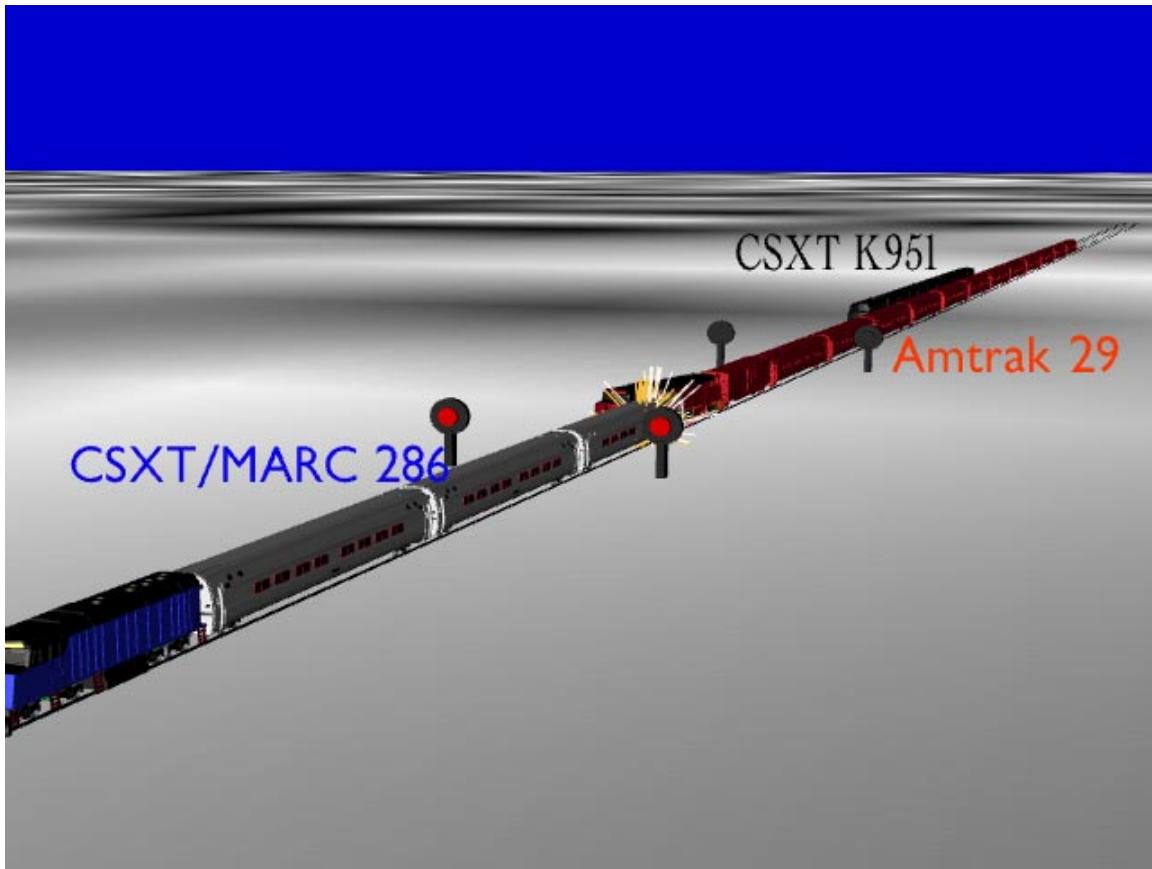
Figure 1--View of trains at point of impact.

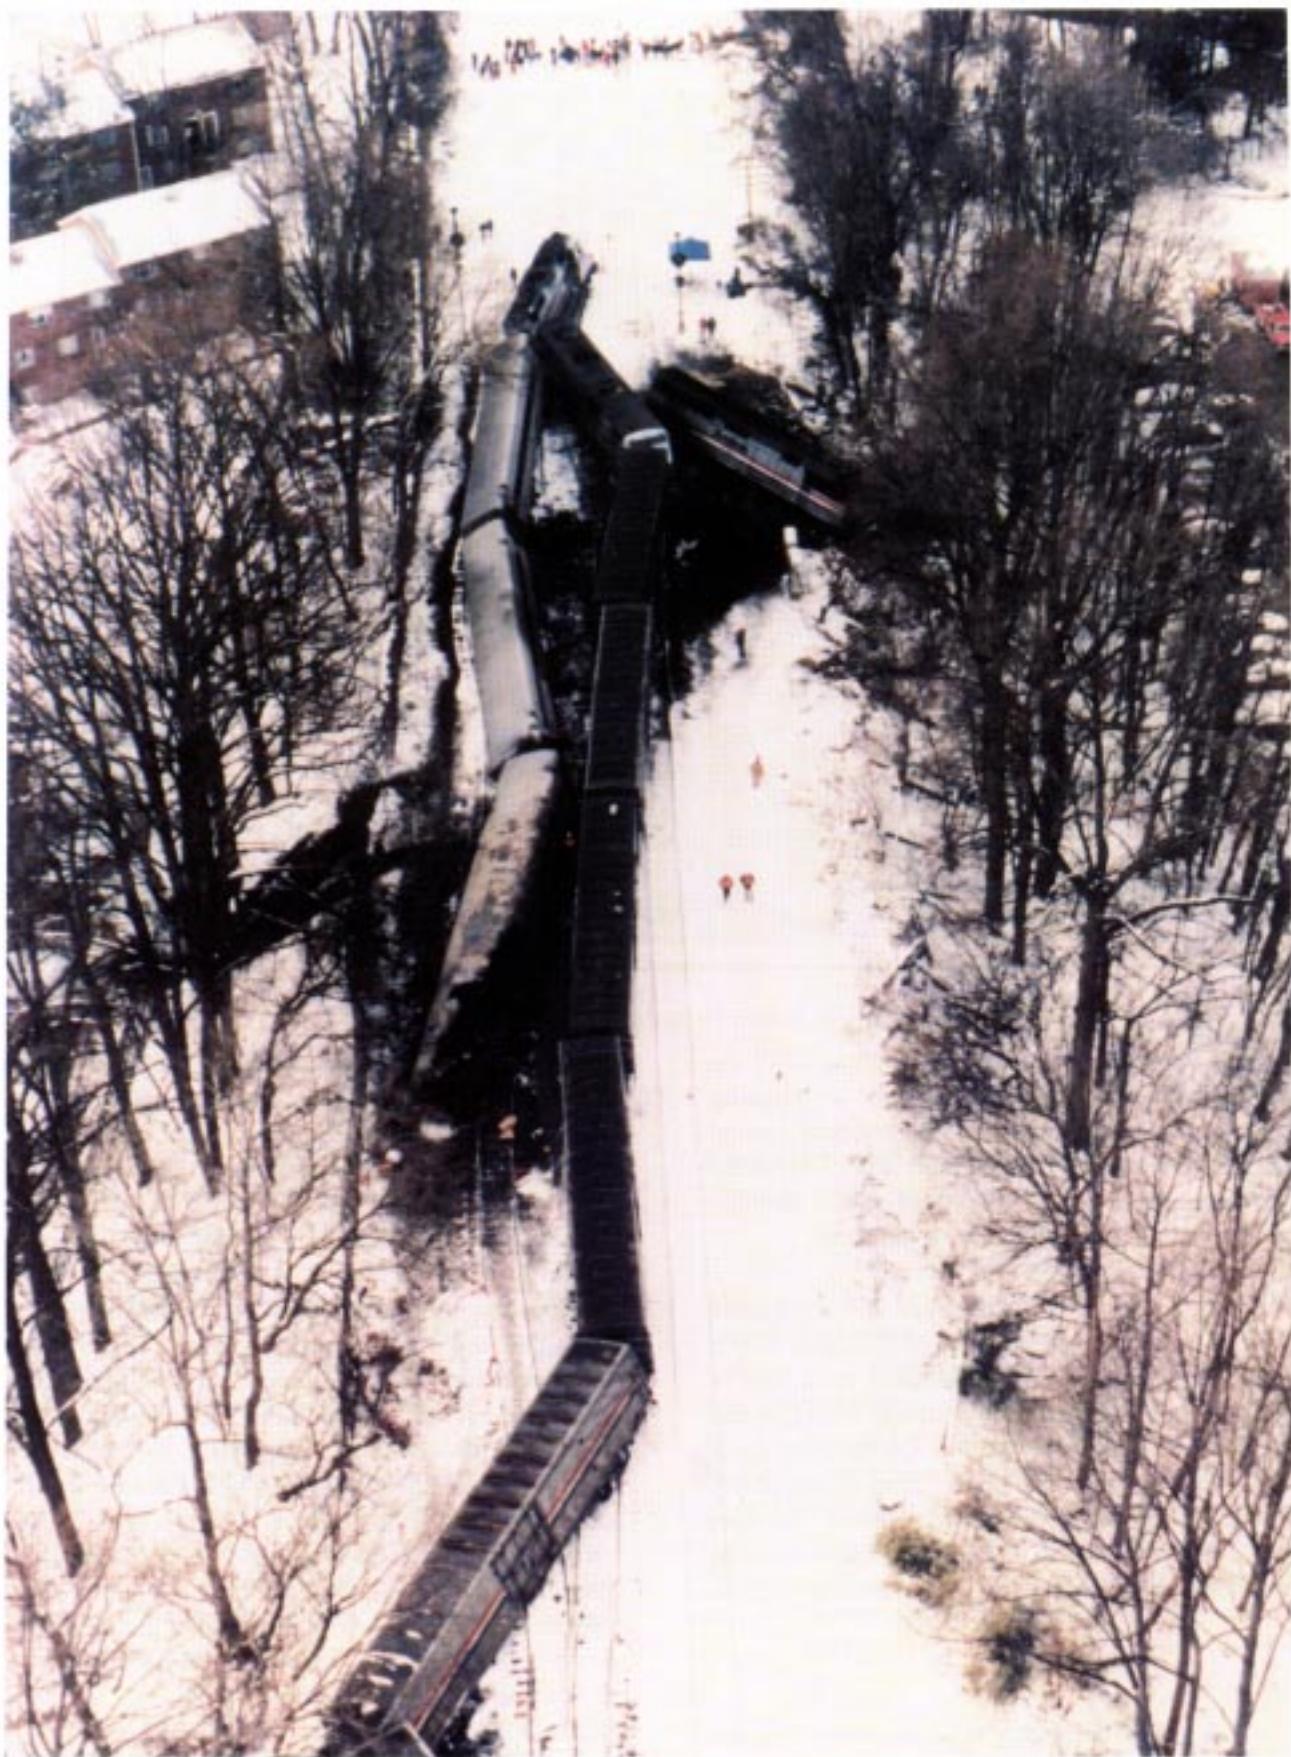
Figure 2--Aerial photograph of postcollision scene.

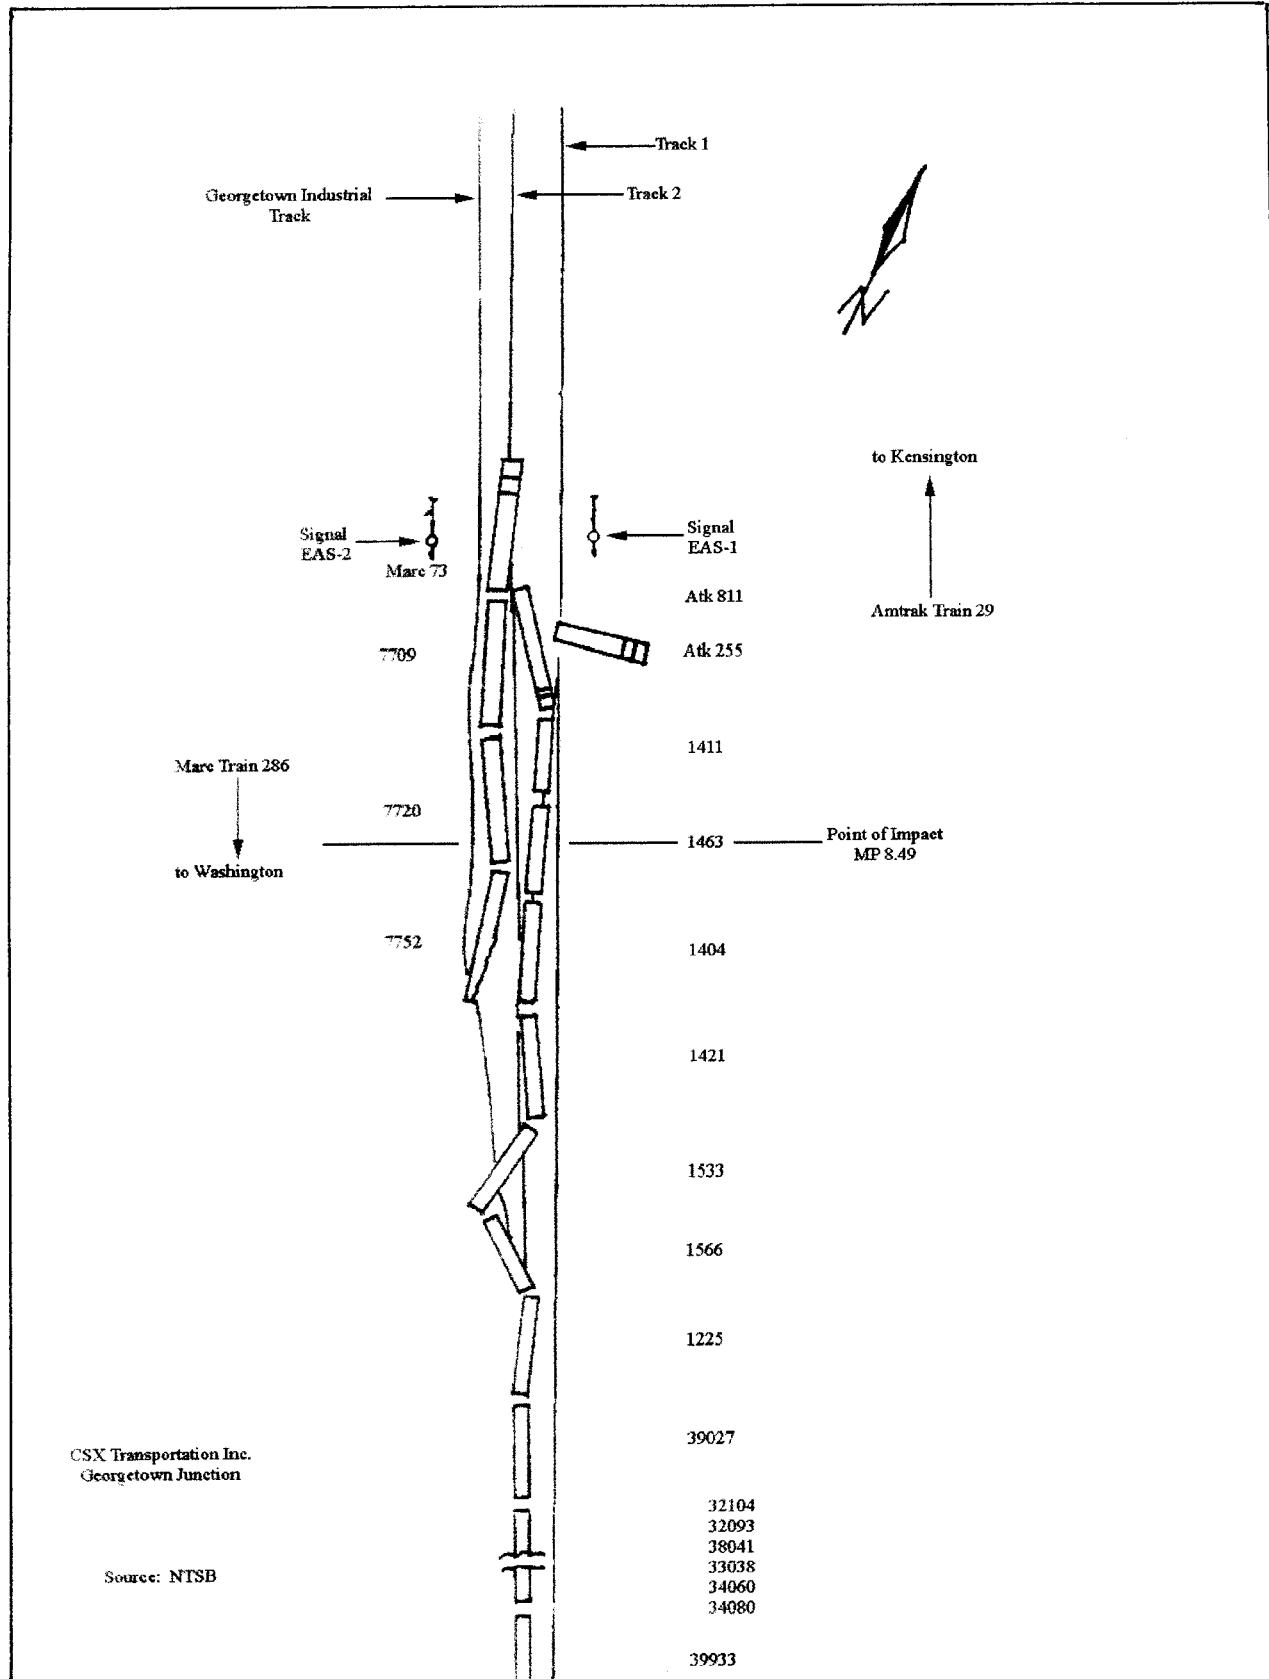
The collision between the lead Amtrak unit and the MARC cab control car tore away the front left quadrant of the cab control car. The fuel tank on the lead unit was ruptured in the collision and sprayed fuel on the cab control car. All three MARC cars and the MARC locomotive derailed in the accident. Both Amtrak units and the first eight cars of train 29 derailed. The derailed Amtrak equipment consisted of six material handling cars, one baggage car, and a transition-sleeper car, which was the only occupied Amtrak car to derail. (See figure 4.)

Figure 4—Schematic of postcollision site.

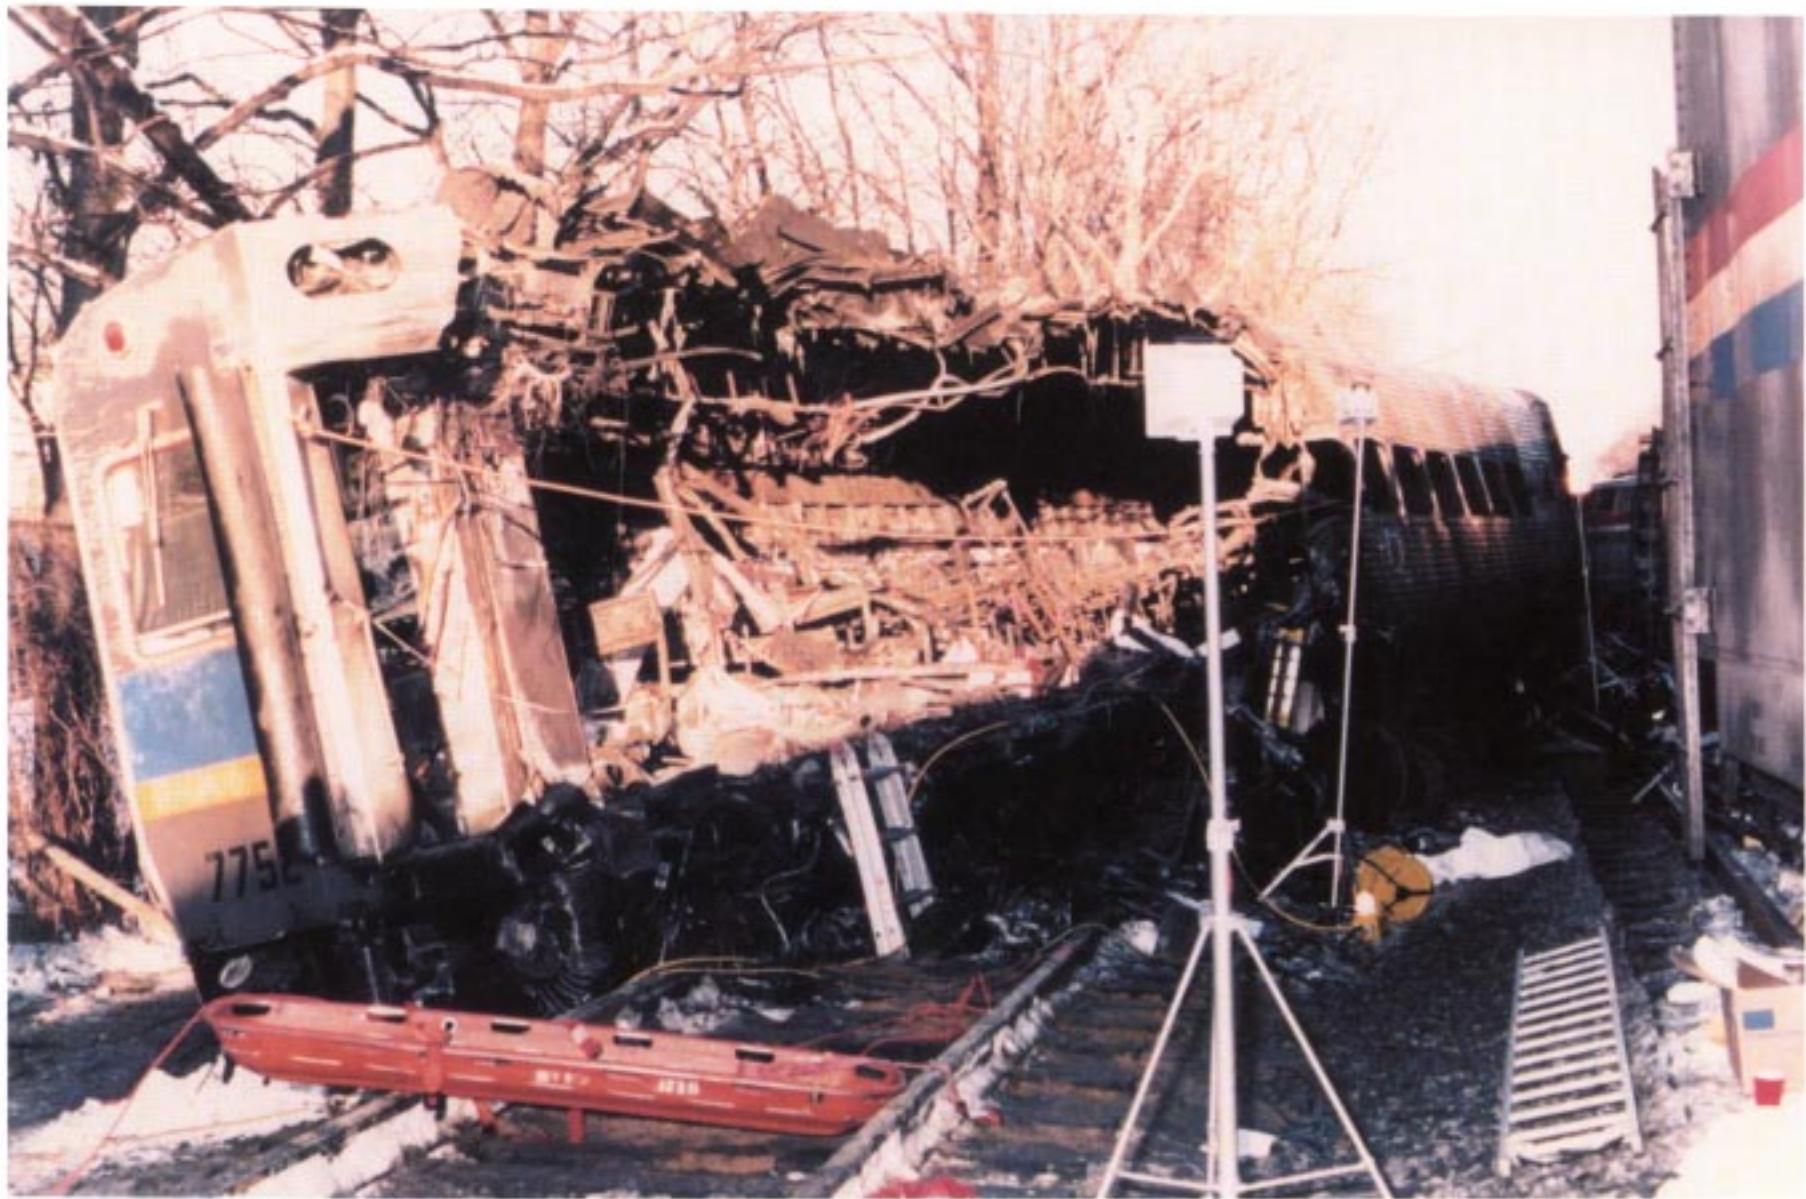
After colliding with Amtrak train 29, cab control car 7752 derailed and came to rest tilted approximately 10 degrees clockwise. (See figure 6.) The leading truck assembly of the car had separated from its mounting and was found upside down and lodged under the car midsection to the right of centerline. The car body plymetal floor above where the truck assembly came to rest was indented about 2 feet in depth. The left-side front anchor bracket assembly of the truck had fractured and was torn from its attachment to the car.

Figure 6--Photograph of postcollision passenger coach cab control car 7752 at accident site.

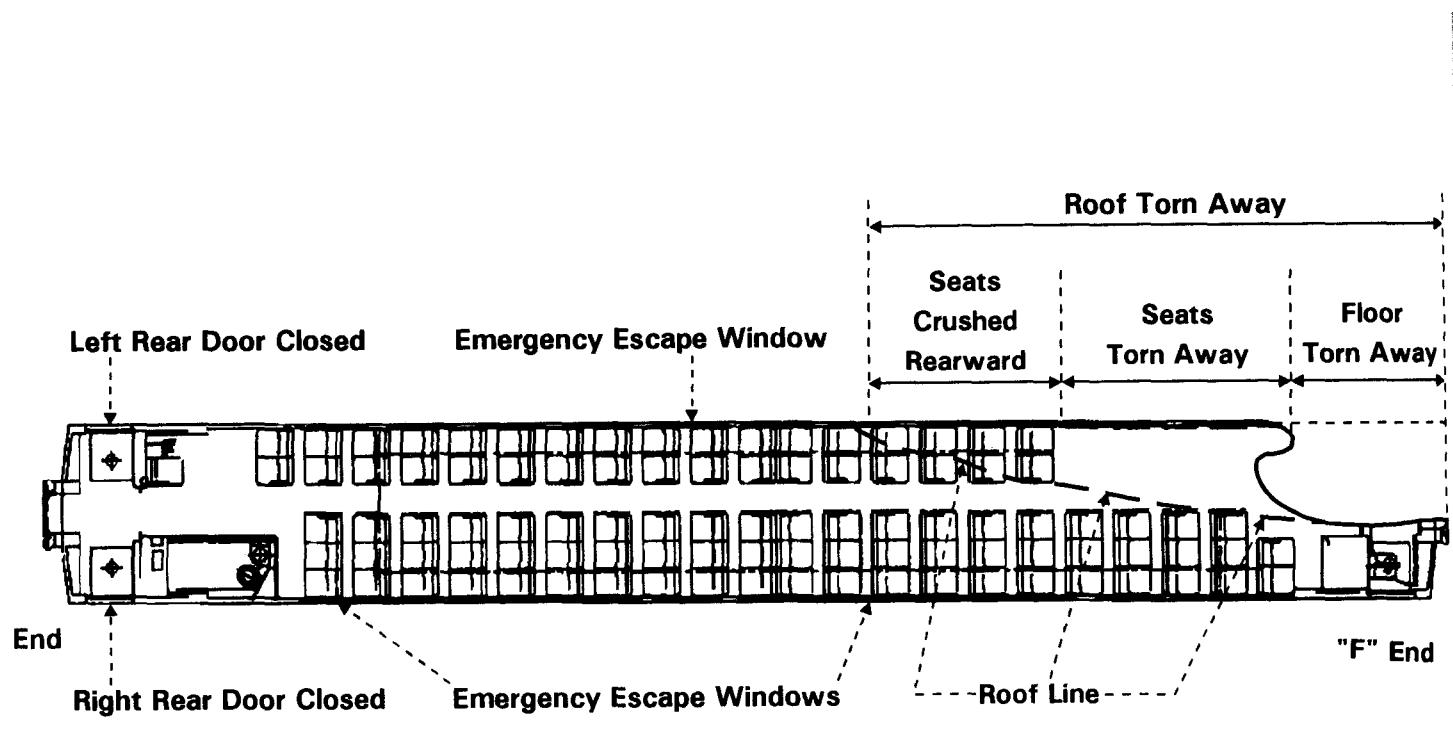
The interior of cab control car 7752 (see figure 7) was gutted by fire, leaving the charred metal shell, internal fittings, and combustion residue. Damaged remnants of insulation remained

in the ceiling and side walls. The rubber diaphragm at the rear passageway door was burned near the roof. The rear safety bar was horizontally positioned. A 50-pound portable fire extinguisher, normally secured by a metal strap on the front bulkhead of a vestibule, was missing and later discovered in the debris. The glass cover of the emergency toolbox was shattered, and the tools were missing.

The rear interior door of the car was open and slid within the wall pocket between the vestibule and the lavatory. The fire destroyed the controls for the left- and right-side rear doors and burned the position indicator lenses. The right-side rear door was open 0.5 inch, and its window was missing. The door contacted the front of the car body shell, into which it slides, 12 inches above the vestibule floor. Its interior emergency release handle was in a secured cabinet in the lavatory. (During an inspection of the car on March 14, 1996, at the Middle River, Maryland, MARC facility, the door did not open when this handle was pulled fully down.) The right-side rear "T" handle (exterior emergency door release mechanism) was missing from its cable, which, when pulled downward by pliers, moved the inside emergency release handle downward; however, the door did not open. The left-side rear door was open 1 inch, and its window was damaged by the fire and outwardly displaced at the top. The door contacted the front of the car body shell, into which it slides, 8 inches above the vestibule floor. Its interior emergency release handle was damaged by the fire and could not be pulled down or operate the door. The cover to its cabinet was missing. The left-side T-handle was also missing from its cable, which, when pulled downward by pliers, did not move, and the door did not open.

Figure 7--Schematic of postcollision interior passenger coach cab control car 7752.

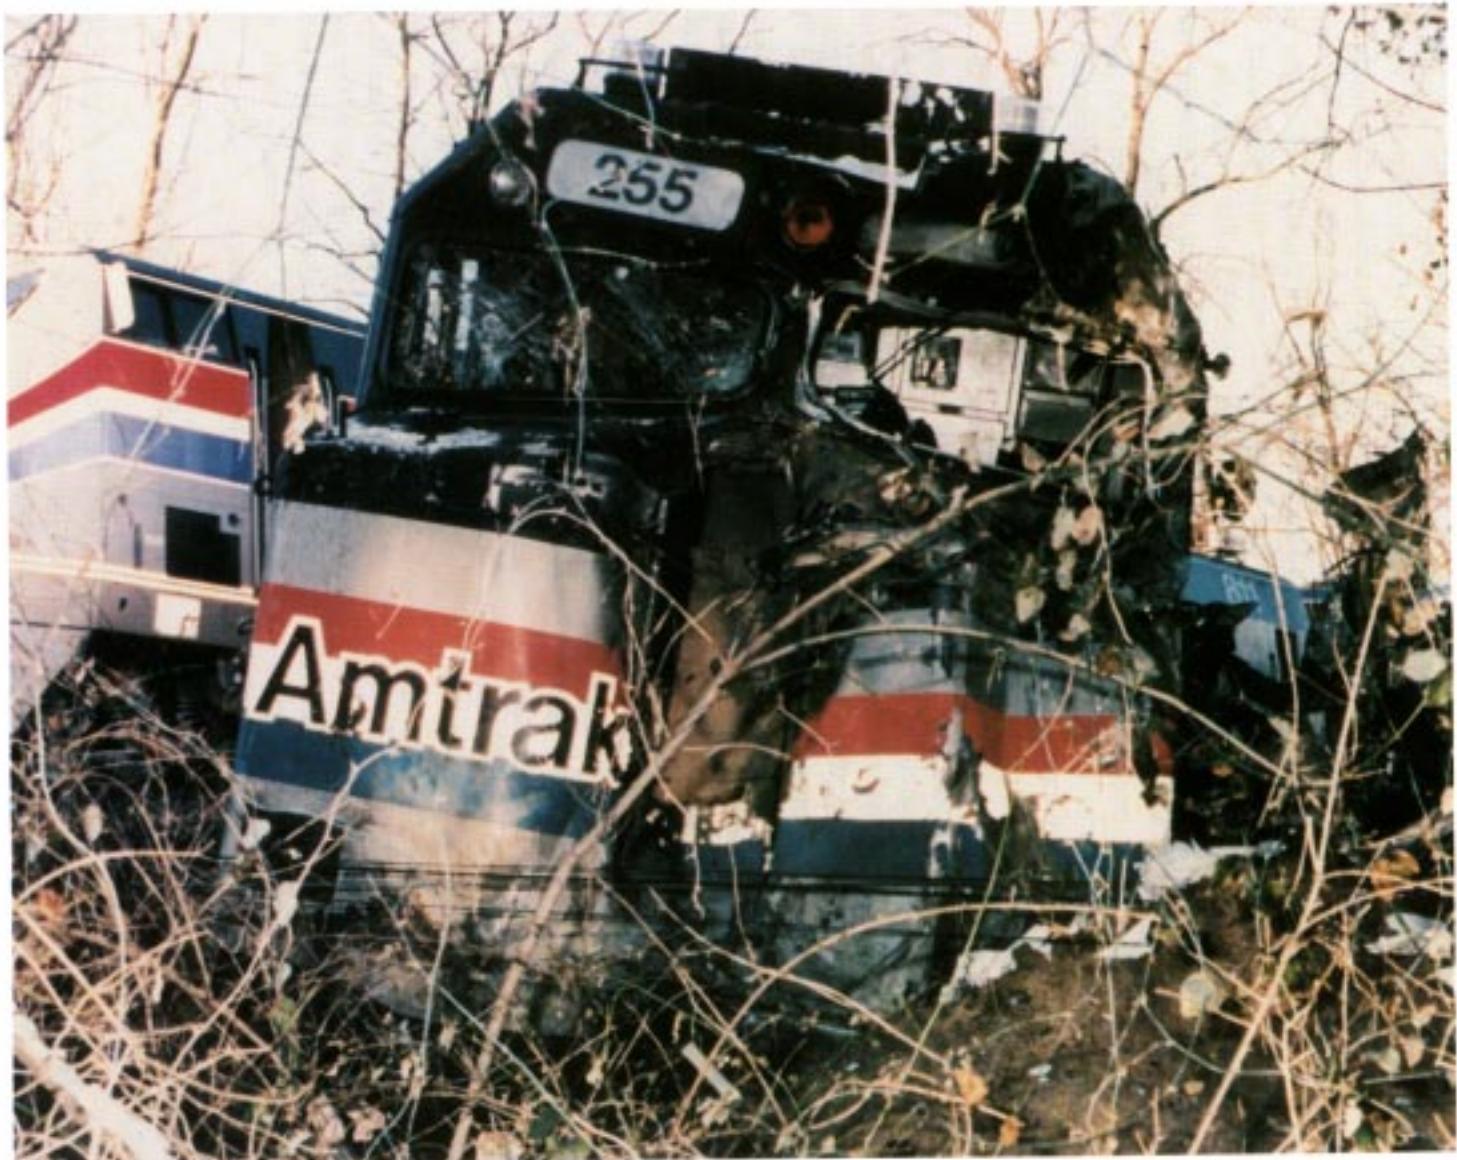
Lead unit ATK 255 derailed and received damage to the hood, fuel tank, and running gear. (See figure 8.) The left side of the unit superstructure received fire damage behind the control compartment, which remained intact. The lavatory was destroyed. The right-side windshield was shattered, and the left-side windshield was not present. The side windows were shattered. Unit ATK 811 derailed and received substantial damage to its superstructure and running gear.

Figure 8--Photograph of postcollision Amtrak locomotive unit ATK 255 at accident site.

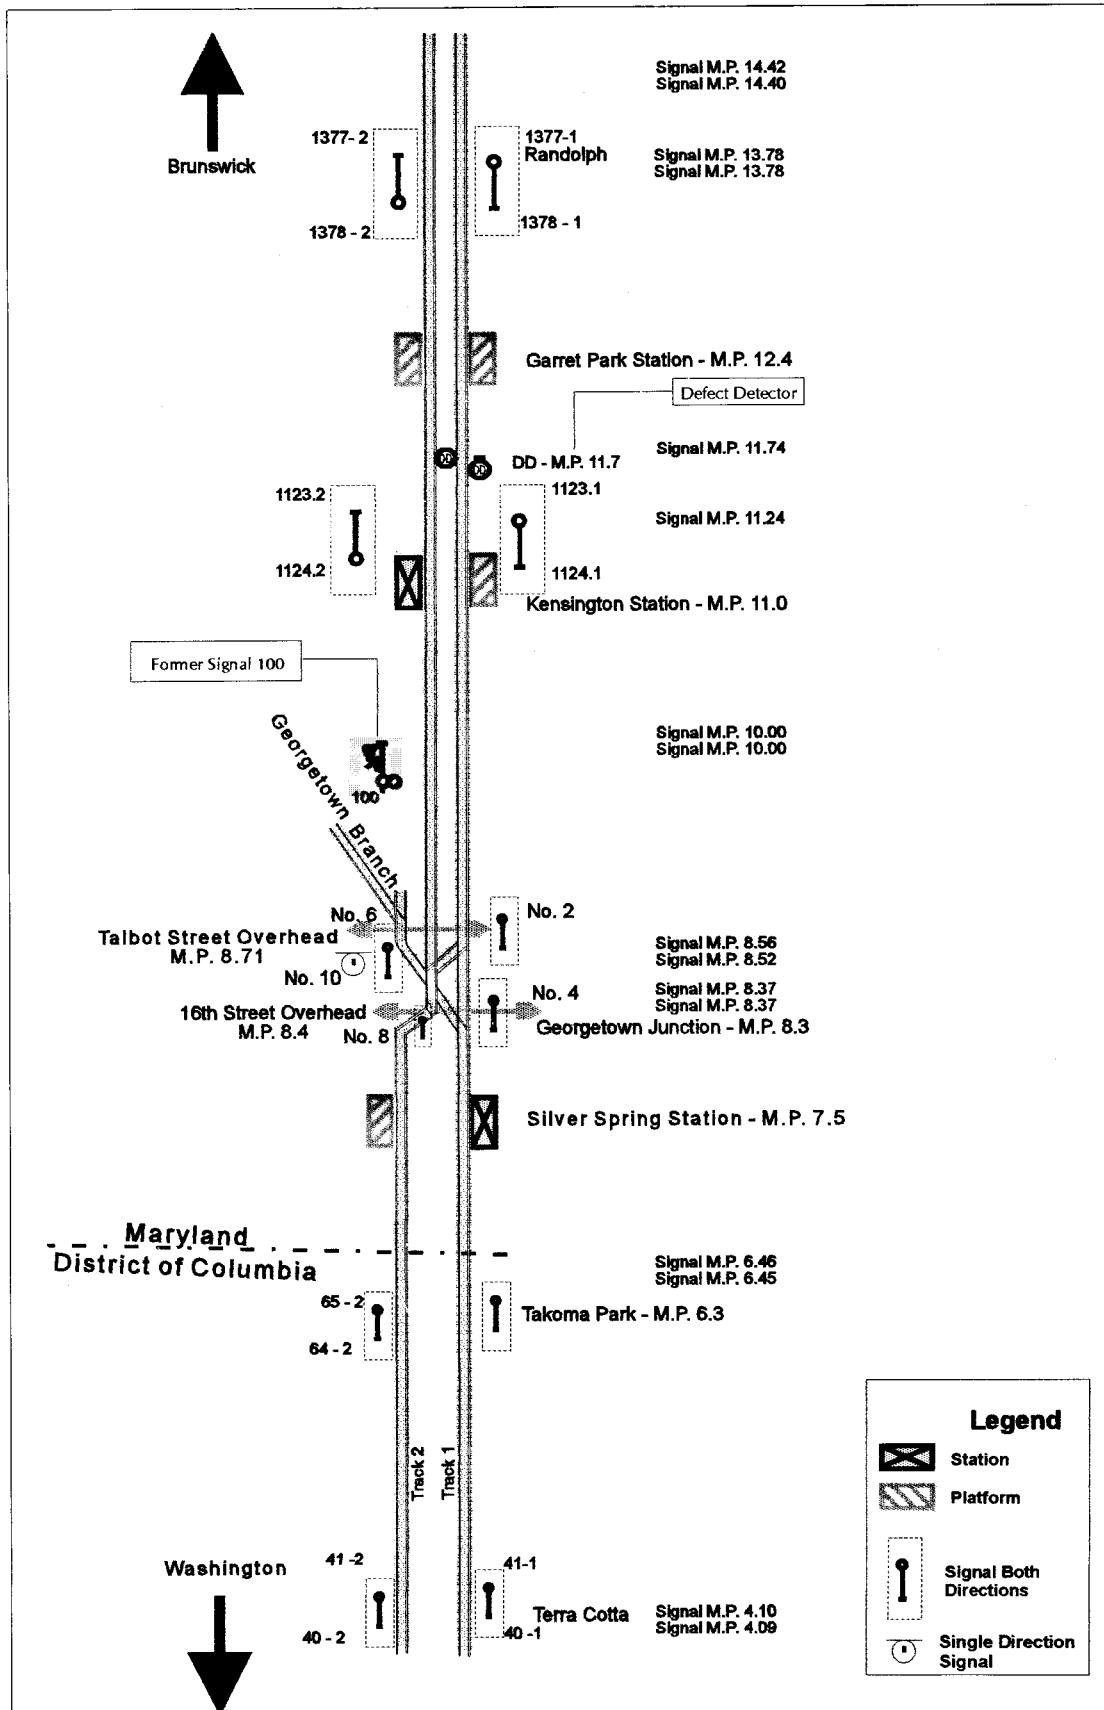
Tracks—The collision occurred on the CSXT Baltimore Division, Metropolitan Subdivision, which was double main track territory. The tracks were designated as track 1 and 2, and they were spaced on 12.5-foot centers at the collision point. The point of collision was in a turnout on track 2 about MP 8.49, where the track crossed over to track 1, about 180 feet east of the EAS for track 2. (See figure 9.)

Figure 9--Schematic of tracks and signals at collision site.

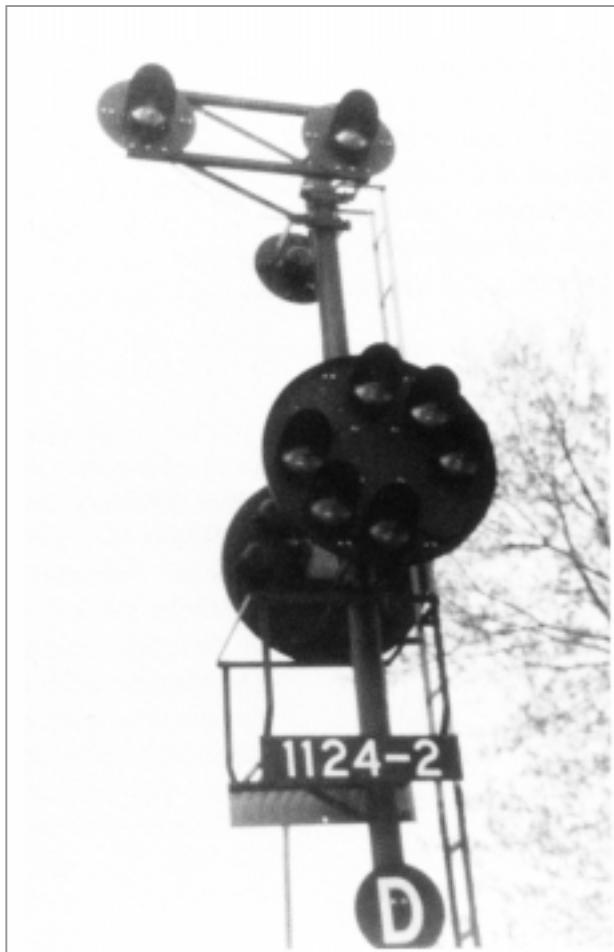
Figure 10--Signal 1124-2. The “D” was added after the accident.

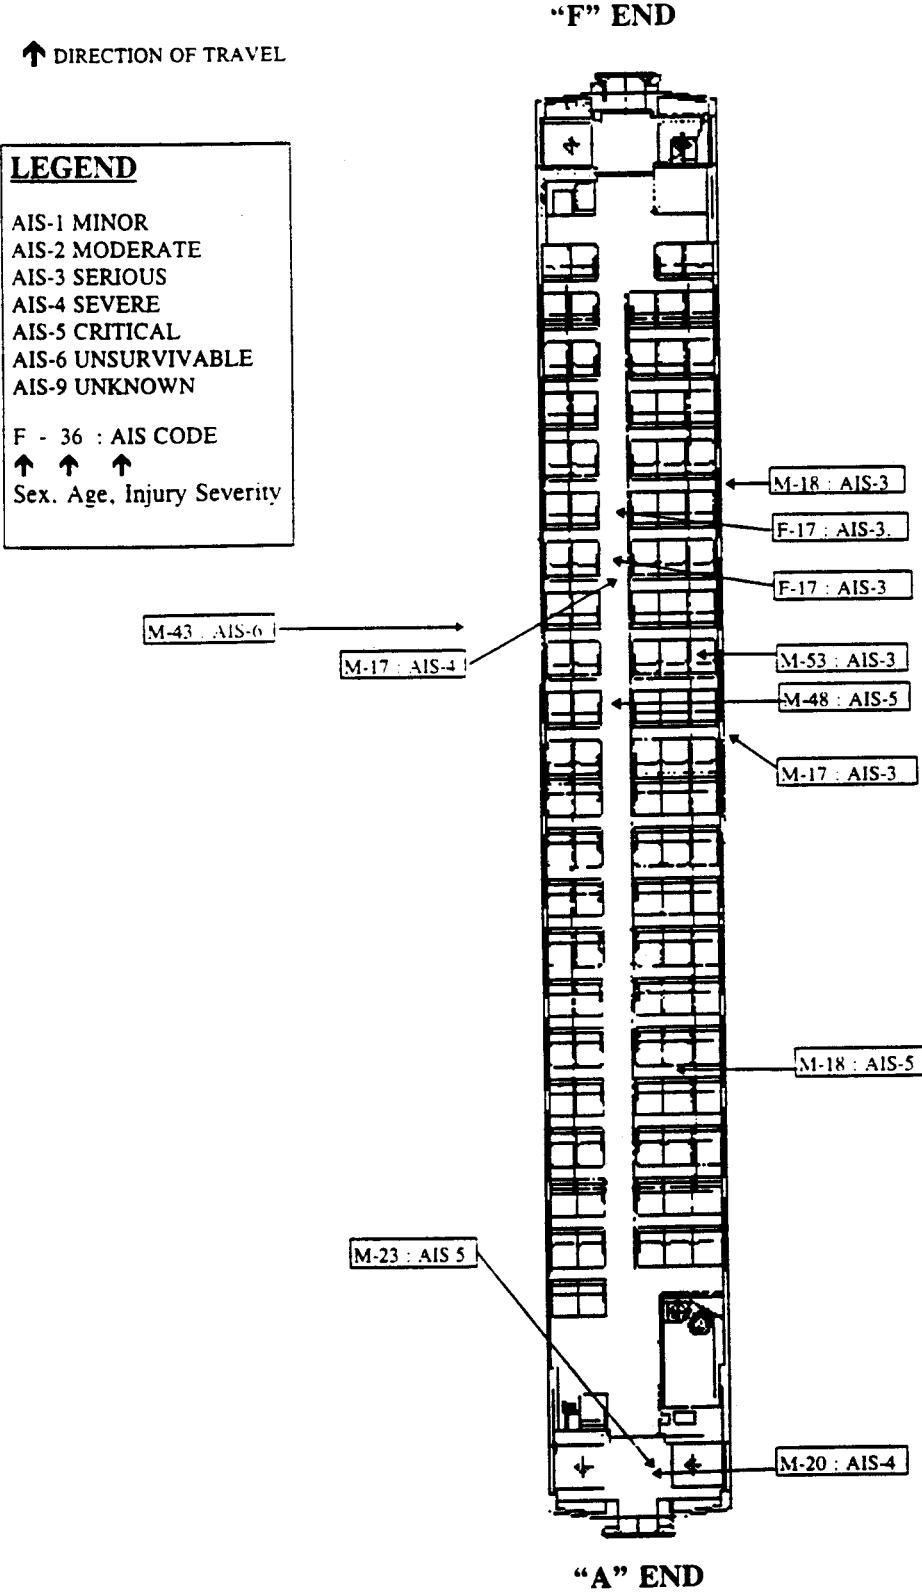
The engineer, who was found on the exterior left side of cab control car 7752, received fatal multiple injuries and generalized body burns. The conductor, who was recovered from the aisle floor at row 10, sustained fatal multiple injuries. The assistant conductor, who was discovered lying over a right side seat of row 9, received fatal smoke and soot inhalation and generalized body burns. The eight passenger fatalities were also in cab control car 7752: two sustained fatal smoke and soot inhalation injuries, three received fatal smoke and soot inhalation injuries plus general body burns, one sustained fatal generalized body burns, another received fatal soot inhalation injuries and generalized body burns, and the final victim sustained fatal multiple injuries with generalized body burns. (See figure 12 for the postaccident placement of fatalities, which was based on information obtained from the MARC train survivors, the MCPD, and the Maryland medical examiner report.)

Figure 12--Placement of fatalities in MARC passenger coach cab control car 7752.

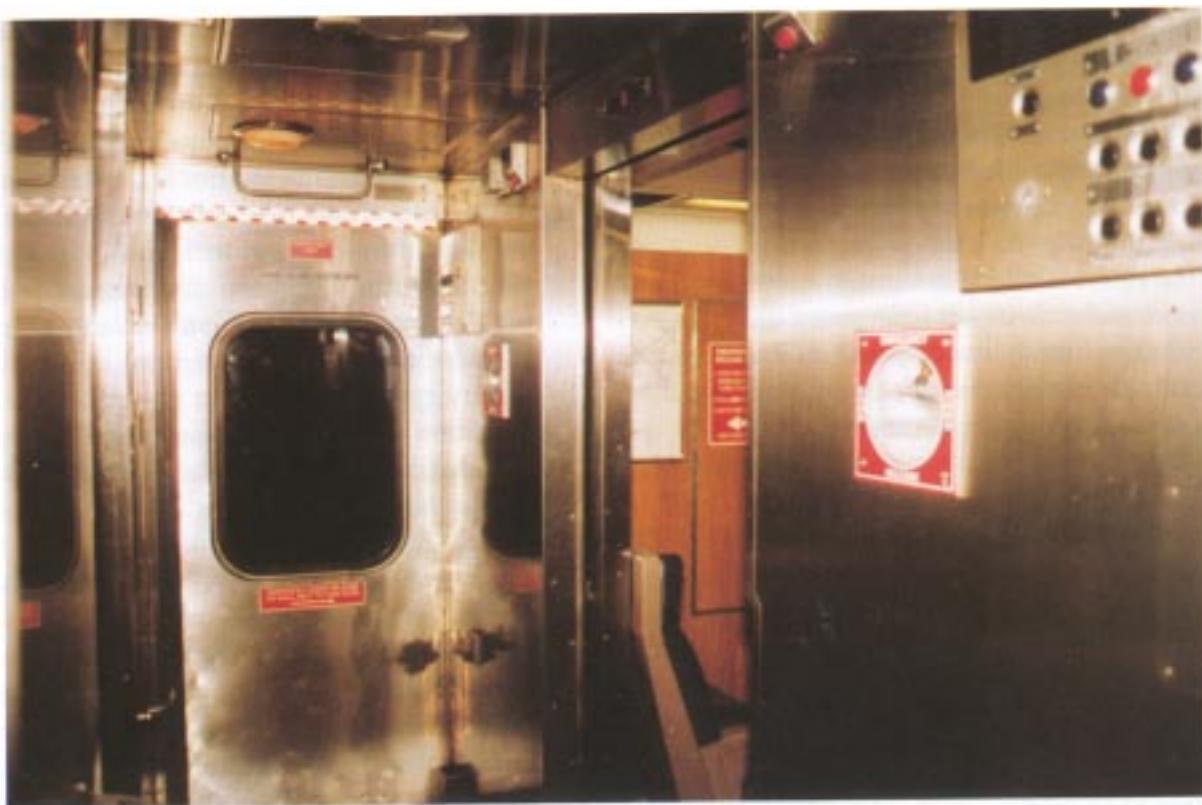
Figure 14--Photograph showing quick-release mechanisms on MARC cars.

Require all passenger cars to have easily accessible interior emergency quick-release mechanisms adjacent to exterior passageway doors and take appropriate emergency measures to ensure corrective action until these measures are incorporated into minimum passenger car safety standards.

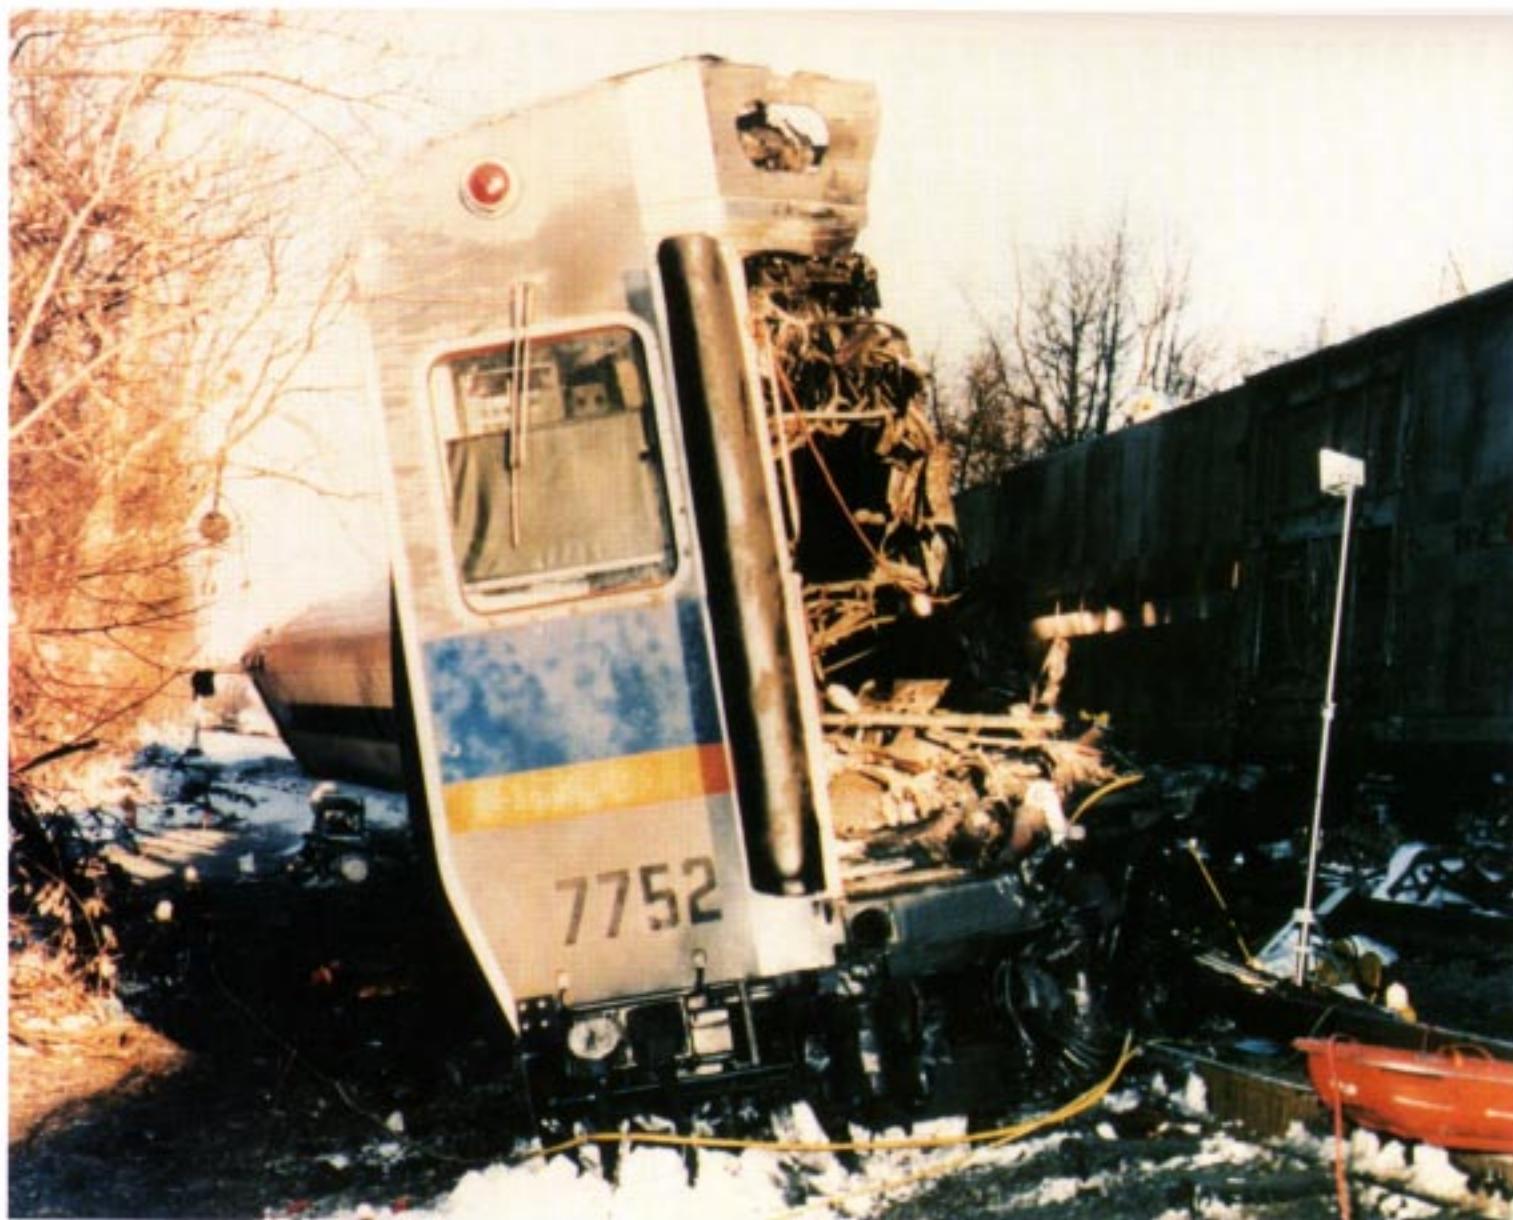
Figure 15—Photograph of MARC passenger coach cab control car 7752 at accident site.

tures on all self-propelled passenger cars and control cab locomotives to afford occupant protection during corner collision. If feasible, amend the locomotive safety standards accordingly. (R-93-24)
