HIGHWAY-RAILROAD ACCIDENT REPORT

Adopted: September 18, 1968

WATERLOO, NEBRASKA, PUBLIC SCHOOL  
SCHOOL BUS  
UNION PACIFIC RAILROAD COMPANY FREIGHT TRAIN  
ACCIDENT  
WATERLOO, NEBRASKA  
OCTOBER 2, 1967

NATIONAL TRANSPORTATION SAFETY BOARD  
DEPARTMENT OF TRANSPORTATION  
WASHINGTON, D. C.  
20591

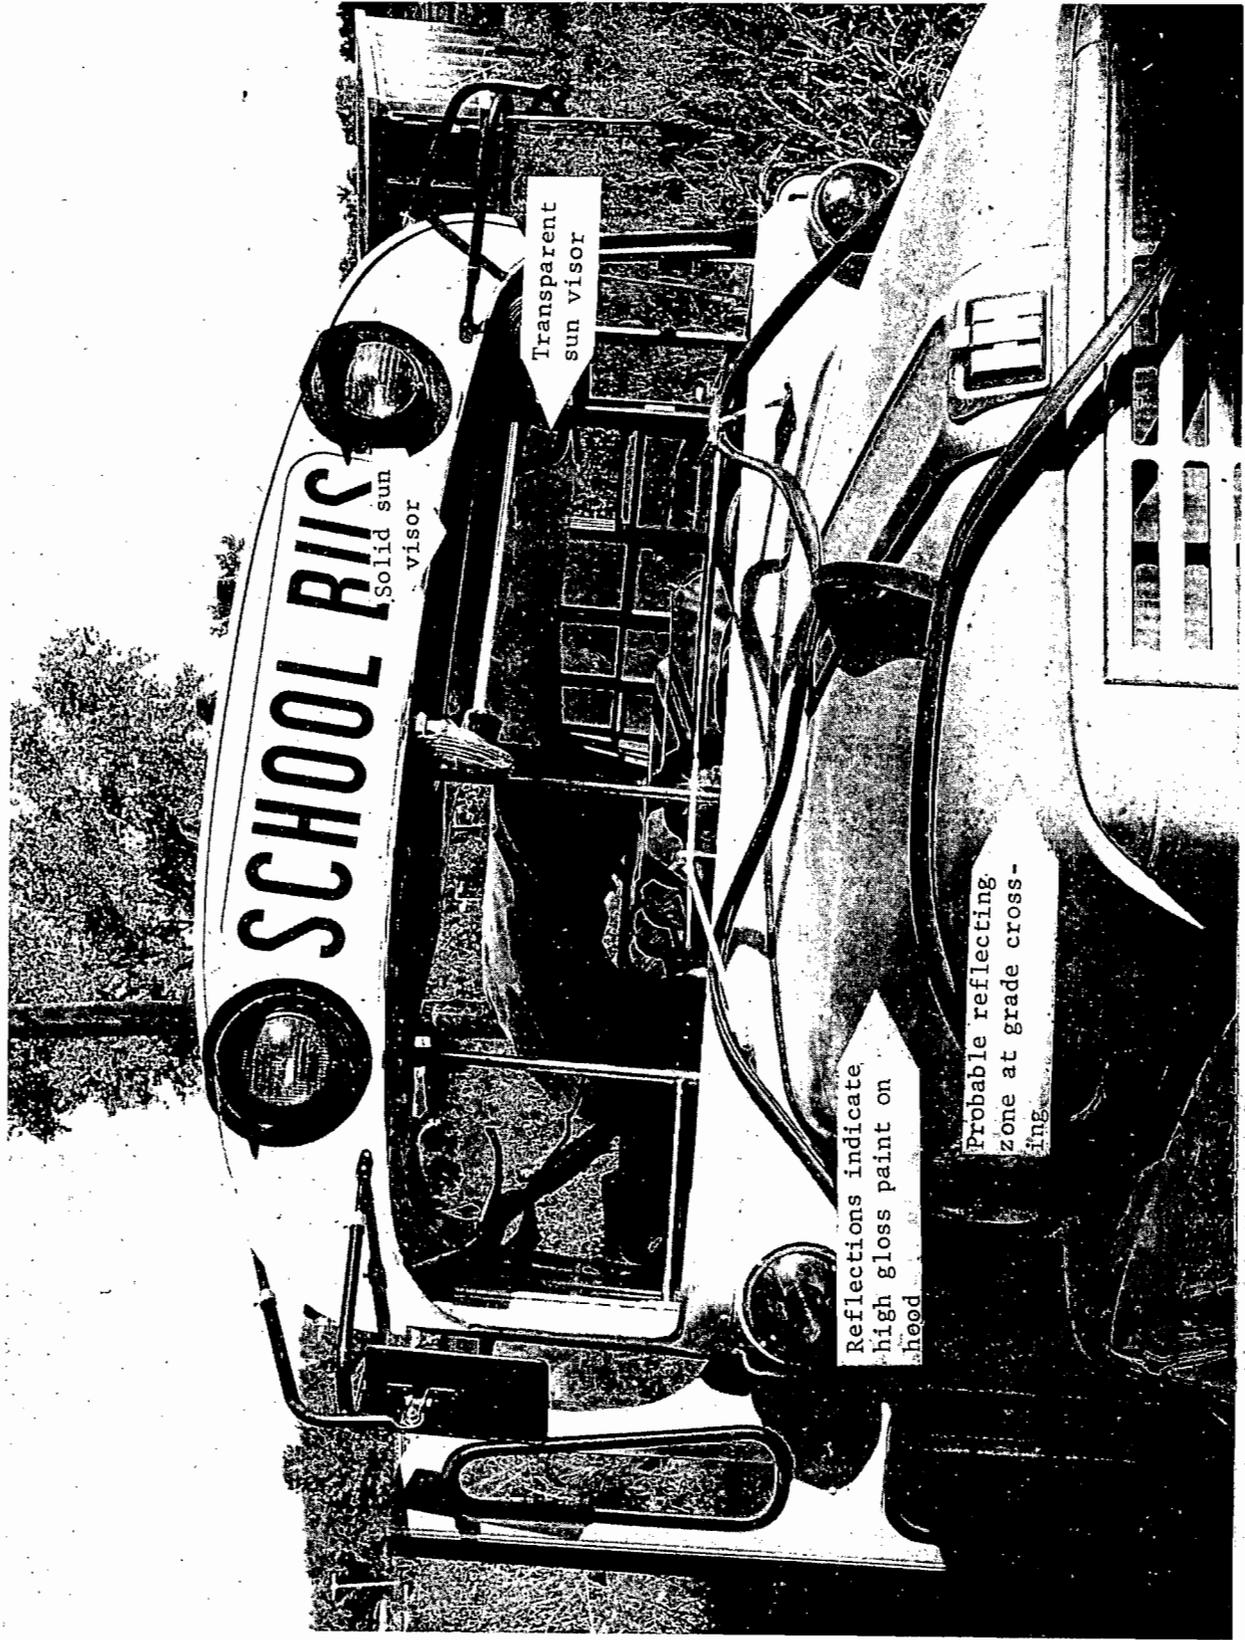
The second problem was the upward inclination of the road, tending to move the shadow of the visor and to allow the sunlight to strike directly into the driver's eyes. This has been noted in analysis as a possible surprise factor tending to blind the driver, but there is no way to determine whether this condition actually occurred. The change in angle and other glare problems are diagrammed in Illustration 7. The visor arrangement on the school bus was actually superior to that generally found in most passenger cars and most trucks, and the visor design alone is not considered a cause of the accident.

1. FRONT OF SCHOOL BUS AFTER THE ACCIDENT. PHOTOGRAPH ILLUSTRATES THE GLOSSY HOOD OF THE BUS, THE POSITION OF THE TWO SUN VISORS, AND THE OPEN WINDOWS ON THE LEFT SIDE OF THE BUS.

6. The Safety Board recommends that the Federal Highway Administration establish a vehicle safety standard to protect driver vision against external sun glare.

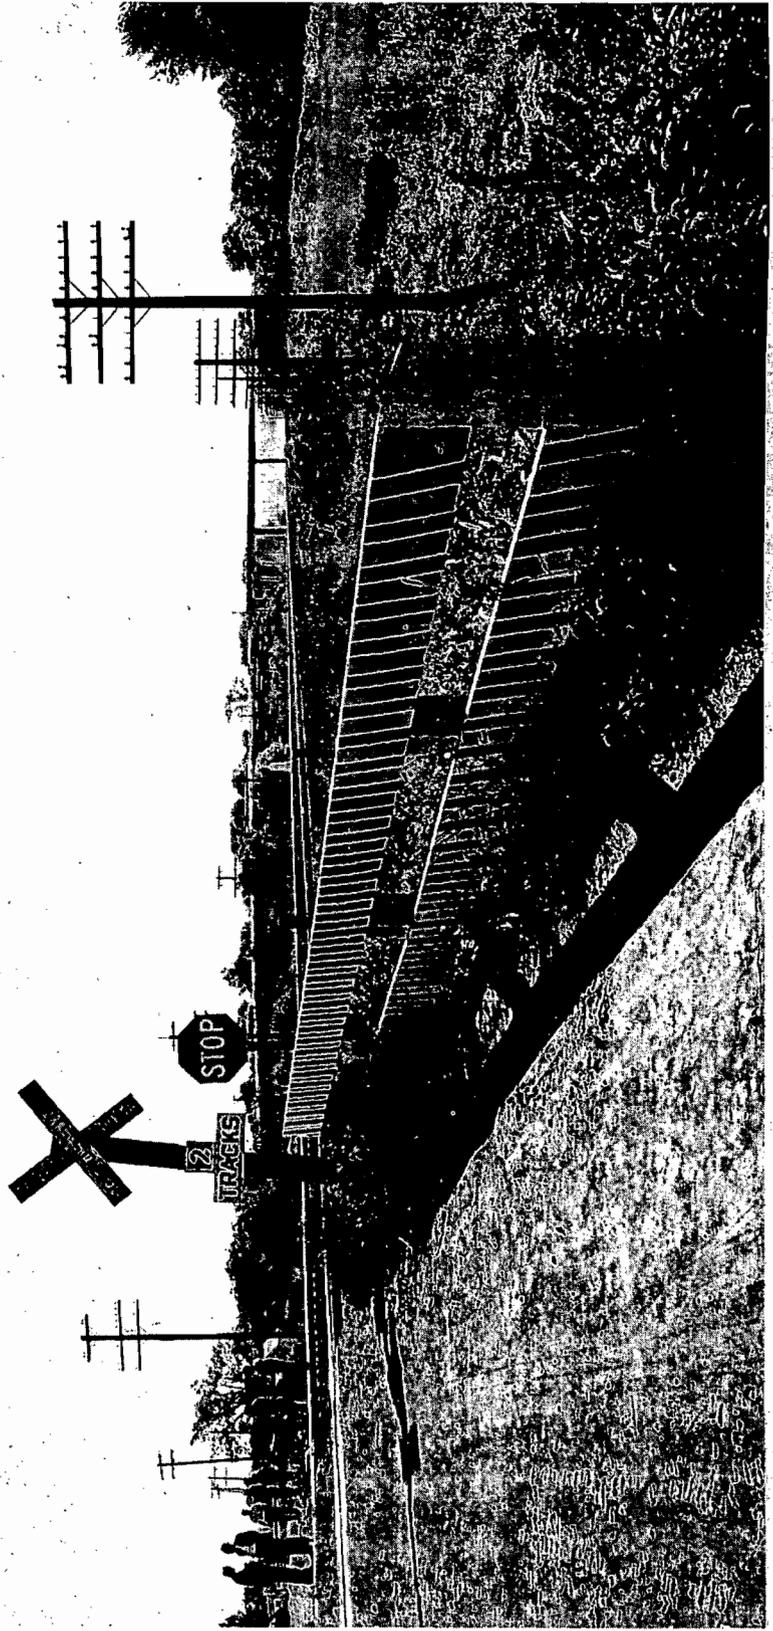
Possible contributing causes of this accident were the height of the stop sign and the "2 TRACKS" advisory sign which could have obstructed the driver's view of the approaching train; and the lack of contrast between train headlights and bright daylight which reduced the effect of the headlight as a visual attention-getting warning system.

2. VIEW OF THE RAILROAD CROSSING, THE WARNING SIGNS, THE TRACKS, AND THE COMMUNICATION POLES, SEEN WHEN LOOKING IN THE DIRECTION OF THE VIADUCT.

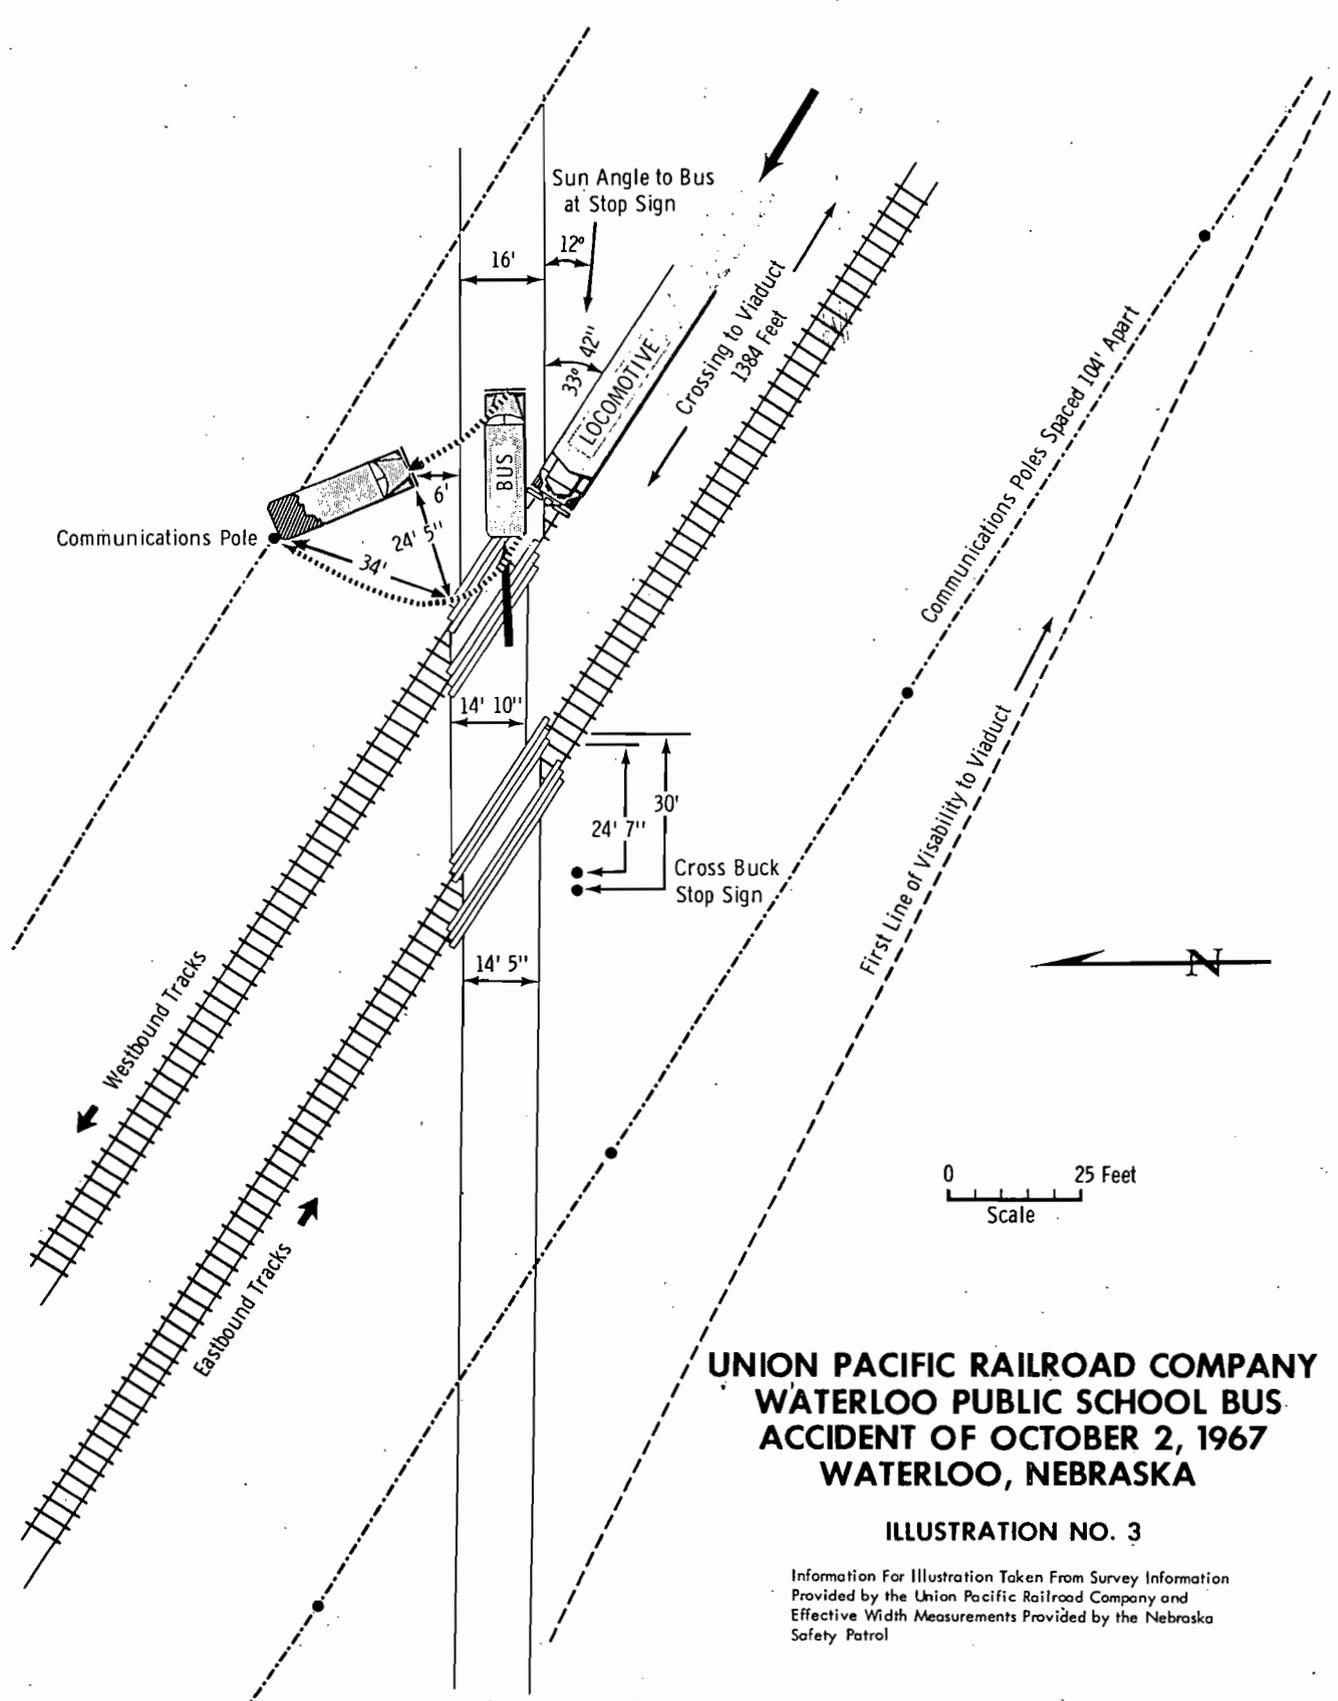
**ILLUSTRATION NO. 3**

The train thus impacted the bus at a glancing angle while the bus was moving in a direction which tended to carry it forward and away from the point of impact. (See Illustration No. 3). At impact, forces were generated by friction and by direct physical engagement, abruptly halting the forward motion of the bus while accelerating its rear end in the direction of travel of the train. The bus was then rotated so that the longitudinal axis of the bus first became parallel with the train, and the rotation continued until the bus had achieved a significant backward velocity and the rear of the bus was turning away from the train.

**UNION PACIFIC RAILROAD COMPANY  
 WATERLOO PUBLIC SCHOOL BUS  
 ACCIDENT OF OCTOBER 2, 1967  
 WATERLOO, NEBRASKA**

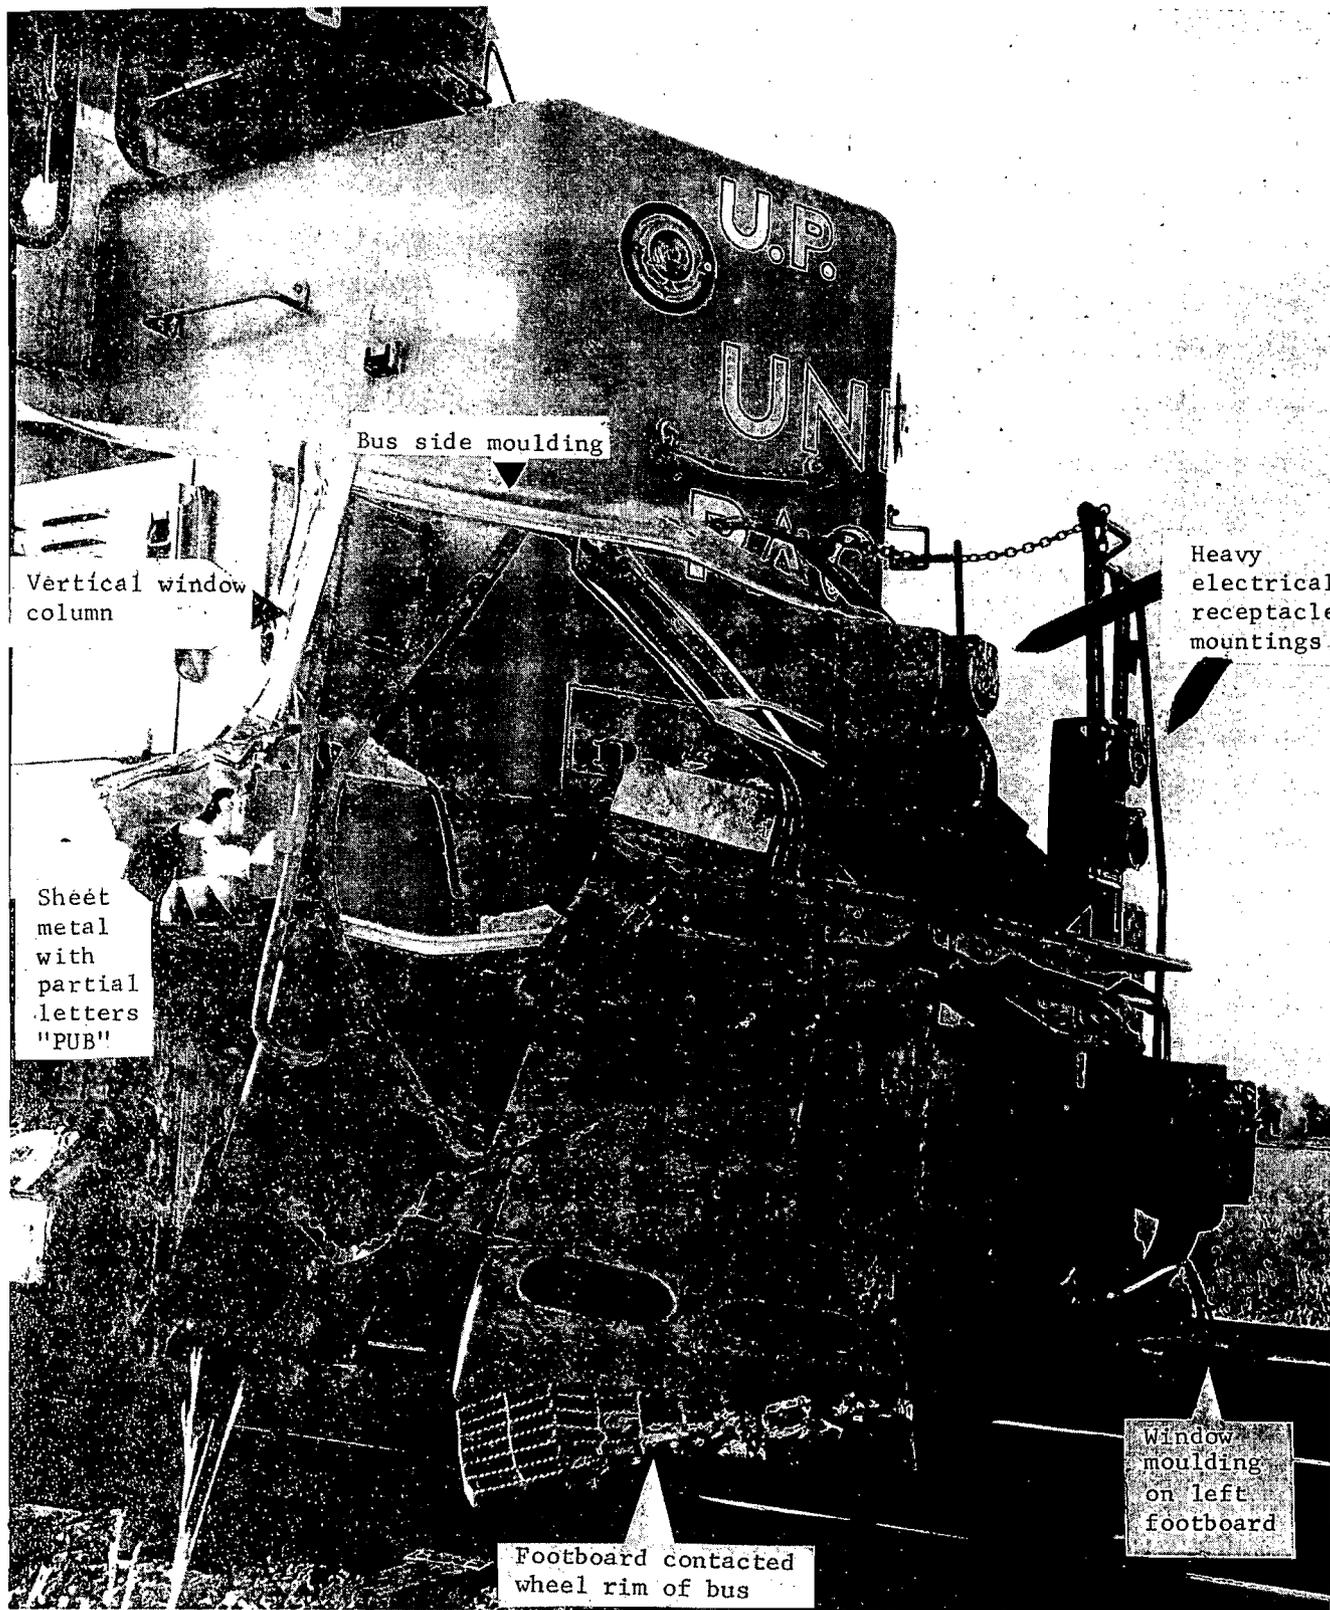
Part of the bus structure, including one windowpane, at least one window post, and longitudinal structure was struck and held by the front of the locomotive and remained there after the impact. (See Illustration No. 4.) Detailed areas of the train caused specific forms of damage. The first point of contact between train and bus was at the outermost vertical edge of the fourth post from the front door of the bus. The next contact was the front surface of the right footboard of the locomotive which struck the right rear dual wheel of the bus, catching and indenting the rim. This rim contact created the forceful pull on the bus frame to the rear, rotating the main chassis of the bus.

With few exceptions, the sheet metal sections of the body did not fail internally, but separated along their lines of connection. The most frequent form of failure was the pulling out of rivets.

Spacing between rivets varied from two inches to as much as nine inches between rivets, as measured on another bus of the same model, so that the full strength of joining was not obtained. Welds in body structure which failed included some which had been welded over only a portion of the available length of contact. The majority of failures at welds were through welds, not in parent metal, again accompanied by little or no distortion of nearby structures. The wreckage includes numbers of highly significant examples of failures in which the general shape of sheet metal remained, but the parts have separated. (See Illustrations No. 5 and No. 7.)

The bus was equipped with a so-called "impact rail" of 14-gauge steel which extended fore and aft along the sides of the bus directly below the line of the windows. This rail on the left side of the bus also failed without distortion at a joint and appeared not to have lent any support in the crash.

4. FRONT END OF LOCOMOTIVE, U.P. #708, TAKEN SHORTLY AFTER ACCIDENT

Clean separation  
with pulled out  
rivets

Roof bow-  
to-side  
strainer  
broken  
welds

Separated but  
undistorted side  
impact rail

3. The Safety Board recommends that the Federal Highway Administration consider the need for requirements for structural strength of school bus bodies in connection with its study of desirable standards for protection of school bus occupants. In particular, the Board recommends that program A.1.1.4 of the National Highway Safety Bureau, titled "Design, Fabrication, and Test of a Safe School Bus Interior," be expanded in scope to include consideration of structural integrity and intrusion into the school bus interior.

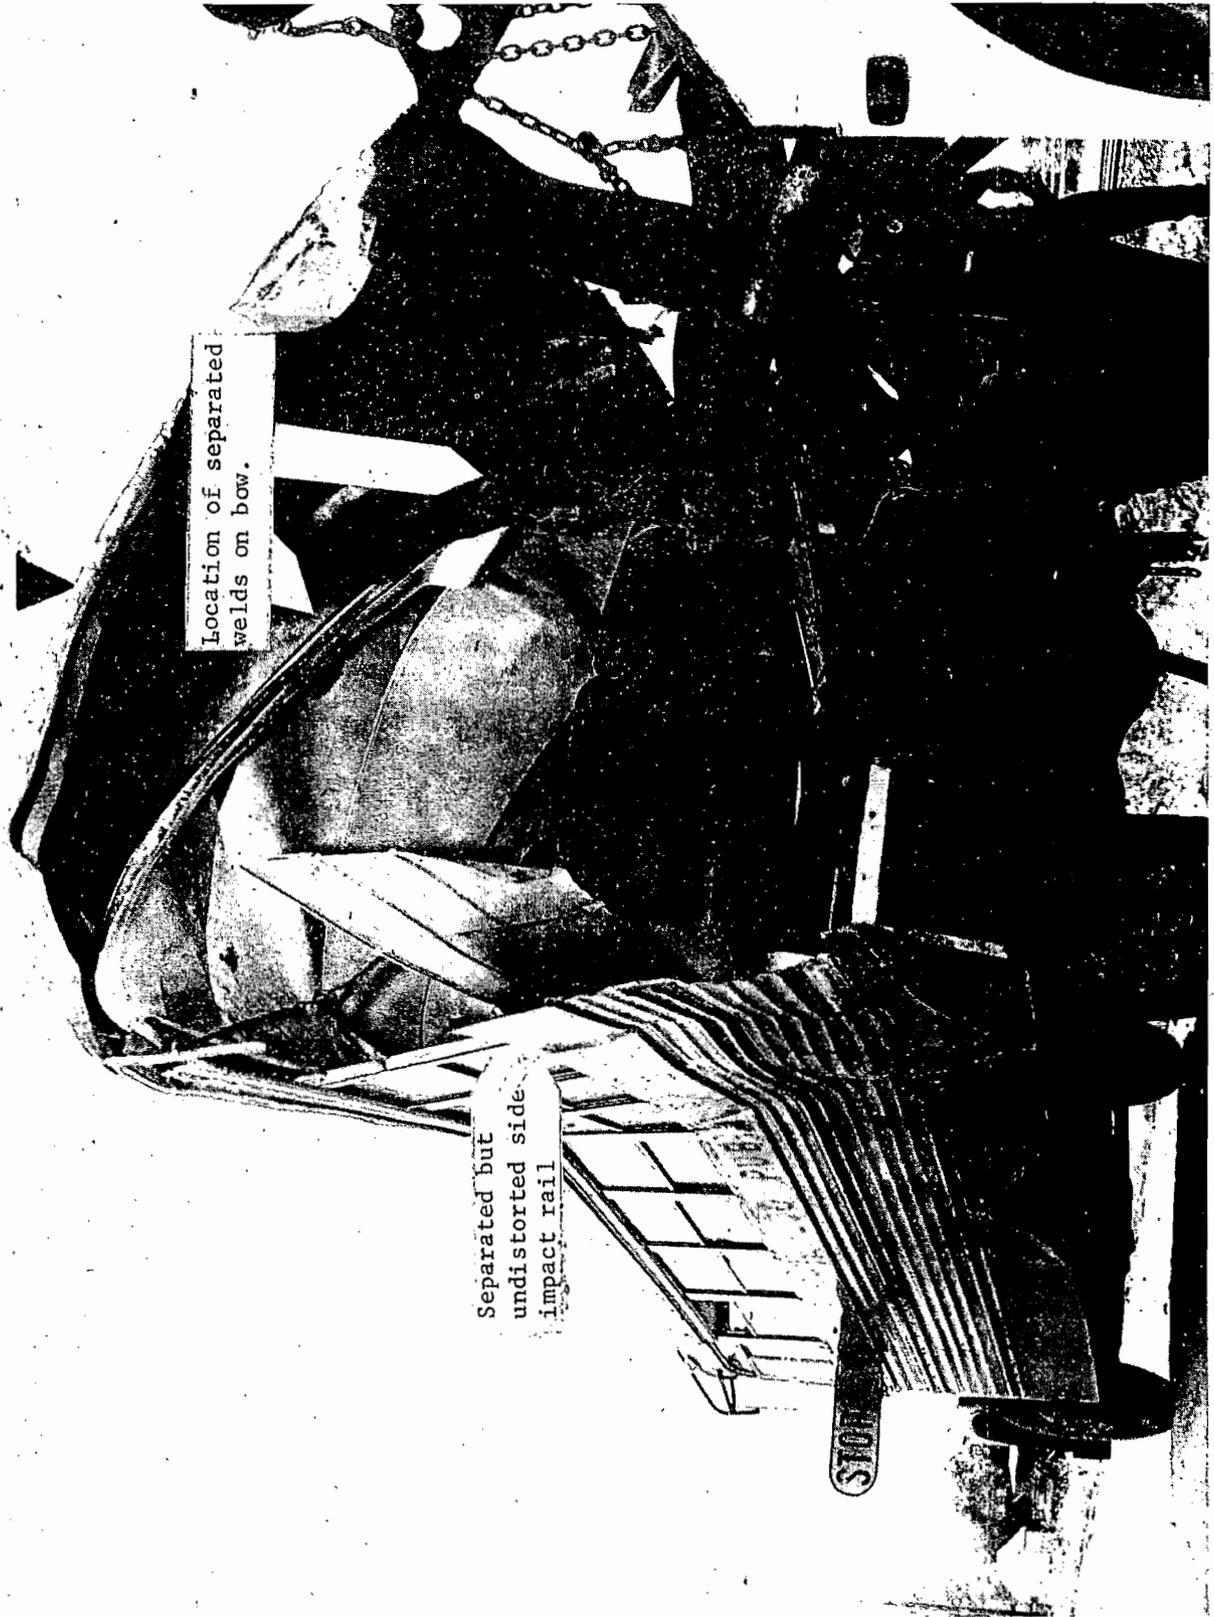
When the impact with the pole occurred, a large portion of the rear of the bus, including the side, window posts, floor, rear seats, and emergency door, continued backward away from the direction of the train. This portion had been loosened and partially detached by the initial impact and appeared to have rotated around the relatively rigid pole. At least four seats and other components of the bus were projected approximately 50 feet to the rear of the bus, or were dropped there by the train.

The rear structure of the bus disintegrated due to a combination of forces caused by protuberances on the locomotive and low structural strength of the bus. The structural strength of the bus would have been greater if the structural elements and the skin had been more effectively joined. The

6. REAR END OF THE SCHOOL BUS AFTER THE ACCIDENT AND AFTER THE BUS HAD BEEN MOVED FROM CONTACT WITH THE COMMUNICATIONS POLE. PHOTOGRAPH SHOWS THE DISINTEGRATION OF THE REAR OF THE BUS.

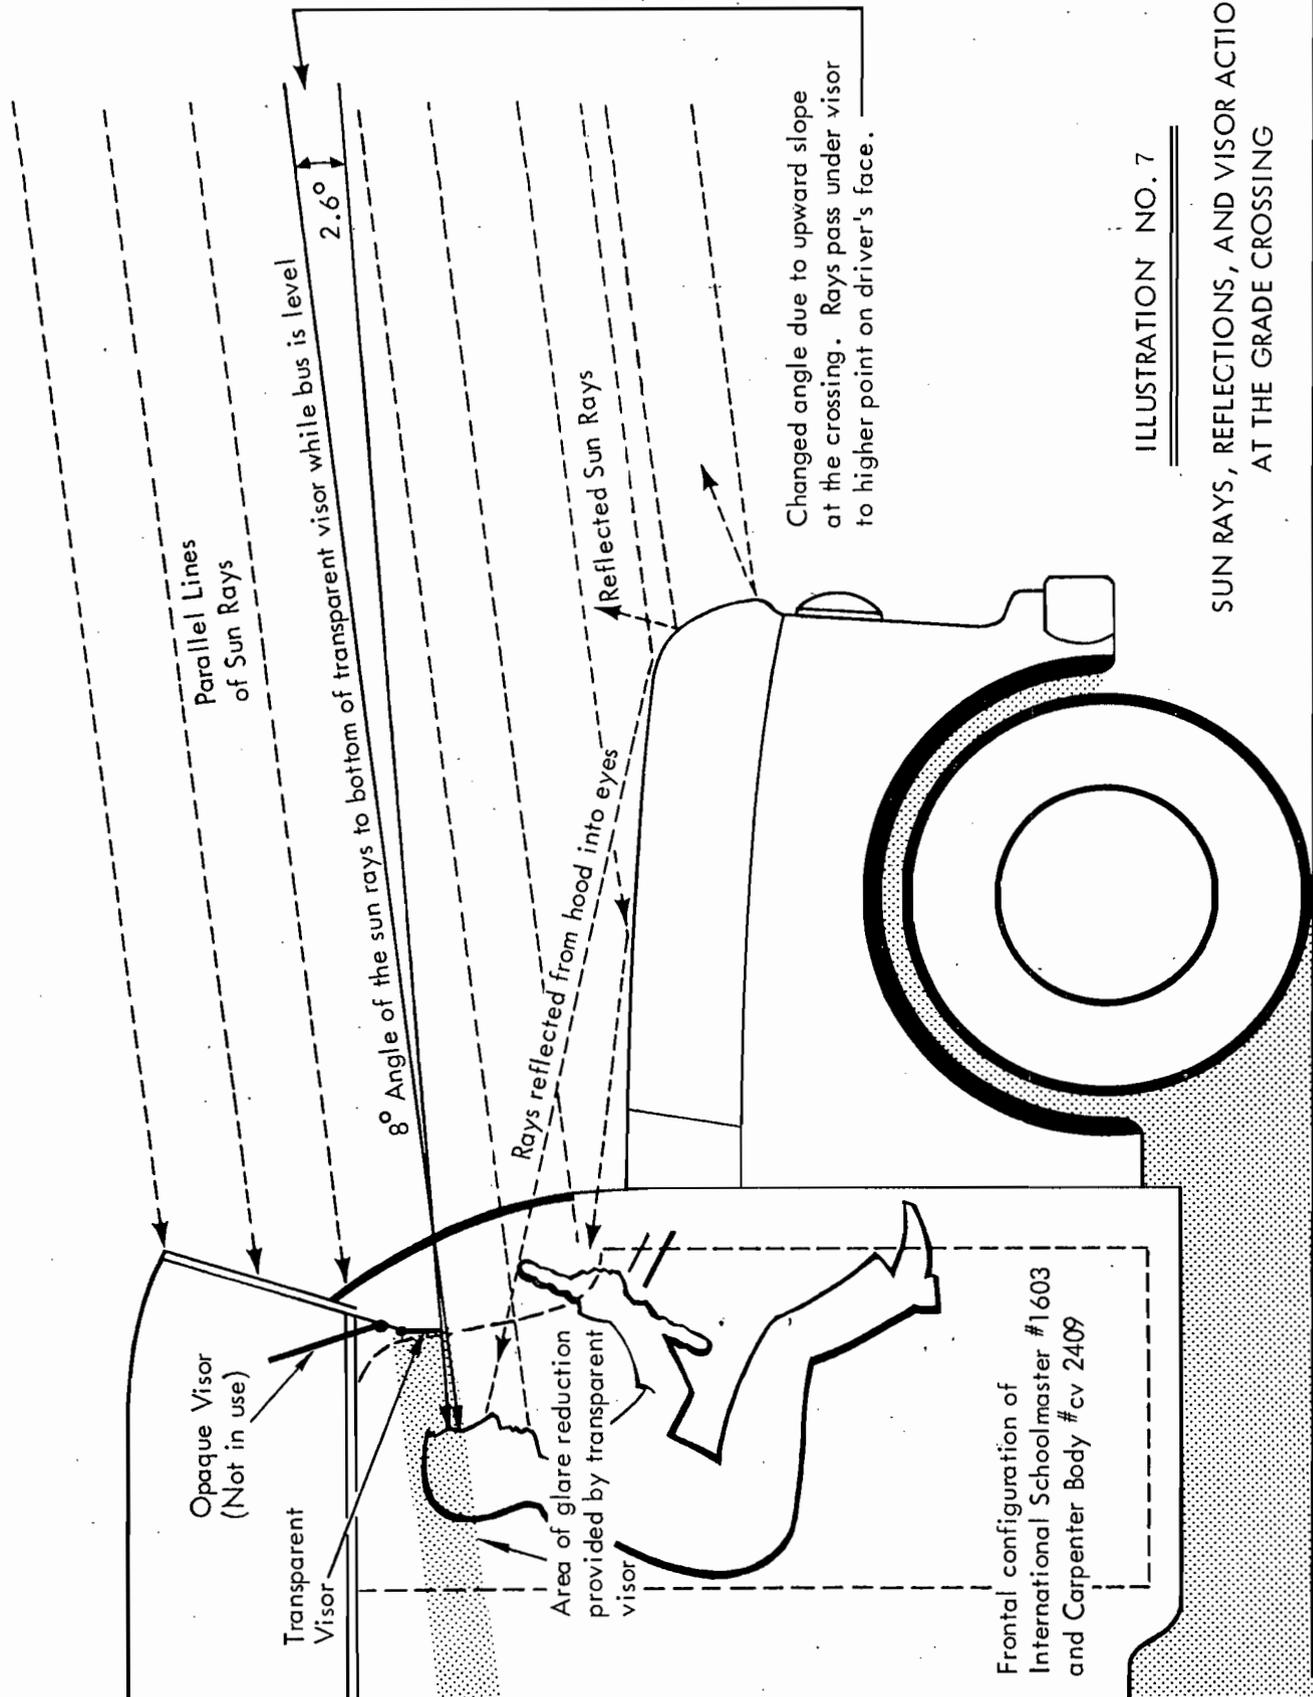
ILLUSTRATION NO. 7

It is concluded that, as the bus driver reached the crossing, he encountered a difficult problem in maintaining adequate vision due to the direct rays of the sun and lesser indirect reflections from the vehicle hood. If during that time, the sun's rays did shine directly into his eyes, his ability to see objects would be impaired for some undetermined period of time even after he looked away from the sun. He was not wearing dark glasses. Whether or not the driver succeeded in protecting his eyes against the direct rays of the sun, some part of his attention would necessarily have been occupied by this task, tending to distract him from other driving tasks. The time of stopping was momentary.

SUN RAYS, REFLECTIONS, AND VISOR ACTION AT THE GRADE CROSSING
