PENN CENTRAL  
FREIGHT TRAIN/SCHOOLBUS COLLISION  
NEAR CONGERS, NEW YORK

MARCH 24, 1972

NATIONAL TRANSPORTATION SAFETY BOARD  
Washington, D.C. 20591  
REPORT NUMBER: NTSB-RHR-73-1

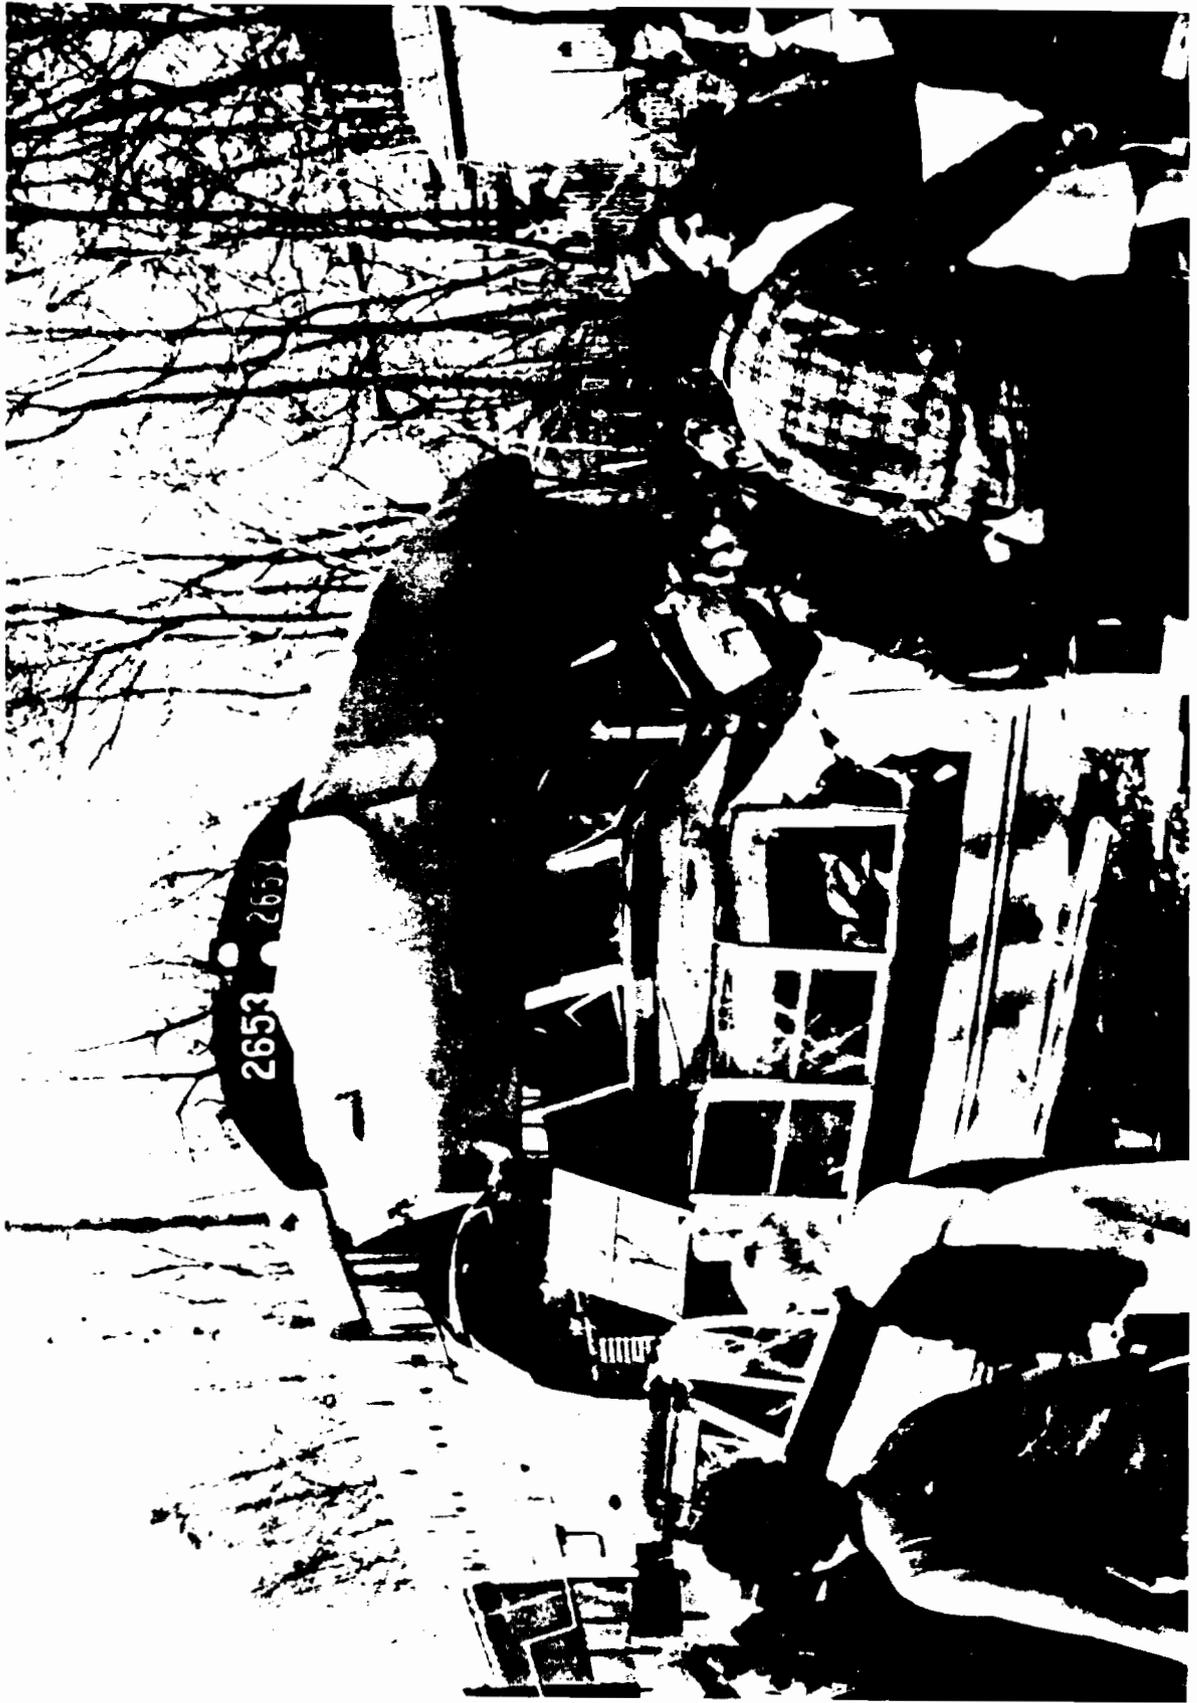
The locomotive struck the middle of the right side of the schoolbus. Just after impact, the rear section of the bus was torn loose from the remainder of the body and roof. This rear section, with students still inside, was found in an inverted position on the west side of the track, 85 feet north of the impact point. The remainder of the bus was pushed broadside ahead of the train 1,116 feet down the track. (See Figure 2.)

Figure 2. Final position of schoolbus and lead locomotive.

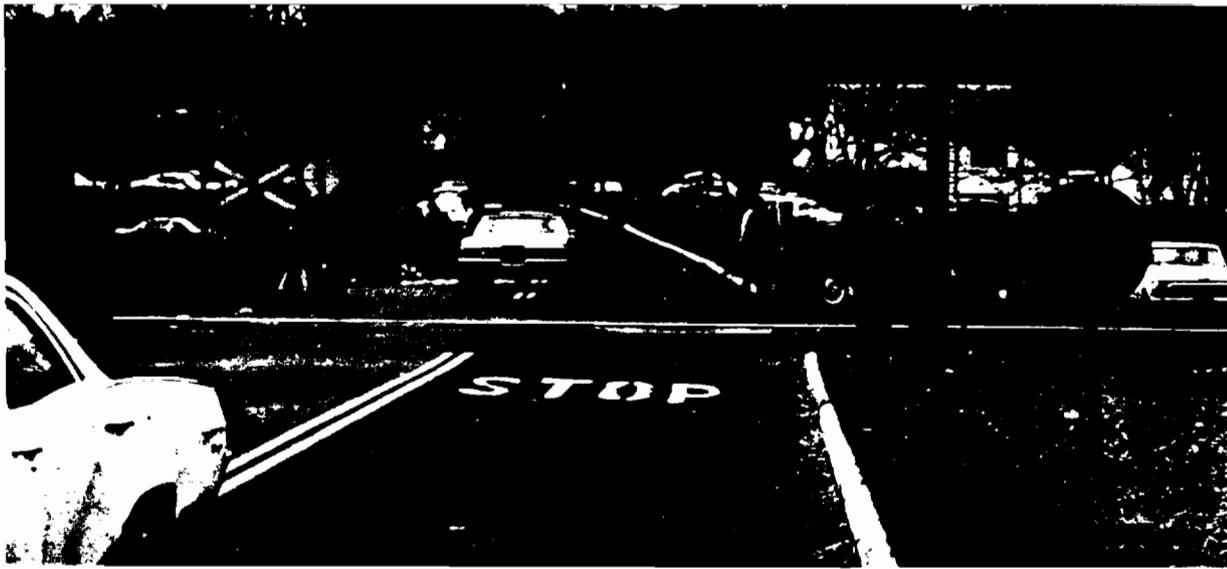
Figure 3. Traffic control devices on the eastbound approach to the Gilchrist Road Crossing.

Traffic control devices in New York are located in conformance with the New York State Manual of Traffic Control Devices. The placement of railroad advance-warning signs underneath stop signs is not prohibited by the manual. The manual, however, does recommend that such warning signs be placed 300 feet before a crossing.

14. The normal crossbuck sign was missing, and the advance-warning sign was placed too close to the crossing to serve as an advance warning.

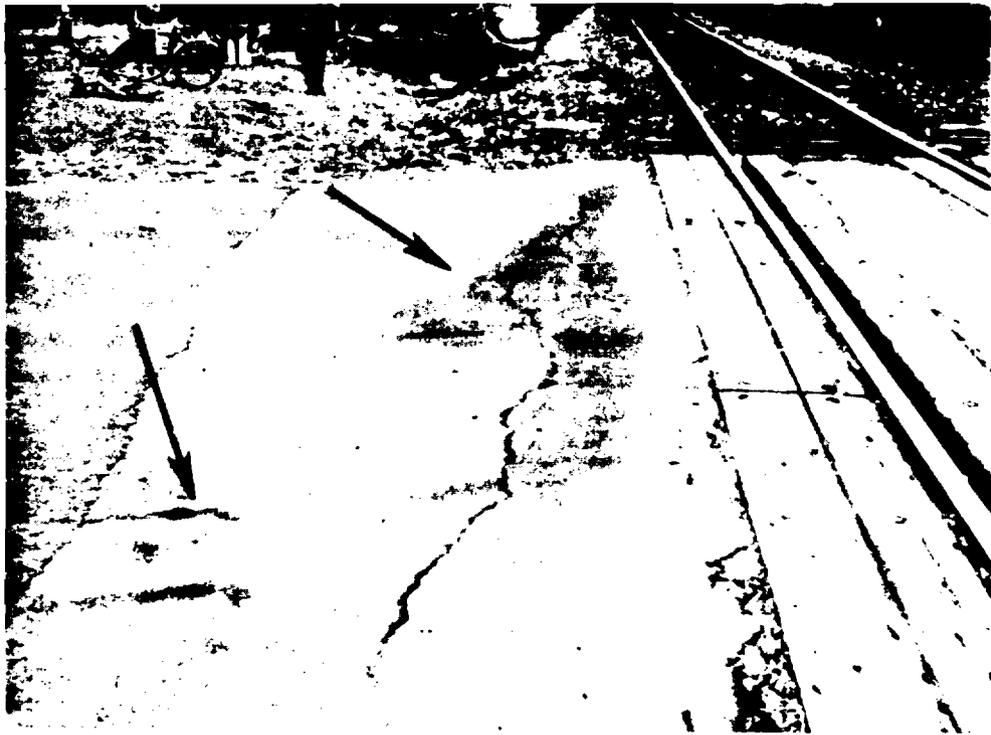
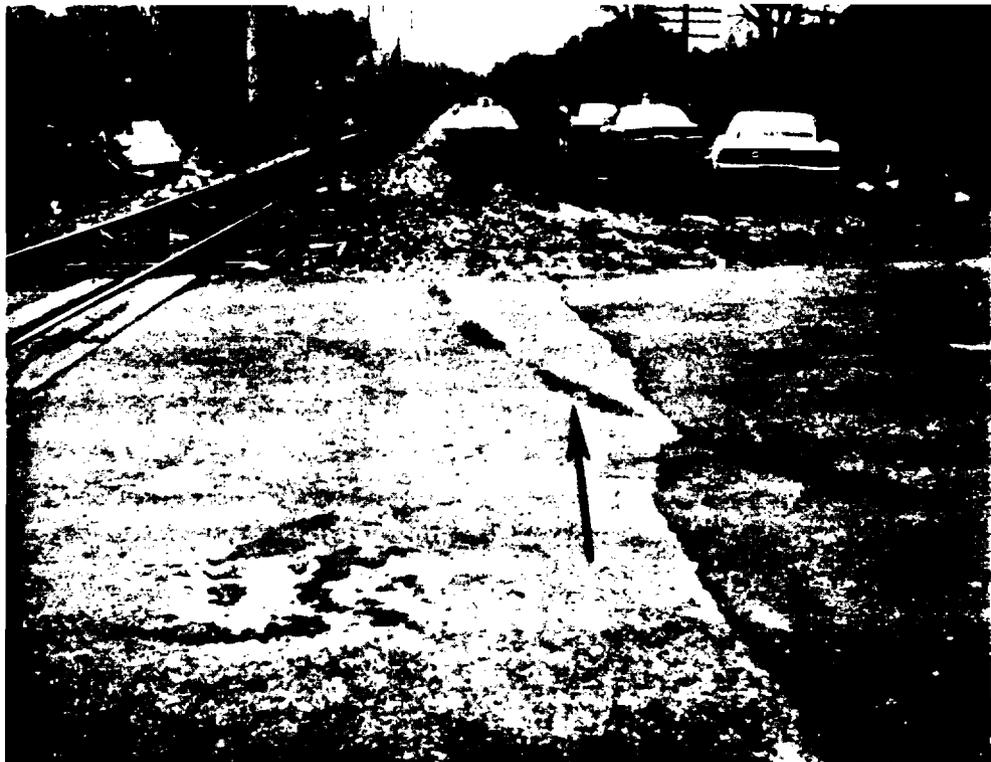
After the accident, several tire marks were found at the grade crossing. (See Figure 4.) On the west side of the west rail was a pair of marks made by dual tires. The right tire marks started about 13 feet 5 inches west of the rail, continued due east for about 3 feet 2 inches, and then shifted in a northerly direction. The left tire mark was one foot long and parallel to the pattern of the right tire marks.

These three marks west of the track appeared to have been caused by sliding of tires. The right tire skid began at a point 4 feet 8 inches north of the southern edge of Gilchrist Road and blended into the left tire mark. The marks extended to the northern edge of the pavement, a distance of about 18 feet, and then faded out.

a. West of the track.

b. East of the track.

Figure 4. Tire marks on Gilchrist Road after the accident.

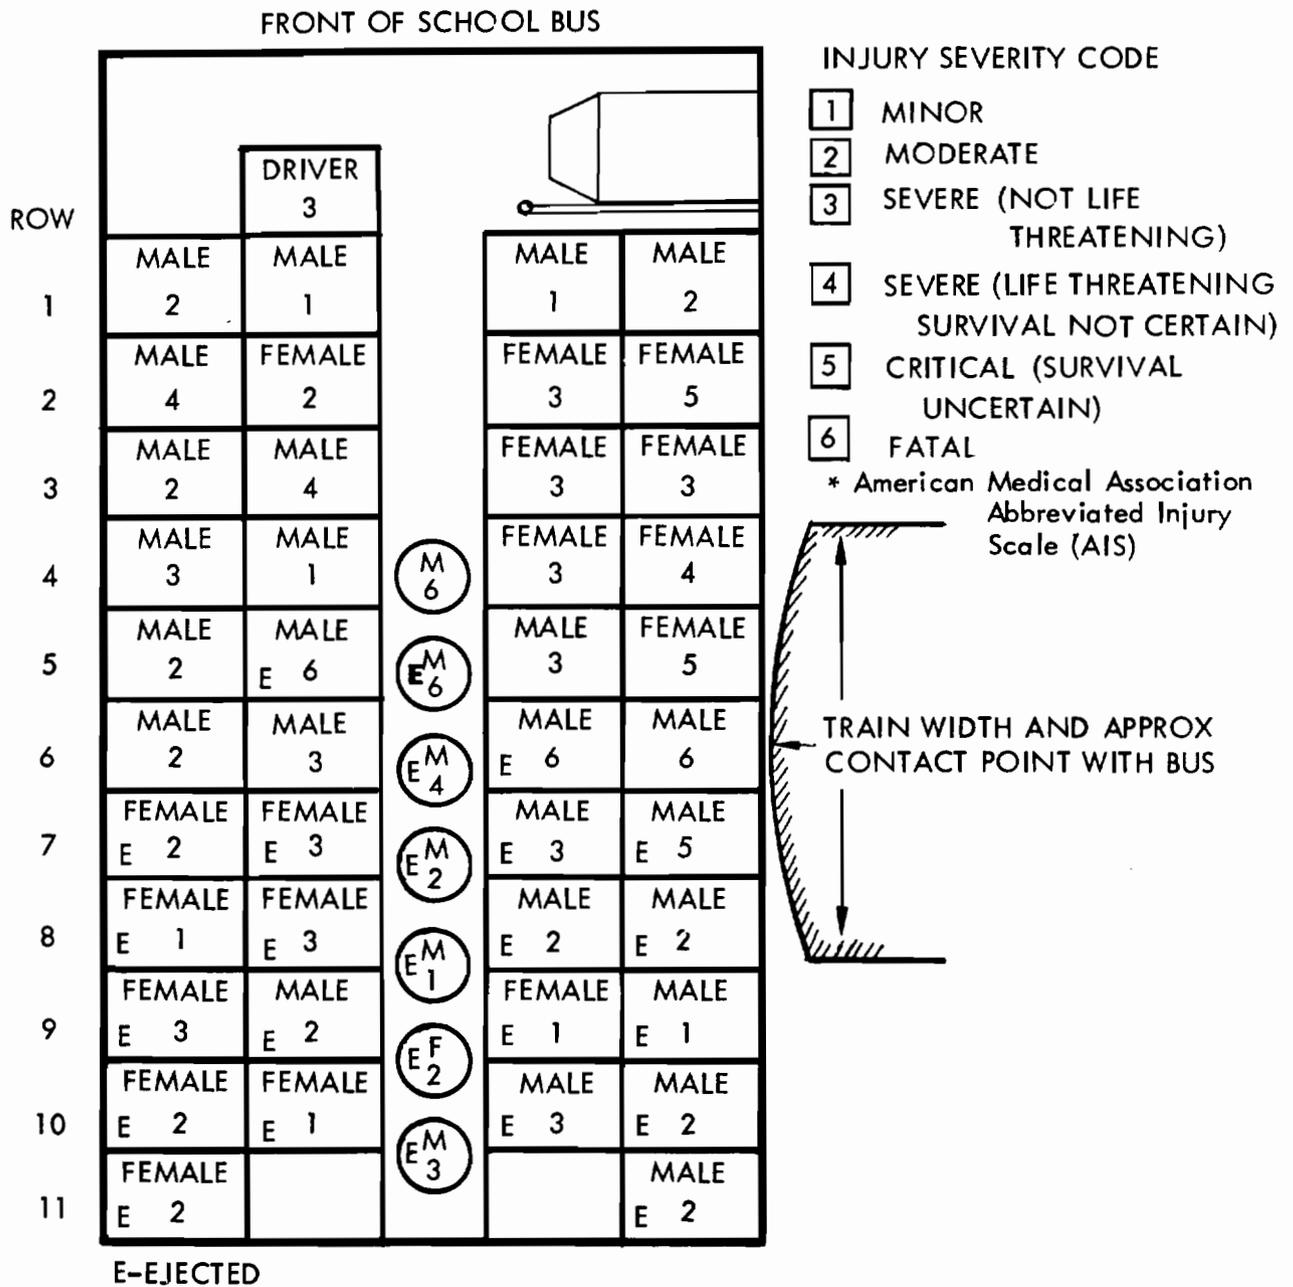
**Schoolbus passengers.** The position of the busdriver and the 49 passengers before the accident and the severity of their injuries are shown in Figure 6. A detailed description of the injuries suffered by each occupant of the bus can be found in Appendix C.

Figure 6. Precrash position of bus occupants and severity of each occupant's injuries.

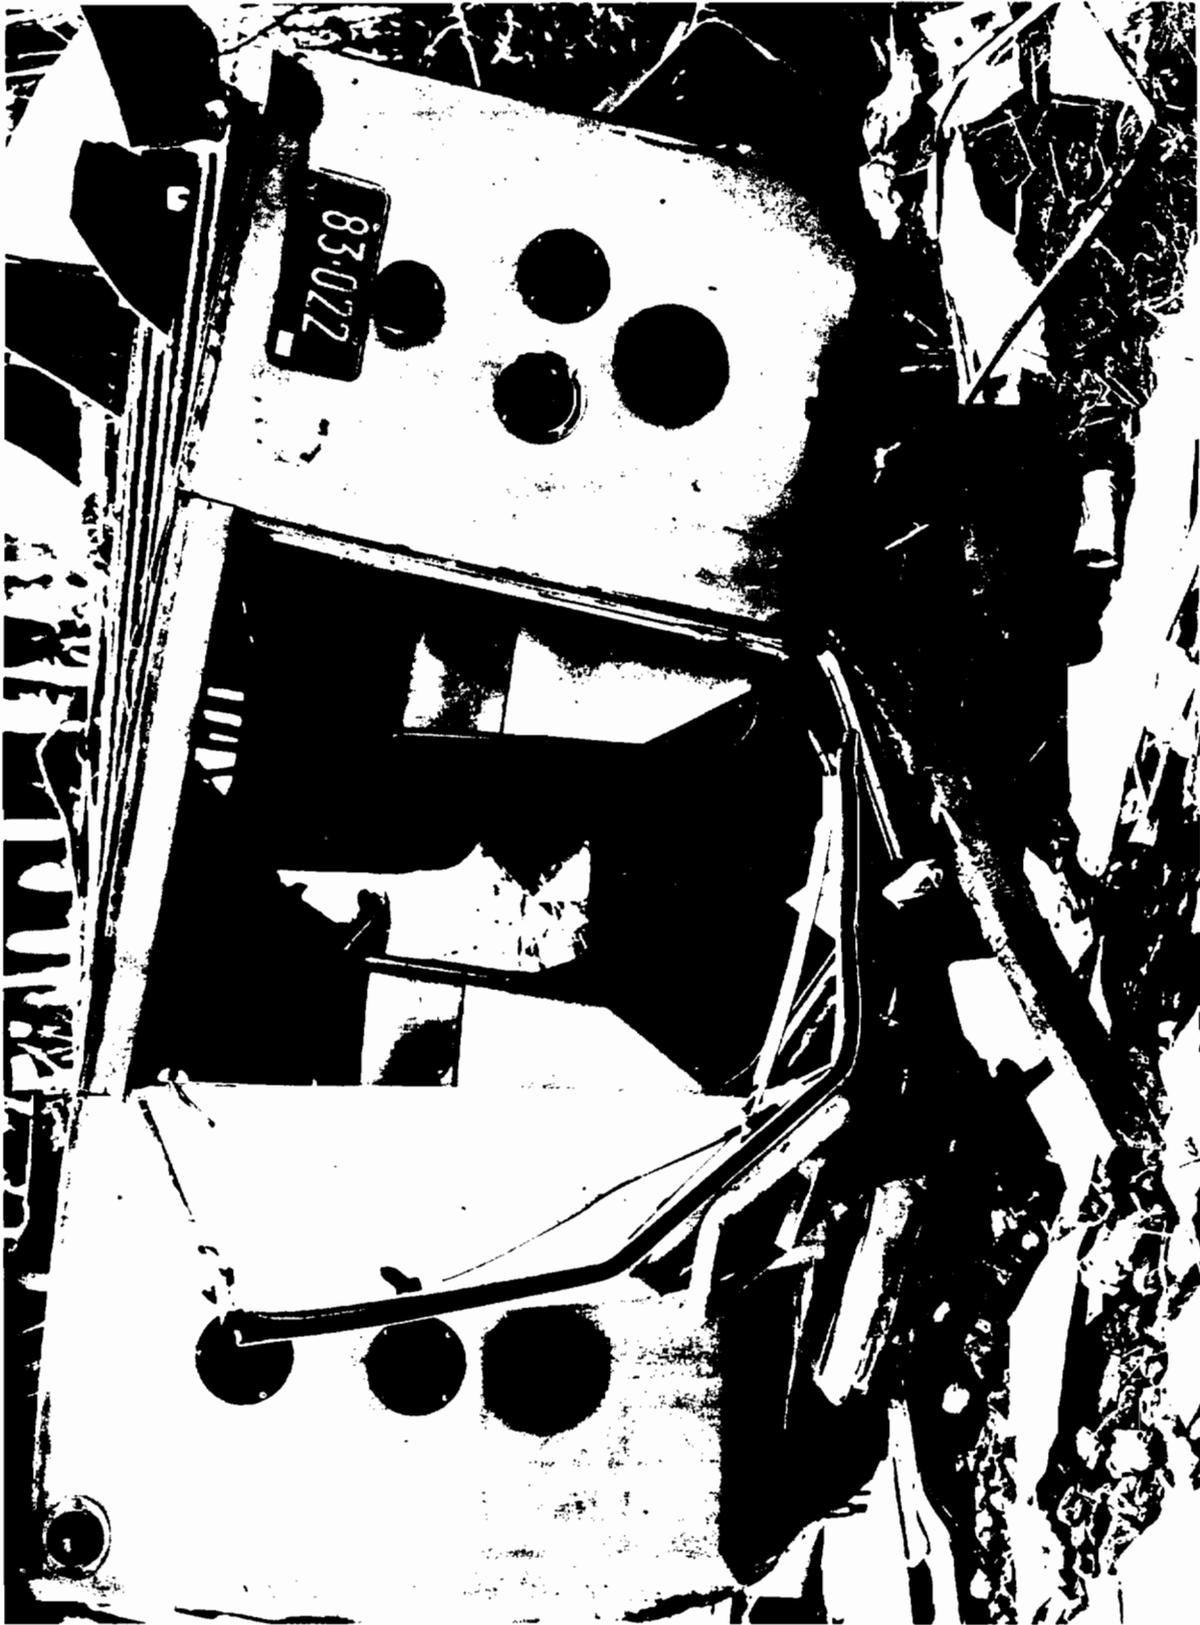
Figure 7. Rear section of schoolbus at final resting position.

After making contact with the ground, 34 feet north of the impact point, the separated rear section slid in a northerly direction for approximately 50 feet before a distorted piece of metal on the right front corner embedded in the dirt and caused the section to vault forward, turn over, and come to rest on the still-intact window columns, which then collapsed.

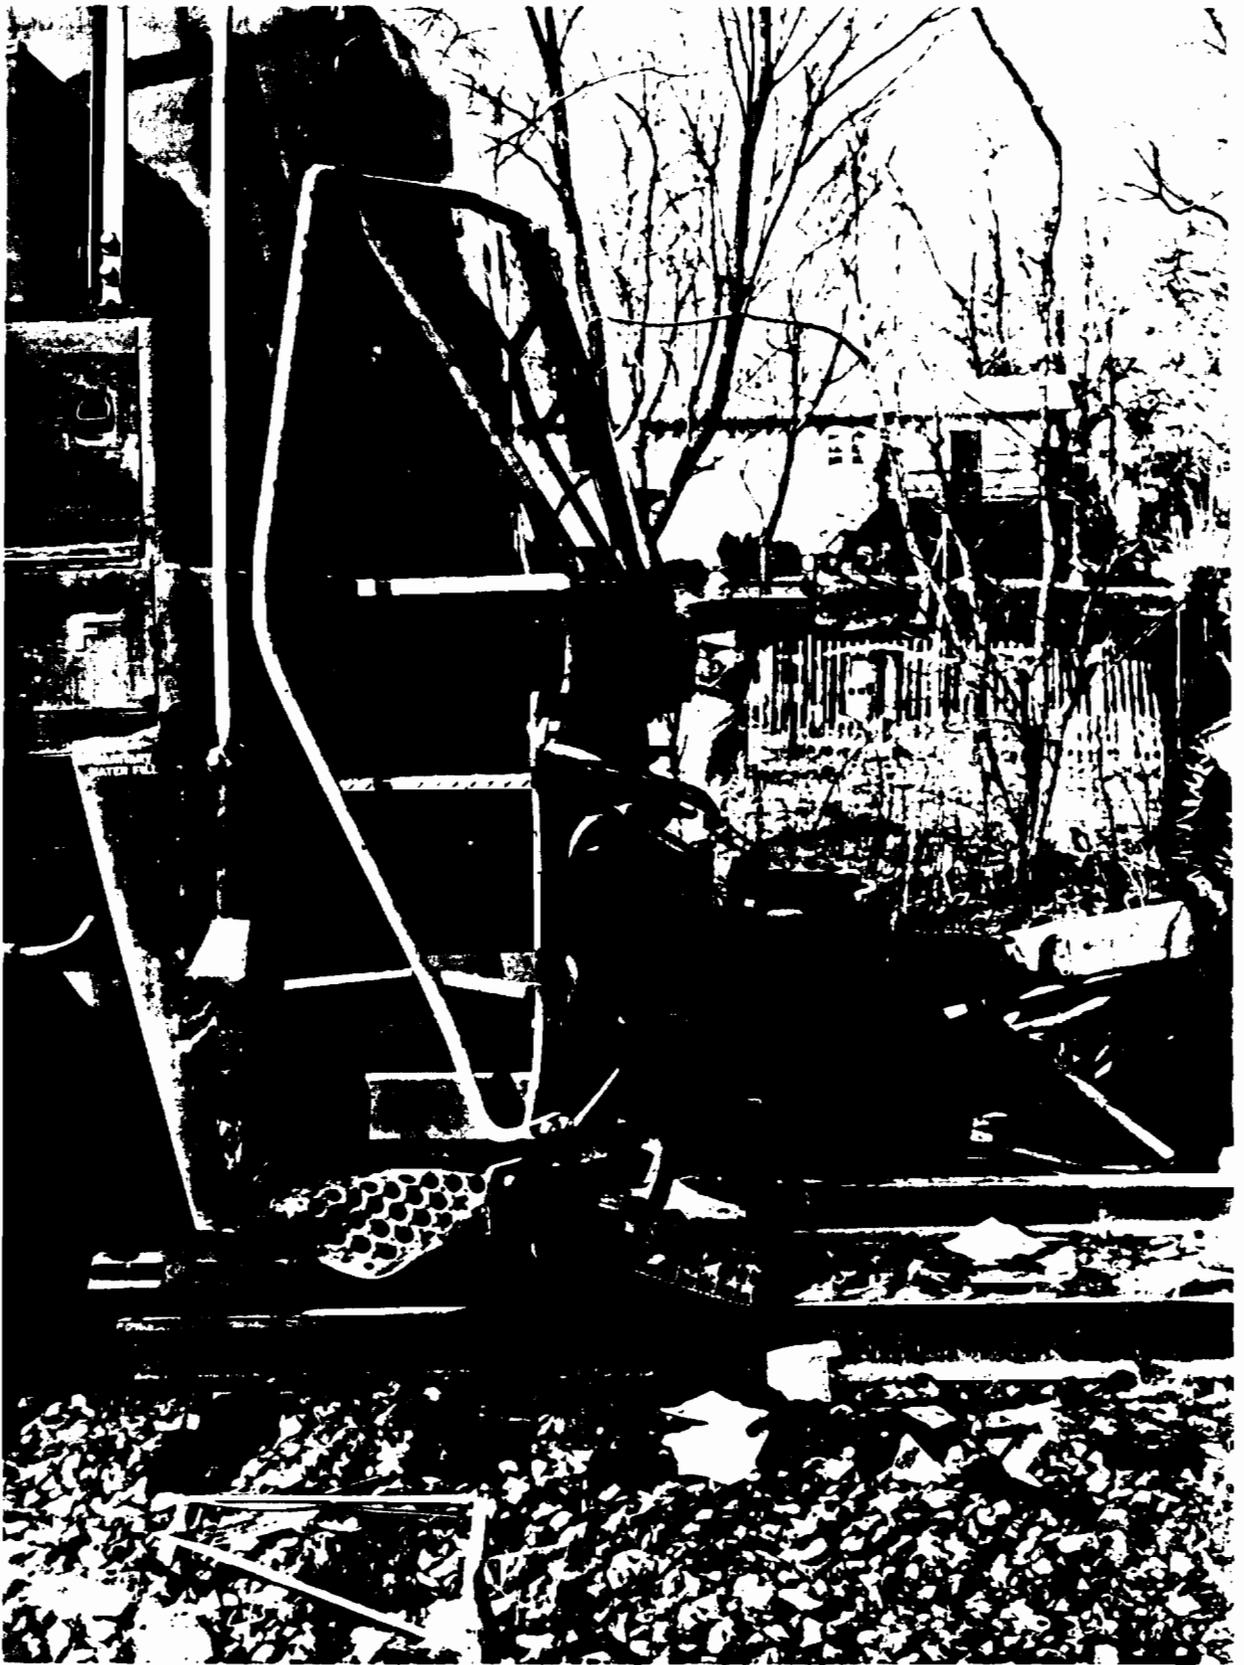
Exterior damage to the lead locomotive was relatively minor. (See Figure 9.) None of the interior components of the locomotive incurred any permanent damage.

Figure 9. Damage to lead locomotive. Note the position of the coupler.

The protruding coupler was not necessary for the operation of the locomotive on the mainline. Although the coupler is important in yard operations, it is nothing more than an occasional convenience in mainline operation. There are practical means of covering the coupler to present a configuration with greater deflective qualities. Future locomotive designs could reduce one source of collision damage through recessing the front-end coupler, as provided on passenger train locomotives. Indeed, the Federal Railroad Administration, in response to a Safety Board recommendation,<sup>7</sup> had instituted a research project to investigate the feasibility of locomotive impact-attenuation devices.

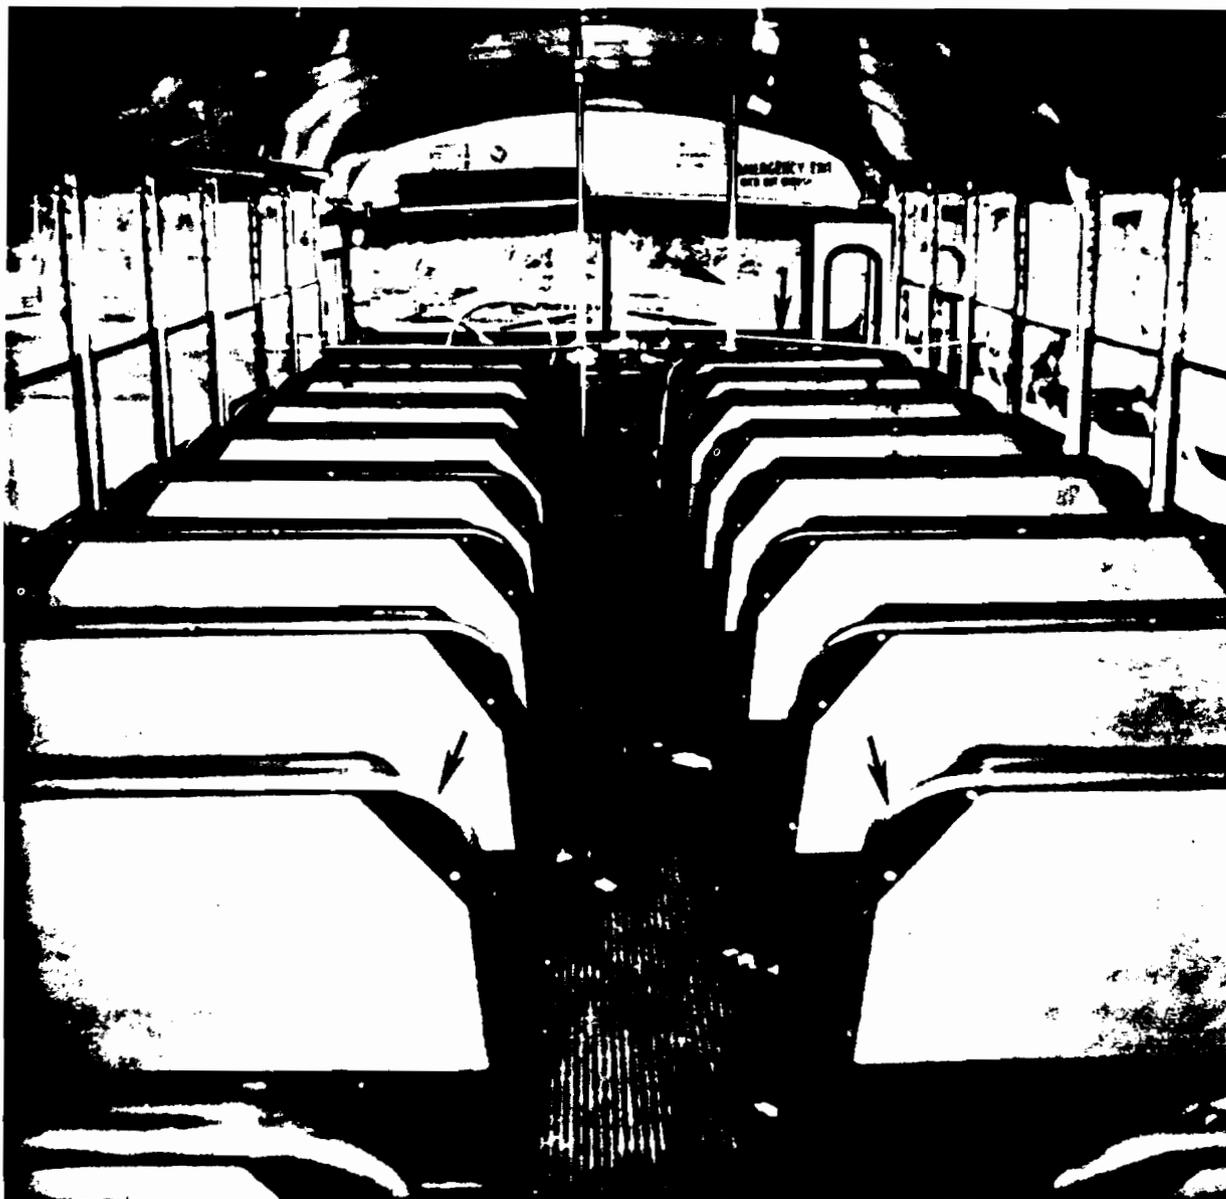
The greatest number of injuries occurred to the head. These injuries can be attributed to the tumbling movements of the passengers as they struck each other and interior components of the bus. Figure 10 shows exposed seat-frame rails which can cause head injuries. Also, seat cushions in crash situations become detached and exposed additional areas of metal framework. This condition not only increases the occurrence of head injuries, but also results in fractures of the arms and legs when those extremities become entangled in the framework. A highstress, well padded, highback seat that would retain its cushions and anchorage with the floor would prevent a significant number of such injuries. Such protection, especially for children, is important because disfiguring head and facial scars can have long-lasting effects on the development of their personalities as young adults.

Figure 10. Interior of a schoolbus similar to the vehicle involved in the accident.  
Arrows point to injury-producing components.
