NATIONAL TRANSPORTATION SAFETY BOARD

RAILROAD/HIGHWAY ACCIDENT REPORT

COLLISION OF A
LOUISIANA & ARKANSAS RAILWAY
FREIGHT TRAIN AND A L.V. RHYMES
TRACTOR-SEMITRAILER AT
GOLDONNA, LOUISIANA
DECEMBER 28, 1977

REPORT NUMBER: NTSB-RHR-78-1

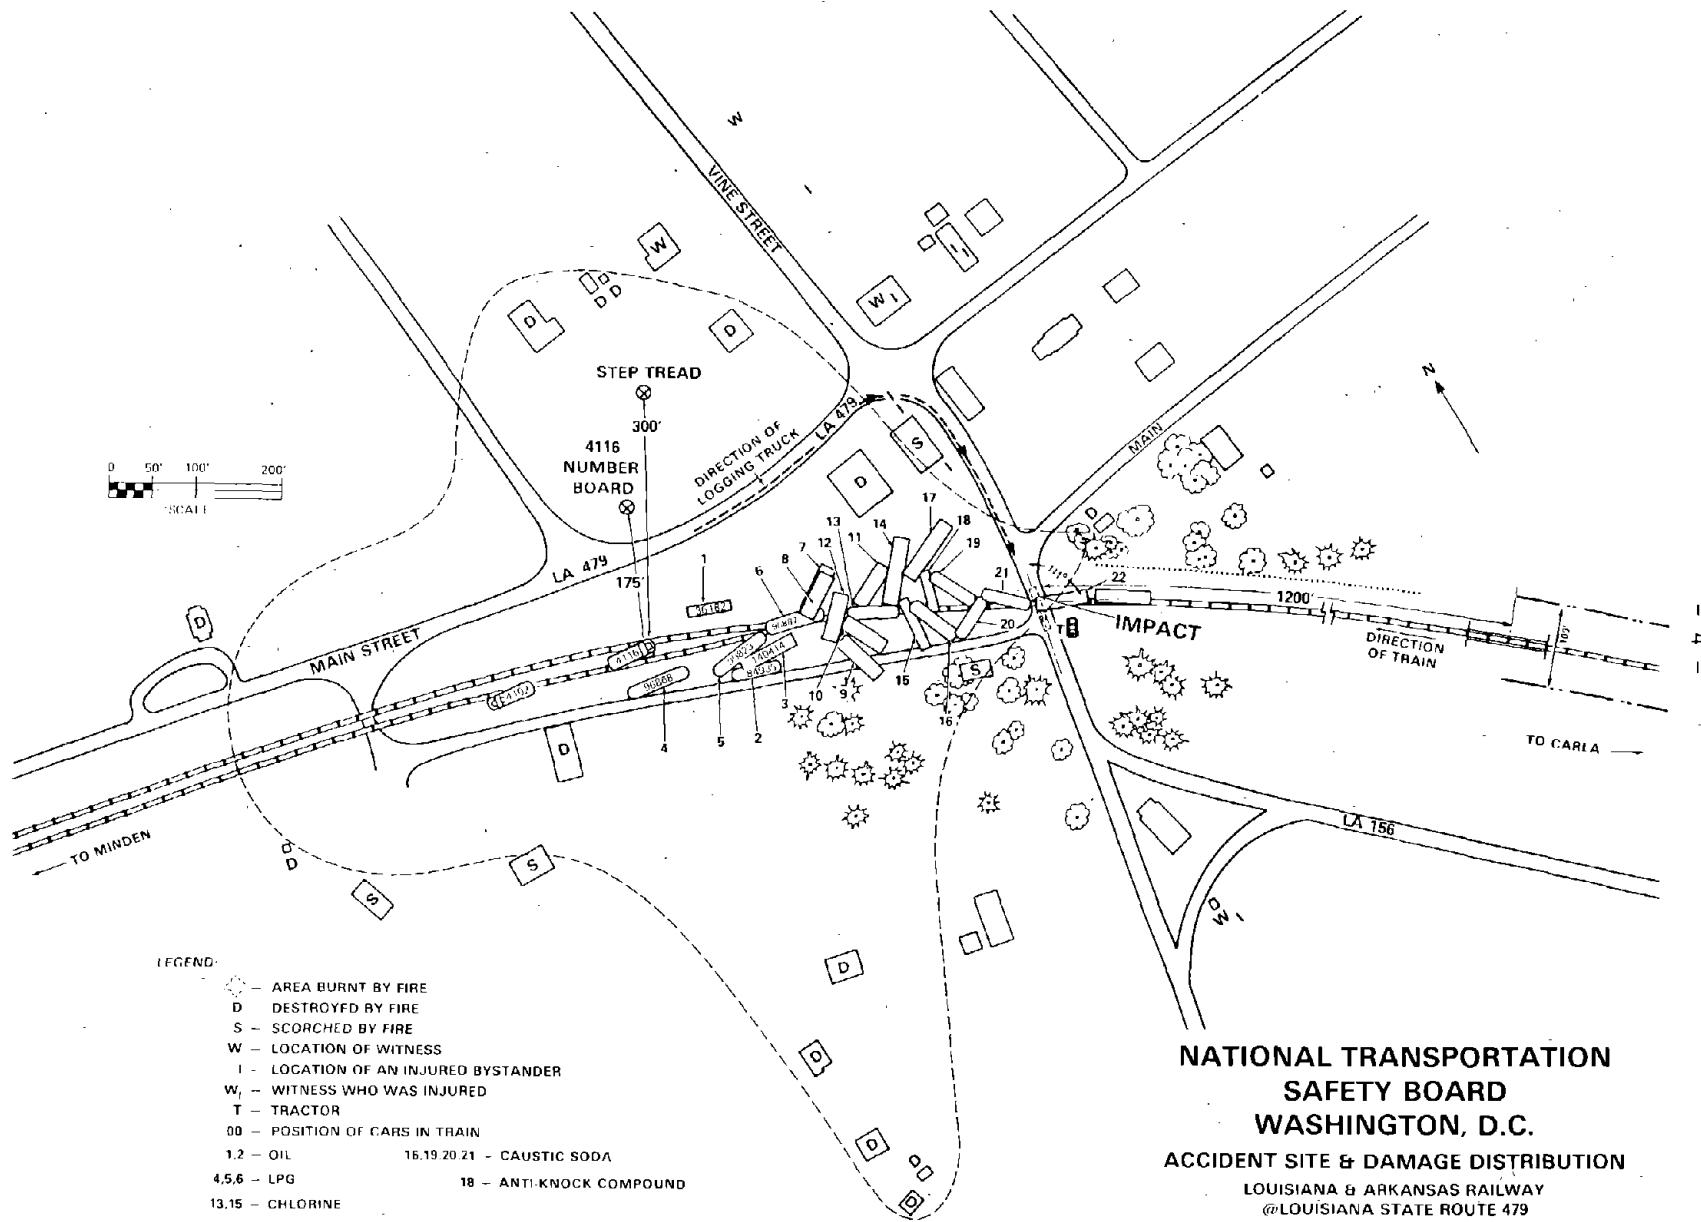
The first 22 cars of the train derailed between the turnout and the crossing, and all but the last two derailed cars became separated. The first car veered to the north and the next two cars derailed to the south. The fourth car, a tank car loaded with liquefied petroleum gas (LPG), left its trucks at the turnout, and had its rear tank head punctured by the coupler of the following car. The tank car continued to slide forward along the main track and rammed the rear of the trailing locomotive unit which was still moving westward. The impact punctured the front head of the tank and ignited the gas. The resultant fireball covered an elliptical area about 1,200 feet long on a north-south axis. (See figure 1.) Fire completely enveloped the trailing unit, killing the flagman in the cab. Fuel that escaped from the ruptured tank of the lead locomotive unit was ignited and killed the engineer and severely injured the head brakeman. The truckdriver was burned slightly as he fled his truck. Sixteen buildings in the area were burned and eight persons were injured when caught in the open after the LPG ignited.

Figure 1. Plan view of accident site and wreckage distribution.

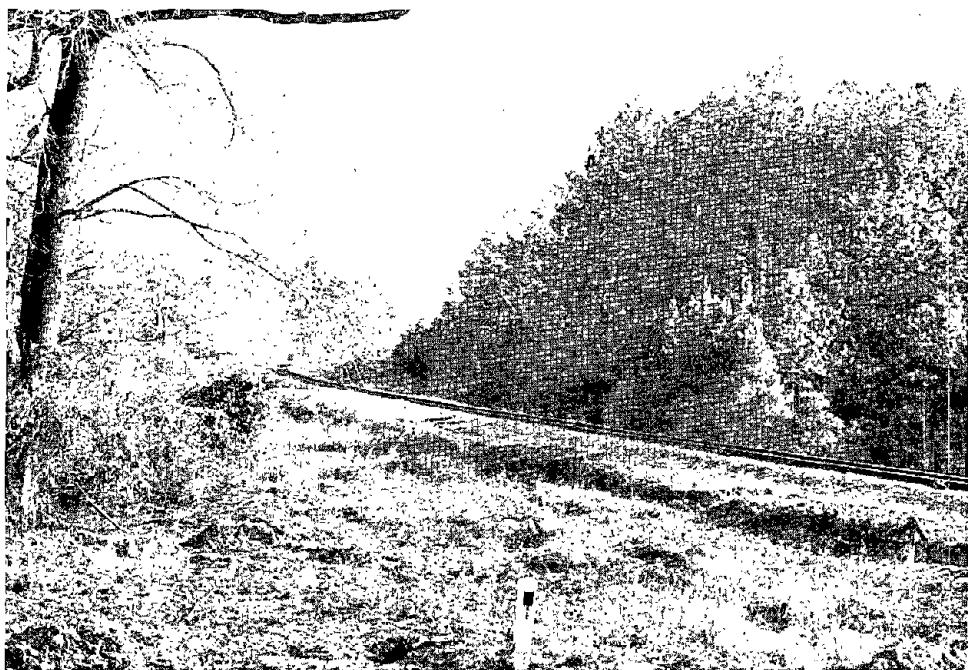
The first unobstructed view that the driver of a southbound vehicle had of the track east of the crossing was from a point 96 feet north of

the crossing. (See figures 2 and 3.) Angle of intersection in the northeast quadrant is 111°. Standard crossbuck warning signs with reflectorized faces were located in the northwest and southeast quadrants. There was a standard advance warning sign for southbound traffic located on the right shoulder of the road 106 feet north of the crossing.

Figure 2. View of track to east from 96 feet north of the crossing - truckdriver's first, unobstructed view across northeast quadrant.

In addition to the short sighting distance in the northeast quadrant of the crossing, the train's angle of approach was nearly dead ahead as seen from the point of first clear view. The driver would have had great difficulty judging the speed of the approaching train when viewing it dead ahead. After seeing the train, a driver of a heavy vehicle must instantly decide what action to take. Louisiana law requires him to stop and yield the right of way only when, in his judgment, the train's speed and location represent a hazard to him.

"Include in its grade crossing safety criteria the evaluation of existing quadrant sight distances. Include in its grade crossing safety program provision for intermediate remedial action to eliminate hazards at crossings where there are no train-activated warning devices. (Class II, Priority Action) (H-78-47)

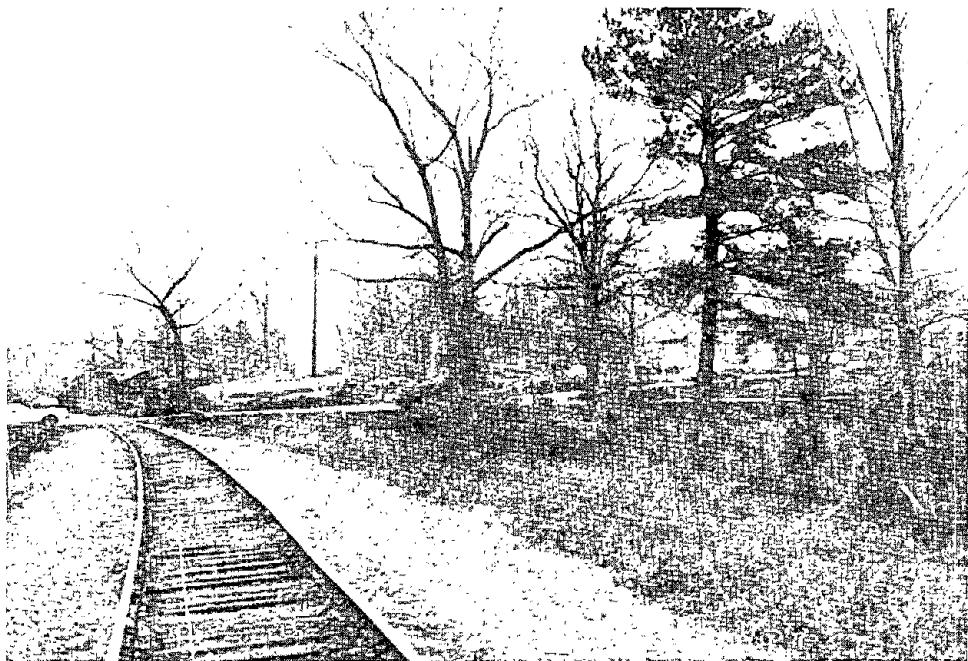
Figure 3. View of north approach to the crossing from the track 300 feet to the east. Fire defoliated the trees and destroyed a small building located in this quadrant.

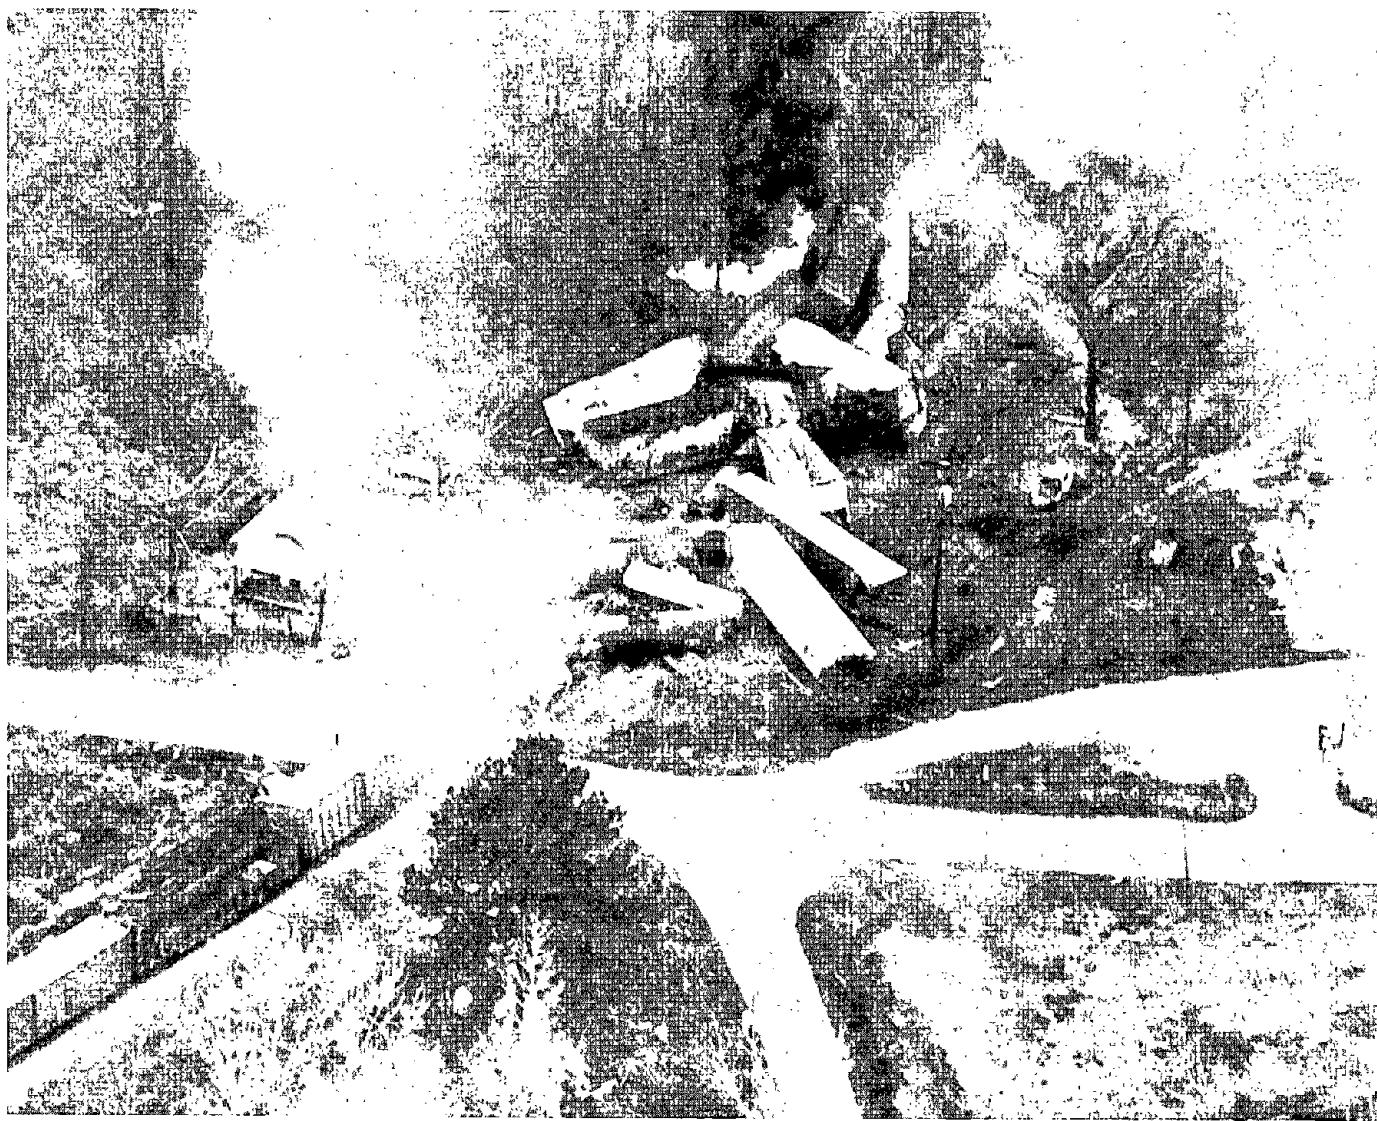
The lead locomotive unit's short hood compartment and cab were heavily damaged by the collision. Fire from the fuel tank completely burned out the unit. The trailing locomotive unit was extensively damaged when it was rammed by the tank car. Additional damage was caused by the explosion of the gas and the resultant fireball. Both locomotive units and 9 of the 22 derailed cars were destroyed. All but 2 of the remaining 13 cars were heavily damaged and much of their lading was lost. About 1,000 feet of track and a turnout were destroyed. (See figure 4.)

Figure 4. Aerial view of accident area taken from the east.

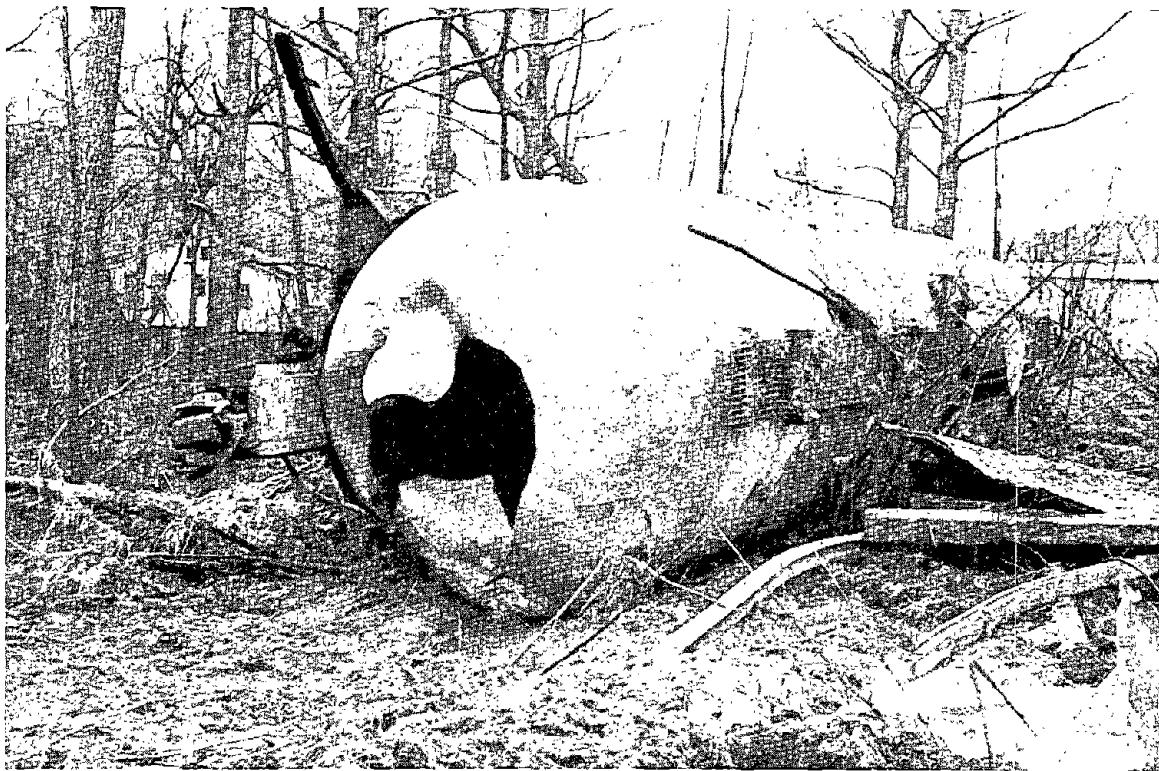
The three loaded tank cars coupled together near the head end of the train were DOT Specification 112A340W, provided with standard Type E couplers. Each was loaded with about 31,000 gallons of LPG and was placarded "Flammable Gas." The tank heads of these cars were of 11/16-inch plate steel. None of the cars were fitted with head shields or top and bottom shelf couplers. (See figure 5.)

Figure 5. Punctured head of LPG tank car GATX 96868.

The three train crewmembers on the locomotive units should have survived the collision without serious injury. The severity of the casualties was attributed to the rupture and ignition of the LPG tank car, the proximity of this car to the locomotive units, and the inability of the engineer and head brakeman to escape because the operator's compartment was so badly deformed.

"Assure that the Louisiana & Arkansas Railway Company complies with the requirements of 49 CFR 174, Transportation of Hazardous Materials. (Class II, Priority Action) (R-78-26)

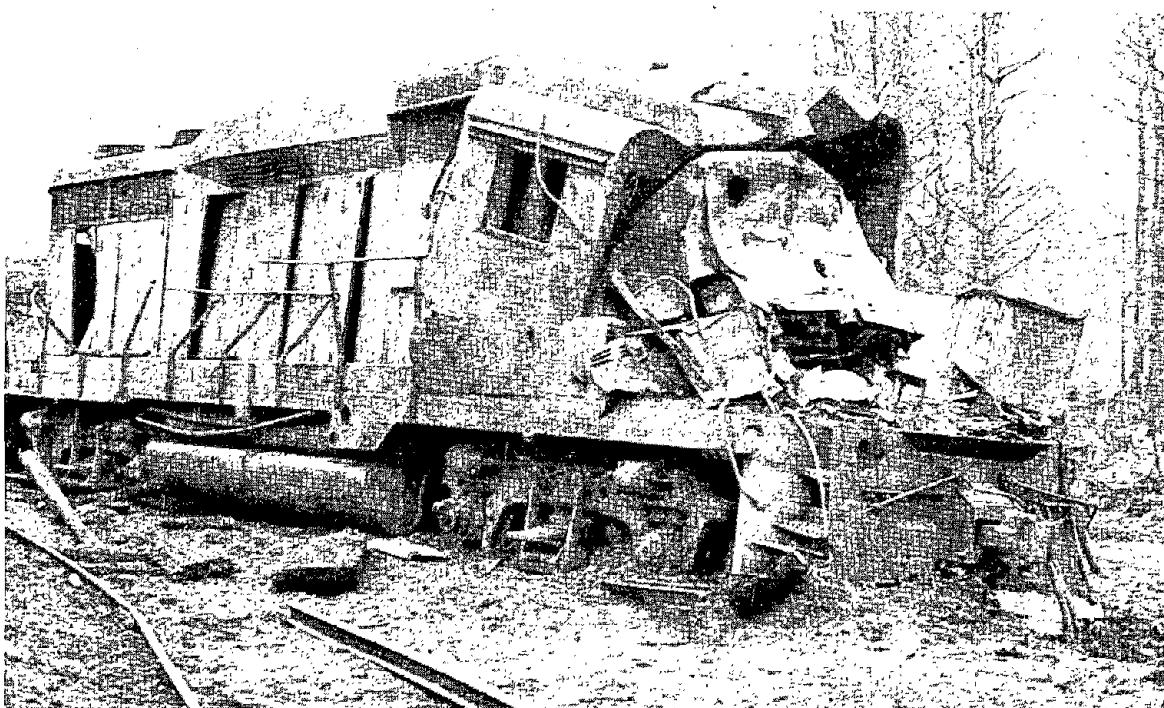
Since the lead locomotive unit's deck passed under the truck's load of logs, most of the collision impact was absorbed by the unit's forward hood compartment and cab face. (See figure 6.) The two T-type collision posts inside the hood compartment were butt-welded to the frame and the welds were not sufficient to withstand the impact force. The hood was driven back displacing 90 percent of the cab area. The cab roof partially collapsed and the floor supports on the right side were torn loose permitting the engineer's control stand to be moved back to within 7 inches of the back cabinet wall. Because of this deformation of the cab, the engineer and head brakeman could not escape. Both were trapped on their respective sides of the cab with the brakeman pinned between the hood and the left side seats. The cab of the trailing unit was within a few feet of the ruptured tank car when its cargo of LPG ignited. The force blew in the cab windows on the south side, passed through the cab, blew out the windows on the north side, and scattered parts of the locomotive unit as far as 300 feet to the north. The brakeman inside the cab was killed. There were no other persons within the area affected by the fireball; those bystanders who were injured were outside the fireball's perimeter.

Figure 6. Front end of lead locomotive unit 4102.

Because the lead locomotive unit's collision posts were inadequate, the operator compartment was so severely deformed that the men inside were trapped and unable to escape. The inability of locomotive cabs to withstand collision impacts was originally pointed out by the Safety Board in its report on an accident at Sound View, Connecticut, in 1970. ^{4/} The Safety Board recommended in 1971 that the FRA:

"Quickly conclude its study of improvements to the design of locomotive operator compartments to minimize crash damage, and promulgate necessary regulations to assure the adoption of appropriate findings. (Class II, Priority Action) (R-78-27)"
